FINAL REPORT THE CHIEF INSPECTOR OF COAL MINES

Investigation into the nature and cause of the fatal injury

BMA Blackwater Mine

February 20, 2009 On

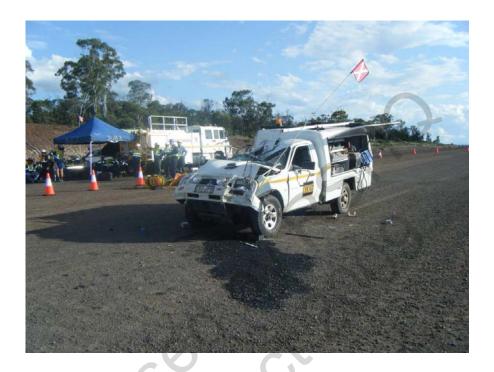
The local police officers had already taken control of the scene. The site was marked by witches' hats and a mine employee had been assigned to record the names and functions of those entering the site. The mine's rescue and ambulance teams were also near the scene, waiting to be mobilised.

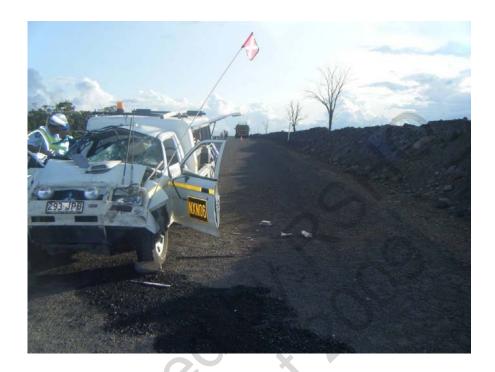
The incident happened on a straight haul road. A Mitsubishi Triton single cab utility with a covered canopy/toolbox was standing on the roadway in a "normal" driving location in left hand lane of road, approximately 4 metres from the left hand safety berm.

The cab roof was severely crushed downward on the driver's side. The deceased was in the cabin when the inspectors arrived. The air bags had not deployed.

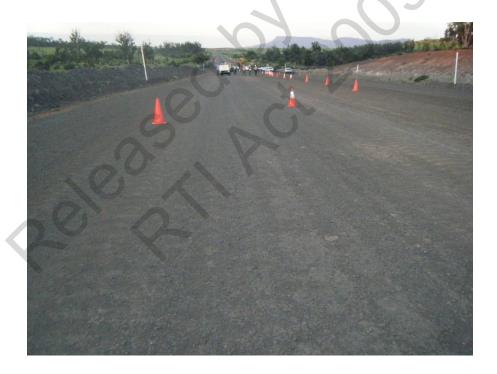
The grade near the point of impact was 4.5% downhill in the direction of travel. The road was between 25 and 28 metres wide.

The point of impact was approximately 280 m from a crest in the road to the rear (south). The road to the north (direction of travel) was straight for approximately 2.4 km, then curved to the right. The average grade over the full distance from the crest to the curve was 1.5%.

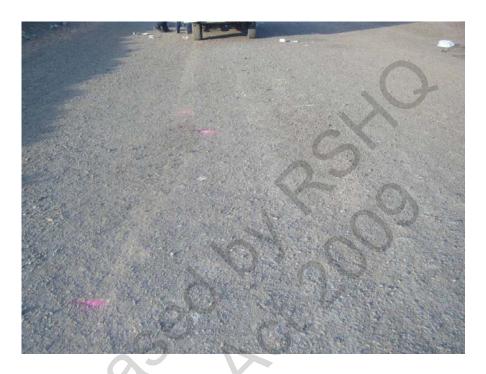
About 6 to 7 metres immediately behind light vehicle there was a zone, about 400 mm wide, with no tyre marks and covered in a thin layer of gravely material which may have been dried mud dislodged from wheel arches at the time of impact. From this gravely zone to the vehicle, fragments of broken glass are evident — the density of fragments increasing toward the vehicle.

Beyond this zone there were distinct tyre marks for both wheels extending south for a further 6 to 7 metres. They curve slightly to the right in the 1 metre or so before the gravely zone.

These marks continue to the south (up the grade), but as "normal" tyre marks for a further 80 metres. Starting from the furthest point from the LV (near top of crest) this 80 m of tyre marks indicate a gradual "drifting" off line to the left in the direction of travel - perhaps 1 metre in total. In that distance there appears to be two partial corrections about equally spaced.

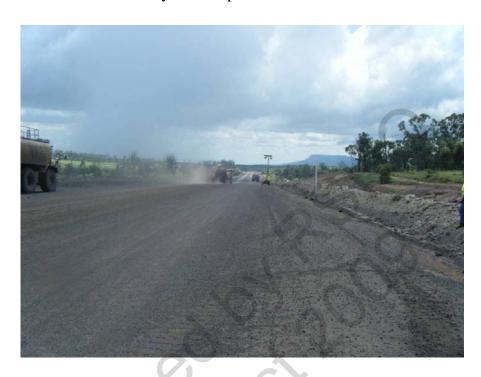
The environment at about the same time on the next day is shown in this photo. Weather conditions on both days were reported to be similar.

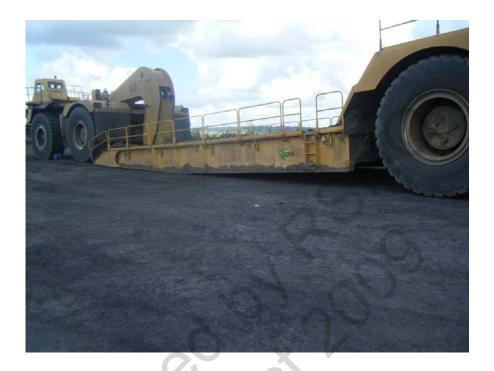
The Towhaul was secured at Ramp 50 crib hut after the driver was advised of the incident.

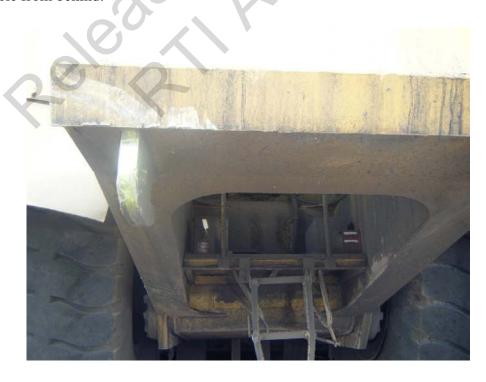
A visual inspection showed marks that were consistent with a collision with a light vehicle from behind.

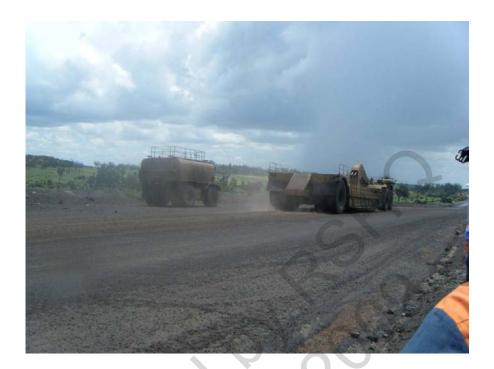
In the opinion of the inspectors, the amount of dust raised would not affect visibility on the road at the time of the accident.

Mr s.73 | red | had advised that, in his opinion, the dust was not significant on the previous day. He advised that on a scale of 1 to 10 with 10 being the worst dust on a normal haul road at the mine, the rating would have been 6 at the top of the crest, gradually reducing to 4 at the bottom of the slope.
