# Lessons Learned from Mine Disasters: New Technologies and Guidelines to Prevent Mine Disasters and Improve Safety

By Jürgen F. Brune and Benjamin Goertz

## A Research Report

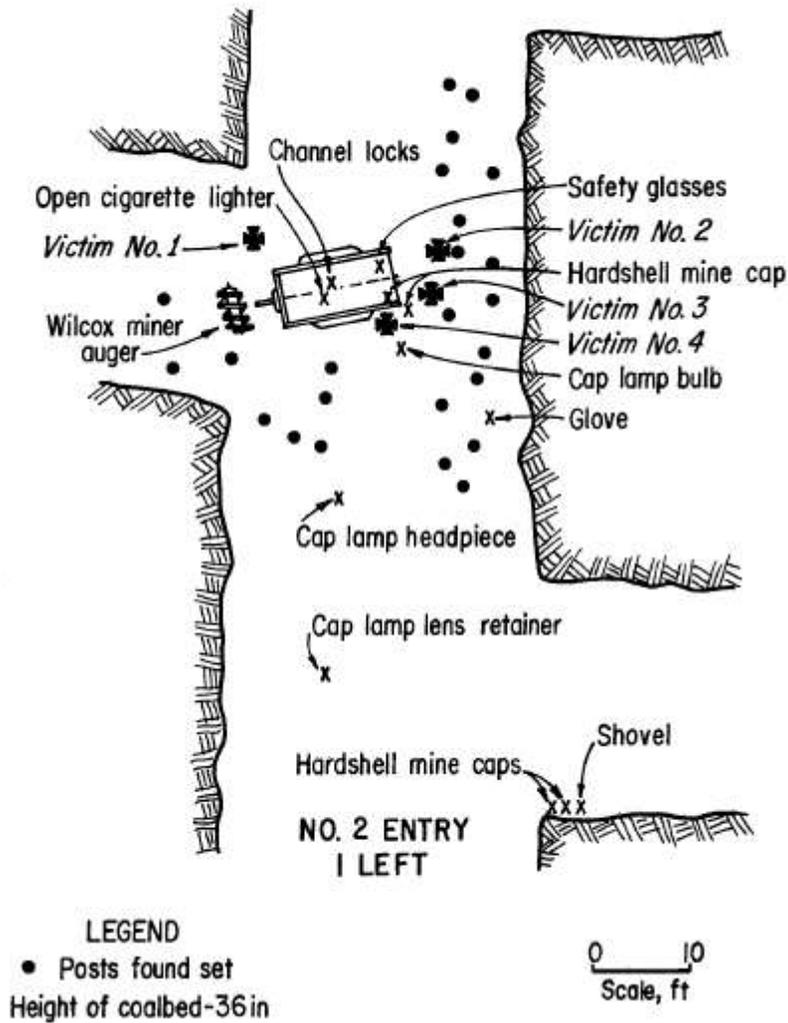
Figure 4: Detail of explosion scene showing victim locations, P and P mine explosion, 1977 (Michael et al., 1977)

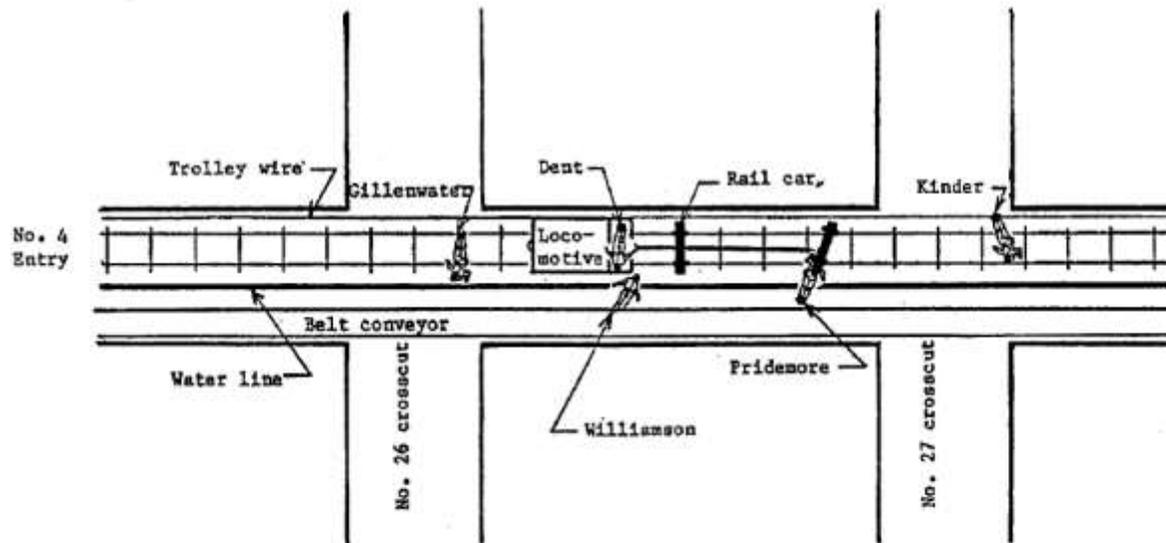
suspected ignition source was a spark from a trolley wire mantrip locomotive the crew was using to transport themselves and equipment to the worksite.

Figure 5: Sketch of the accident scene at the Ferrell No. 17 mine (Potter et al., 1980)

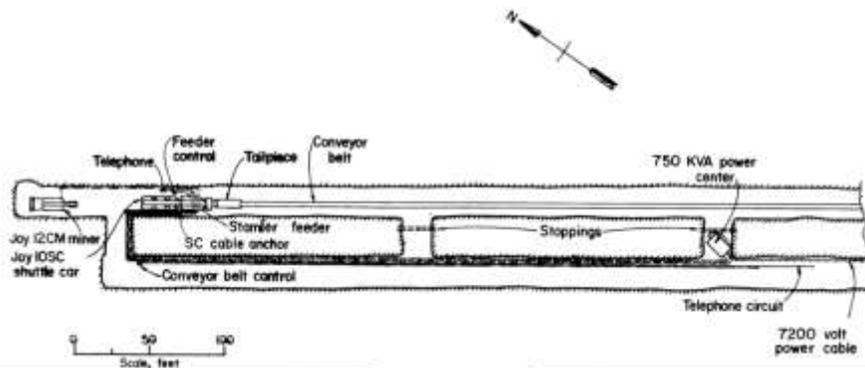
Figure 6: Map of 102 Section, Dutch Creek No. 1 Mine (Elam et al., 1981)

The outburst had occurred due to extensive stress from the overburden and other geological conditions prevalent at the mine. The ventilation at the time of the explosion was not sufficient to properly dilute the methane and coal dust that was introduced into the face environment. The continuous miner had a methane monitor installed that was designed to de-energize the machine when the methane concentration exceeded 2.0 percent. The lighting system had been installed by an unqualified person. The installation left a gap that led to the electrical components not being in permissible condition.

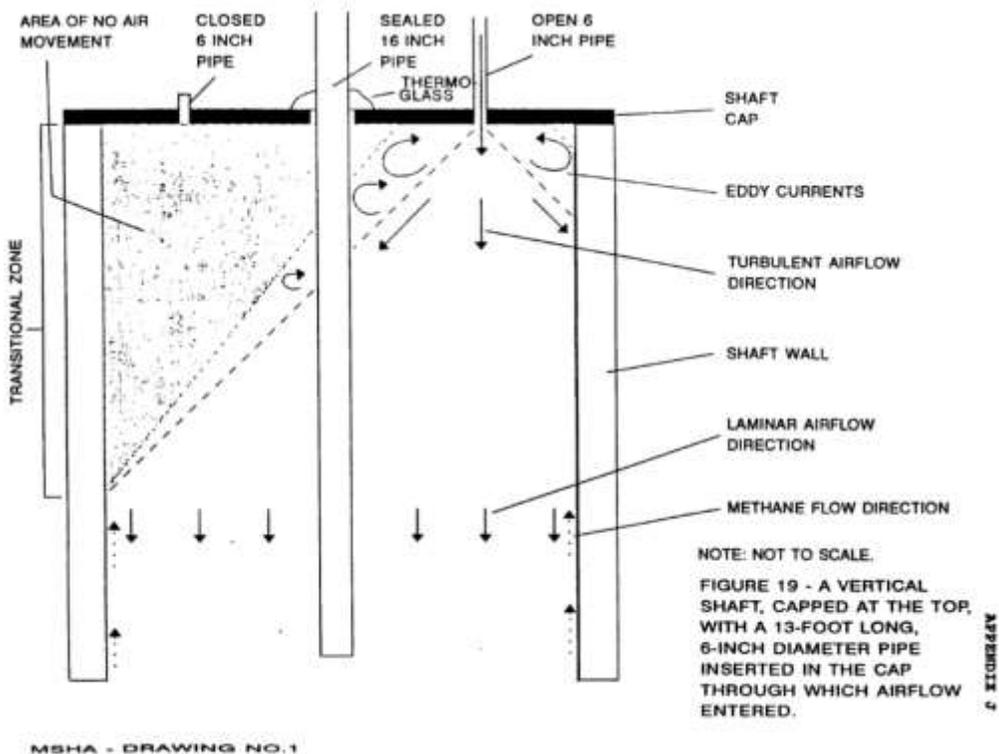
Figure 16: Cross section through the shaft cap at the Blacksville No. 1 mine (Rutherford et al., 1992)

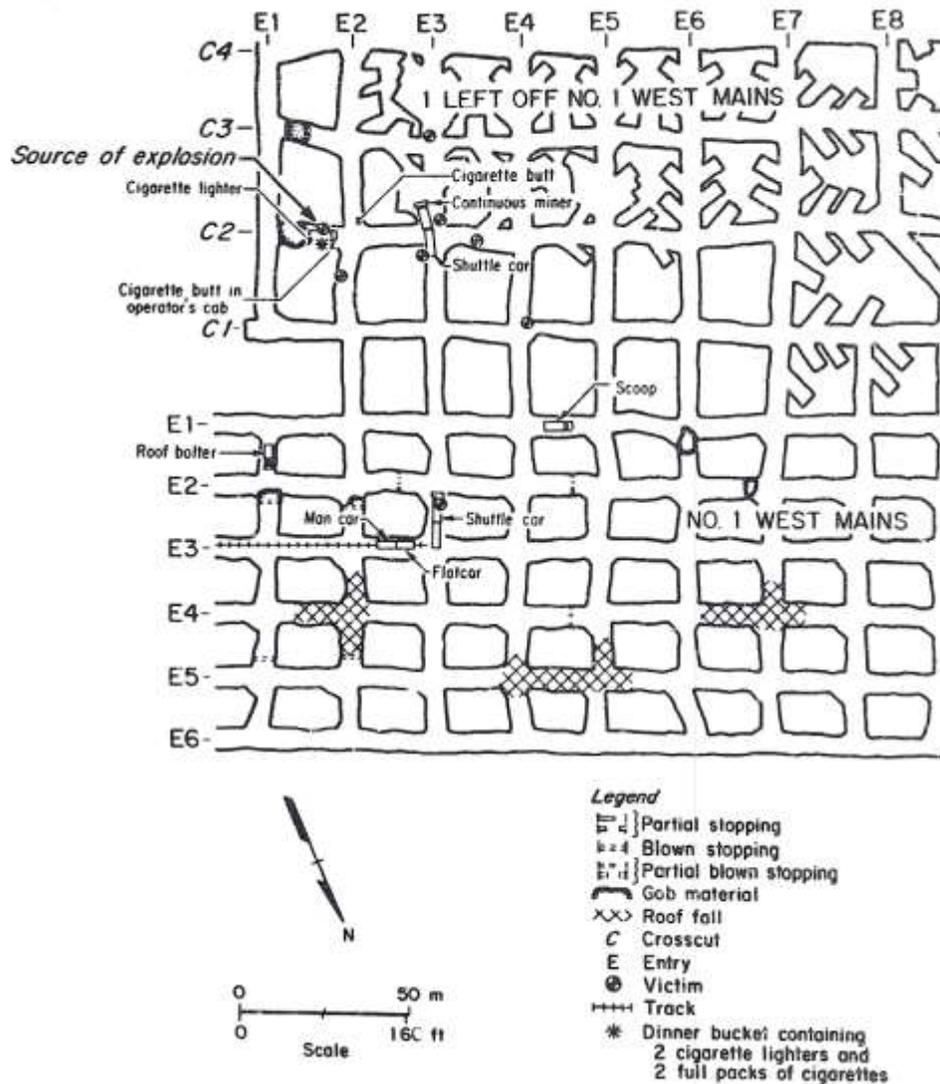
The Southmountain Coal No. 3 Mine, operated by Company, located in Norton, Virginia, produced coal using room and pillar mining with continuous mining machines. Figure 17 shows the explosion location on the mine map. At approximately 6:15 a.m. on December 7<sup>th</sup>, 1992 a methane and coal dust explosion occurred on the 1 Left section of the mine which resulted in the death of eight miners. The MSHA investigation report by Thompson et al. (1993) provided the following detail: The source of ignition was determined to be a cigarette lighter found on the mine floor. A cigarette pack containing nine unsmoked cigarettes was found on a victim located at the point of origin and ten cigarette butts were found in his pockets.

Figure 17: Explosion origin and important locations for Southmountain Coal Co. No. 3 Mine (MSHA 1998).

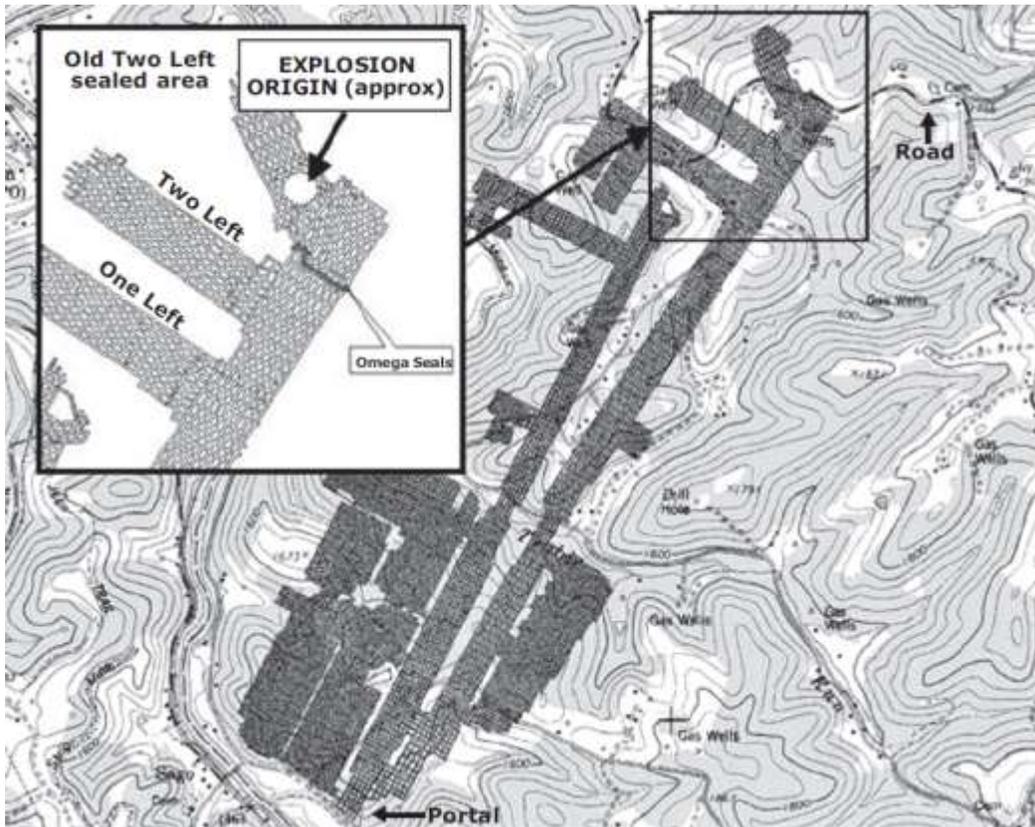
Figure 22: Map of Sago Mine (McAteer 2006), showing the location of No. 2 Section and the origin of the explosion.

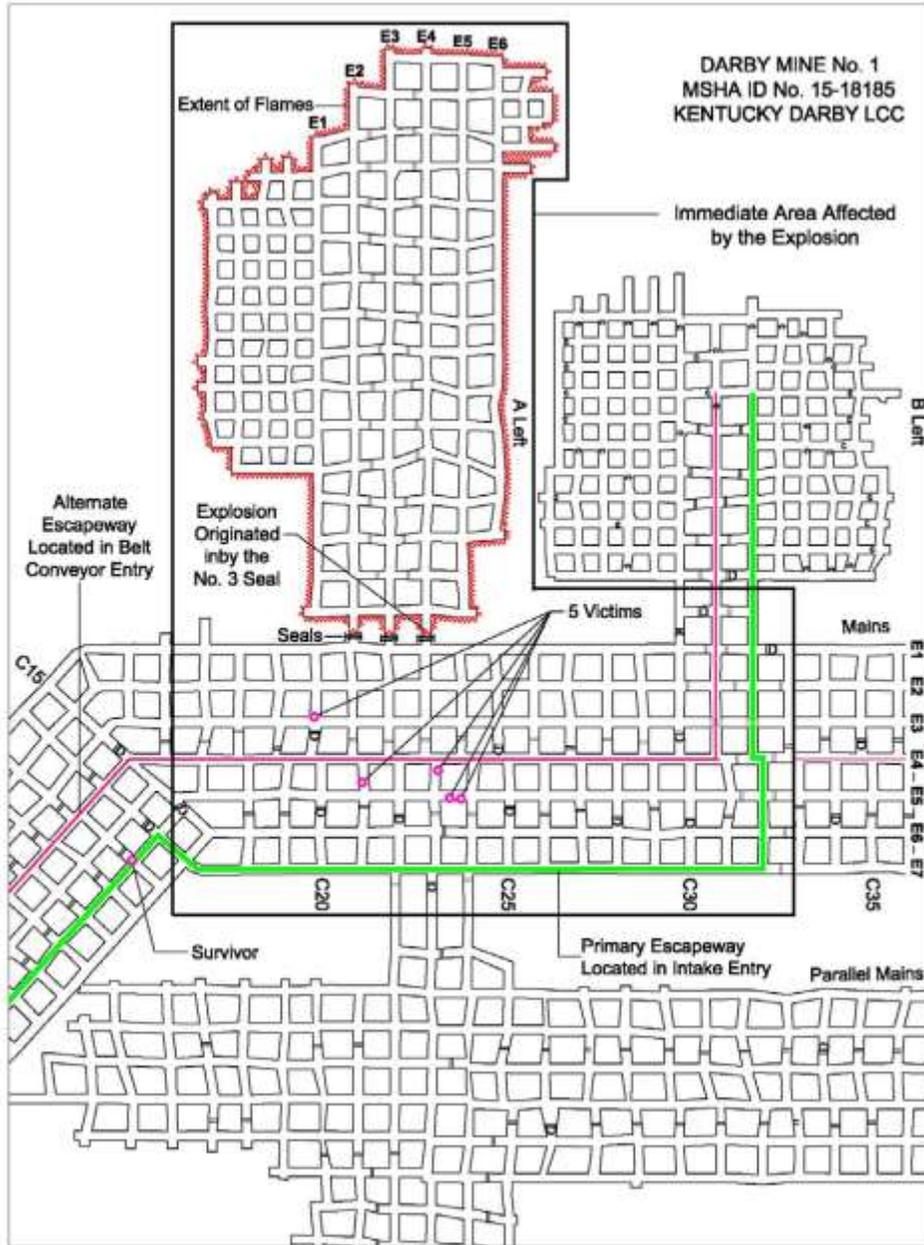
Approximately two months before the explosion, the company had completed mining in the A Left Section and had built three seals to isolate the worked-out area from the active, ventilated sections. During the construction of the No. 3 seal, metal roof straps had been left in place that extended from the active area into the sealed area. Two workers went underground at the beginning of the shift at approximately 12:45 a.m. with the intent of cutting off the metal straps at the face of the seal. Evidence suggests that the two miners had begun cutting the metal straps with the acetylene torch and this was the likely source of ignition. The force from the explosion is the identified source of the fatal injuries to these two miners.

Figure 24: Diagram of explosion area and victim location as identified by Light et al. (2006).

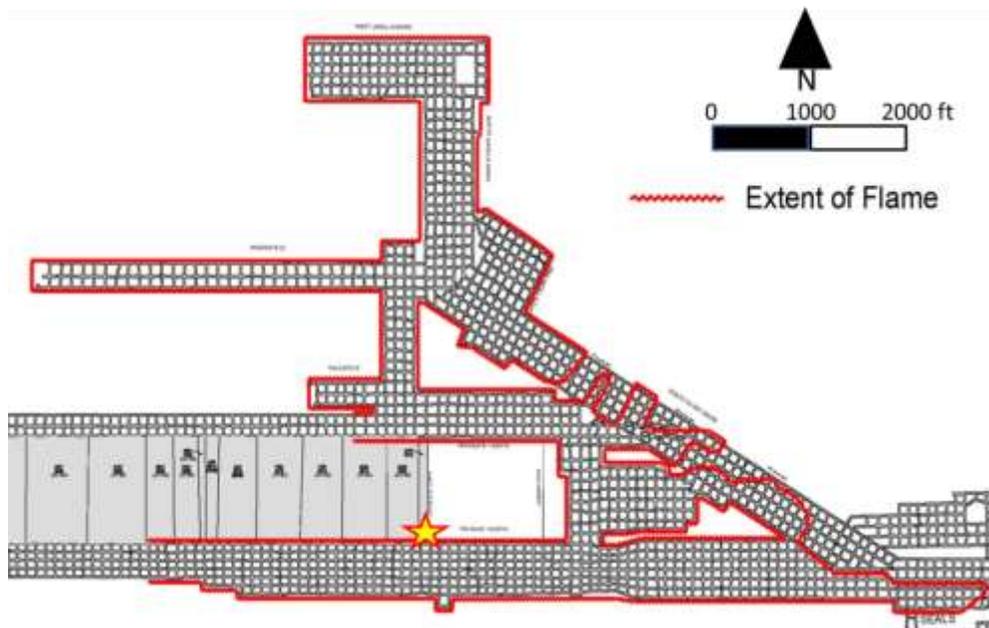
in the longwall tailgate entries inby the face. This water may have reduced the amount of air flowing across the longwall face and contributed to the accumulation of methane that led to this initial explosion.

Figure 28: Extent of the flame zone of the Upper Big Branch mine explosion. The star indicates the origin of the explosion on the tailgate side of the longwall face. Modified after Page (2011).
