## INSPECTOR'S REPORT

**FATALITY**  
**IAN DOWNES**  
**GRASSTREE MINE**  
**11 DECEMBER 2014**

DATE of REPORT: 12 April 2015  
FILE REF: [FILE NUMBER FROM DATABASE]

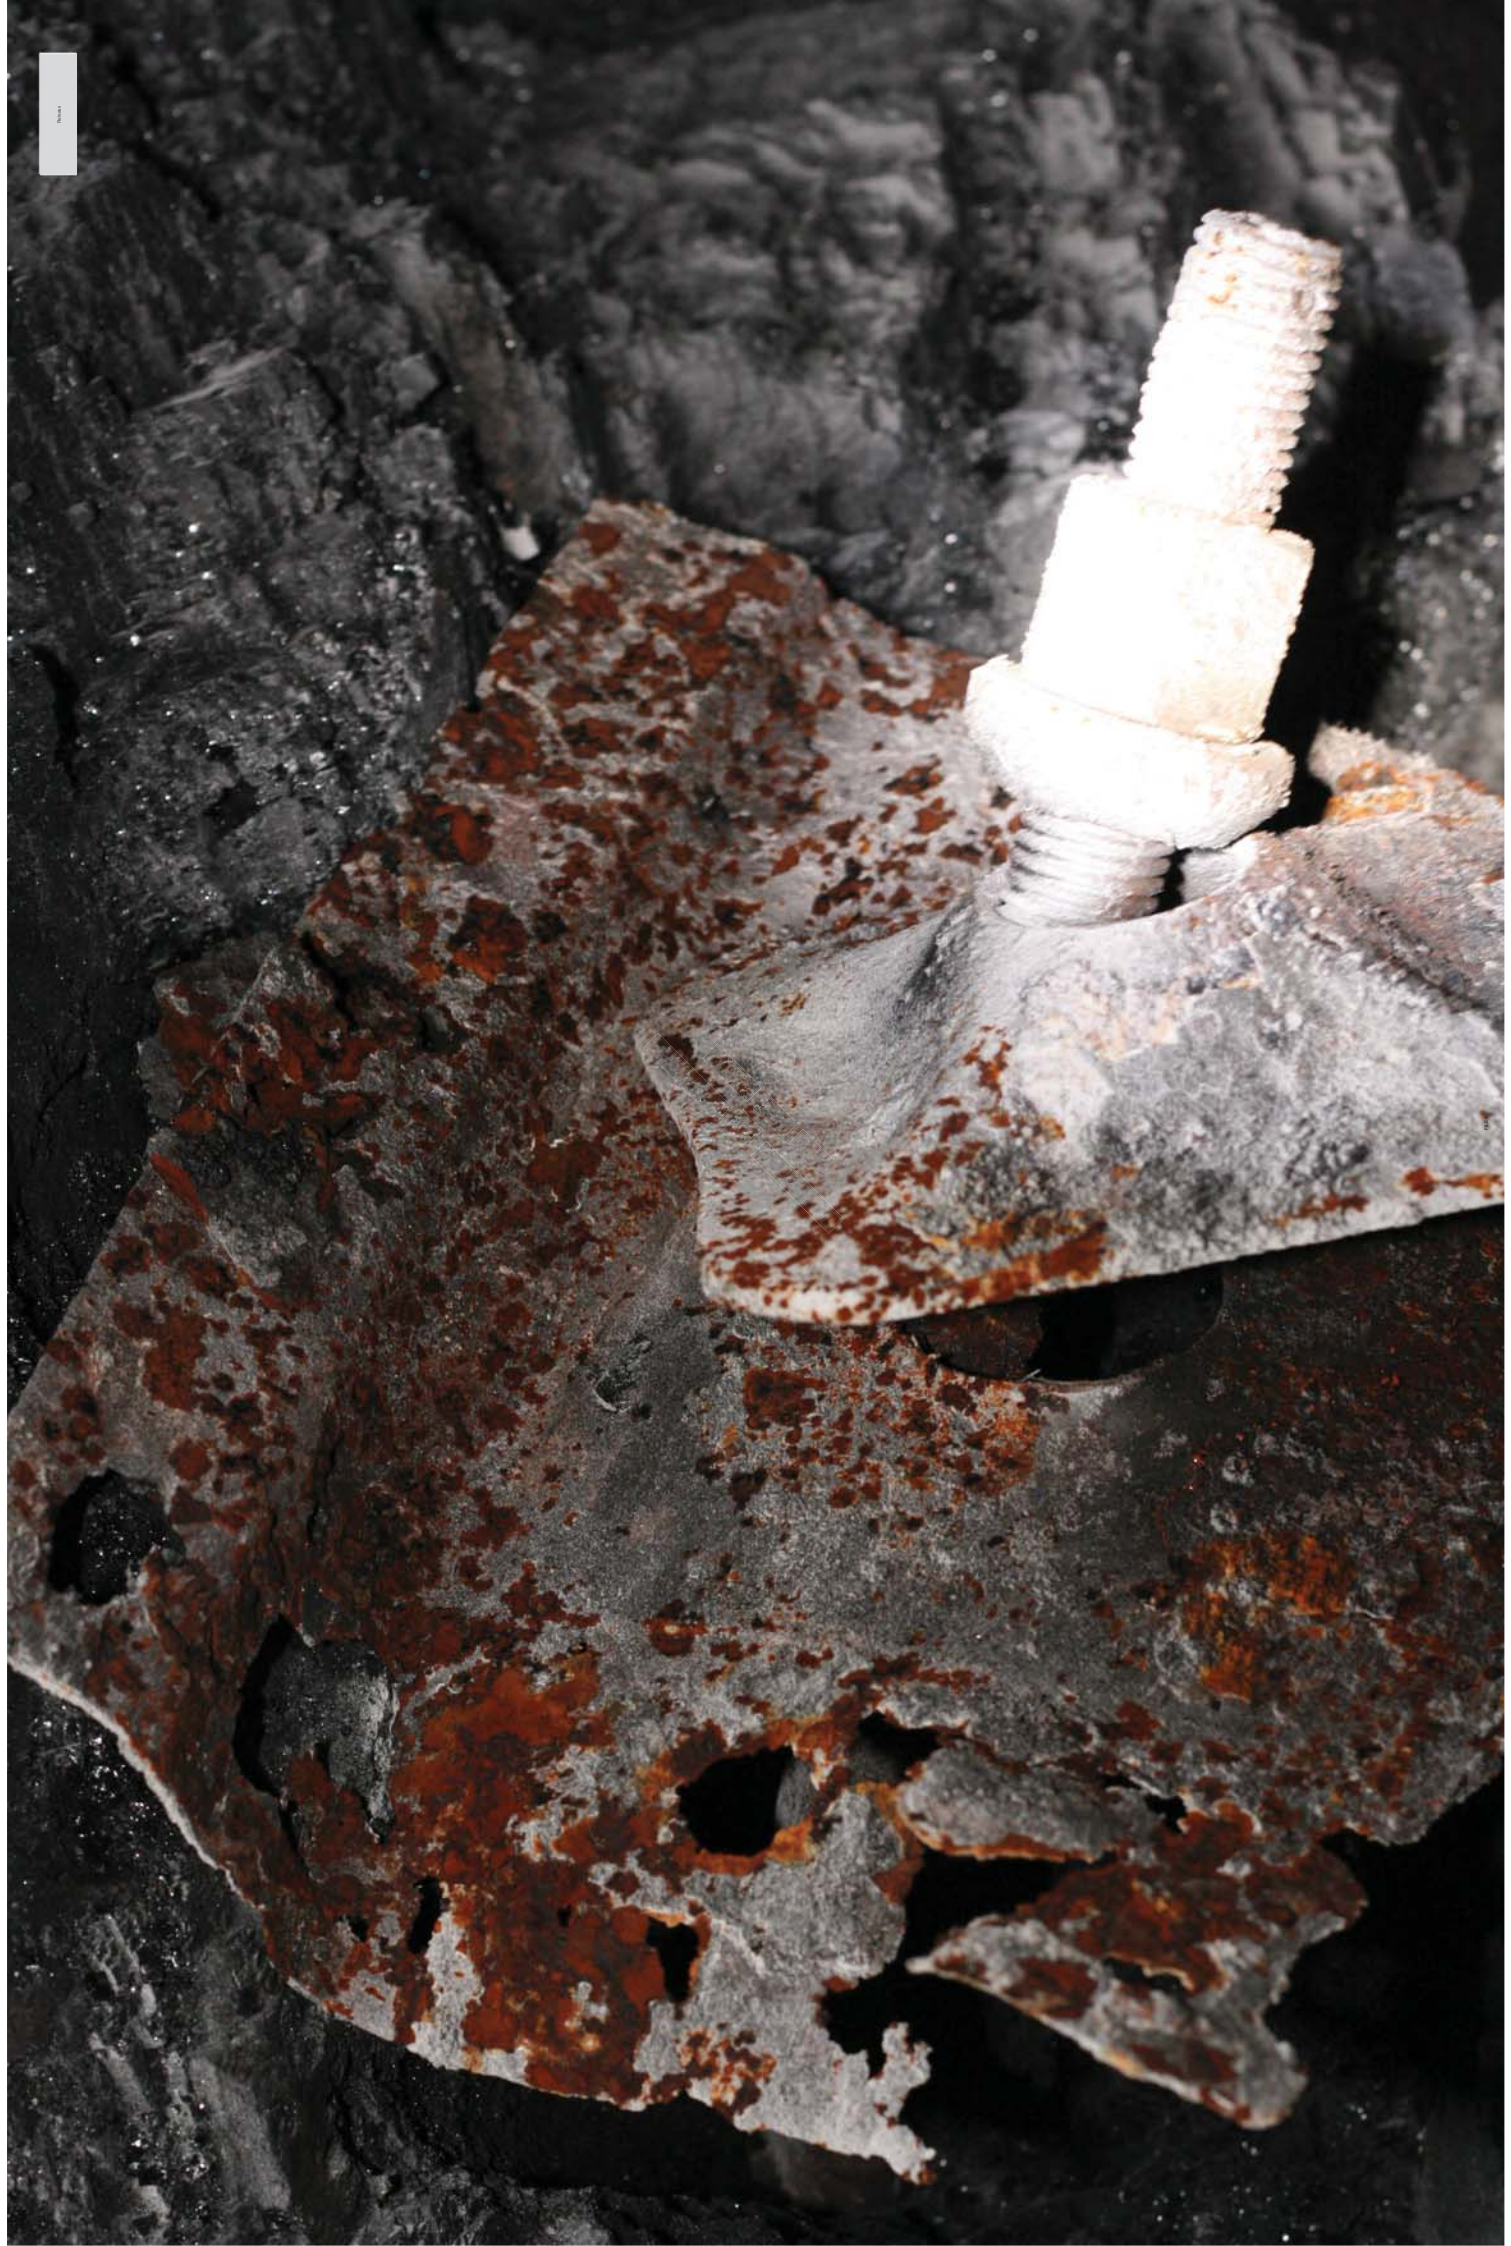
The stowage was in the roadway for approximately 15 months. This resulted in the primary rib support bolts becoming extensively corroded. The stowage was removed by LHD Loader, and during this process several rib bolts and plates were damaged. As a result of the corrosion and damage, these bolts were not performing to their design standard.

Fail Zone

Corroded and damaged  
rib support

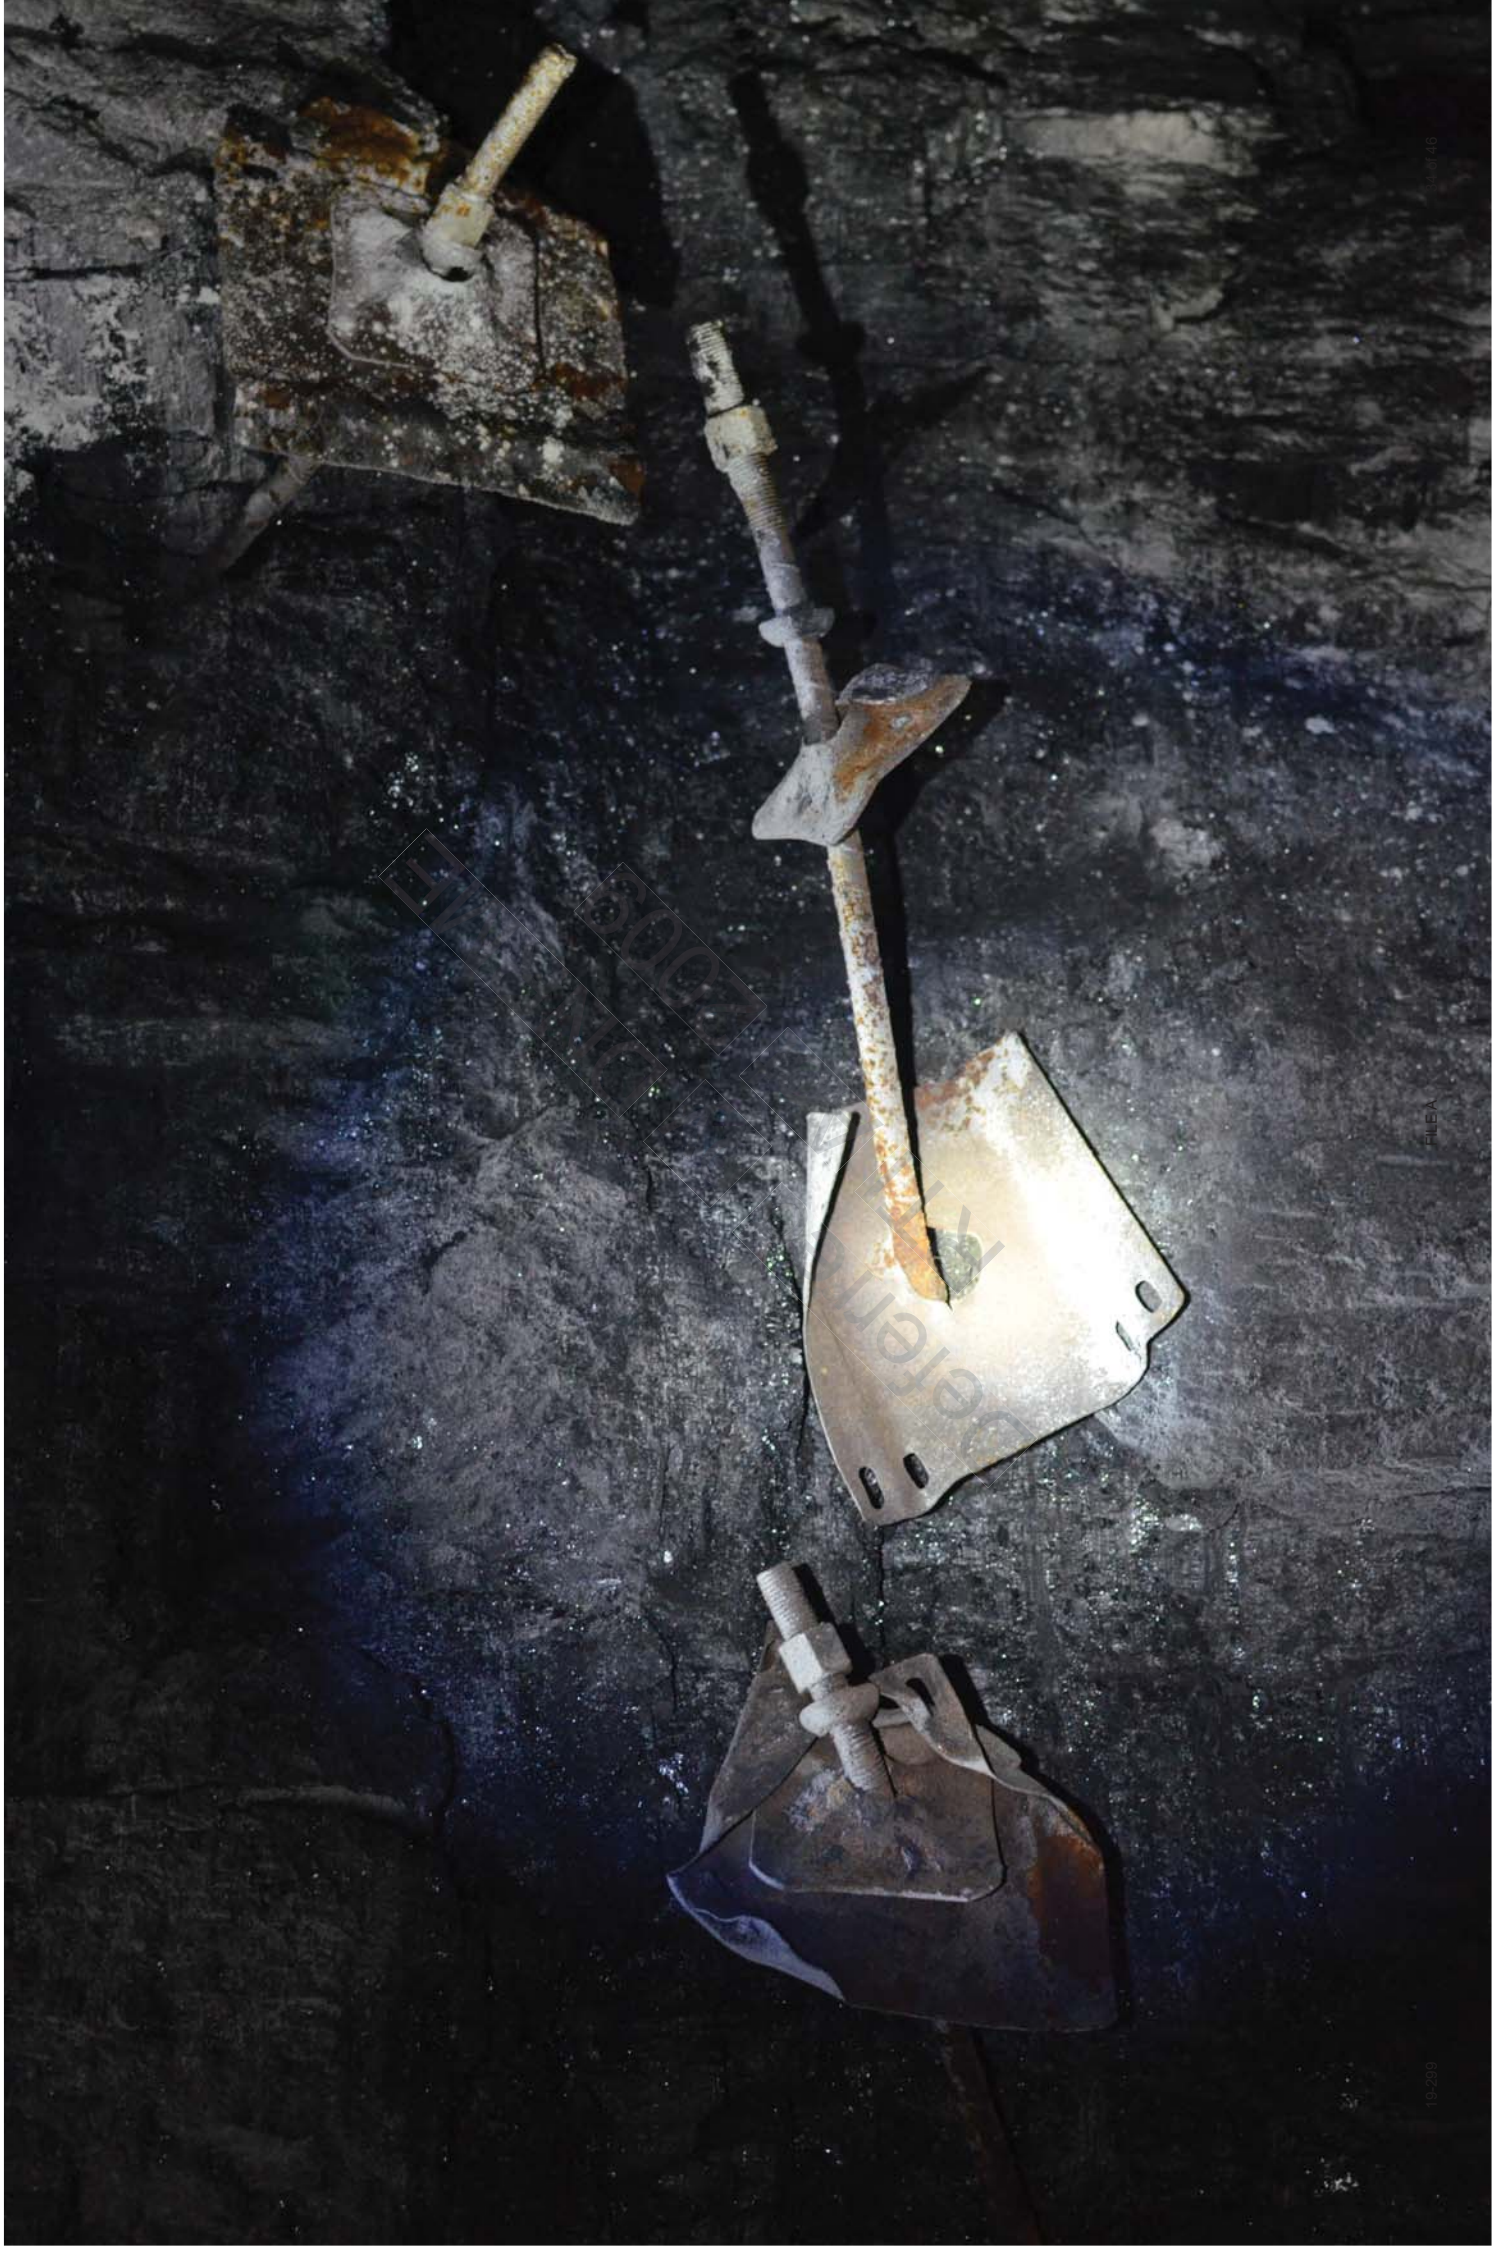
The stowage was removed between 4 and 7 December 2014. It was removed by LHD Loader and during this process several rib bolts and plates were damaged. As a result of the corrosion and damage, these bolts were not performing to their design standard, and therefore were not supporting the rib as they were installed to do. (Refer Appendix 7-Photographs).

Damaged rib support

Coal and Rock fell from this area

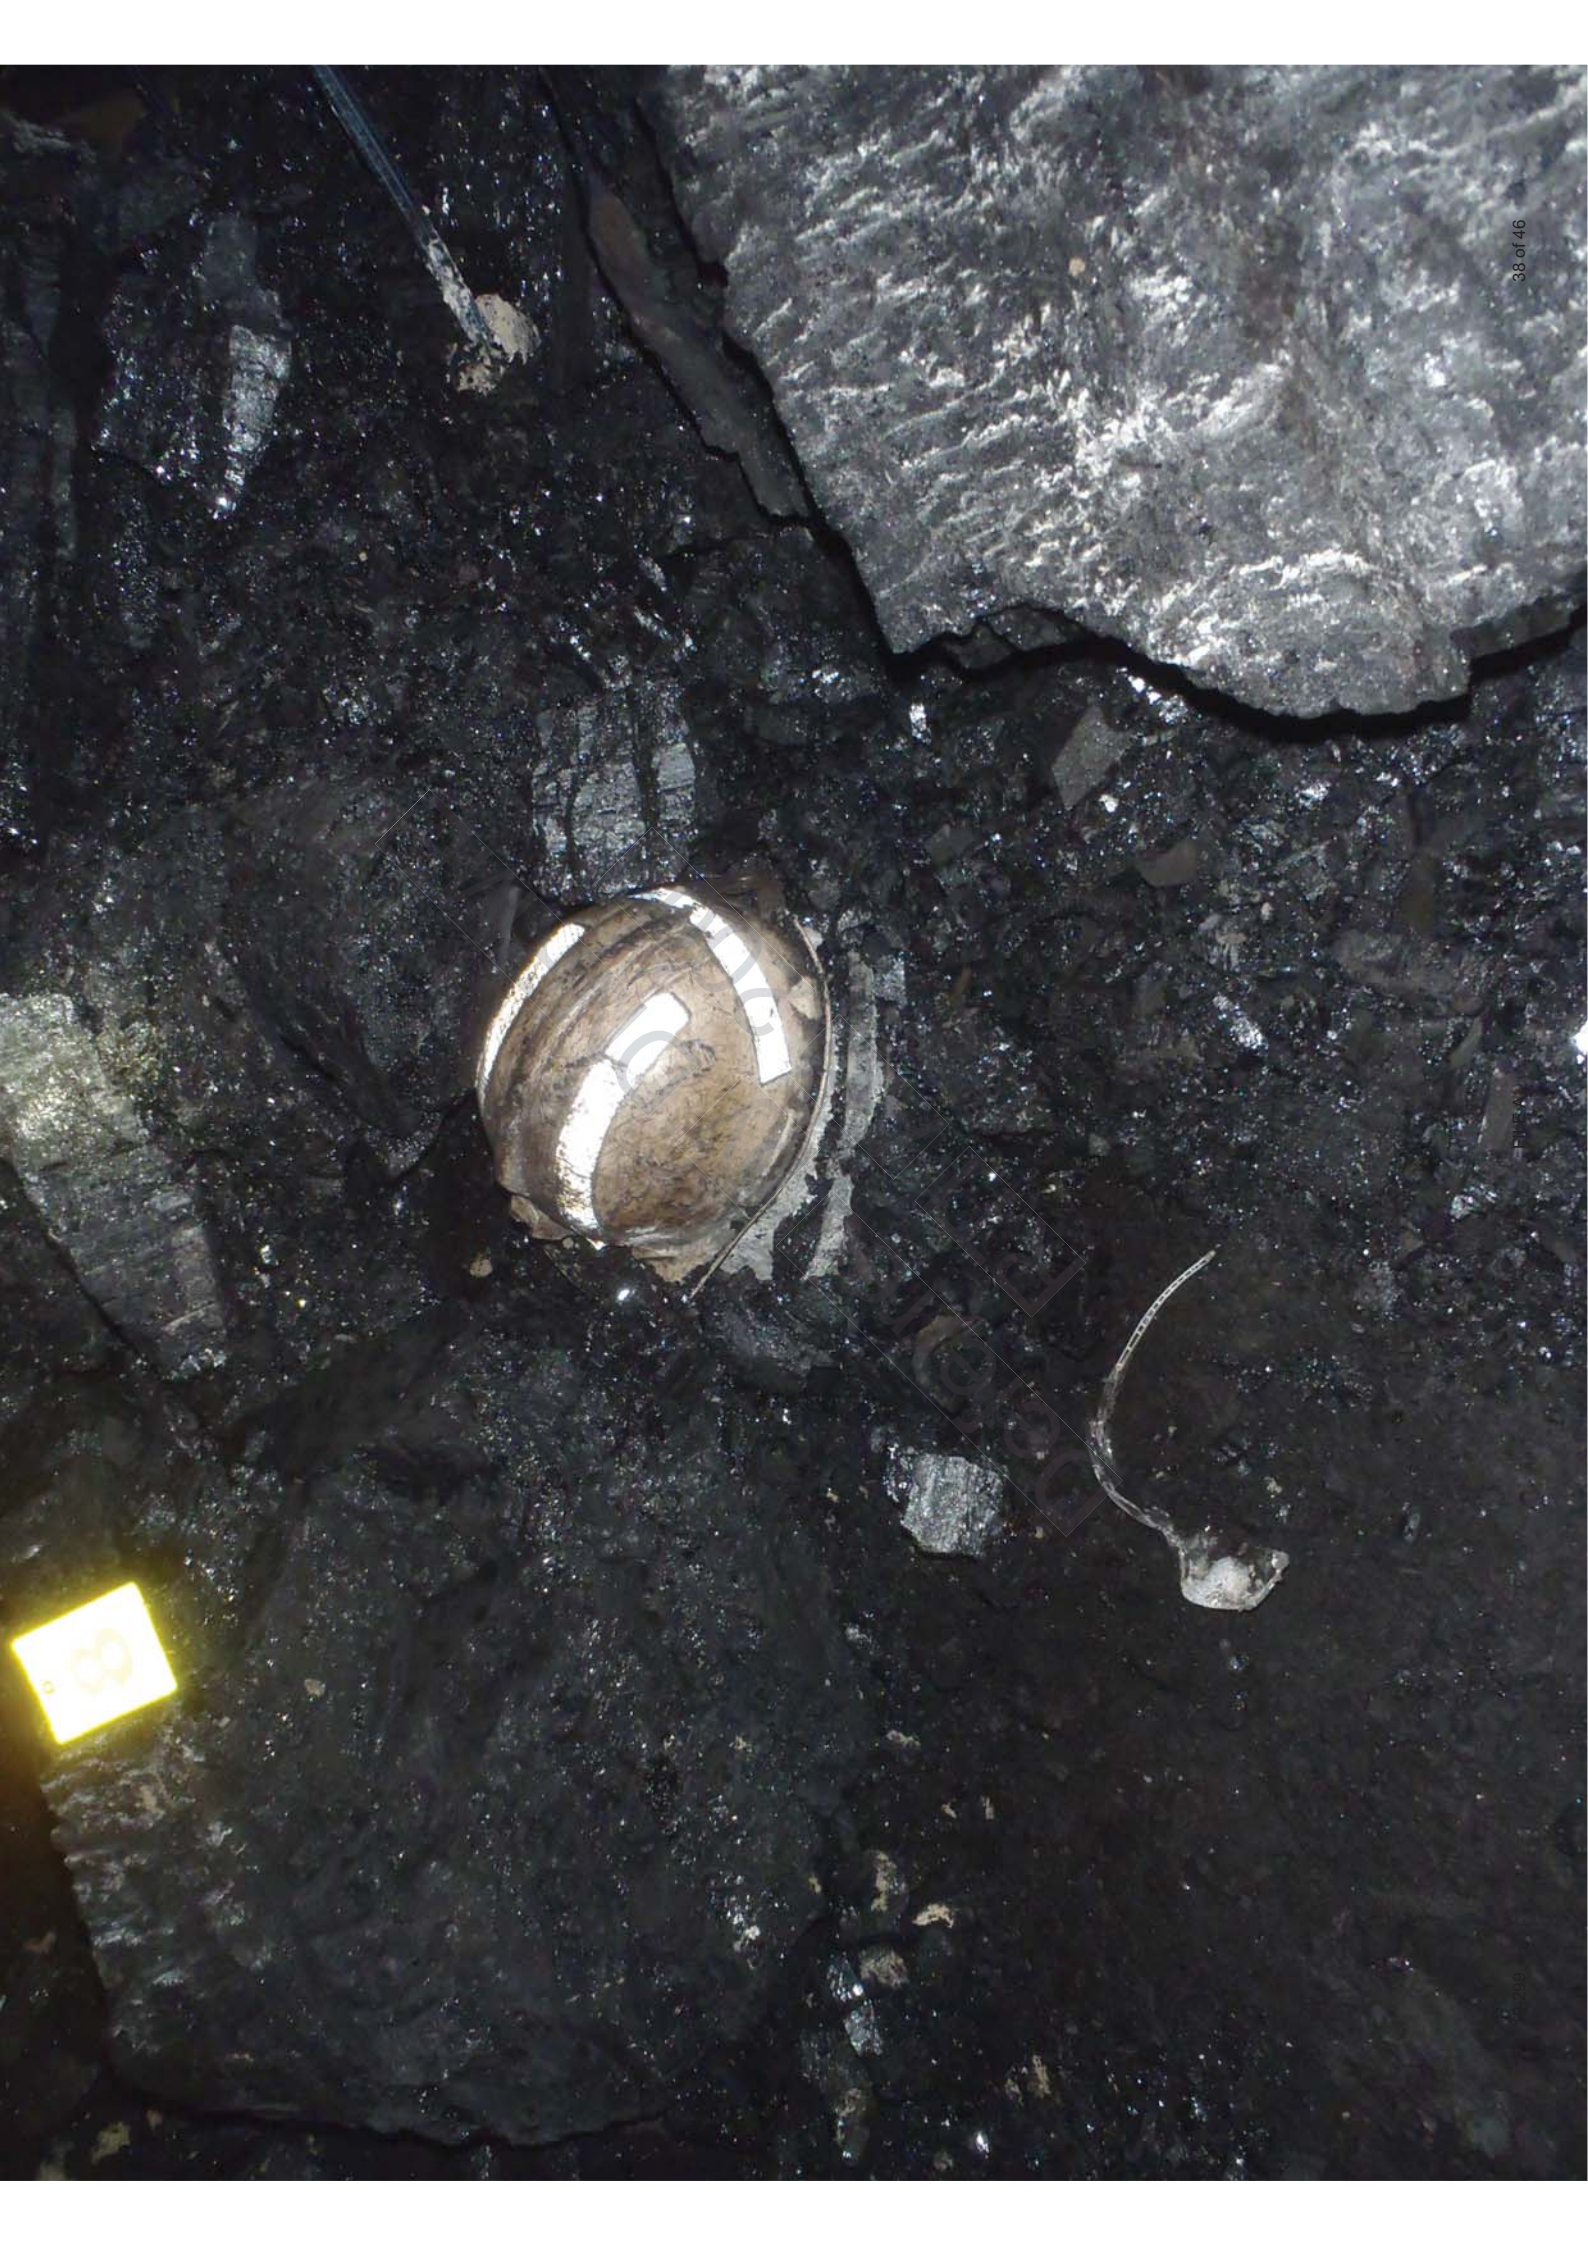
The exact profile of the stowage in the roadway is not known, but it is clear that some of the rib bolts and plates have suffered substantially more corrosion than others. This is due to some bolts being buried for approximately fifteen months.

Corroded rib bolt
