Nature and Cause Investigation Report for Chief Inspector of Coal Mines

Accident at Moranbah North Mine on 20 February 2019, resulting in the death of s.73 Irrelevant information

Date of report - 31 August 2019

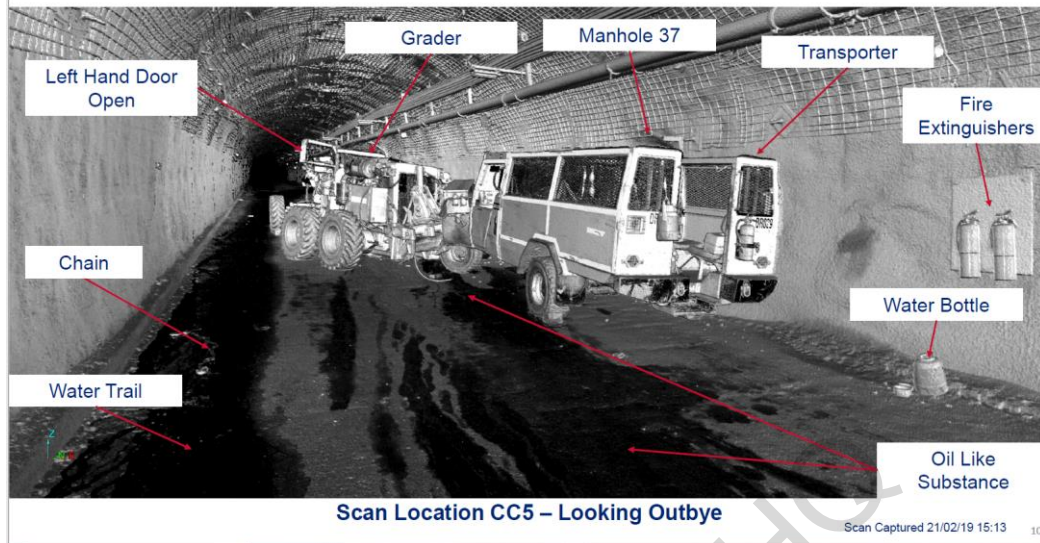
s.73 Irrelevant saw the loose wheel approaching and the grader following it. The grader collided with the Driftrunner and the two machines slid down the drift, see figure 7, stopping near to manhole 37.^{7 8}

Figure 7: Showing final position of GR002 and DR029 at 37 manhole

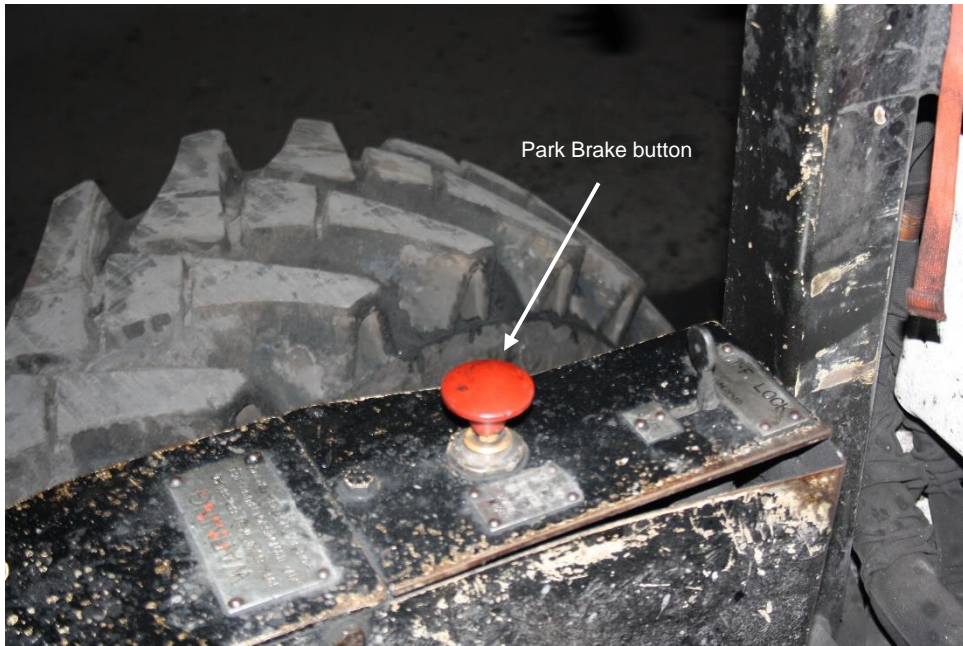
2. Rope around the handle, see figure 11
3. The park brake button in the engaged position, see figure 12
4. The run/stop toggle switch in the run position, see figure 13
5. The transmission lever in the neutral position, see figure 14
6. The implements in the travel position,
7. The seat belt joined, see figure 15
8. A length of hose attached to the air fill point with the valve in the receiver charging position, see figure 16. There was no coupling fitted to the free end of the hose.

Figure 12: Park Brake Button engaged

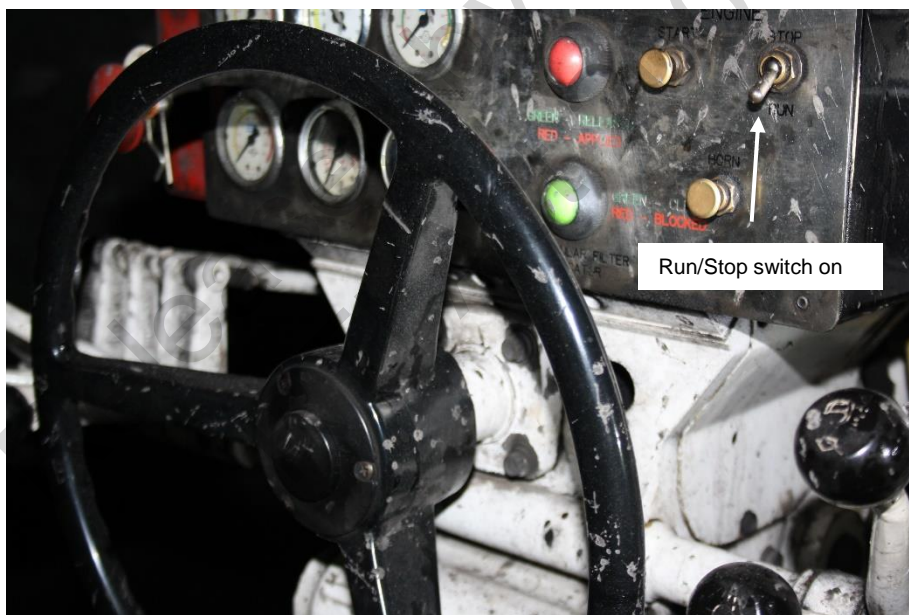
Figure 13: Run stop switch in the run position

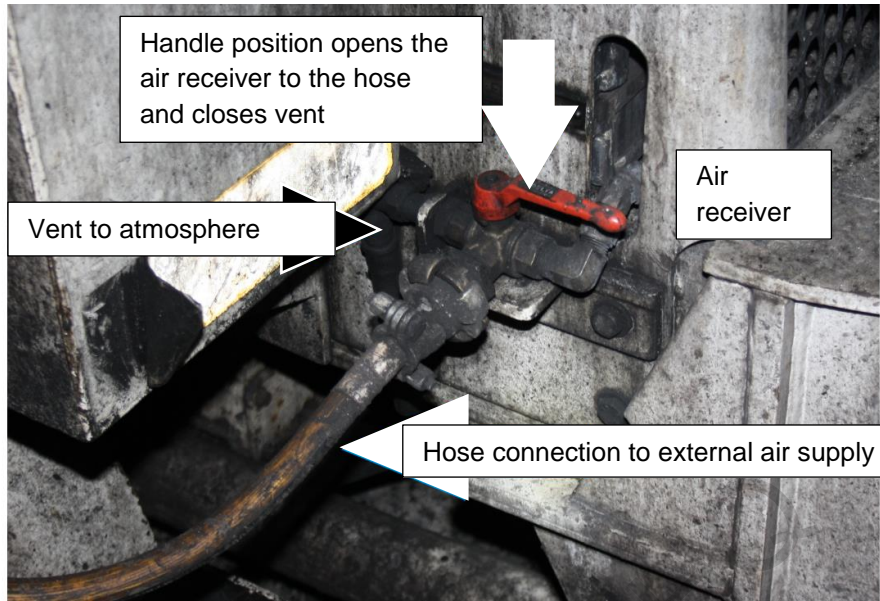
Figure 16: Hose attached to air fill point with valve open to the receiver

The inlet valve found open to the air receiver points to the possibility [s.73 Irrelevant info] dismantled from the grader to access compressed air services to refill the receiver.

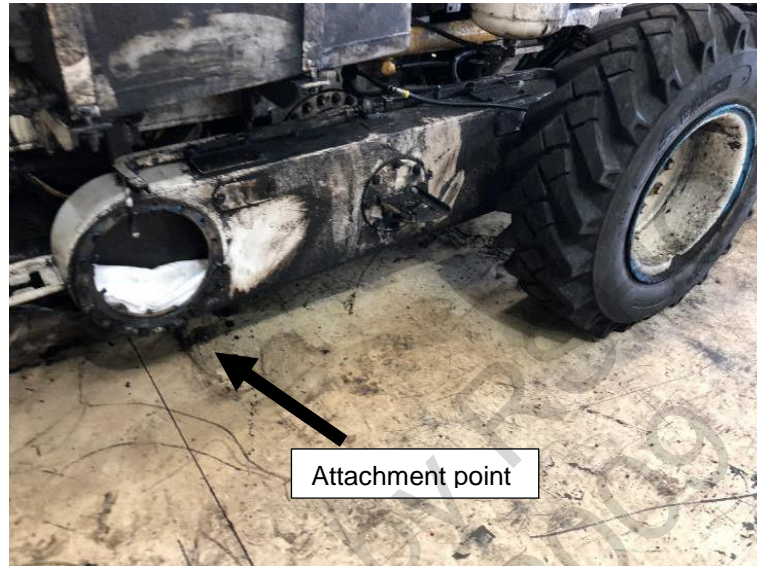
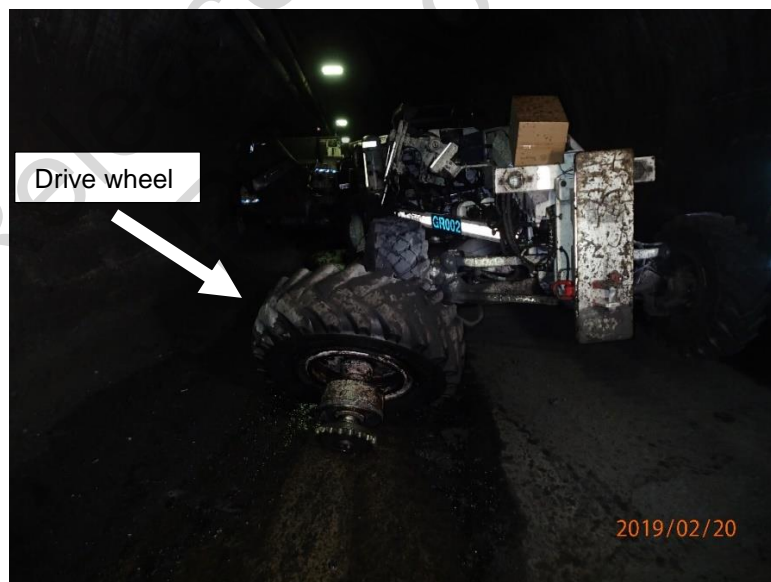
A drive wheel on the right hand side was detached from the grader during the runaway, see figures 20 and 21. It finished movement on the uphill side of the two vehicles after the collision. Witness marks of an impact were found on the wall of the drift near manhole 33. It is likely that the wheel detachment occurred there. The loss of the wheel unit opened the pneumatic circuit supplying the service brake units to atmosphere.

Figure 20: Drive wheel attachment point

Figure 21: Drive wheel found after collision

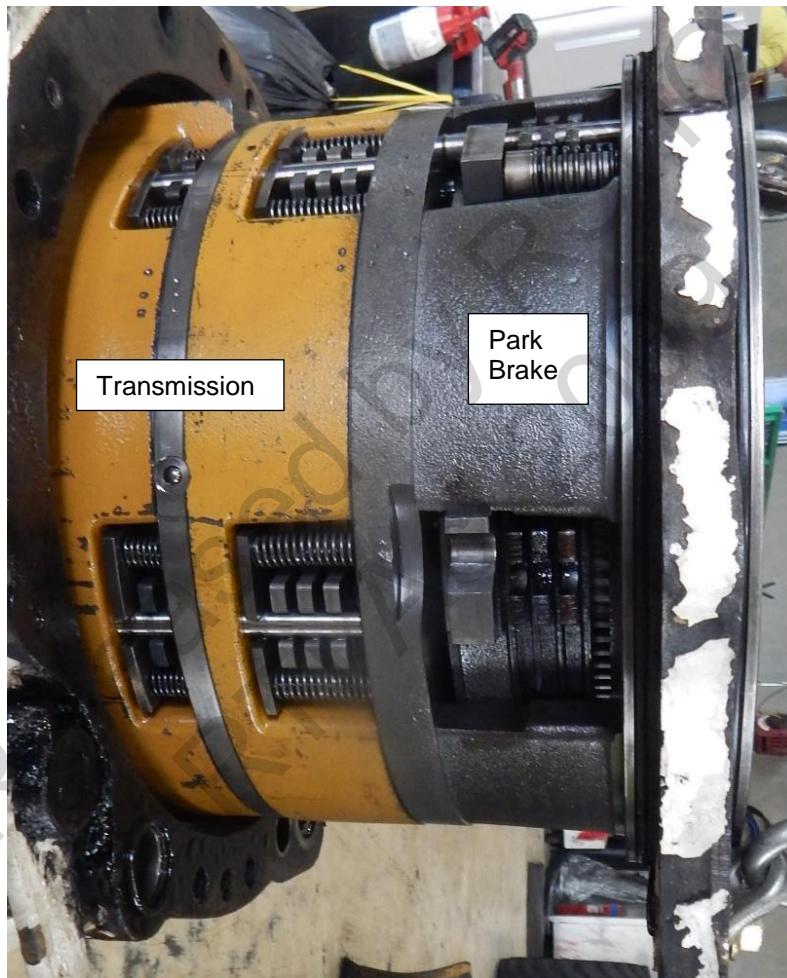
Figure 22: Transmission mounted Park / Emergency brake

When removed from the transmission housing, a physical inspection found sufficient wear on the brake components to explain the lack of any retardation capacity.

The wear on the brake's friction discs is such that when the park brake actuator is at maximum travel, there was still clearance between some of the friction discs and the brake plates. This rendered the park brake unserviceable.

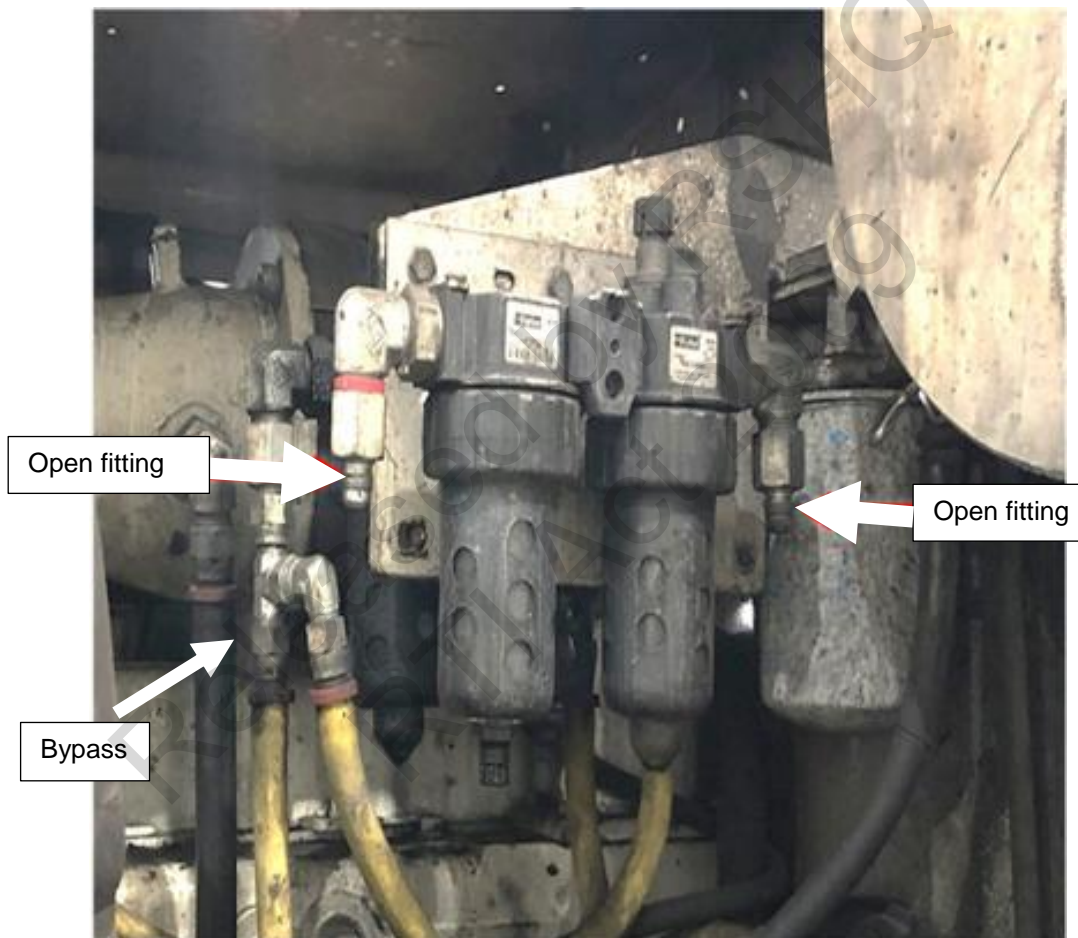
Figure 23: Modification to service brake pneumatic circuits.

This component removes moisture from the left hand side service brakes pneumatic circuit and adds lubricating oil. Prior to the accident, it was disconnected from the pneumatic circuit and a bypass connection installed, see figure 23.

The method used to bypass it has joined the separate left hand side and right hand side service brake circuits into one circuit. All the service brakes were being supplied from the right hand side dryer/lubricator.

The arrows on the image point to the open fittings of the left hand dryer/lubricator. The hoses can be seen to the left side of the photo, joined together, where they are then connected to the right hand dryer/lubricator.

All attempts to identify who made the modification and when it occurred have been unsuccessful.

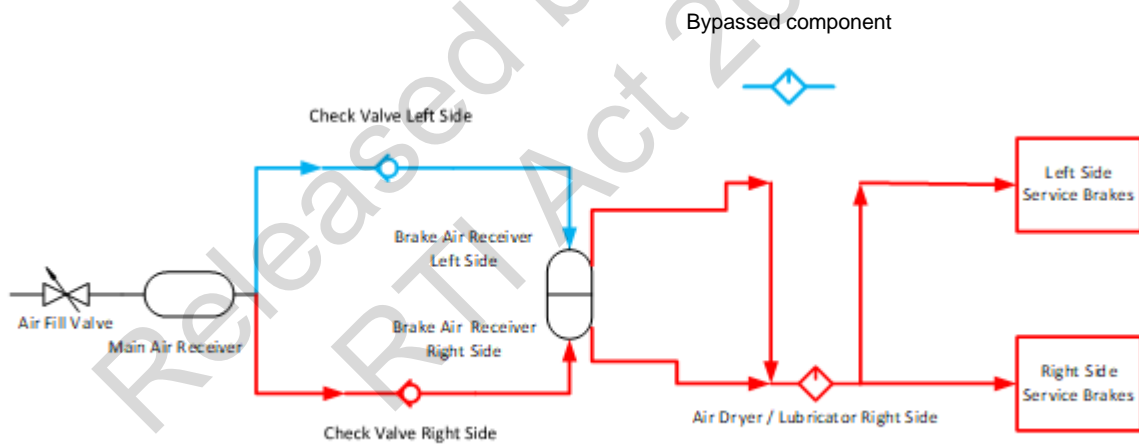
Figure 25: Air Dryer/Lubricator left side bypassed by modification. No evidence modification is authorised. Converts dual circuit into a single circuit.

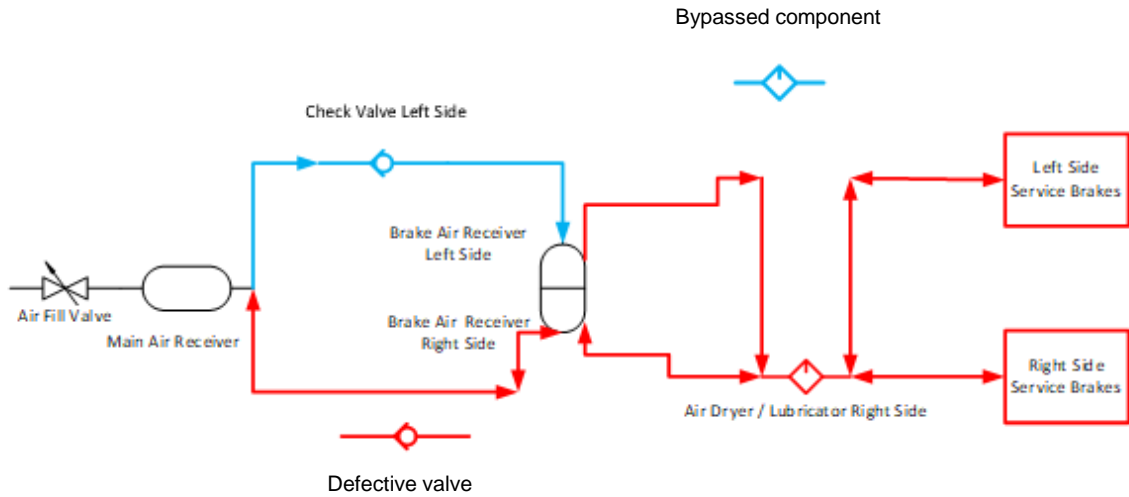
Figure 26: Right side check valve failed in service. Allows air to flow in both directions. Any reduction in main circuit air pressure reduces air pressure in service brakes allowing springs to release brakes.

The pneumatic circuit for the right hand side service brakes had a defective one-way check valve in it, between the main air supply and the brake air receiver, see figure 26. The function of the check valve is to allow air from the main air supply to enter the service brake circuit, but prevent air from leaving the brake circuit to enter the main pneumatic circuit. The fault in the valve identified in the testing made the one-way valve into a two-way valve.

The faulty check valve described in 16.4, allowed air to leak to atmosphere from the circuit when the engine is off and the run/stop switch is in the “run” position. Over time, this loss of air pressure would allow the springs to release the service brakes without further human intervention. Testing found this took some 30 minutes to occur, depending upon the initial system pressure.
