# Coal Inspectorate

## Final investigation report to the Chief Inspector

### Fatal Incident at Middlemount Coal Mine on Wednesday 26

June 2019 –

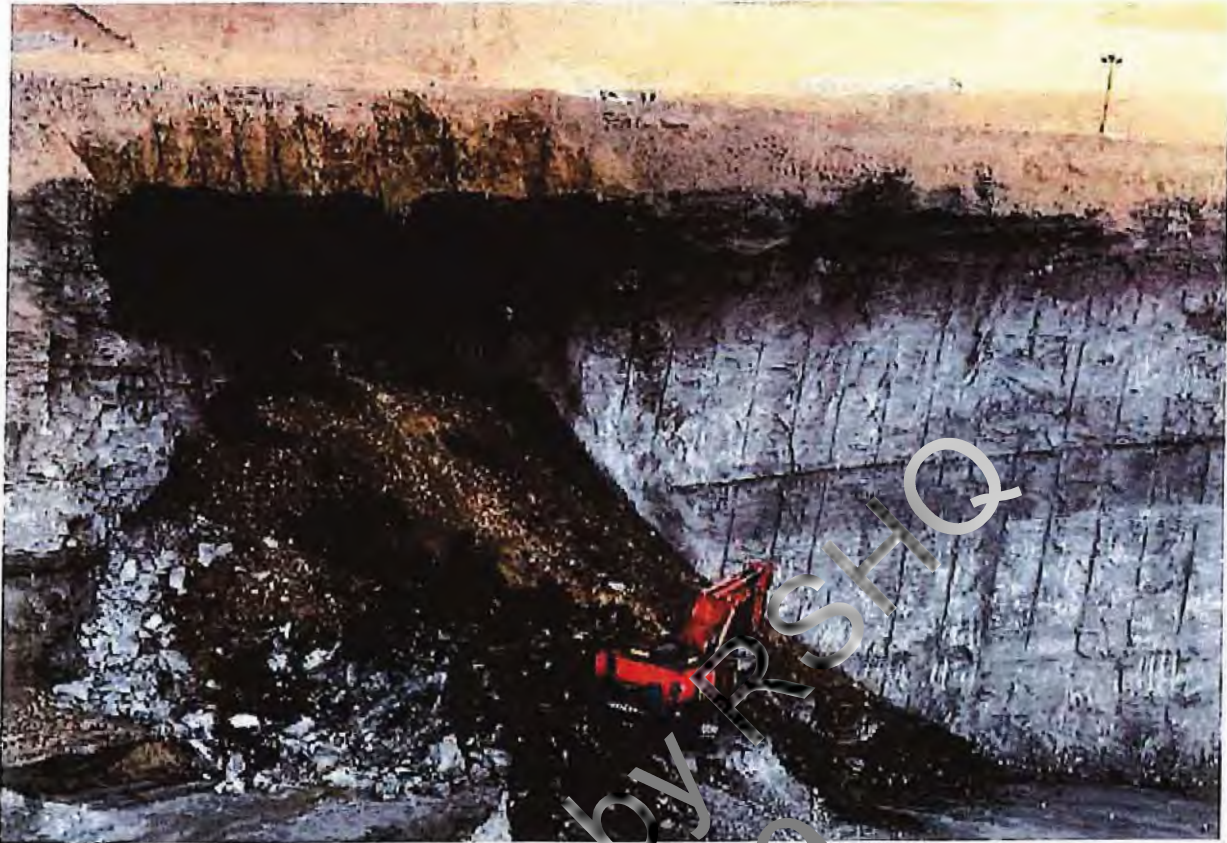
Approximately 7,000 cubic metres of material had tumbled which engulfed the operator's side of the excavator and crushed the cabin. This failed material was hung-up in front of the presplit line, above the area that the excavator was operating and had not been removed during the mining process as required.

At approximately 12.21 PM on Wednesday 26 June 2019, Sch4p4(6) was operating a Hitachi EX3600-6 excavator (EX0046) when an adjacent section of pit wall suddenly failed. The material that fell from this pit wall engulfed the excavator and partially crushed the operator's cabin. (Figure 4)

Figure 4. The failed pit wall that partially engulfed EX0046

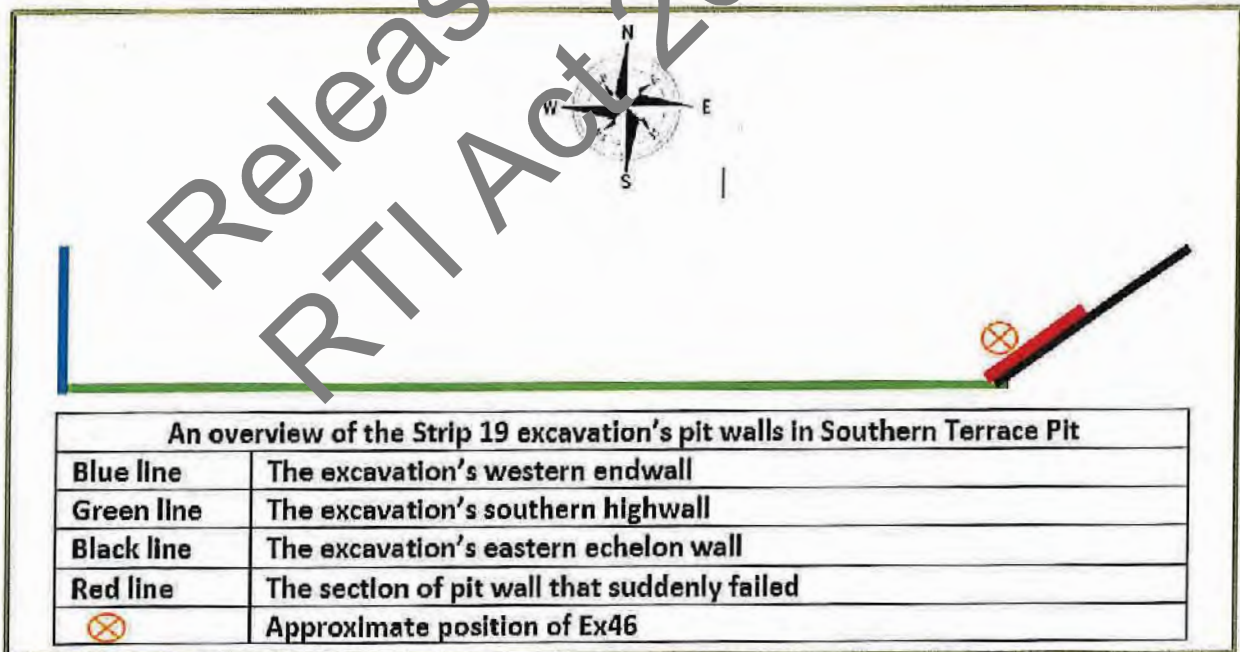
The pit wall that failed was approximately 42m higher than the bench where EX0046 was positioned at the time of the incident occurring. The section of pit wall that failed was along the pit excavation's eastern echelon, next to where it intersected the pit excavation's southern highwall. (Figure 5)

Figure 5. An overview of the Strip 19 excavation pit walls (not to scale)

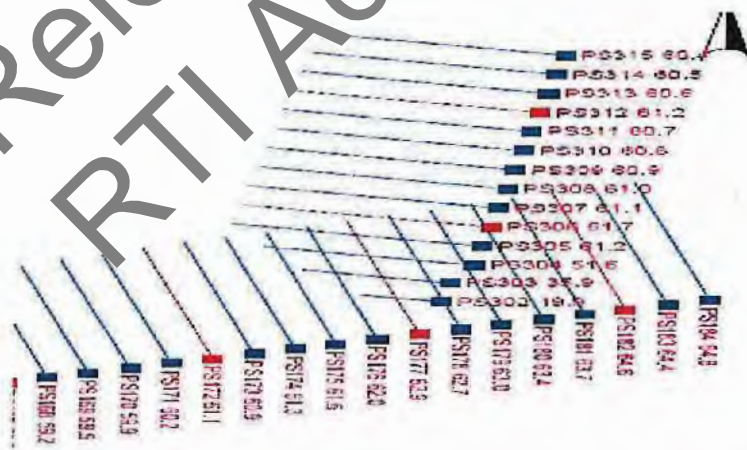
The initial drill design for BL422 shows there was to be 14 pre-split holes drilled across the eastern echelon wall. The approved drill design shows that there is 8 pre-split holes across the eastern echelon wall. The loading map used by the blast crew is an adjusted copy of the original drill design. It indicates that there were 15 holes drilled across the echelon wall. The loading map used by the blast crew also indicated that 4 pre-split holes across the echelon wall were not loaded with explosives. As a result this reduced the powder factor which in turn reduced the pre-split energy in the immediate area above the incident site. This contributed to the amount of hanging up material left on the echelon wall.

Eastern End section - Blast 422 PS Design - 03.06.2019 - Initial Design

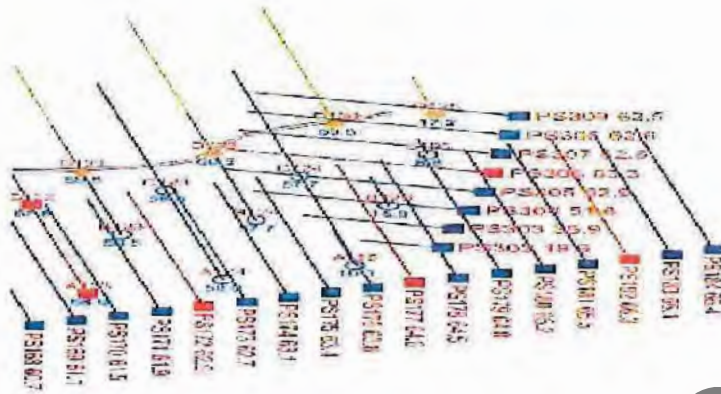
There were inconsistencies in the actual drill design when compared to the actual blast plan that was carried out. The original number of blast holes on the approved design was 206, yet 212 holes were drilled. On one of the blast hole rows, the design angle changed from 70 degrees to 65 degrees.

Eastern End section - Blast 422 V2 Design - 05.06.2019 - As Approved (Signed)

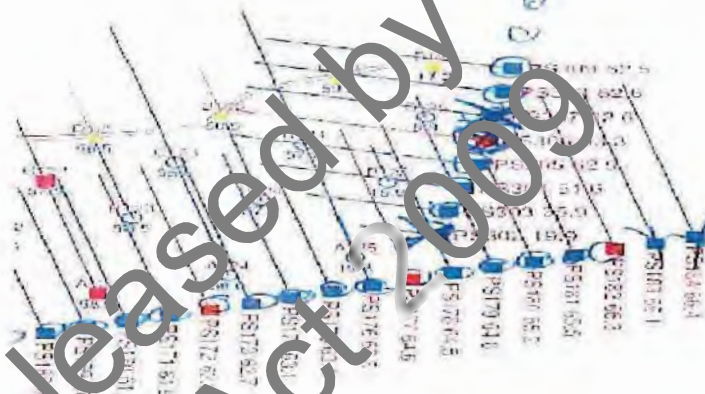
Eastern End section - Blast 422 V2 Design - As Loaded by Blast Crew

10. **DE-** The design of the excavator involved in the incident, saw the operator cabin be positioned facing the echelon wall at time of failure.
11. **DE-** The blast at Strip 19 South Terrace was drilled and loaded not in accordance with the approved design.

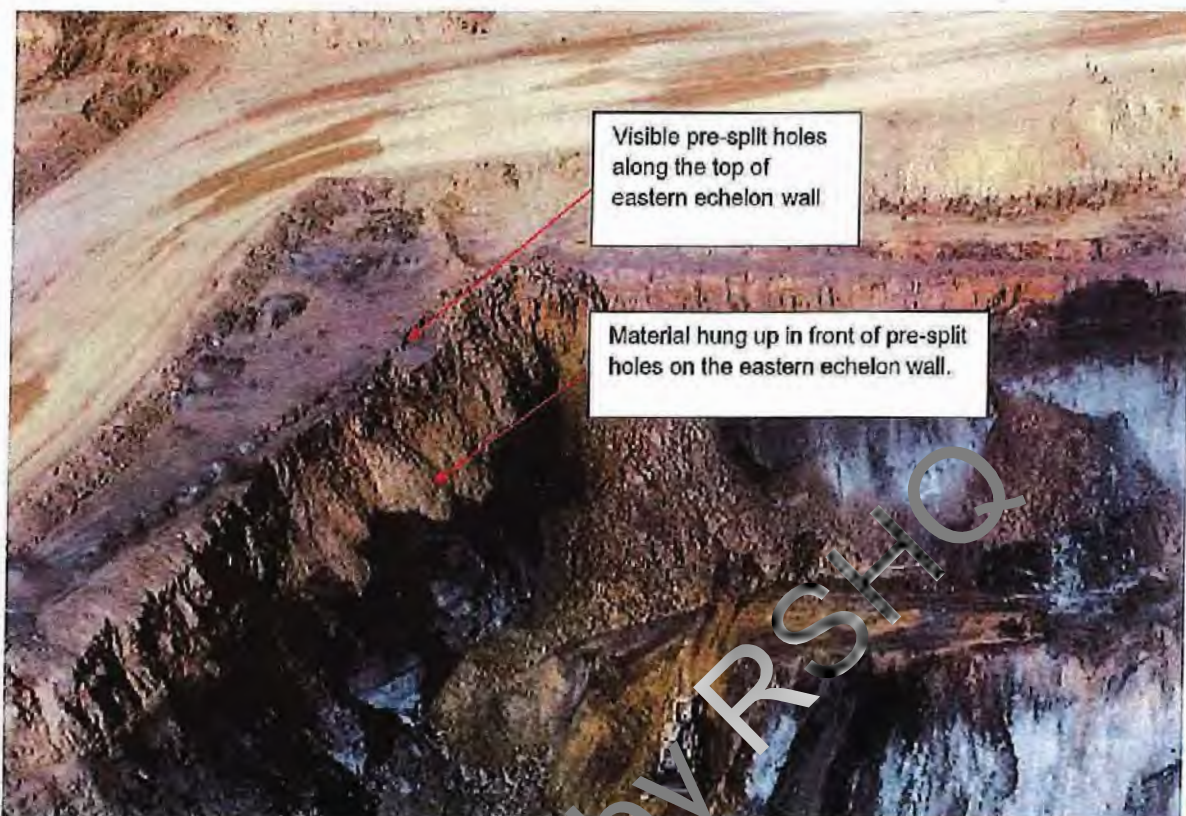
A CMW was assigned the task by a supervisor on day shift 20 June 2019 to use an excavator to try and remove the hung-up material from on top of the wall. During this process, the CMW raised concerns directly with the C Crew OCE regarding the hung-up material, cracking and the presence of pre-split holes.

Figure 9 Presplit line and hung up material.

1. Identify all areas where post blast cling-on (hang up) material on pit walls persist in front of the pre-split row.
2. Establish appropriate exclusion zones (determined by way of rockfall modelling software) capable of containing any potential rockfall or failure of cling-on material within the exclusion zone.
3. Until the exclusion zones have been established by way of modelling, access to such areas shall be prevented.
4. A person with geotechnical competencies is to conduct a geotechnical risk assessment of all pit walls in relation to stability.
5. Implement appropriate controls to ensure risk to persons from geotechnical hazards is within acceptable limits and as low as reasonably achievable.
6. Review the current geotechnical monitoring program and associated Trigger Action Response Plans (TARPs) of the mine to ensure that they are adequate and effective.

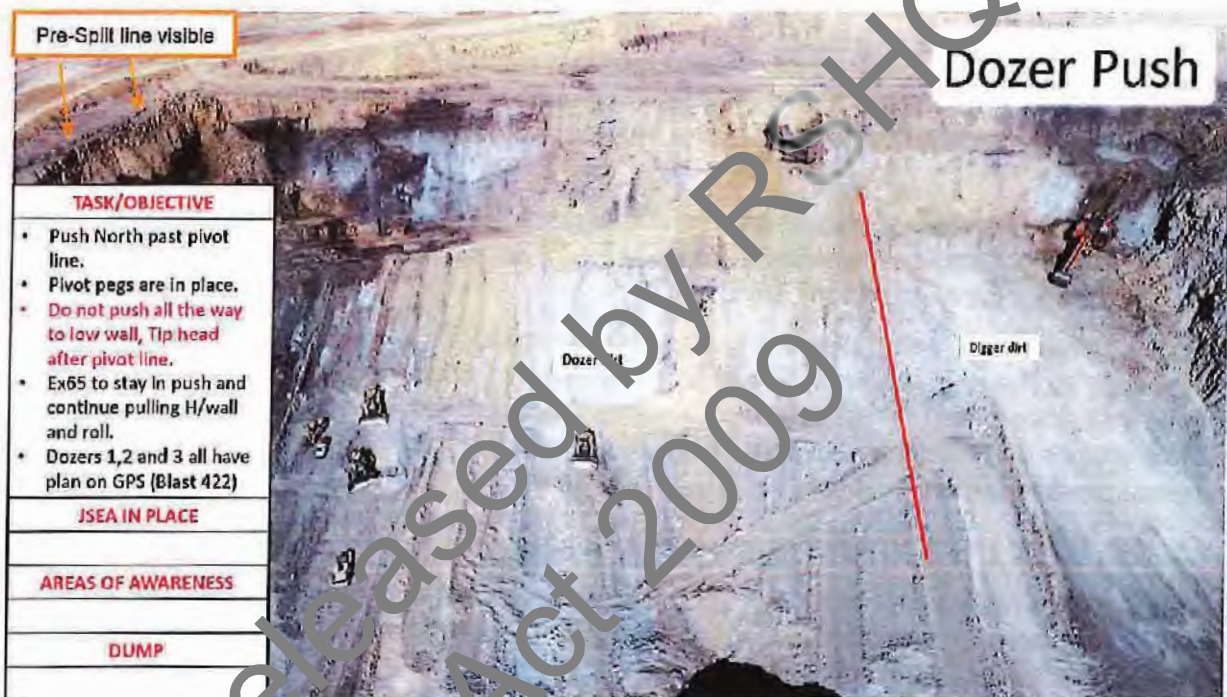
Photographs clearly showed the presence of the presplit on the eastern echelon wall and the significant amount of hung-up material in front of it.

Figure 10 - 12 Hour Dig Plan day shift 20 June 2019

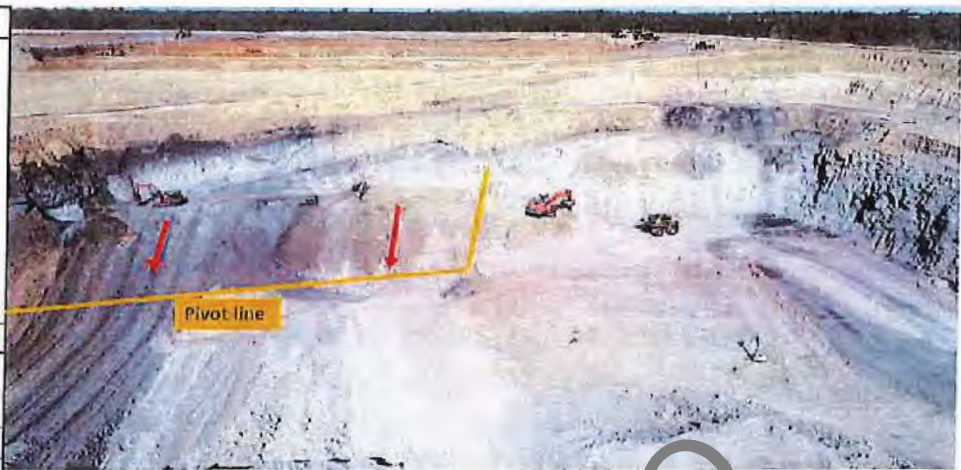
The dig plans from dayshift 22 June 2019 to dayshift 25 June 2019, mention hang-up and full reach on echelon. This means the excavator is to stay away from the wall by the length of its bucket arm to achieve the 10m standoff distance. The plans also mention to "scale highwall as we go down". (Figures 11, 12)

Figure 11 – Twelve hour dig plan 21 June 2019

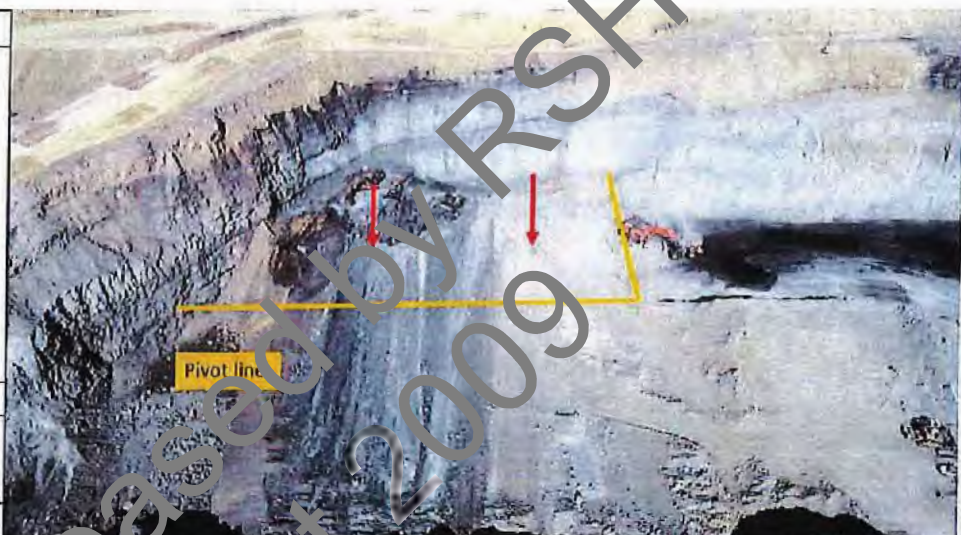
Figure 12 – Twelve hour dig plan 25 June 2019
