A review of fatal outburst incidents in the Bulli Seam

C. R. Harvey

R. N. Singh

A Review of Fatal Outburst Incidents in the Bulli Seam

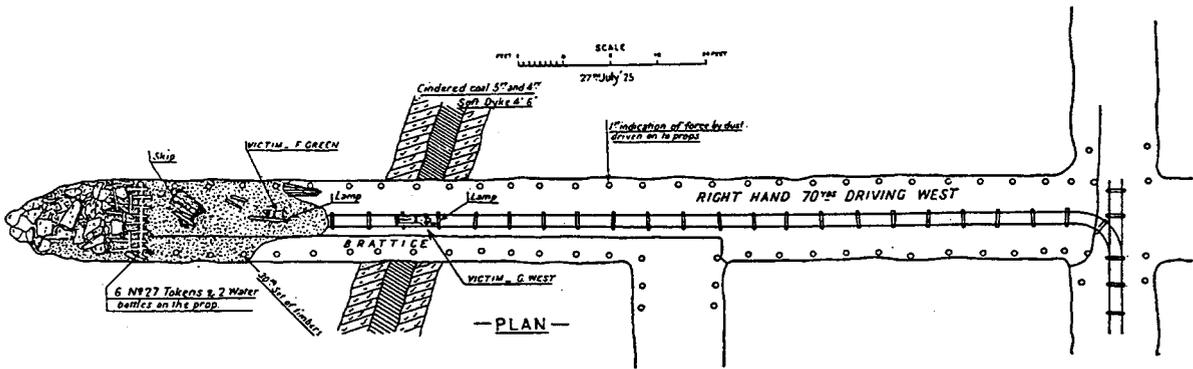
On 27th July 1925, two men were killed by an outburst of natural gas and coal at the Metropolitan Colliery (George West and Fredrick Green). The men were suffocated by the gas emitted (identified in 2 samples as being between 50% and 62% CO₂) from the outburst site and was associated with an upthrow fault immediately adjacent to a dyke in the 70 yard heading of the Western area section of the mine (see Figs 1 and 2). Approximately 220 tones of coal was ejected with the gas concentration being sufficient to kill a horse approximately 115 yards away from the outburst site.

Similarly the mechanism underlying the principles behind outbursts in the Bulli Seam were alluded to when the same inspector commented "The last four feet or so of coal worked by the miners in this place was harder than usual, and no gas had been given off..." "This hard section of coal may have acted as a dam and retarded the escape of the gas which is given off freely from the coal faces in this section."

Fig. 1 - Scene of fatal accident to F Green and G West, outburst of gas Metropolitan colliery

Hence the comments of the Inspector reporting on the fatality and the mechanisms used to alleviate outburst problems are quite telling: - "Since the outburst, boreholes have been kept ahead in all places in the near vicinity of the fault and these have given off a little gas which has proved to be practically pure carbon dioxide".

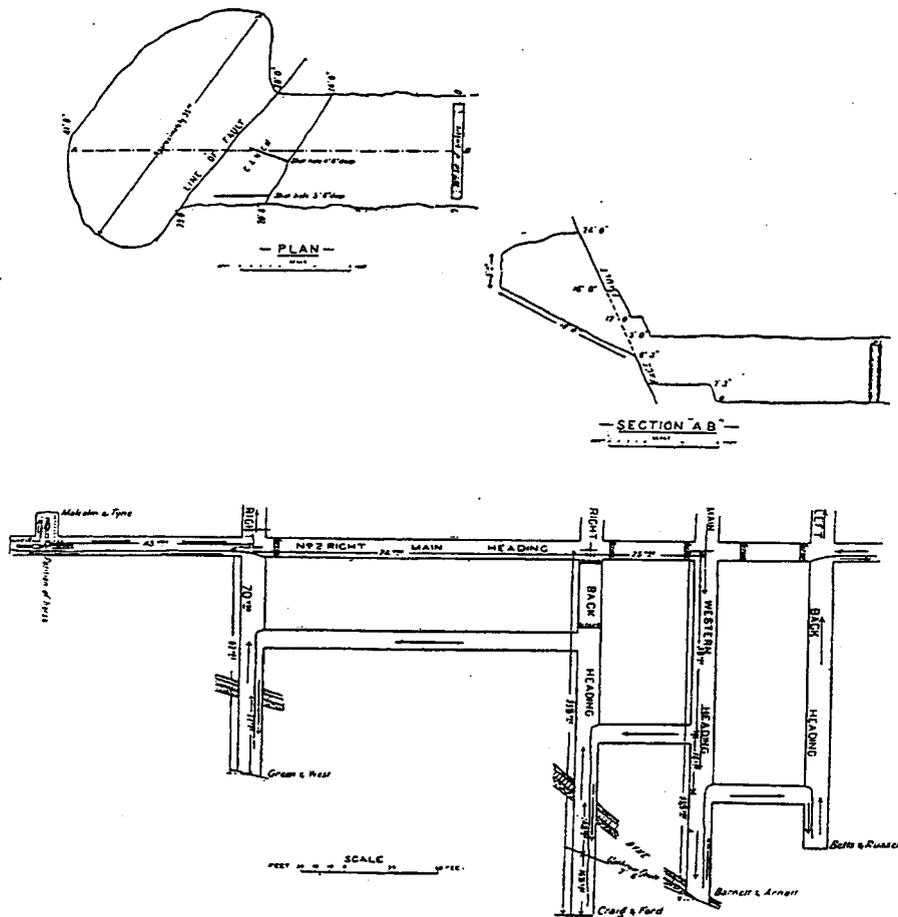
Fig. 2 - Outburst of Gas - Metropolitan Colliery

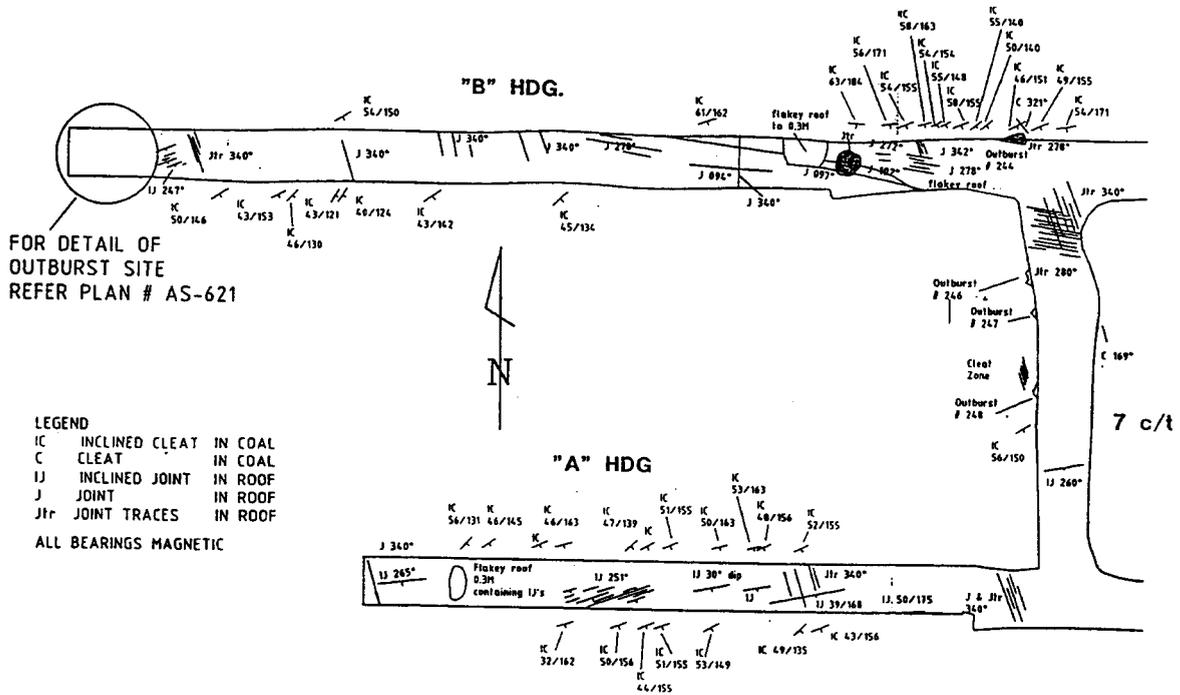
As shown in Figs 3, 4 and 5, the outburst was associated with a combination of two strike slip fault zones (one trending 350°, the other 280° magnetic). The intersection of these two fault structures created a zone of intense shearing/jointing resulting in lower coal permeability and increased stress in the coal and associated roof strata. This in combination with the presence of Mylonite and gouge material was believed to account for the volume of gas released.

The dominant 350° fault zone appeared to have a similar alignment with strike slip fault structures identified in previous mining, associated with development headings for panels 484 and 485. Drilling immediately in advance of mining, in "B" heading of 486 panel did not accurately identify the location of this structure. Gas drainage holes drilled from 485 panel failed to reach across the longwall block and effectively drain the development heading of 486 panel. Also whilst holes had been drilled in advance of mining in 486 panel, they had not penetrated the structure. These holes had deviated to the left (south) and were identified in the left hand rib and face.

Fig. 3 - West Cliff Colliery 486 right panel outburst and fatal accident geological mapping

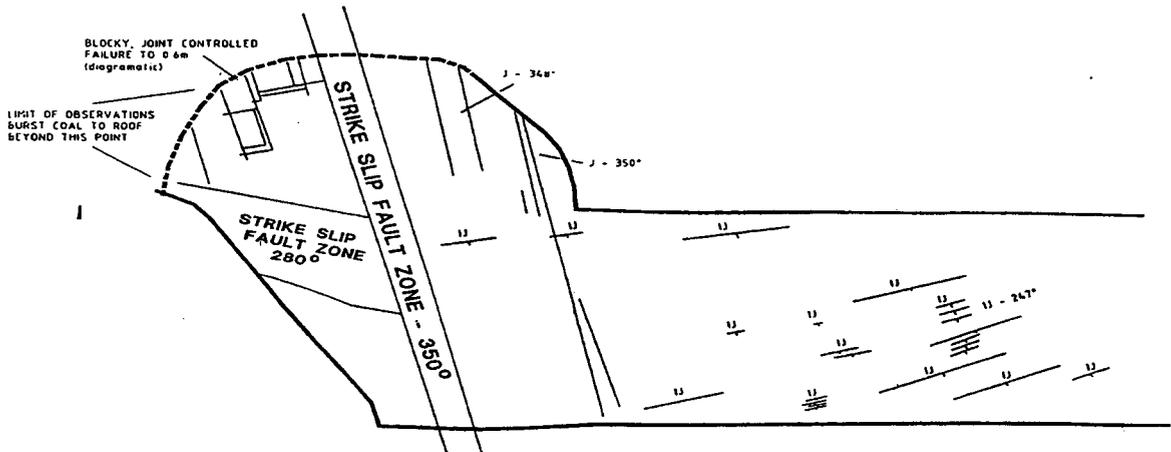
Fig. 4 - West Cliff Colliery 486 right panel outburst and fatal accident site geology plan

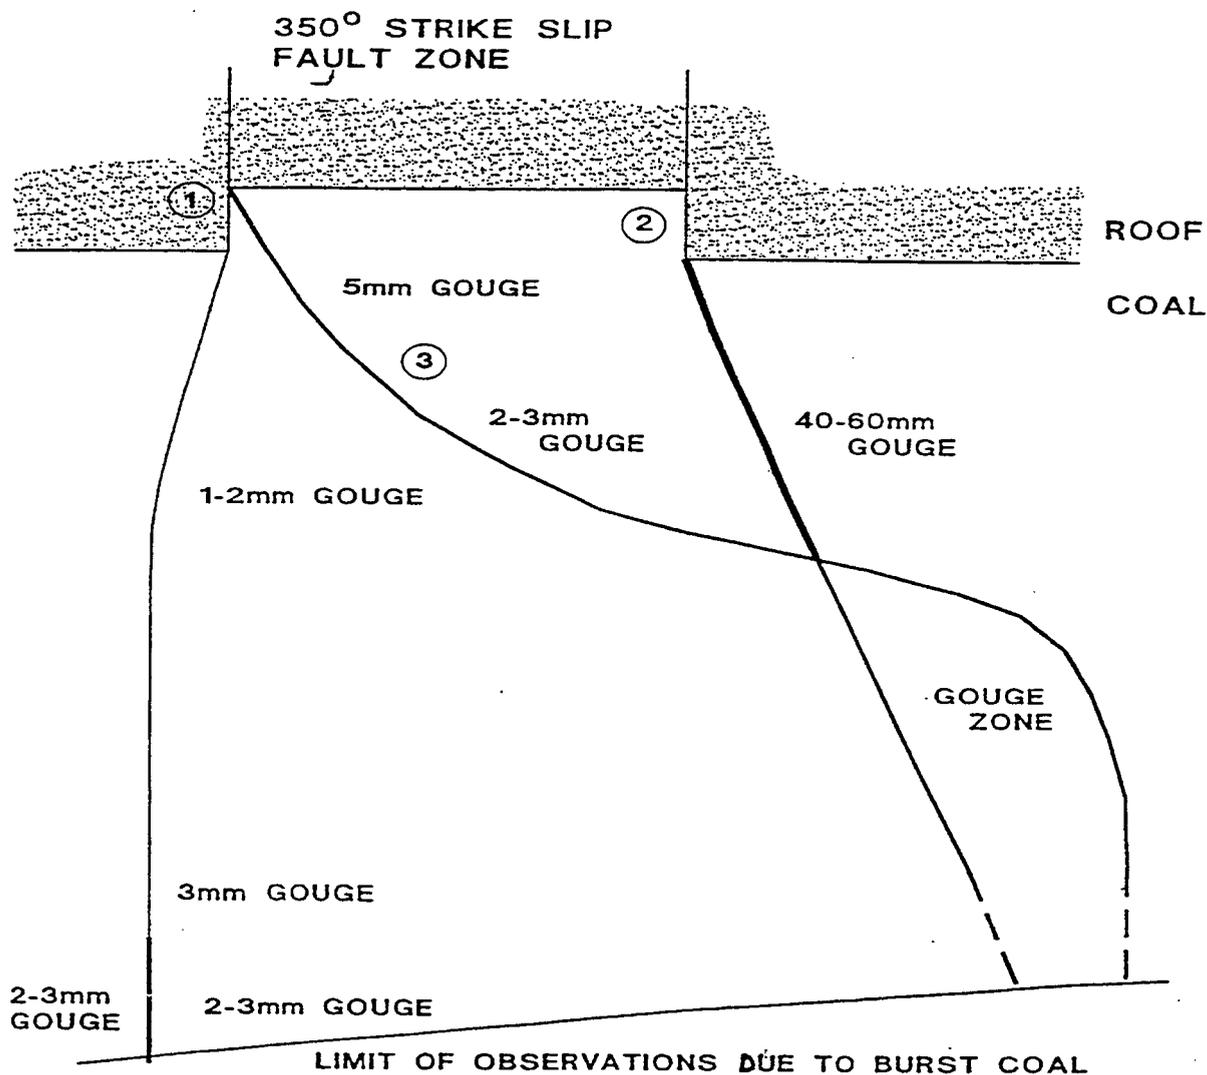
- OBSERVATIONS
- 1 88° to 264° MAGNETIC STRIKE SLIP
 - 2 STRIKE SLIP
 - 3 DIP SLIP

Fig. 5 - West Cliff Colliery 286 right panel outburst and fatal accident section through strike slip fault "b" heading southern rib
