THE EXPLOSION AT MOURA NO. 4 MINE QUEENSLAND

16 July 1986

Consultant's Report No. 4

A view of the possible causes and development  
of the explosion

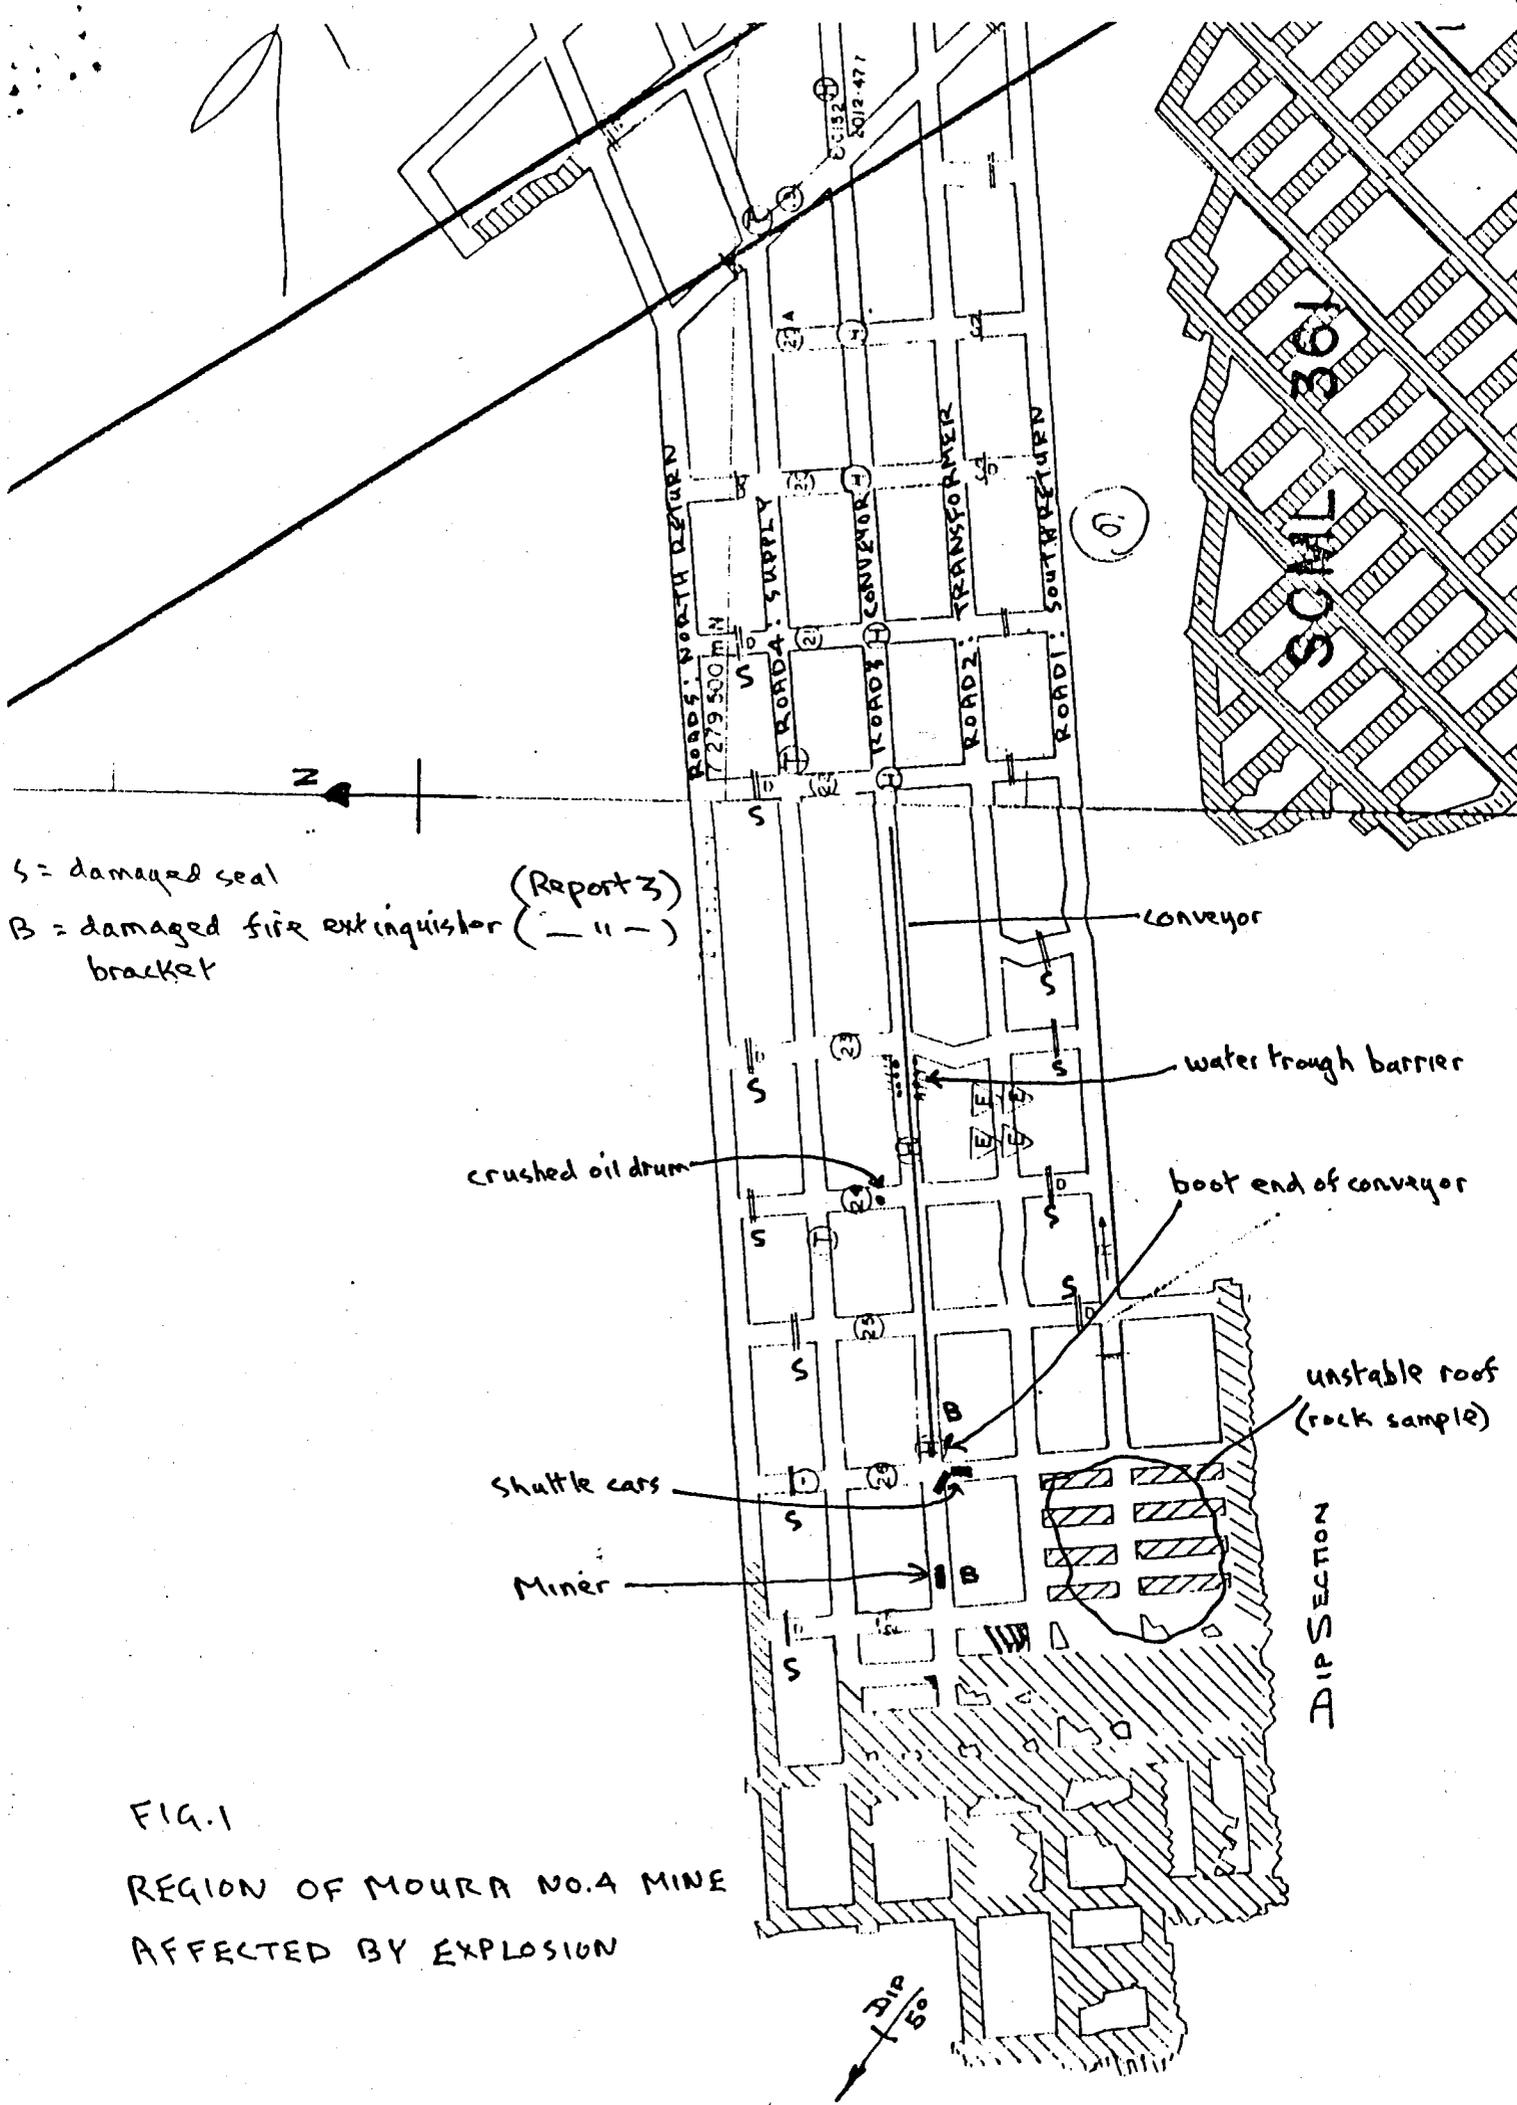
FIG. 1  
 REGION OF MOURA NO. 4 MINE  
 AFFECTED BY EXPLOSION

A plan of the area affected by the explosion is given at the end of the report.

This summary indicates that for both the north and south return roadways, the maximum damage to the seals was associated with the region near CT 23 and 24. This is consistent with the coal dust explosion developing in power as it ran along the conveyor roadway and peaking in violence as the leading edge of the explosion flame began to run into the water from the barrier and progressive extinction occurred.

The flow from the explosion zone westwards along the intakes produced blast effects with a strong directional influence for instance, the bending of fire extinguisher brackets in the conveyor roadway towards the face areas and the displacement of a multi purpose vehicle originally loaded with timber at the No. 2 roadway/No. 25 cut through intersection.
