An analysis of some explosive related accidents

G.C. Sen

D.H. Abrahams

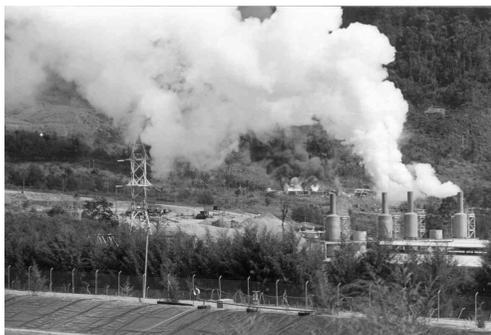
All fatalities are believed to have occurred in this first explosion, which destroyed the manufacturing plant, office and main plant shed. Fires on the bulk truck, around and underneath the bulk emulsion and process oil tanks subsequently led to the second explosion, just after 11:00 hrs. This explosion involved approximately 70-75t of emulsion matrix and between 10-15 t of emulsion and ammonium nitrate in the bulk truck. This explosion may have started a very intense fire in the

Figure 1. Fires burning shortly before the 2nd explosion.

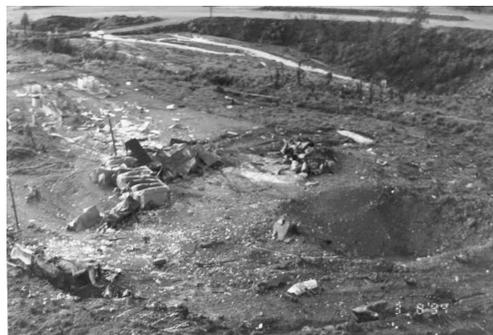
The first explosion left a crater $7 \times 5 \times 2$ m, in the vicinity where the Canter truck had been parked. The second crater was considerably larger, approximately 40 m in diameter and 15 m deep in the area where the bulk emulsion tanks had been located (Anon 1996a; Anon 2004).

Figure 2. The 'Large Hole', left by the second explosion.
