Appin Colliery explosion reassessed

Bob Kininmonth
Retired Senior Inspector of Coal Mines

APPIN COLLIERY EXPLOSION REASSESSED

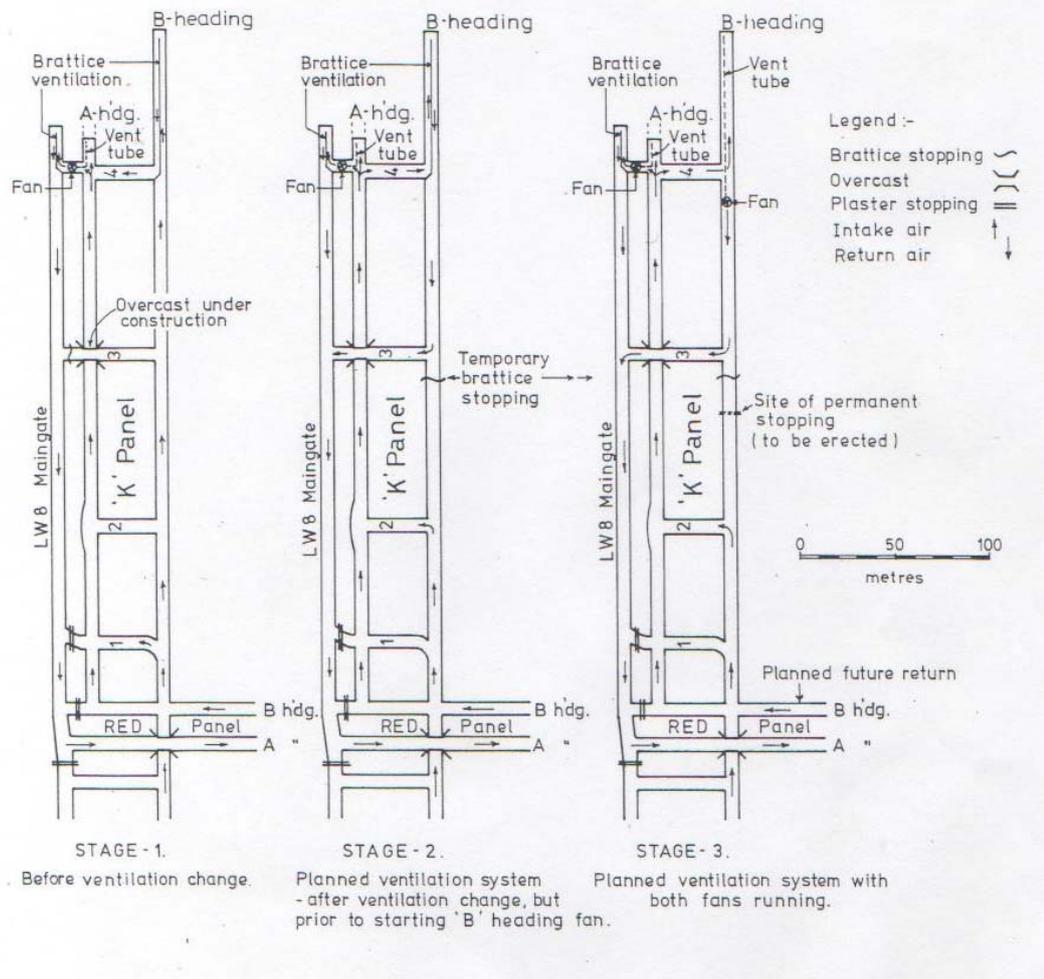
Figure 1 - Changeover plan

Ventilation conditions in K Panel prior to the changeover and the intended affect of the changeover are shown in three stages in Figure 1 as follows:

Stage 1 shows the panel layout on the morning of Tuesday 24th July with A and B headings as intakes and LW8 Maingate as the return. The overcast at the intersection of C/T 3 and A heading was being built. The LW8 Maingate stub was brattice ventilated. An auxiliary fan in C/T 4 provided ventilation for A heading while B heading that had been advanced 70 m as an intake stub, was ventilated on brattice

Stage 2 shows the post-changeover ventilation flow. This situation was planned to be reached, after completion of the overcast, by erection of the temporary brattice in B heading and removal of the brattice stopping in C/T 3.

Stage 3 was to be the completion of the changeover with a fan, that had been placed in B heading being used to ventilate the stub.

Near the end of the afternoon shift the overcast had been completed and the brattice in B heading had been erected. The Deputy who was meant to remove the C/T 3 brattice did not do so because he noticed leakage from the overcast. It was near the end of his shift and he left the panel. During the inquiries it could not be established what messages were passed to the evening shift Deputy, but it is clear that for some undetermined time the whole of B heading inbye of C/T 3 was virtually unventilated.
