Investigation report

Fatality at Baralaba Coal Mine on 7 July 2019

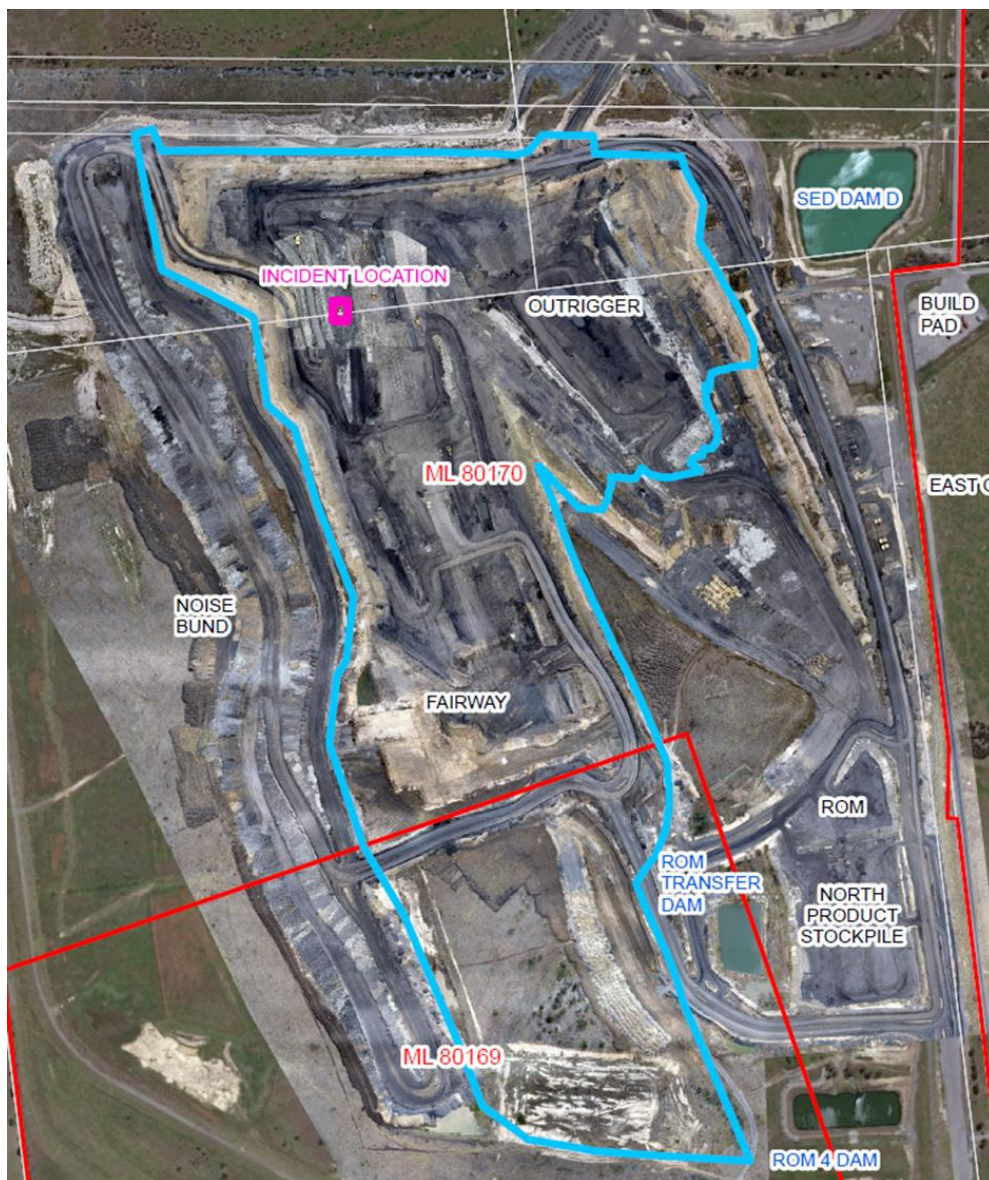
Image 3 A marked aerial photograph of the Fairway pit with incident location

The incident occurred at the Fairway Pit North.

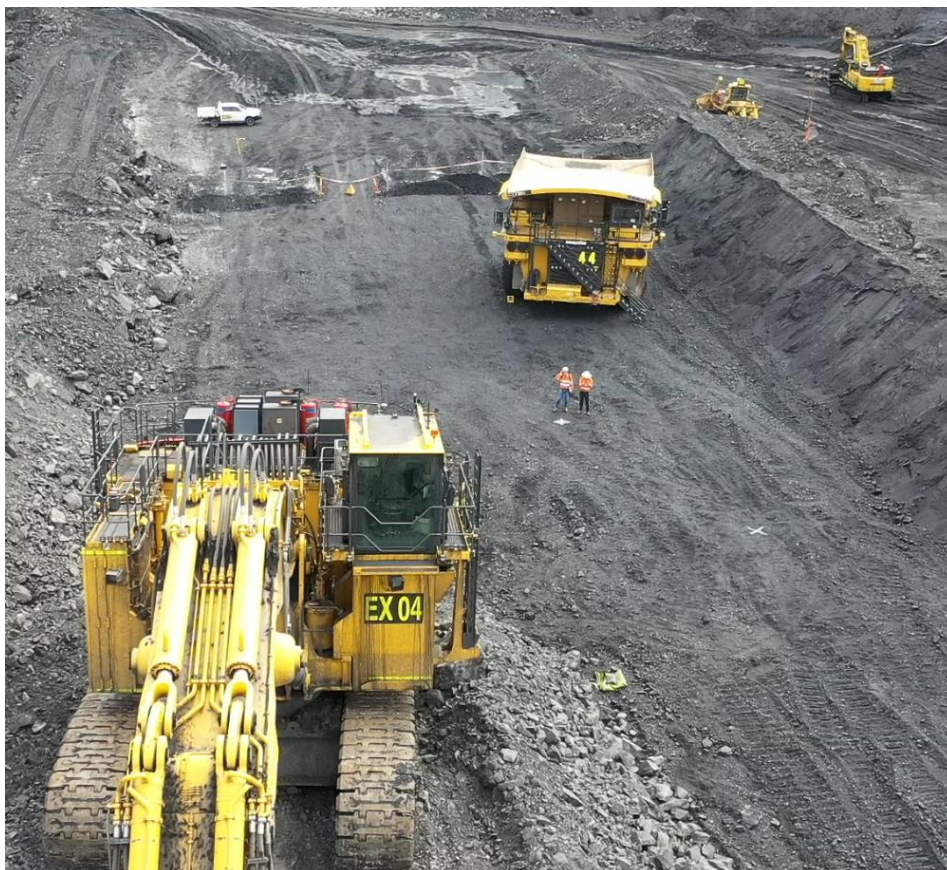
Image 4 Aerial photographs of incident scene with EX04 and DT44 (head on)

After Mr Gerdes had been transported to EX04 and accessed the machine, rear dump truck DT44 arrived ready to be loaded by EX04. In the headlights, the dump truck operator noticed that the ladder was in the lowered position and Mr Gerdes was trapped between the movable part of the access ladder and the wall of the engine room.

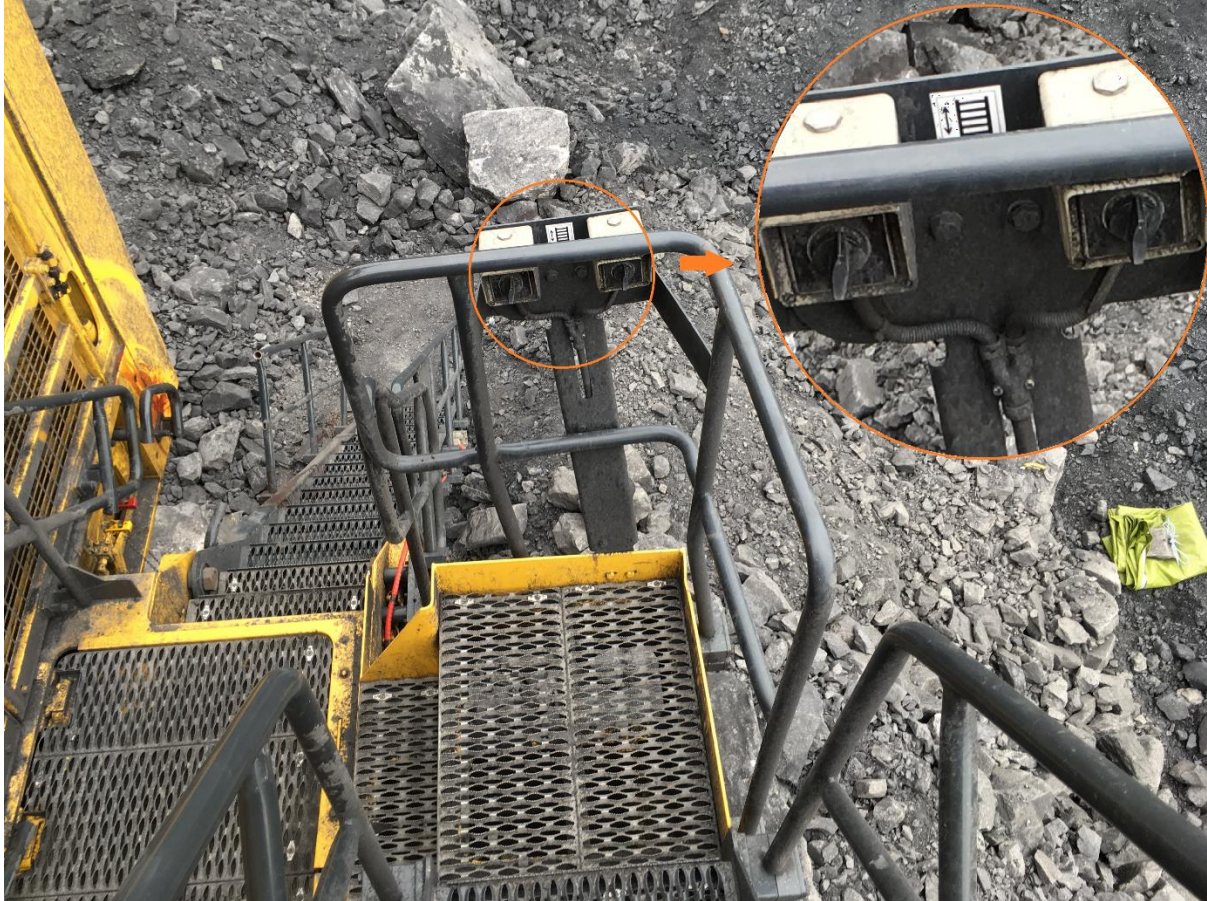
Image 10 Ladder control switches

There is a section of kick plate on the platform under the ladder control switches at the small platform at the bottom of the upper fixed stairway that could have acted as a trip hazard when transferring from the upper to lower stairs (see Image 10).

The excavator design should be reviewed to identify possible trip hazards and implement engineering controls.

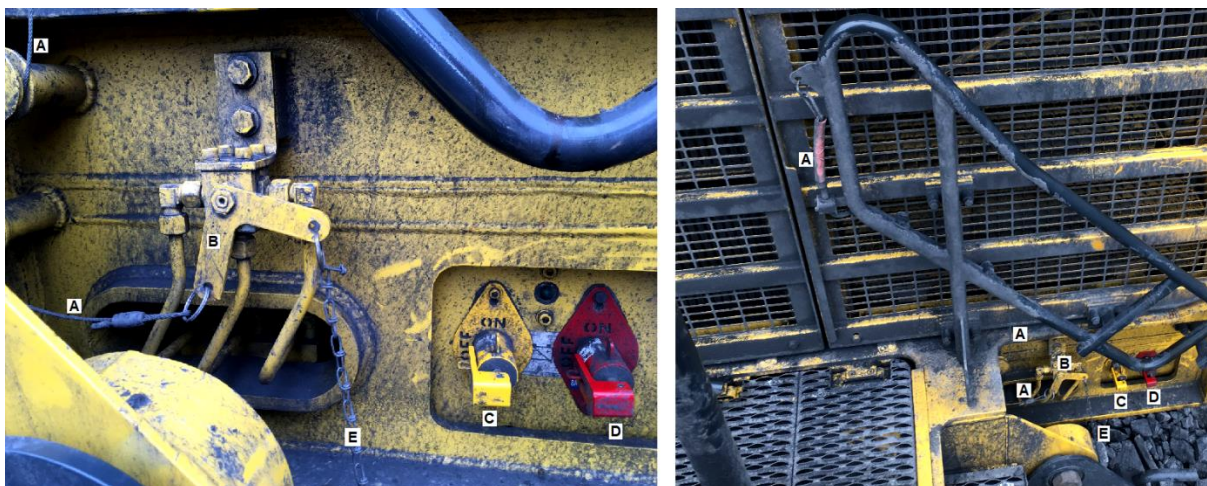
Image 13 Emergency ladder release valve on EX04

In case of an emergency or electrical failure, the ladder can be lowered by opening a magnetic hydraulic valve near the pivot point. The emergency ladder release valve can be opened from level 1 by pulling a cable attached to it. Similarly, it can be opened by pulling an attached chain from ground level (see Image 13). The valve is not intended to be operated by accessing it through the handrails.

It has been suggested that operators may be motivated to lower the ladder with the emergency ladder release valve because that would free up their hands while the ladder is lowering and, during this time, another activity would be possible (e.g. rolling a cigarette, cleaning glasses, tidying attire or checking a mobile phone).
