BEACONSFIELD INVESTIGATION REPORT

PREPARED FOR THE CORONER

The Death of Larry Knight

Which occurred at the Beaconsfield Mine

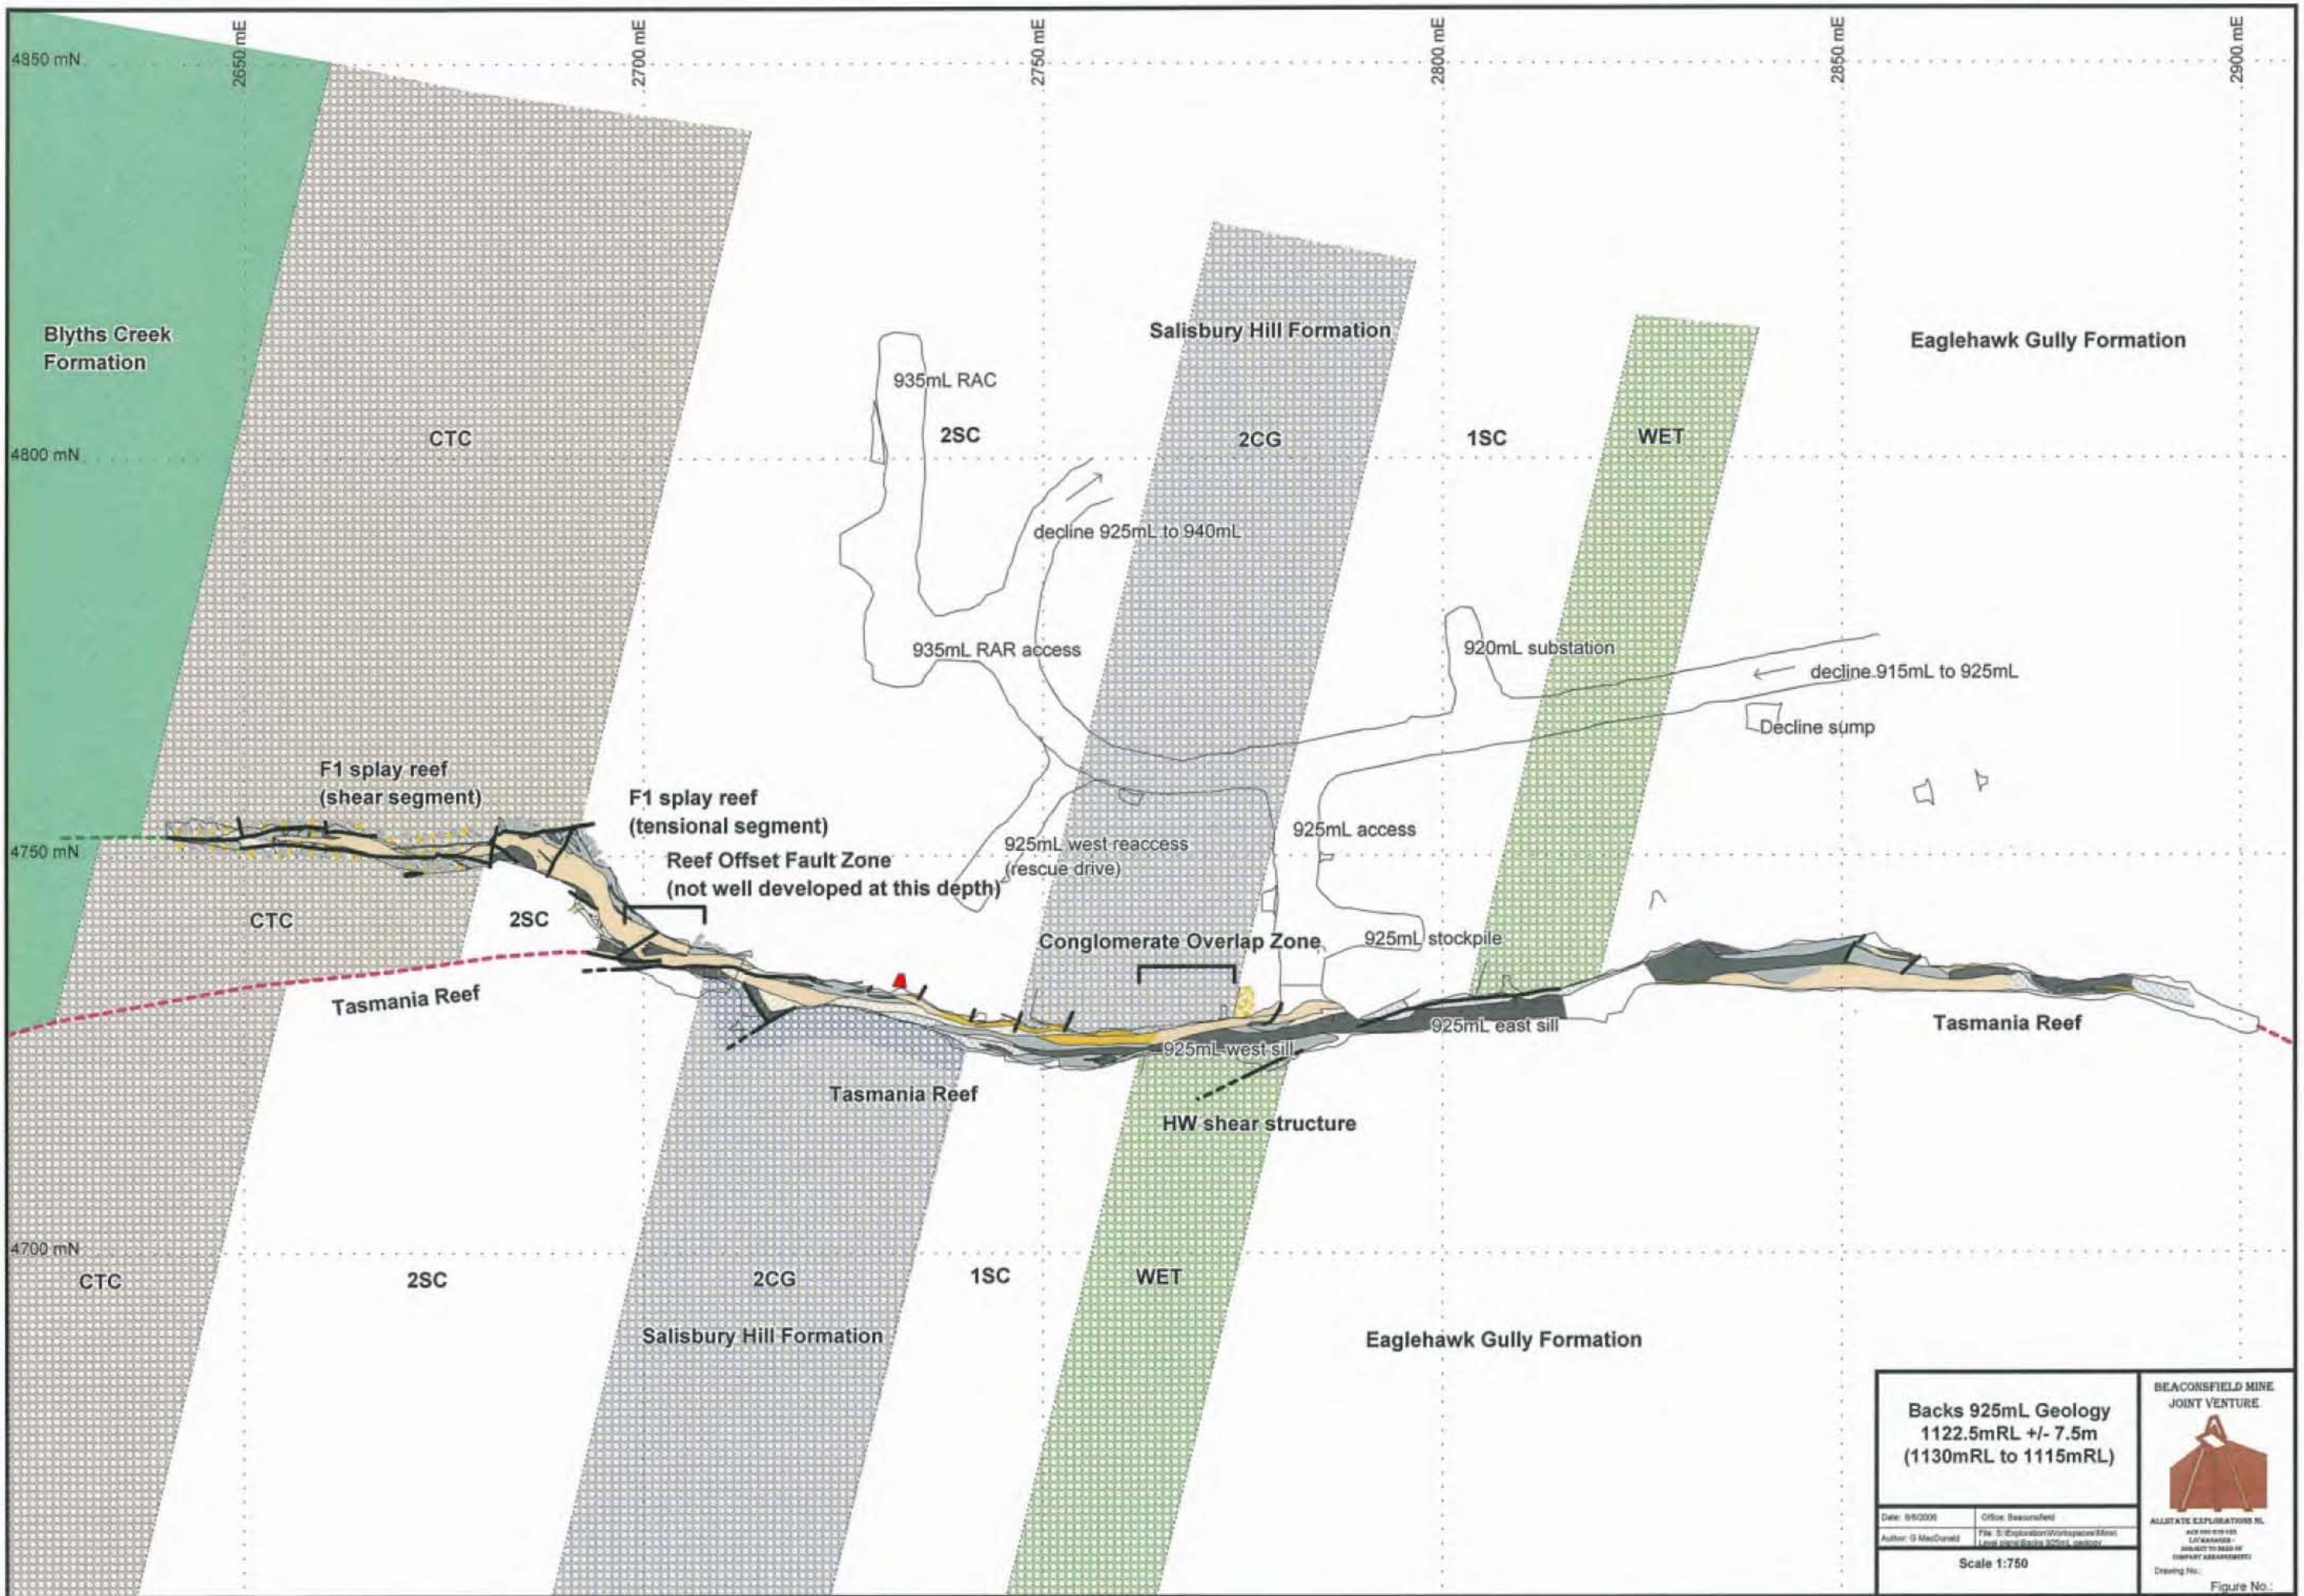
Backs 925mL Geology 1122.5mRL +/- 7.5m (1130mRL to 1115mRL)

Figure 07 which appears as a fold-out page, diagrammatically represents the geology as seen as at the backs of the 925mL. CTC is the Cabbage Tree Conglomerate moving east to the 2SC, Second Sandstone and Conglomerate, then the 2CG, Second Conglomerate, then the 1SC First Sandstone and Conglomerate, and then the WET, or Wet Beds Conglomerate abutted by the Eaglehawk Gully Formation. To the west of the ore body there is the Tasmania Reef Continuation indicated by a red dotted line and it is to be noted that the ore body departs the Tasmania Reef at this junction. There is a hanging wall extension that follows the line of the Tasmania Reef continuation and it is in this area that the 2.1ML seismic event of 26 October 2005 is thought to have occurred.

There is continual seismic pressure travelling both north and south through the ore body but such forces are more readily transmitted through the stiffer conglomerate zones rather than the more yielding sandstone beds. Until the ore body is mined, those forces readily transfer through the Tasmania Reef fault, but once the ore is removed and replaced with rock fill, the reef has a damming effect on those pressures which then seep away around the mined reef. There is a build up of pressure, and hence increased seismic activity in the conglomerate overlap zone because of the tendency of the pressures to follow the conglomerate and there is also increased seismic pressure and activity where the ore body departs the Tasmania Reef fault. These areas are indicated on the diagram as the Conglomerate Overlap Zone and the Reef Offset Fault Zone.

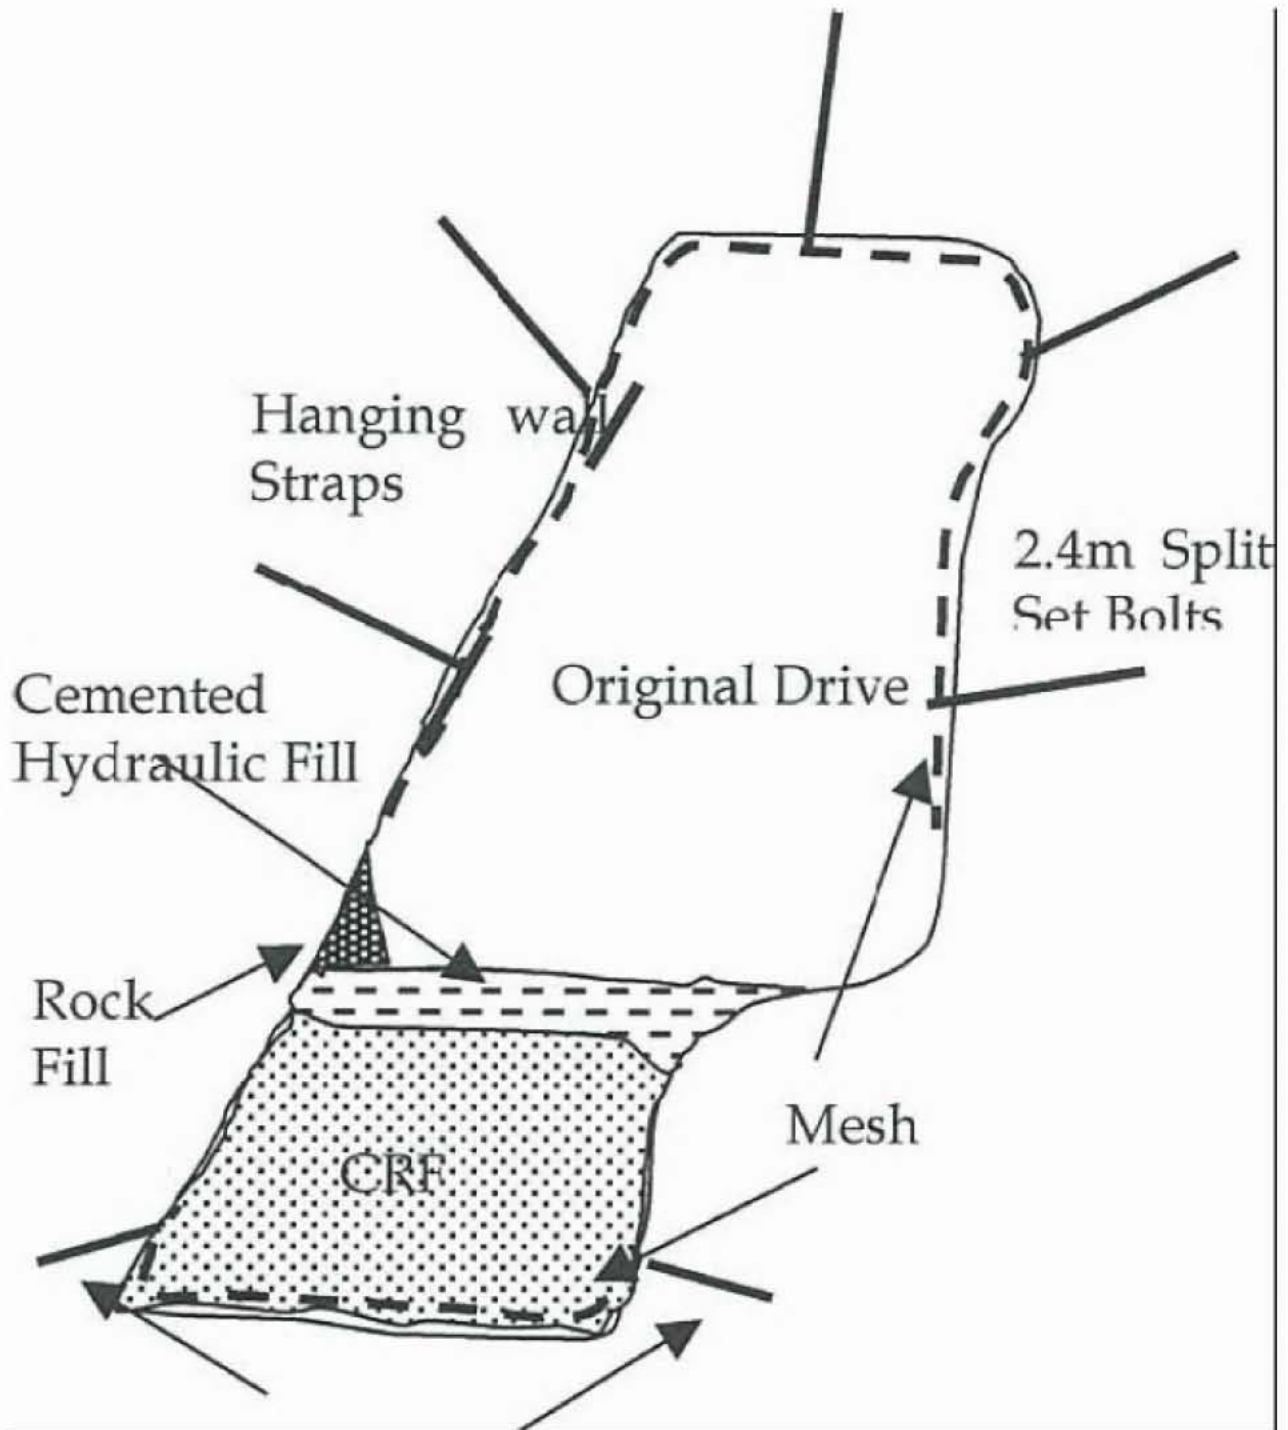
Figure 09

In figure 9 above, the dotted lines around the drive indicate the wire mesh which was held in place by straps which were in turn bolted into the rock face. The diagram refers to 2.4m Split Set Bolts, but different forms of bolts could be used. Usually the greater the length of the bolt, the greater support offered, although a relatively short bolt into solid rock would offer more support than a longer bolt placed into friable or damaged rock. Greater protection could also be afforded by the use of dynamic ground support which would allow a dynamic arch, which could cope with the events of greater seismic magnitude.

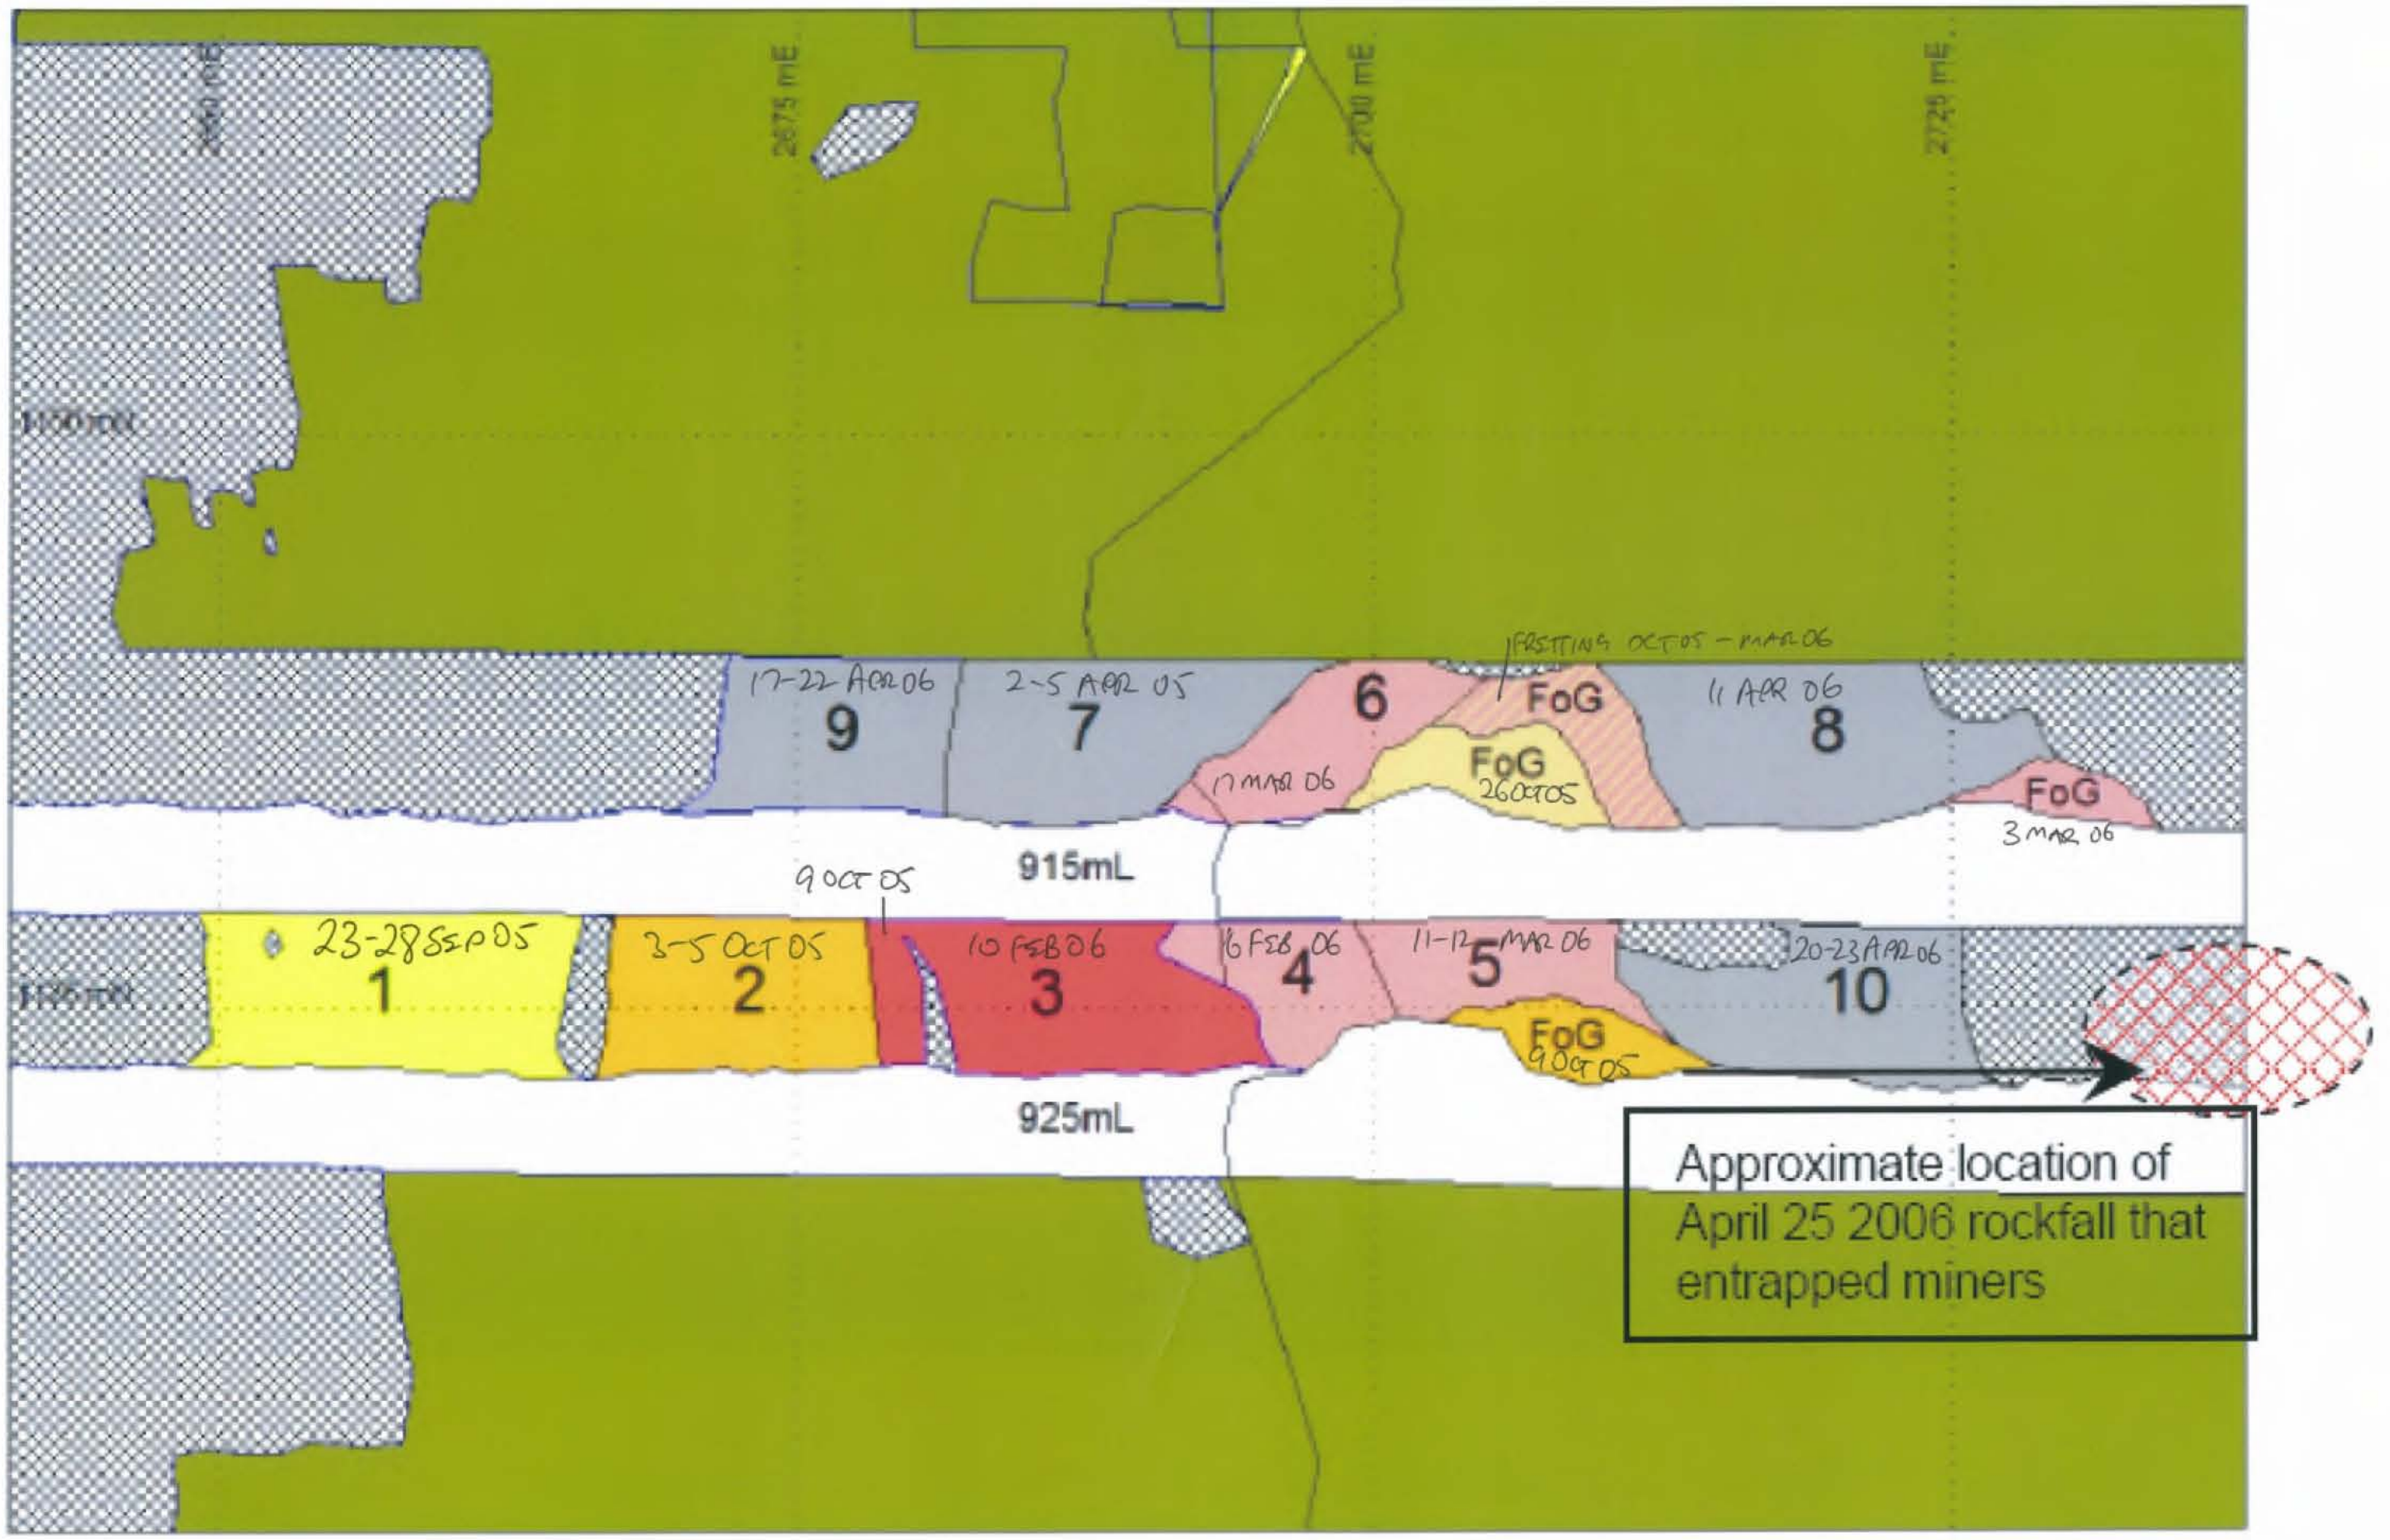
By September 2005 the bottom level of the 940mL mining block had been mined and work had commenced on the intermediate stope, being the 925mL. Foldout Figure 12 illustrates the remaining stopes to be mined on the 940mL block. Panel 1 was fired from 23 – 28th September 2005 and panel 2 from 3 – 5th October 2005. On 9th October the eastern edge of Panel 3 was fired after which there was a fall of ground beneath panel 5 on the 925mL. In the usual course of events, the entirety of the 925mL would have been mined before commencing at the western end of the 915mL. The numbering on the diagram illustrates the revised mining method adopted after the events of 26th October, and the dates within

On 26th October there was a major seismic event of 2.1 M_L which is believed to have originated in the area of the continuation of the Tasmania Reef, to the west of the Tasmania Reef Offset Fault zone. This induced a major fall of ground on the 915mL which is illustrated in yellow on Figure 12. Both the falls of ground on 9th and 26th October involved a failure beyond the level of ground support and naturally caused great concern to the operators of BGM. Workplace Safety Tasmania (WST) were notified after both falls, mining operations ceased, and the Mines' operators sought the advice of at least five consultants, namely

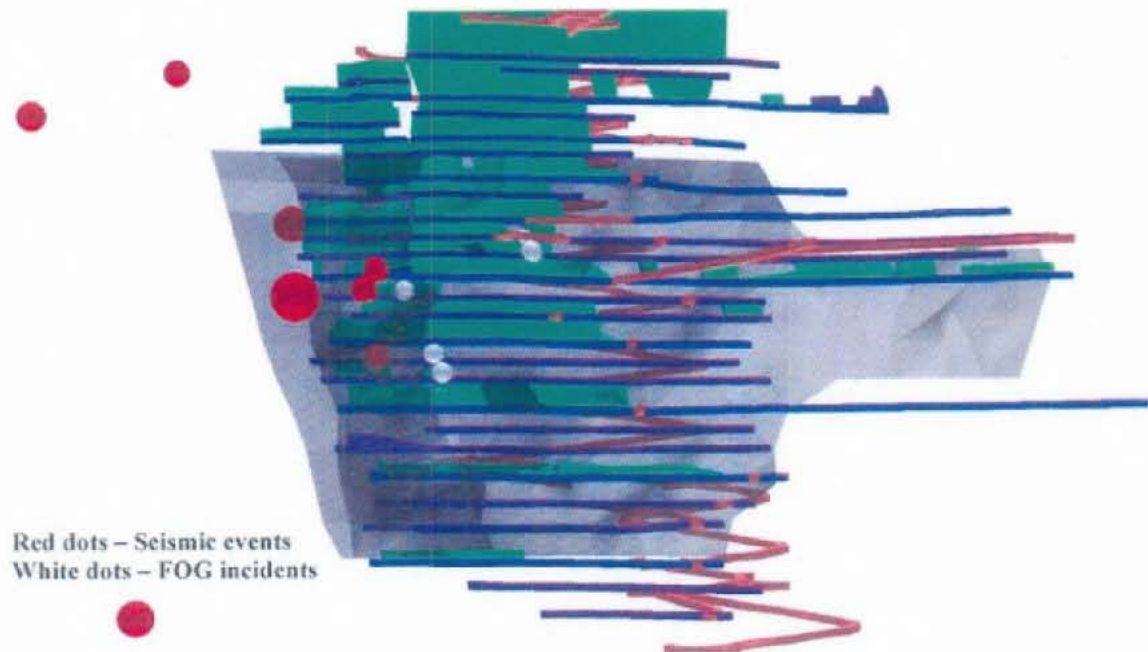
Figure 1.4 All Seismic Events with $ML > 1$ and FOG incidents recorded at Beaconsfield Mine

- *In the seismic data received (2004-06-15 to 2006-01-17), all the $ML \geq 1.0$ events plotted west of the offset fault, either on reef or in the hanging wall (red dots in Figure 1.4)*
- *7 Fall of Ground (“FOG”) incidents were provided to AMC and 5 of them occurred close to an area where stoping broke away from the main reef on one of the Off-set Faults splays (white dots in Figure 1.4)*

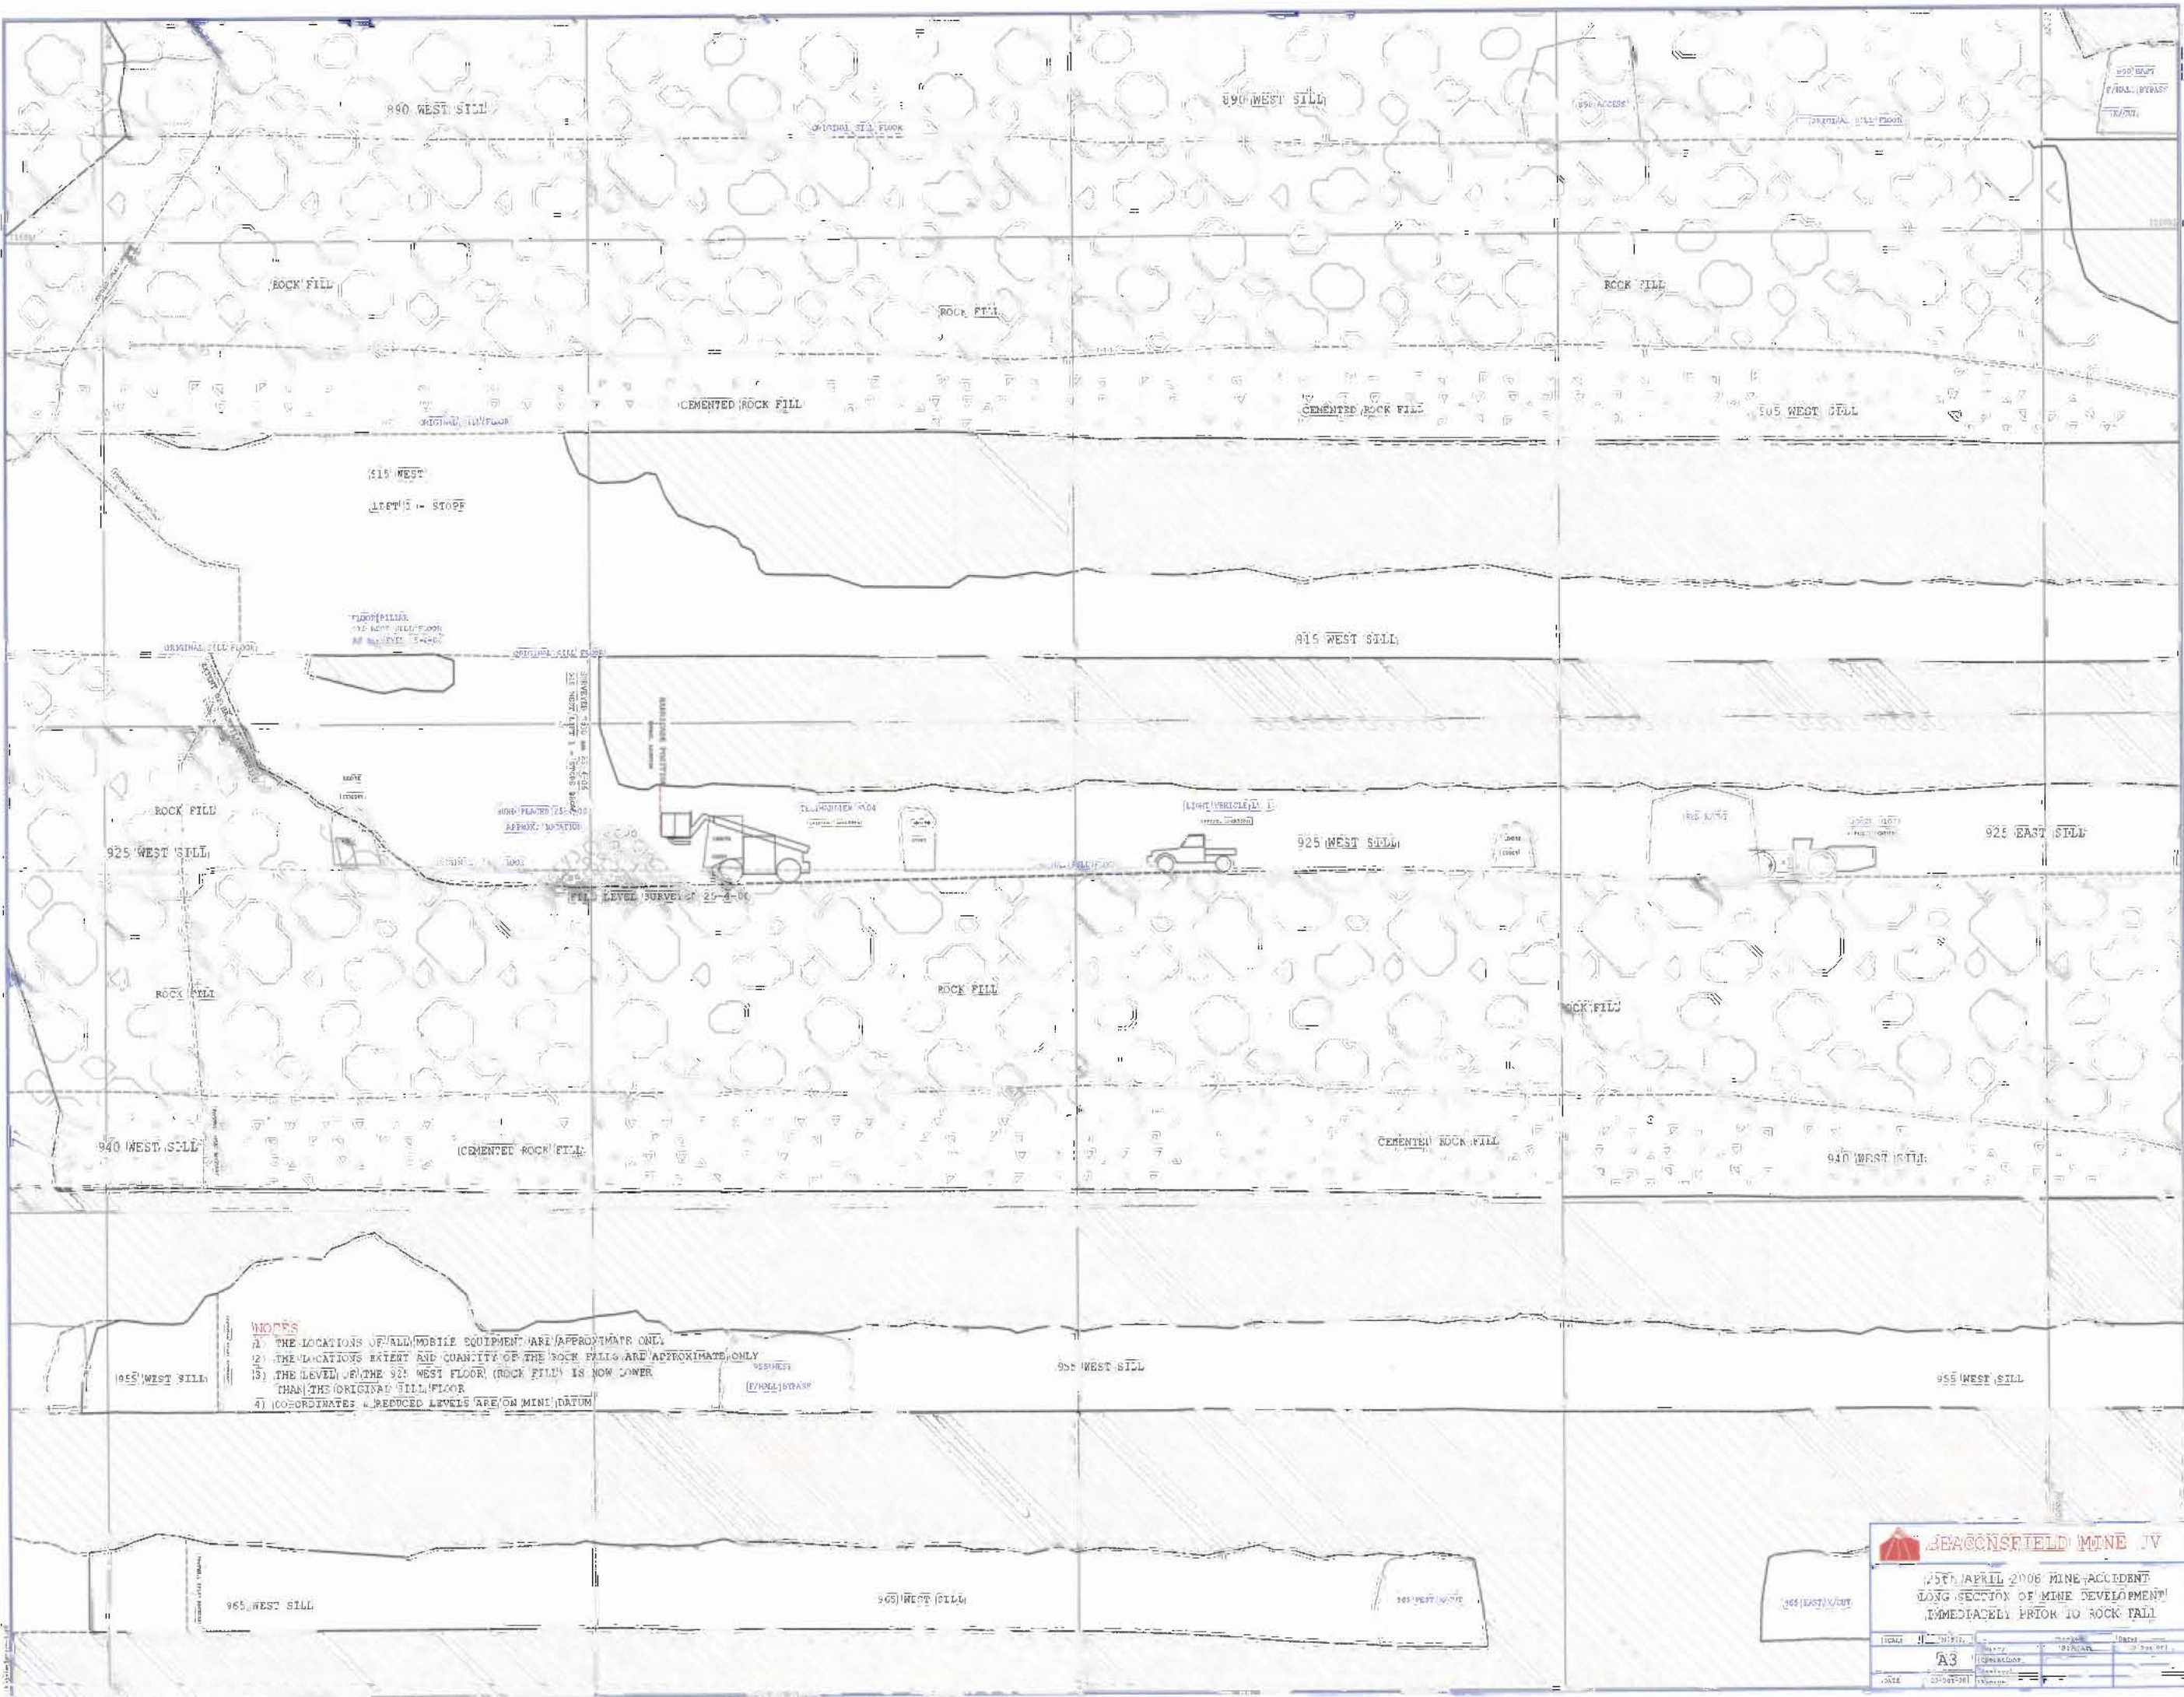
On 25th April 2006, Messrs Knight, Russell and Webb were allocated the task of placing netting at the brow of the remains of the eastern edge of panel 10 to allow the placing of rock fill from the 915 west sill on to the 925 west sill. Figure 13 shows a long section of the operation immediately prior to the rock fall. Messrs Russell and Webb were in a basket at the front of the telehandler which was being operated by Larry Knight. Immediately prior to the rock fall, Mr Knight had lowered the cage onto the rock bund and had left the telehandler to collect some mesh. An overhead plan of the same position is shown at Figure 14. At 9.23 pm there was a seismic event of approximately 2.3 magnitude level, which caused rock falls on both the 925 and 915 levels. Figure 15 is a long section of the mine showing the position of those rock falls and Figure 16 and Figure 17 show overhead plans of the position of the rock falls. Also shown on Figures 16 and 17 is the position of the raise bore tunnel which was drilled to allow the rescue of Messrs Russell and Webb.

It would appear that Mr Knight was trapped under the fall of ground immediately behind

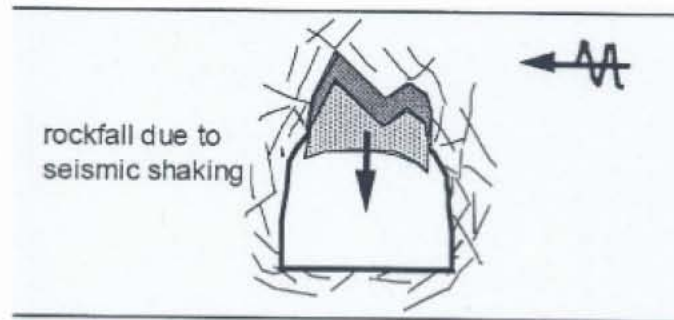
Figure 19 Schematic diagram showing the interpreted mechanism (Kaiser et al 1996)

The main 925L and associated rockfalls were due to seismic shaking caused by the 2.3ML event. This sudden increase in energy was sufficient to exceed the capacity of the installed ground support at the rockfall locations.
