MAGISTRATES COURT of TASMANIA
CORONIAL DIVISION

**IN THE MATTER OF AN INQUEST
TOUCHING THE DEATH OF
LARRY PAUL KNIGHT**

**FINDINGS, RECOMMENDATIONS AND COMMENTS of Coroner Rod
Chandler following an inquest held in Launceston on 22 July to 25
September and 11 November 2008.**

26 February 2009

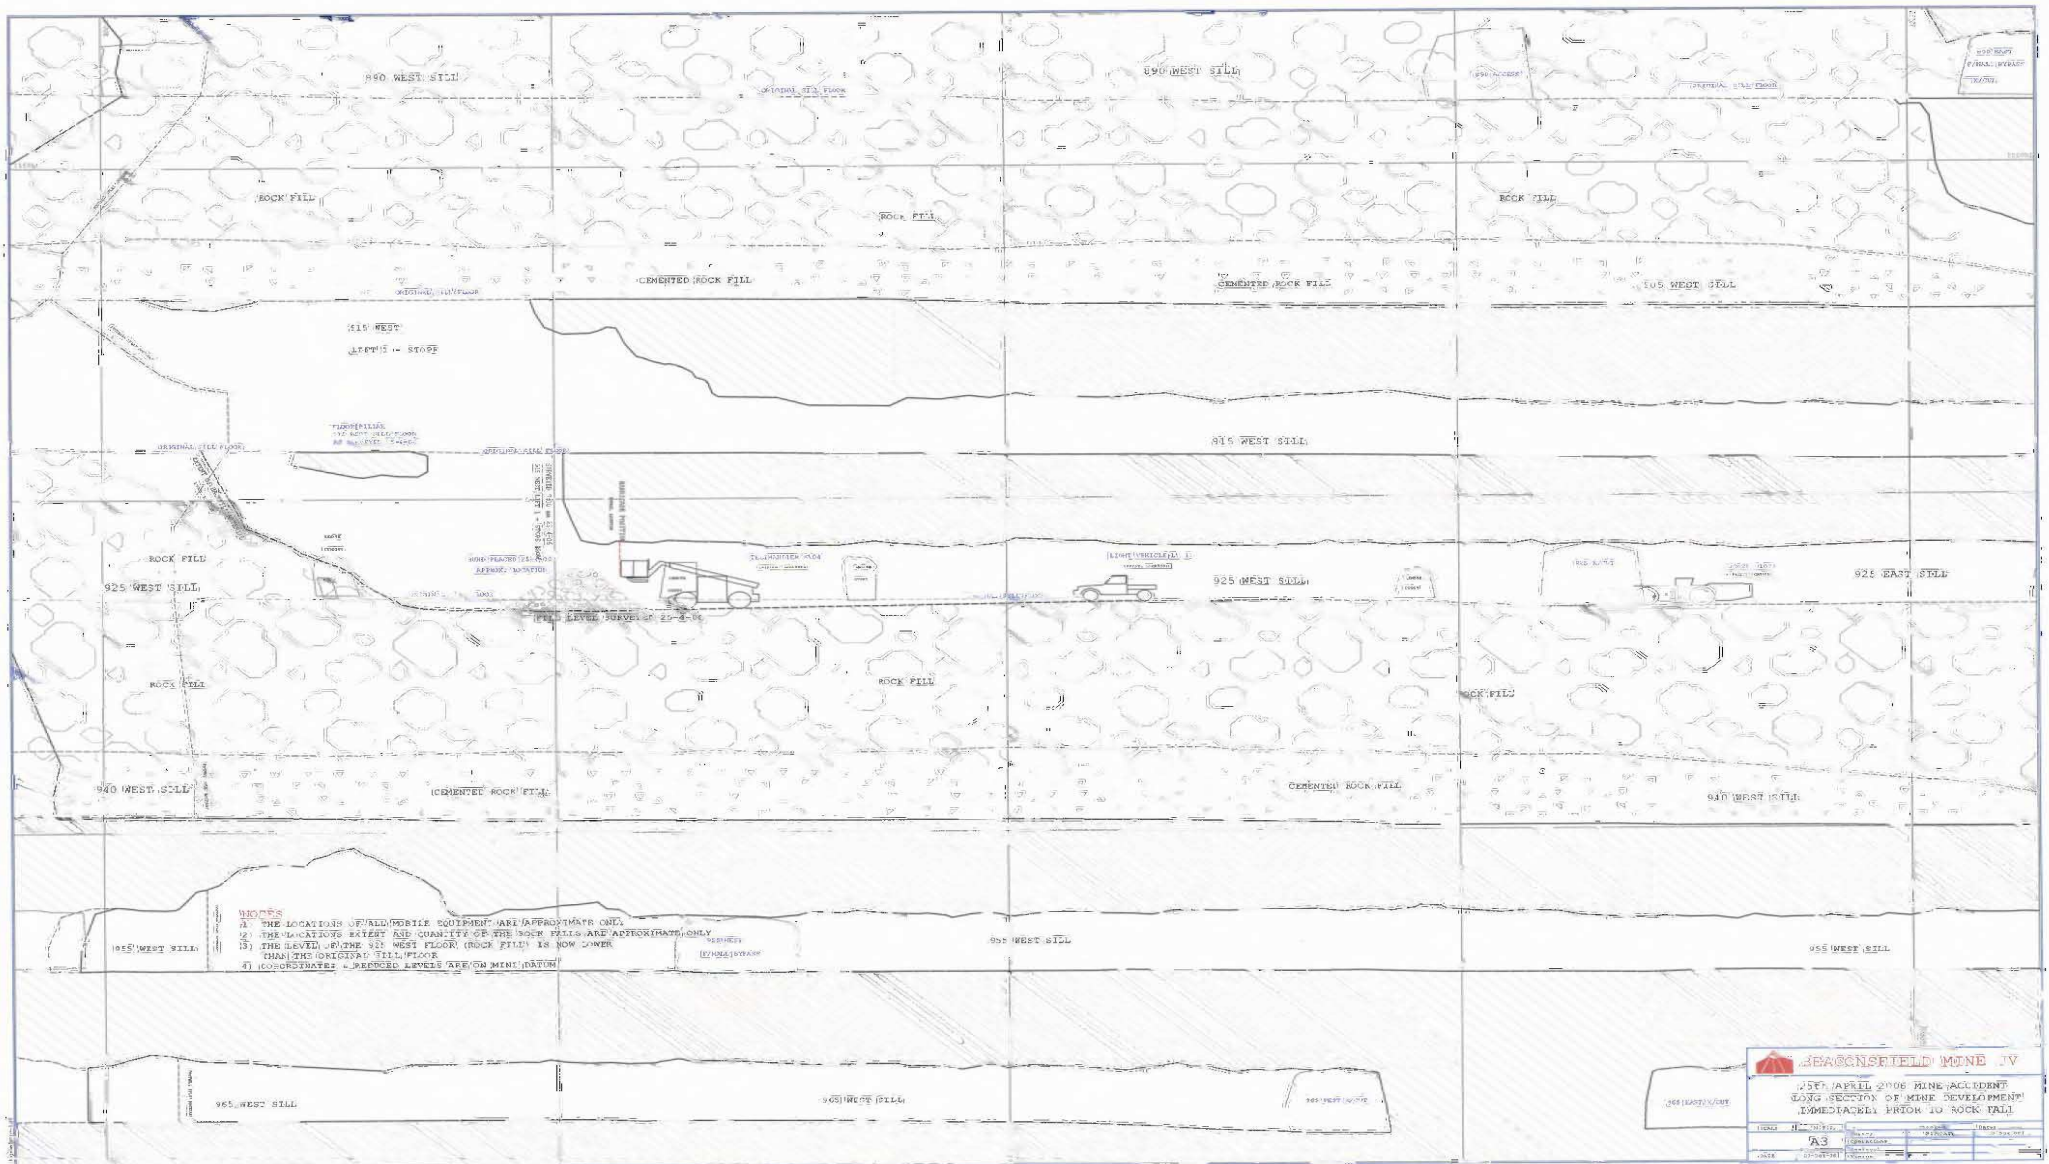
- 2.1.4. It is clear upon the evidence that at 9.23pm a local magnitude 2.3 seismic event occurred at BGM and that it caused three falls of ground within the 925m drive and another in the 915m drive. Of those in the 925m drive, the largest comprising about 800 tonnes engulfed the telehandler and caused the entrapment of Mr Russell and Mr Webb within the metal cage. The second of about 120 tonnes was smaller and occurred about 5 metres to the rear of the telehandler and in the area of a remote cuddy. The third and much smaller fall of ground occurred in the area of the access to the drive.

Fig. 9 is a long section depicting the 940 stopping block after the Anzac Day event
