# Investigation Report

Fire and explosion on Longwall No 1 Tailgate  
at the Blakefield South Mine  
5 January 2011

Published report prepared by the  
Investigation Unit, Thornton

Report Date 8 May 2012

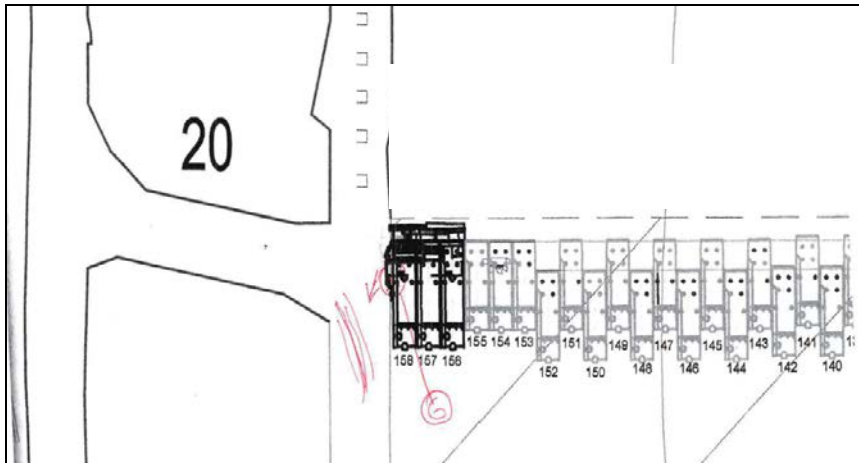
**Figure 3: Extract from interview with deputy: Diagram showing the location of the flames in the tailgate area fanning around into 20 cut-through (Chain number removed for clarity)**

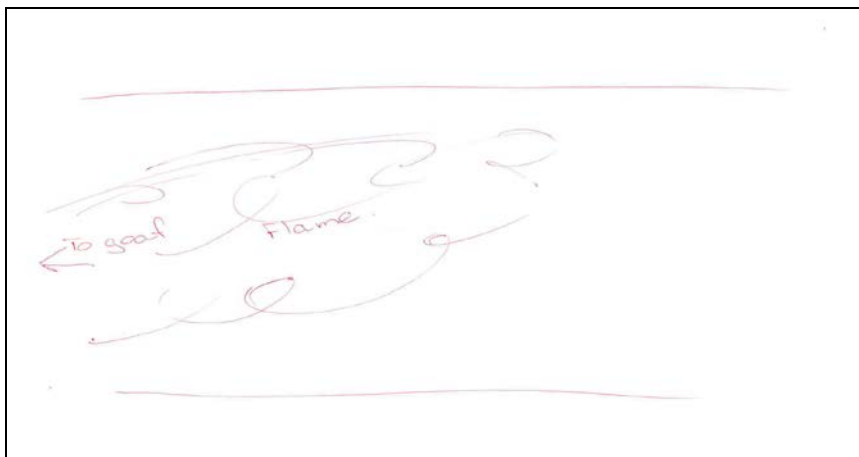
**Figure 4: Extract from interview with deputy: Diagram showing long fanning flames emanating from the goaf area.**

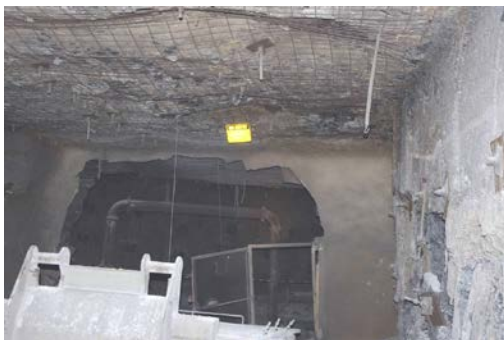
In heading 'B' of the tailgate from 14 cut-through outbye there were further signs of both the fire and the explosion. The clearest signs of an explosion were the blown out stoppings as shown below.

**Figure 10: 14 cut-through in the tailgate with stopping blown out**

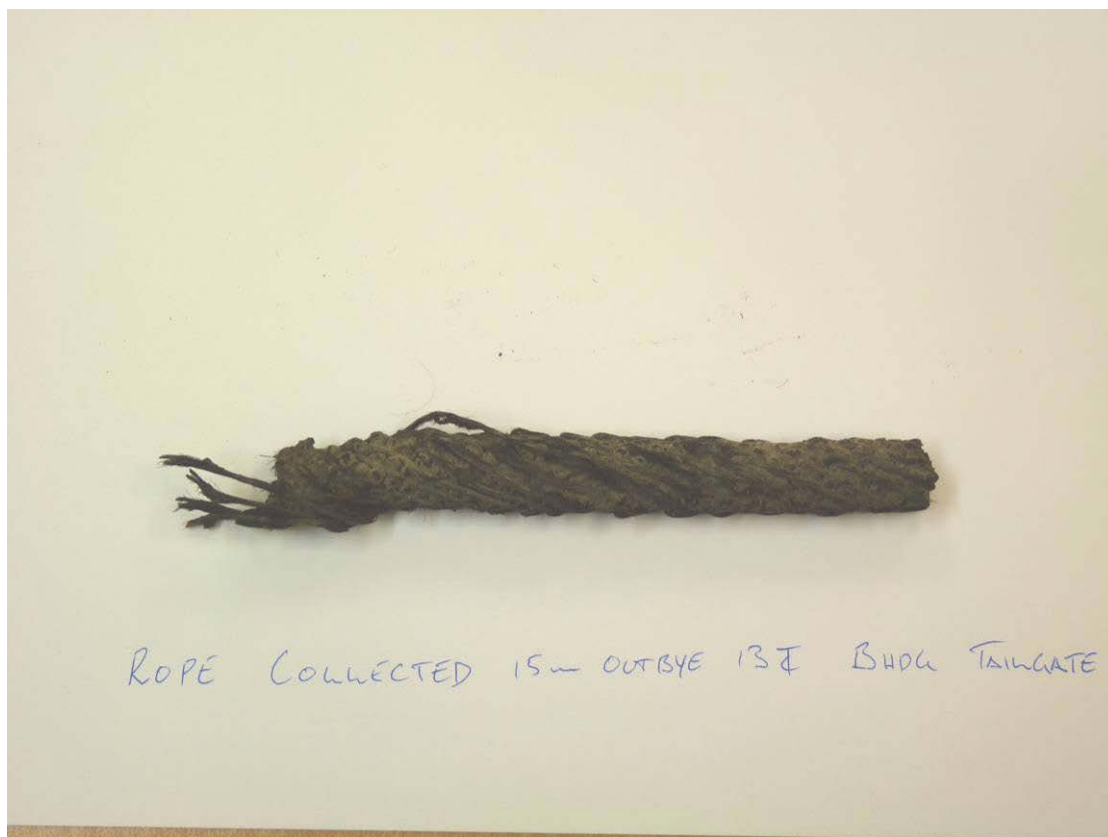
**Figure 12: Sample 1 - A piece of heat-effected rope from 15 m outbye of 13 cut-through heading 'B' tailgate 1**

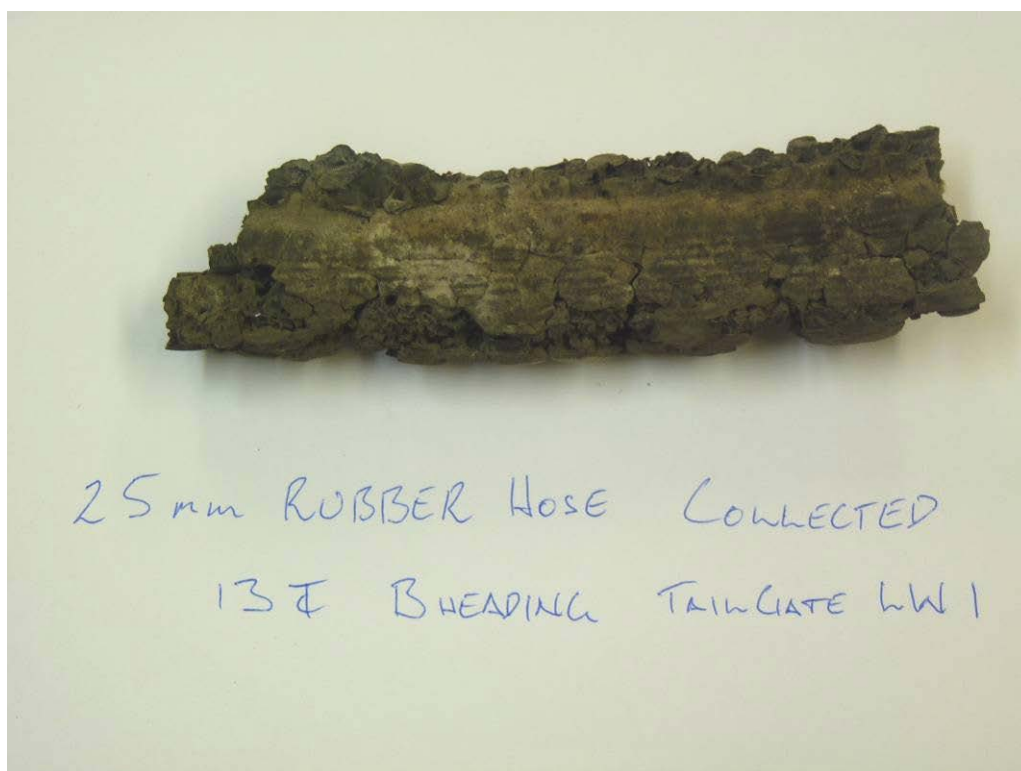
**Figure 13: Sample 2 – A piece of heat-affected 25 mm hose from 13 cut-through heading 'B' tailgate 1**  
 Photograph by Tim Flowers 7 September 2011

*The package contained three sections of double-walled rubber hose, thermally degraded and apparently pyrolysed. The hose material was brittle and friable, with directional bubbling along approximately 1/3 of the circumference consistent with off-gassing of volatiles. Because the orientation of the hose remains was not recorded at the time of recovery, I could not associate this bubbling reliably with the location of a heat source.*

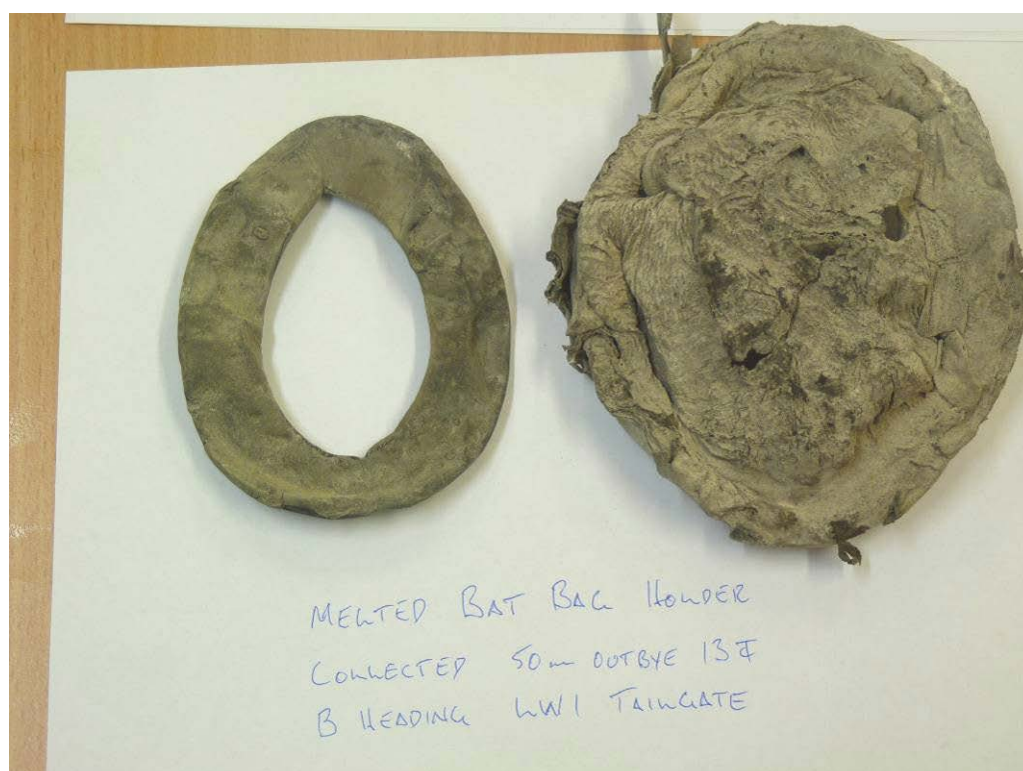
**Figure 14: Sample 3 – Heat-affected bat-bag holder from 50 m outbye of 13 cut-through heading 'B' tailgate1.**

*This item comprised parts of a softened and rehardened polymer assembly, containing more than one polymer. The appearance indicated that high density polypropylene was probably one of the components. As with sample 1, the rigid nature indicated a loss of plasticiser consistent with prolonged heating. There was no visible burning residue, which suggested that the plastic did not reach ignition temperature or it only did so in a low-oxygen environment (below about 11%).*

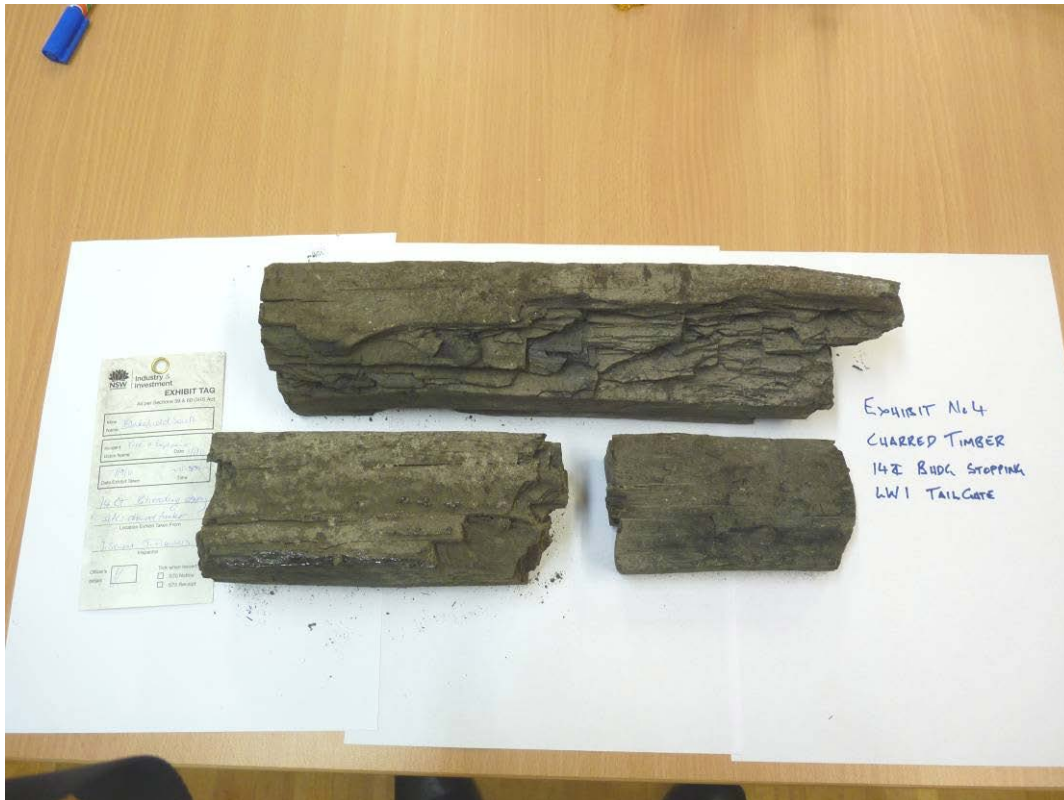
**Figure 15: Sample 4 – A piece of heat-affected wood from 14 cut-through stopping Tailgate1**  
 Photographed by Tim flowers 9 September 2011

*The sample comprised sections of heavy gauge timber, evenly charred through but without distinctive surface burning. This appearance is similar to that of charcoal produced by traditional pyrolysis methods. In my opinion, the most probable explanation is that the wood was in a low-oxygen environment (less than about 8%) for a period of time exceeding 2-3 days. There were no directional indicators which could orientate the wood with respect to a heat source."<sup>24</sup>*

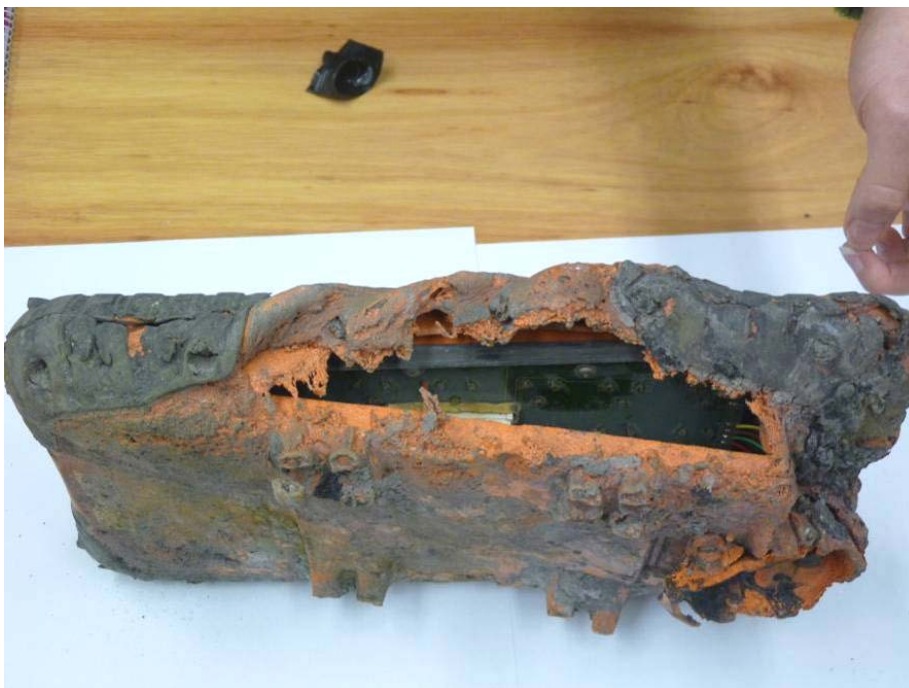
**Figure 16: Joy Mimic Unit IECEx TSA 06.0029X located chock 158 LW1 top of box**  
 Photograph by Tim Flowers 24 November 2011

**Figure 17: Joy Mimic Unit IECEx TSA 06.0029X located chock 158 LW1 bottom of box**  
 Photograph by Tim Flowers 24 November 2011

*"3.09 There was a gap along one edge where the controller appeared to have been broken away from a bracket or mounting. The clean edge showed that this occurred after the heating and I was further advised that the unit was broken away from its location on the chock by the recovery operators. Other than this, the casing remained intact with no heat penetration in either direction.*

*3.10 Initial inspection of the interior through this gap showed no heat, smoke or other internal damage to the electrical components. The unit was then cut open in the presence of interested parties.*

*3.11 This revealed no heat or smoke damage to the interior, no indications of dry solder joints, component failures or other localised heat sources.*

*3.12 In my opinion, the controller was damaged only by exposure to external heating at relatively low temperatures (probably under 300°C)."<sup>25</sup>*

*5.2 Sample 5 as seen was not a viable ignition source for a methane-air mixture, and in my view a malfunction of the controller did not cause this incident.*

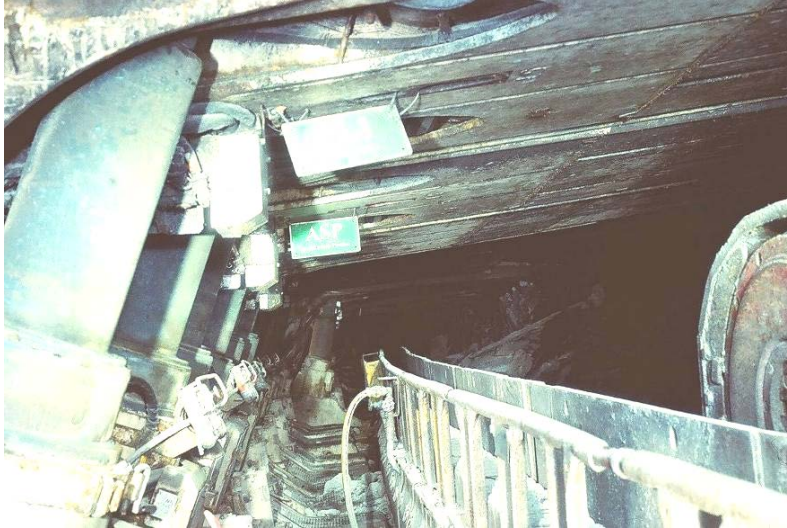
The examination of the LW1 face disclosed that there was no extensive damage along the face from the explosion and subsequent fire.

**Figure 18: Longwall as it looked on re-entry**

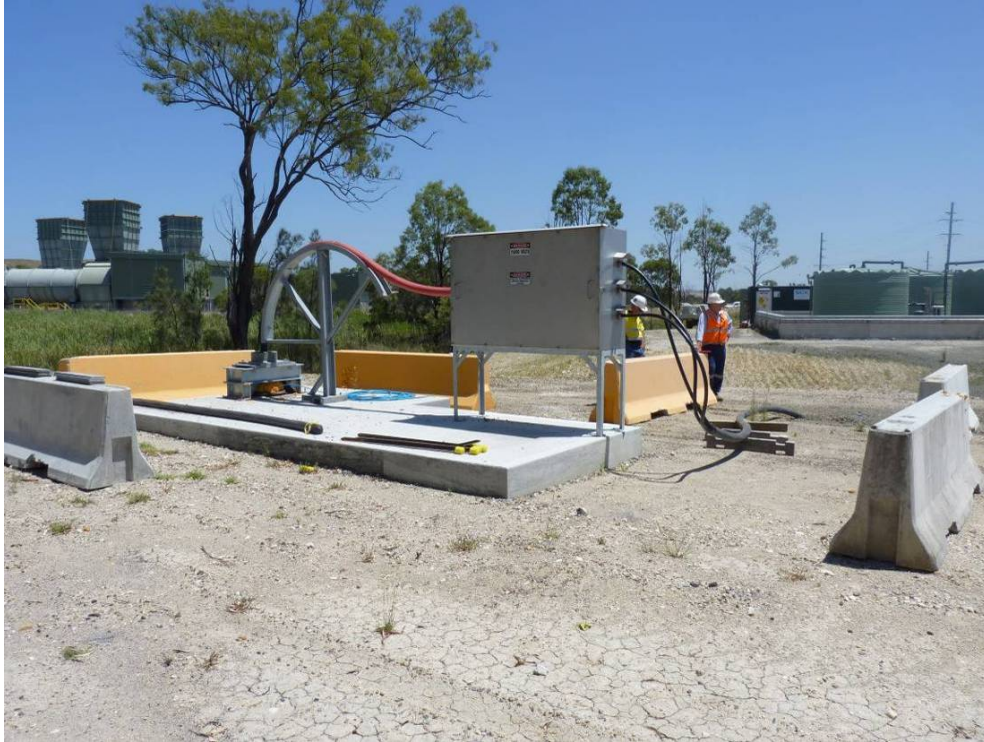
**Figure 26: Junction box and entry point for LW1 11 kV cable entering Blakefield South Mine. Note: the installation is not fenced and cable leading into the junction box is unprotected.**

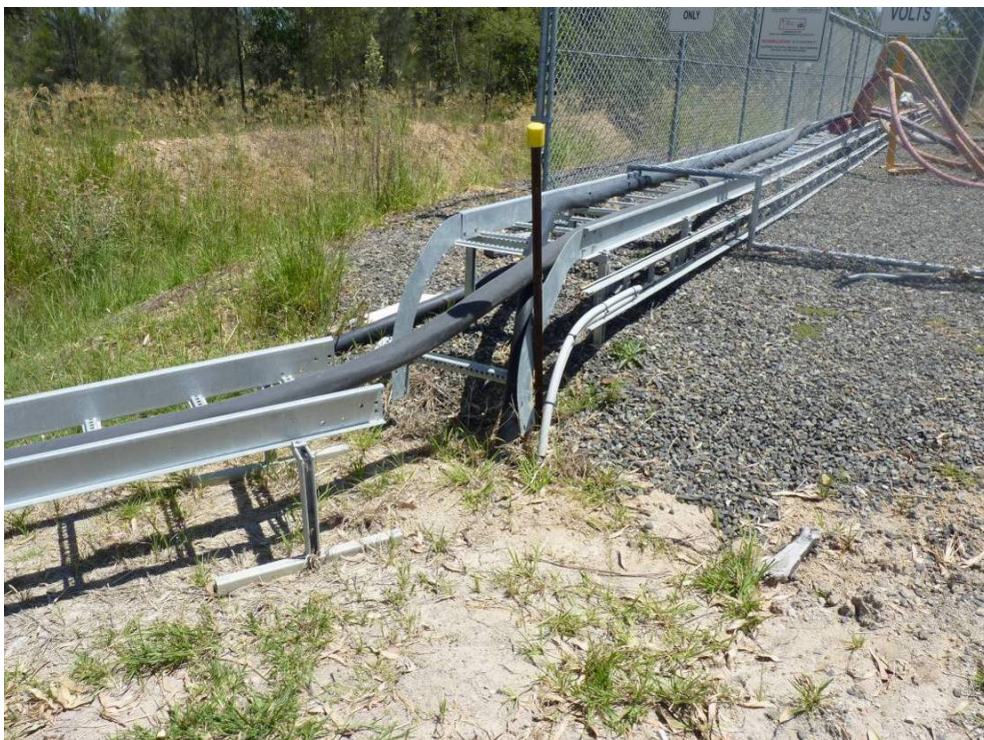
**Figure 27: Break in cable tray showing lack of earth bonding**

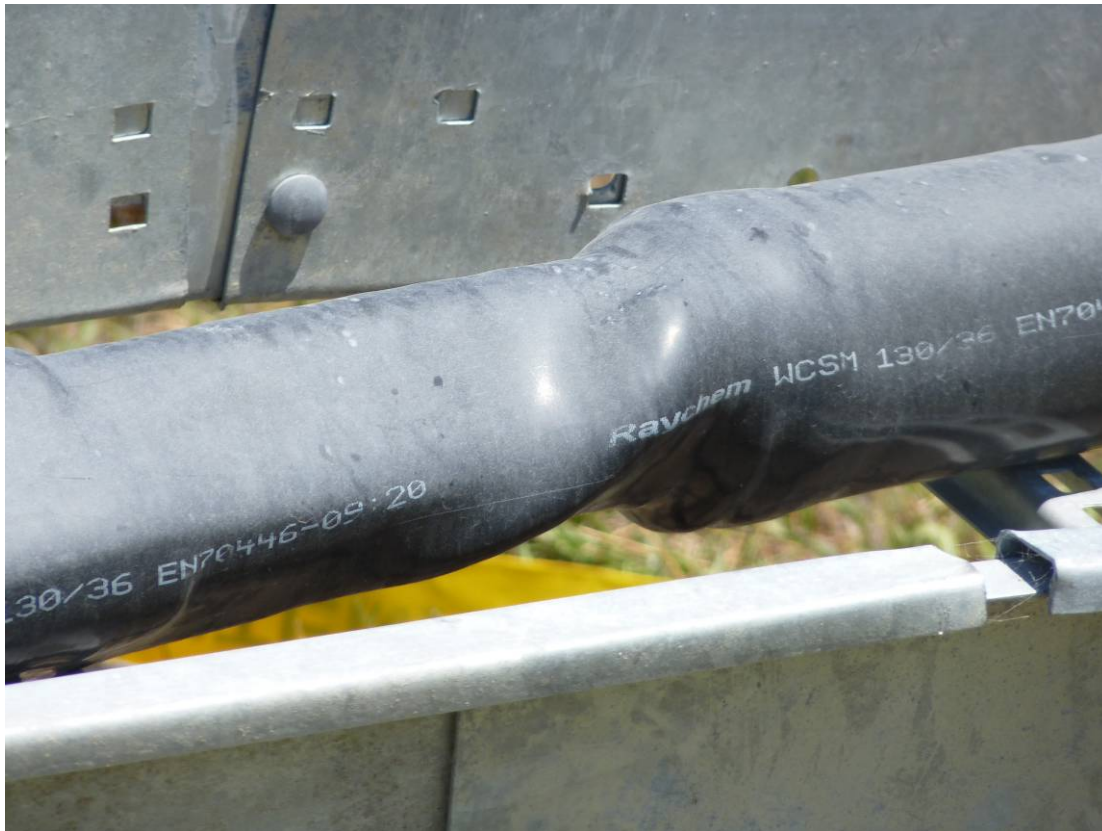
**Figure 28 – High tension cable join showing poor quality join**

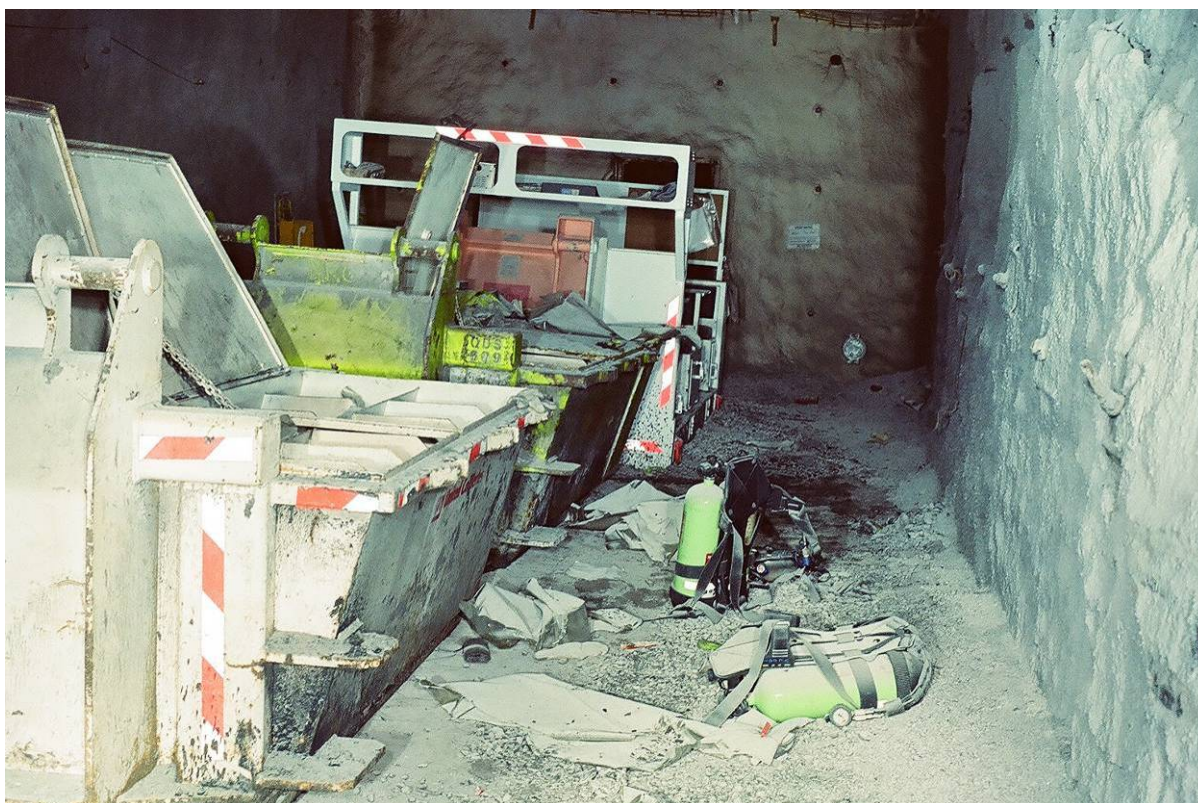
Upon re-entry of the mine both CABA units were recovered from the crib room in 18 cut-through of the Maingate .

**Figure 34: Photo of the two discarded CABA units as found in the crib room**

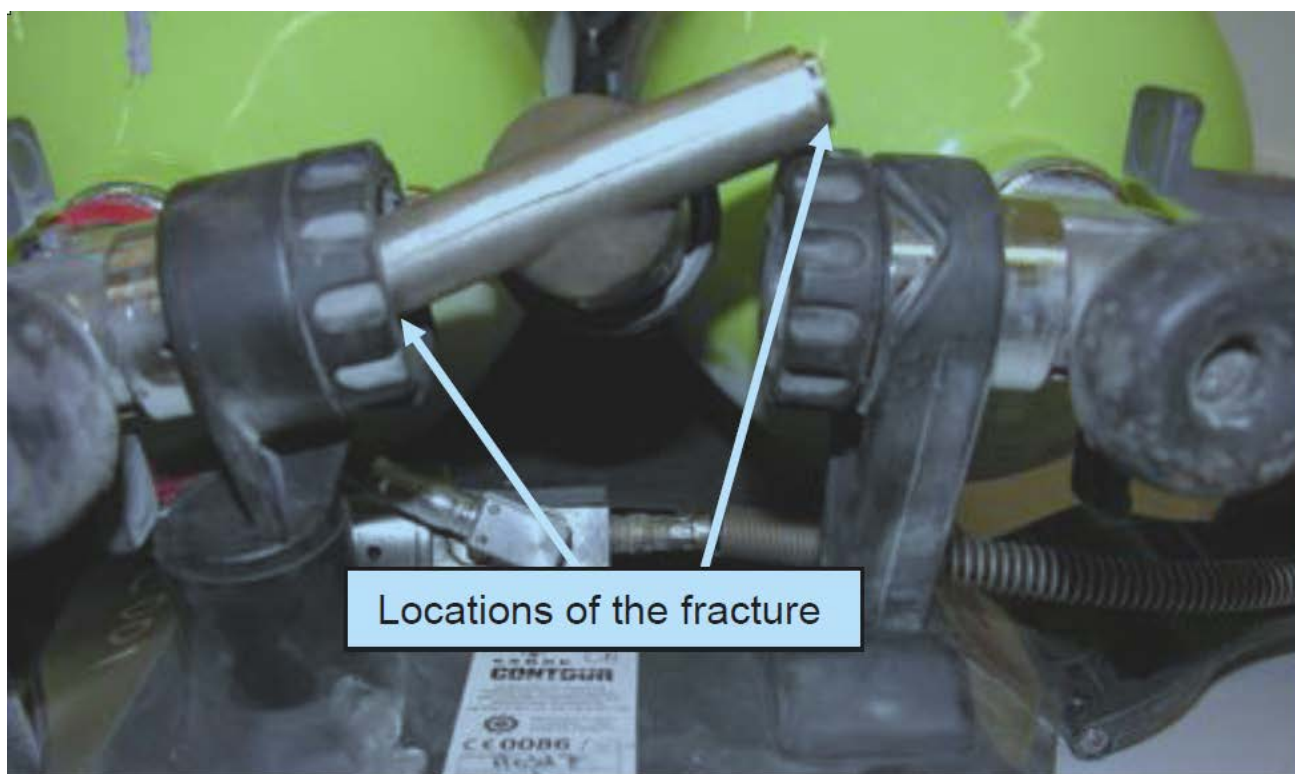
**Figure 35: Photograph of fracture locations in the CABA unit<sup>46</sup>**
