MINE SAFETY INVESTIGATION UNIT

INFORMATION RELEASE

Fatality

Incident date	21 May 2014
Event	Worker crushed while using mobile elevated work platform
Location	Boggabri Coal Mine, Boggabri NSW

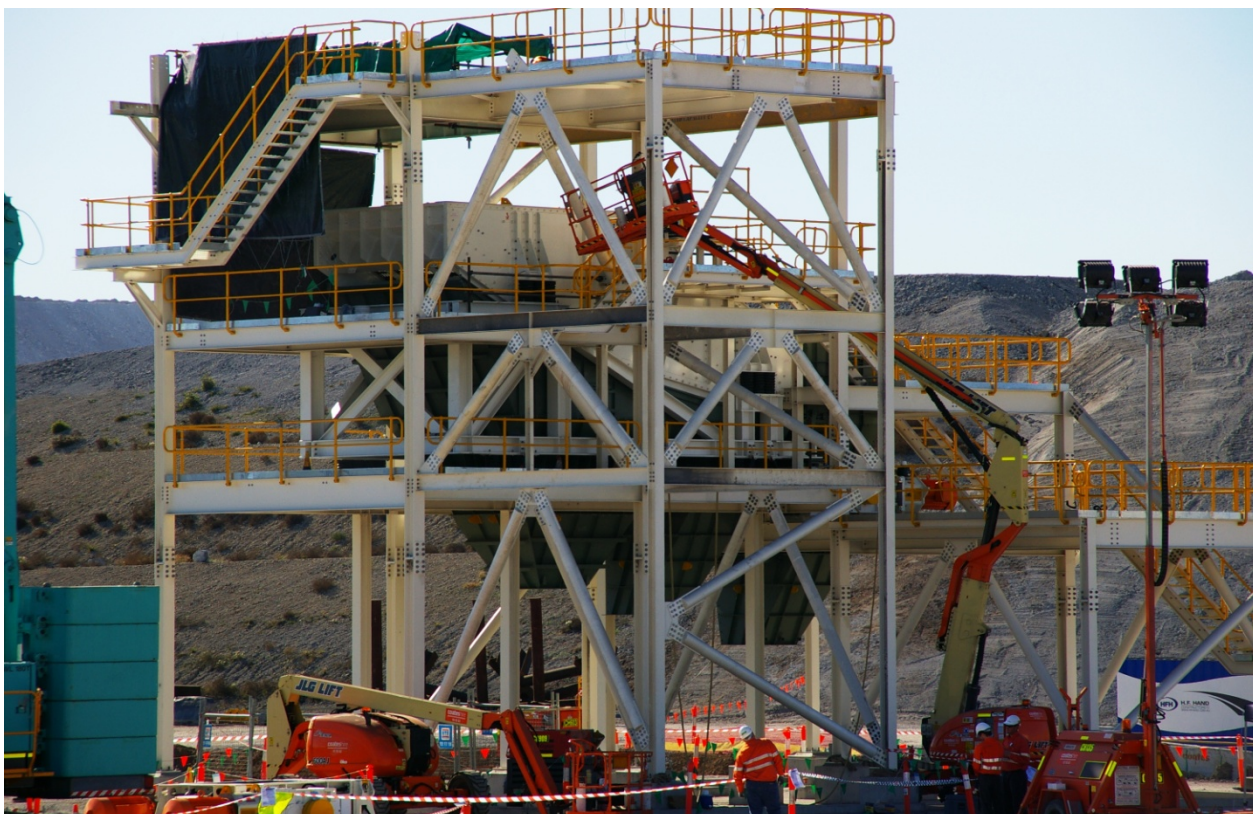
A construction worker was using a mobile elevated work platform (MEWP) within a steel structure when his head was crushed between the protective rail of the MEWP work basket and an overhead steel beam about 14 metres above ground level. Investigations into the incident are continuing.

Steel structure with MEWP in approximate position (after recovery of worker) - *Photograph by Investigation Unit*

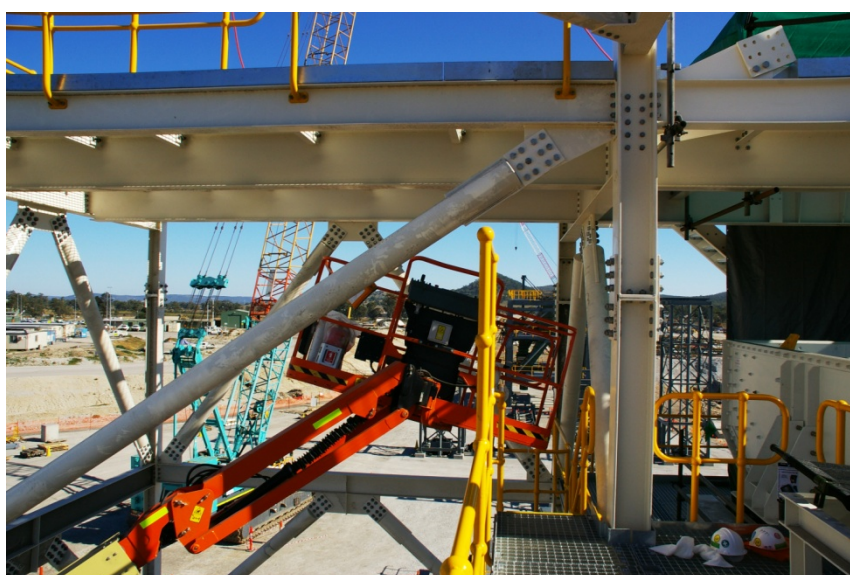
Position of MEWP basket (after recovery of worker) - *Photograph by Investigation Unit*

The base of the mobile MEWP was on a concrete pad at the base of the building. The basket had been positioned centrally within the building, and underneath the upper floor level. The articulated boom had been manoeuvred to reach in between the structural elements of the building.

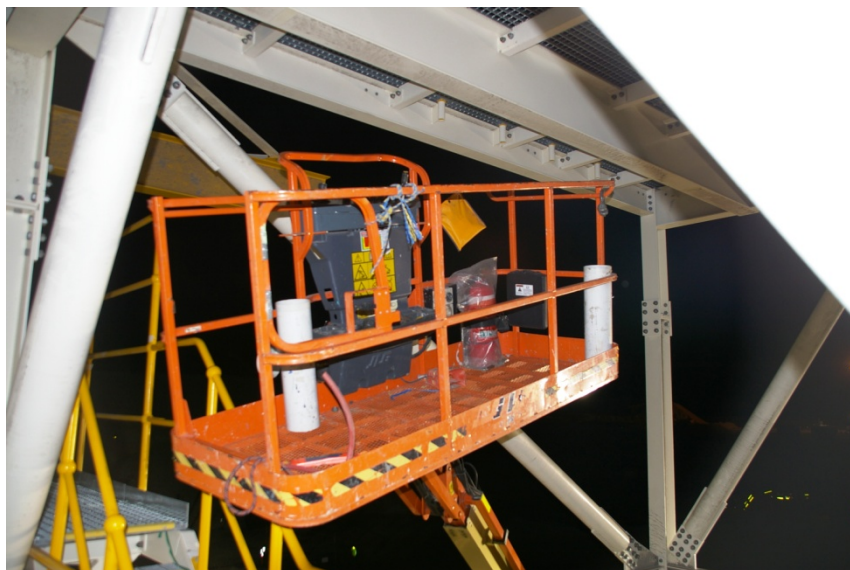
The beam directly above the MEWP basket projected 600 mm into the space below the top floor, and 300 mm deeper than the next beam forward of the position of the operator.

600 mm beams directly above MEWP basket (after recovery of worker) - *Photograph by Investigation Unit*

At the time of the incident the deceased worker was observed standing alone in the MEWP basket. When last observed by a worker, there was only a small distance between the worker's safety helmet and an overhead 600 mm steel beam.

Shortly afterwards, the deceased worker was seen with his head caught between the steel beam and the safety rail protecting the operator's console.

In response to this incident, Mine Safety inspectors issued the mine operator with a notice requiring a full risk assessment to be undertaken in relation to all MEWPs at the site. The notice also requires the mine operator to consider the use of engineering controls that provide overhead protection for operators working in MEWP baskets.

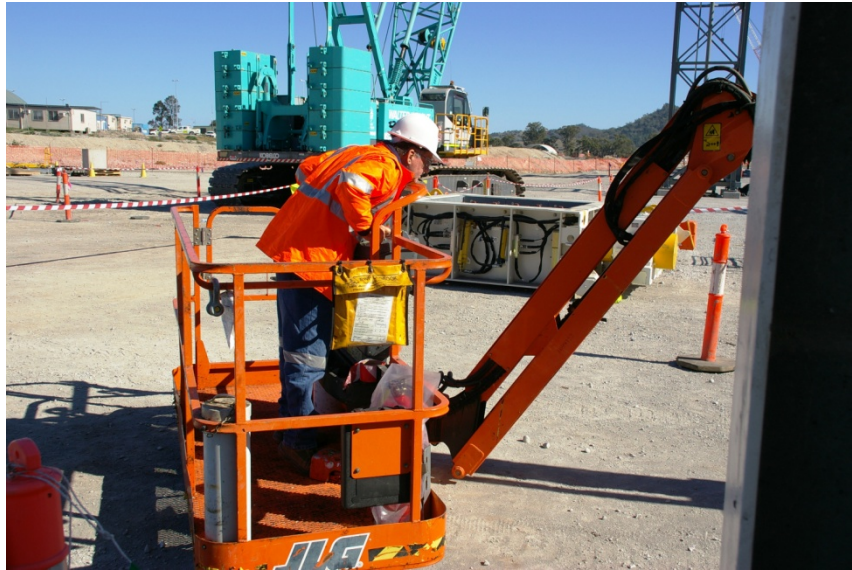
The following photograph depicts a ground level simulation of the approximate positioning of the deceased worker in the MEWP as observed by a worker at the time of the incident.

Simulation showing position of the worker in the MEWP at time of incident- *Photograph by Investigation Unit*
