Investigation report

Report into the death of Mark Daniel Galton at
Boggabri Coal Mine on 21 May 2014

Report prepared by the NSW Mine Safety
Investigation Unit

Published report date: August 2015

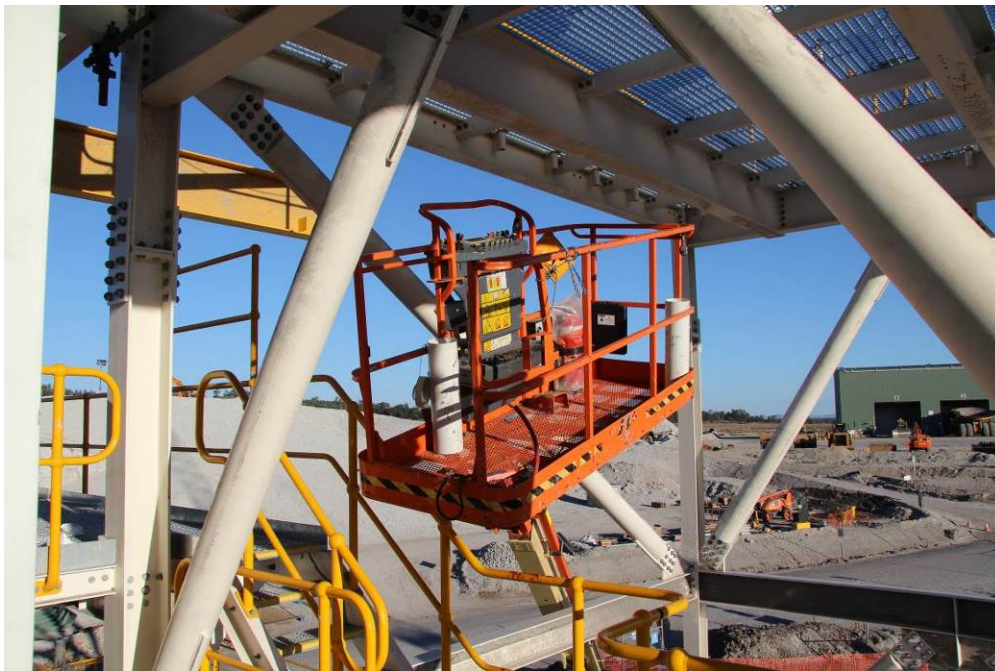
At 8.48 am on Wednesday, 21 May 2014, Mark Daniel Galton, a rigger employed by Thiess Sedgman Joint Venture (Theiss Sedgman) died when his head and neck were crushed between a mobile elevated work platform (MEWP)¹ and the underside of a large, horizontal steel beam.

The incident occurred inside a partly constructed multi-level steel frame referred to as ST202 at the coal handling and preparation plant construction site at Boggabri Coal Mine. The underside of the steel beam was 12.5 m above the concrete floor.

Figure 1. Position of the MEWP after the recovery of Mr Galton inside the ST202 structure.

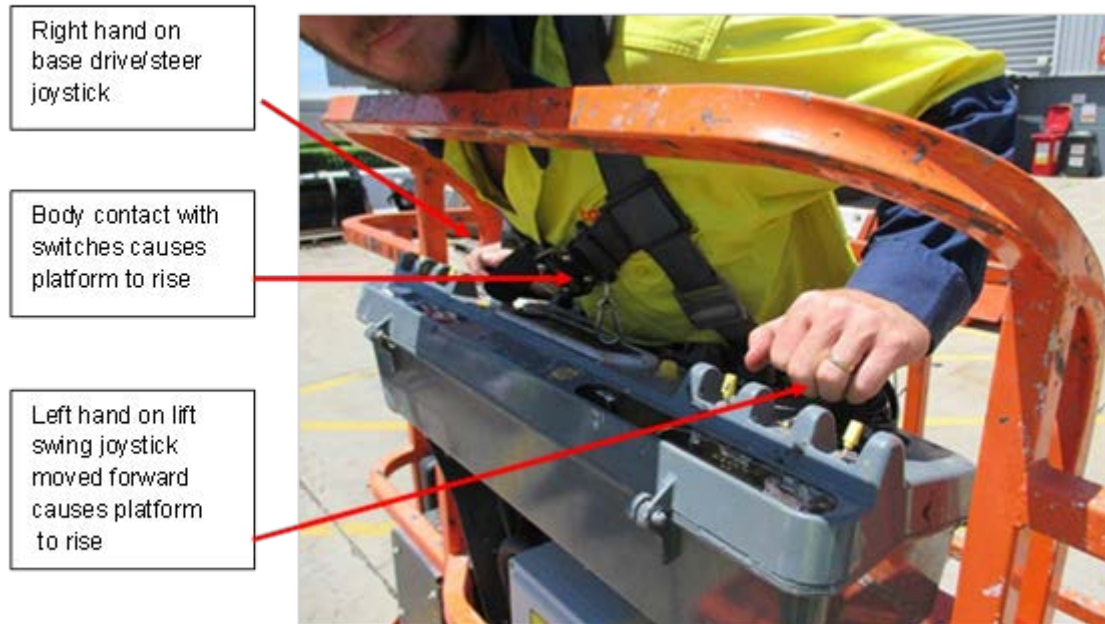
1. **An unintended platform rise** caused by Mr Galton coming in contact with one or more control switches on the platform console, which activated the platform rise functions. In this scenario the main rise control device (the lift swing joystick) was not activated by Mr Galton however the covered footswitch was activated enabling a seven-second window for potential machine movement.

Figure 2. Simulation of an operator in a forward leaning position with his body in contact with control switches that can activate platform to rise. In this position the left hand can apply forward motion to the lift swing joy stick and activate platform to rise. The right hand can be placed on the base drive/steer joystick. The operator's right foot was able to activate the footswitch to permit platform control function.

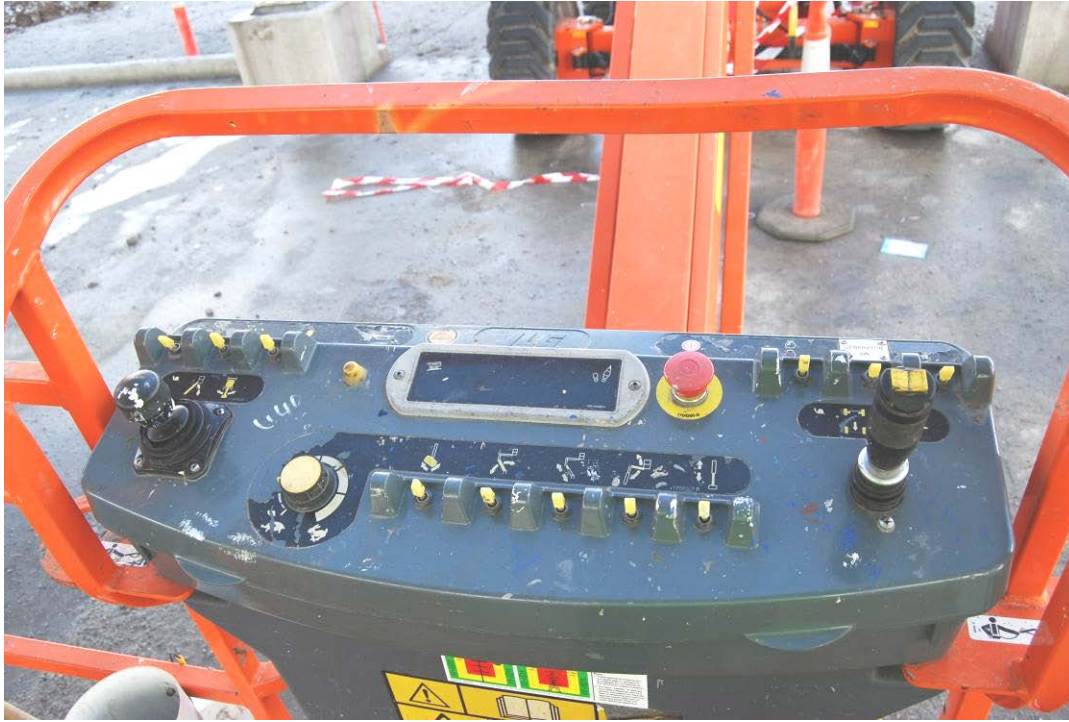
Figure 15: Incident MEWP control console – platform returned to ground level on 23 May 2014.

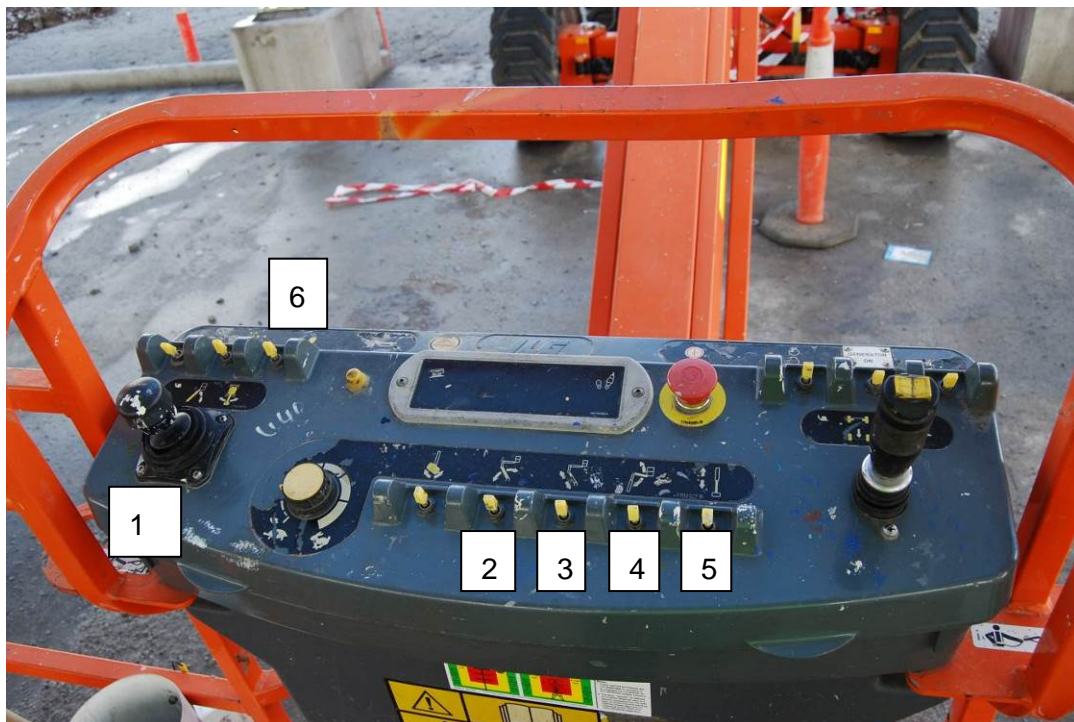
JLG identified six individual platform console controls that cause a rise in the platform.

Figure 18: Identification of the six platform raise controls on the platform control console

1. Main lift swing joystick move **forward**
2. Tower lift toggle switch to **forward position**
3. Tower telescope toggle switch **to forward position**
4. Jib toggle switch **to forward position**
5. Telescope toggle switch **to backward position**
6. Platform levelling over ride switch **to forward position**

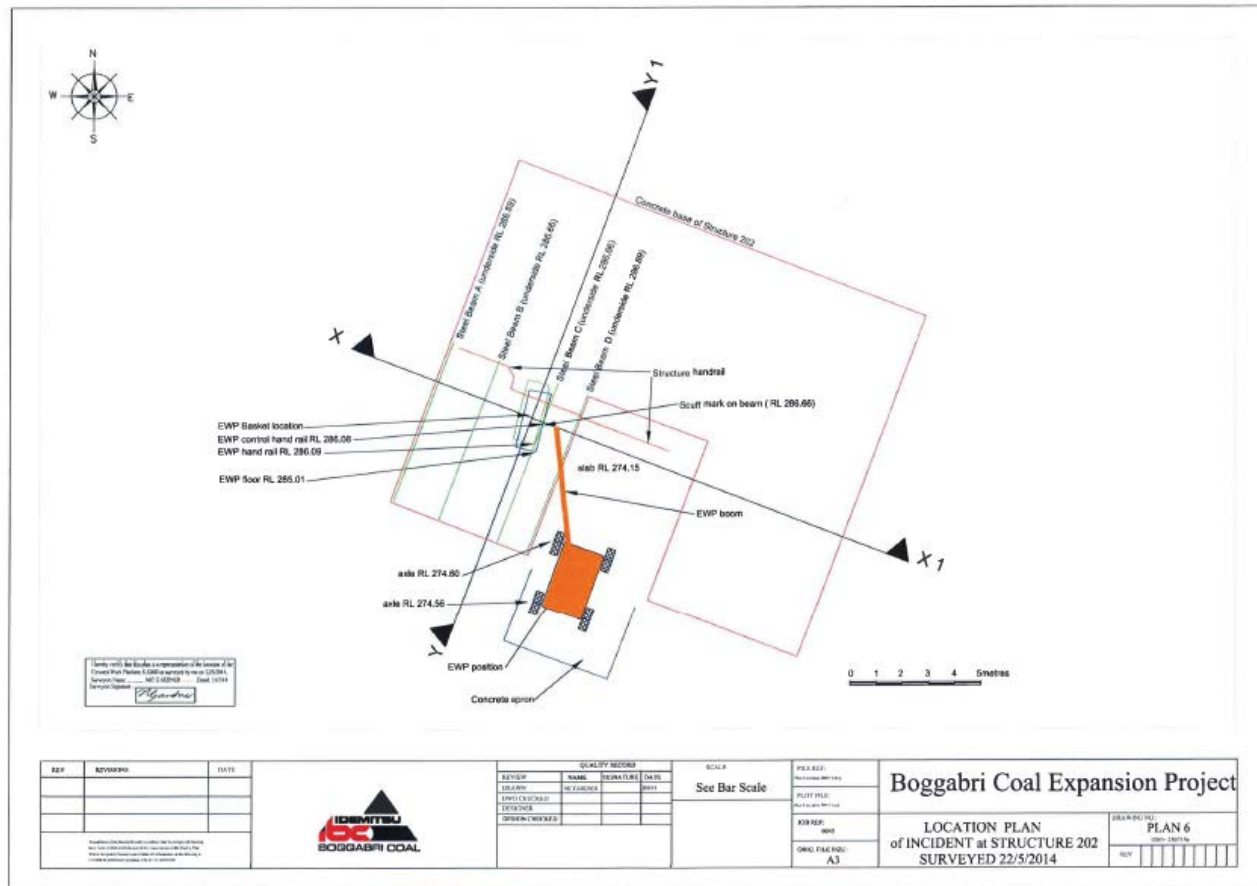
Figure 20: Incident site – top view.

The left hand side of the platform was observed after the incident to be over the handrail of the second floor walkway.

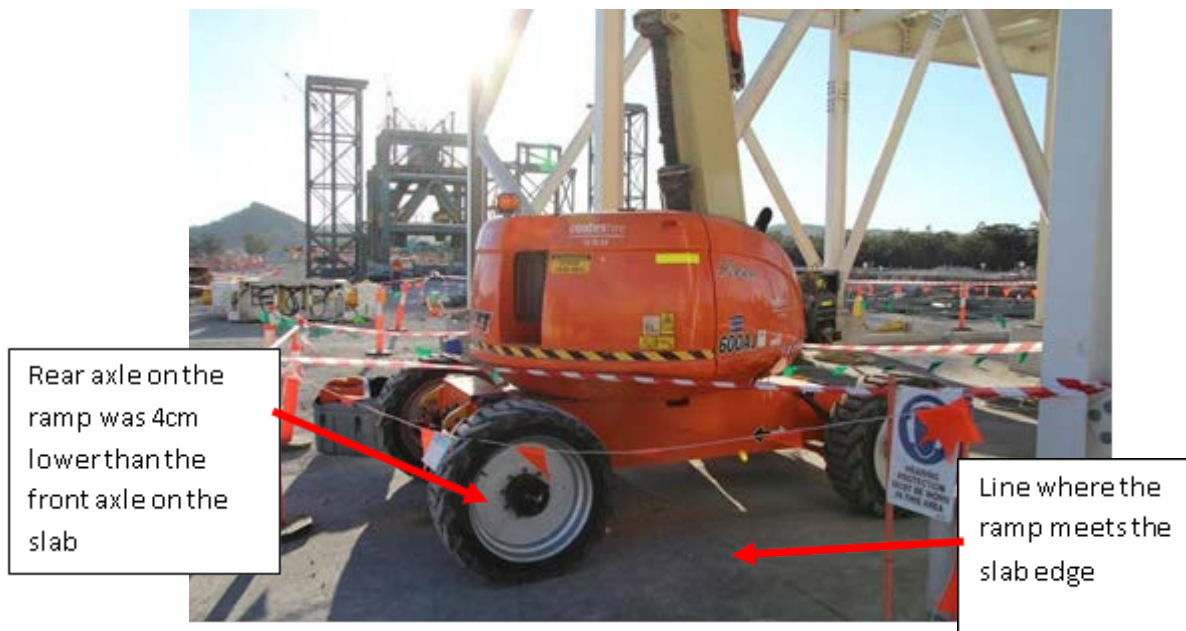
Figure 26: MEWP base on concrete floor.

There was no evidence that any of the MEWP tyres had failed or deflated causing instability on the raised platform.

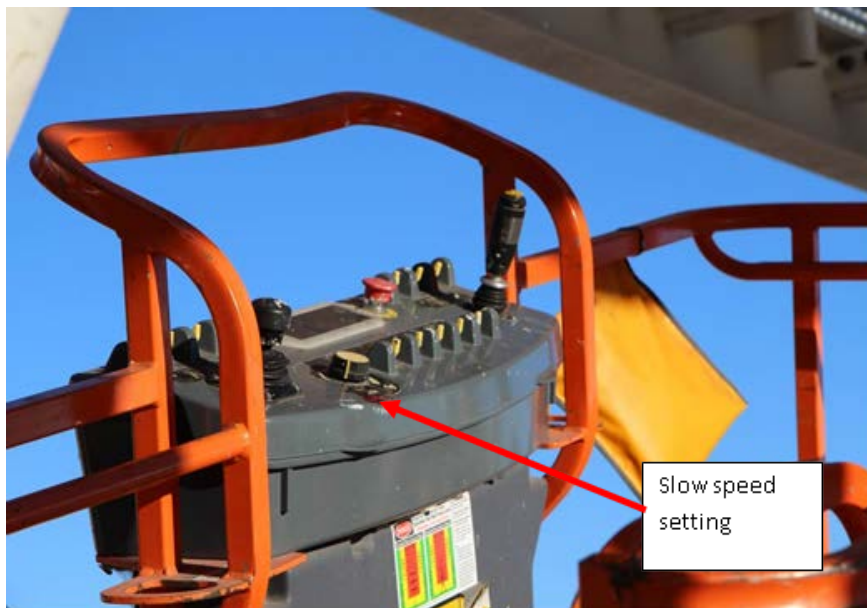
Figure 32: Platform control console position at 5.07pm on 21 May 2014.

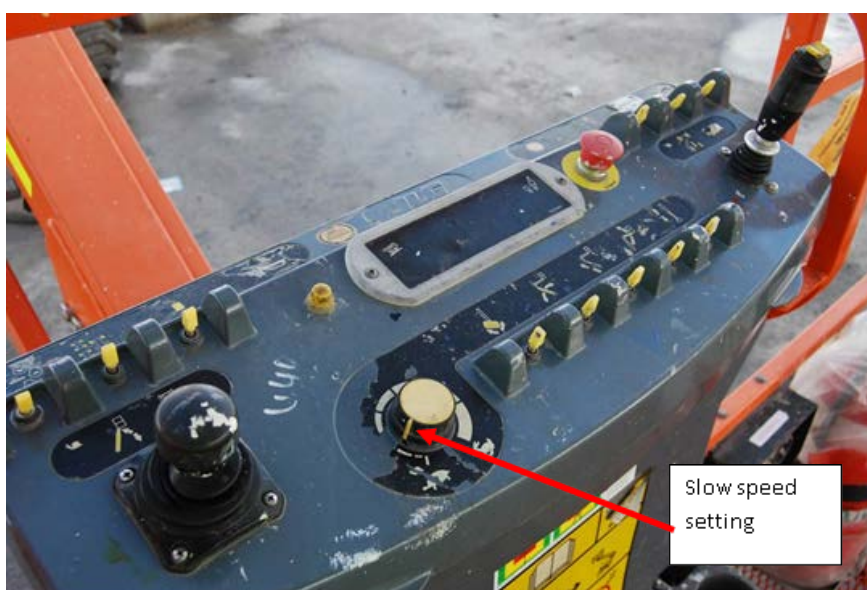
Figure 33: Platform control console at 2.12 pm on 23 May 2014 when returned to ground level.

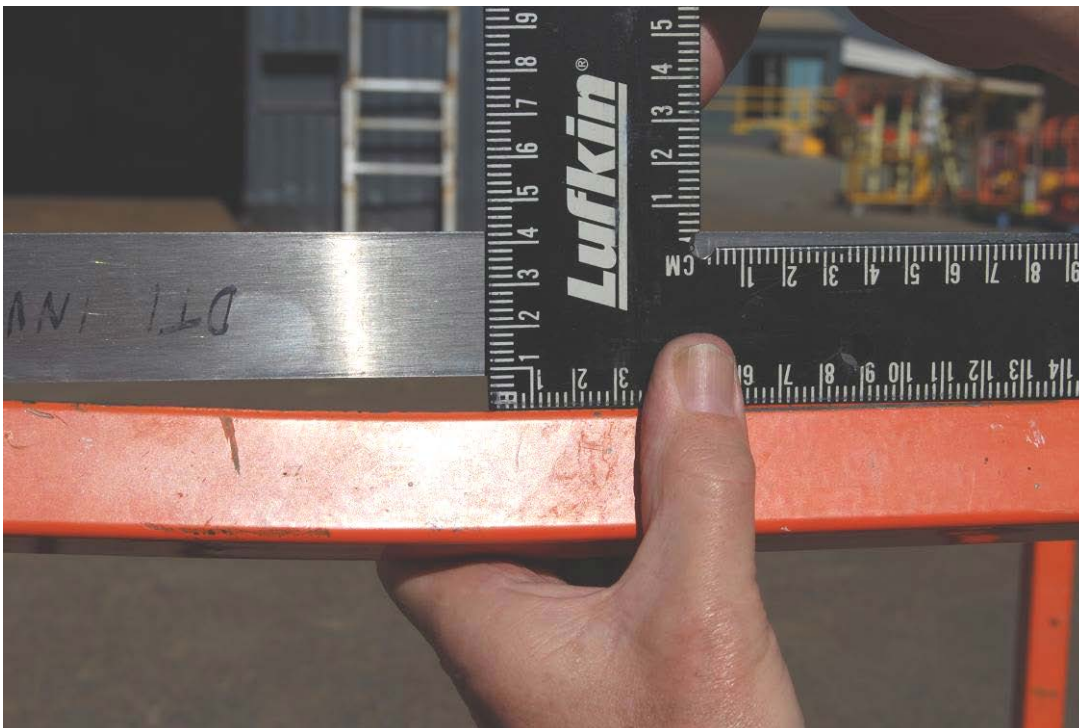
Figure 43. Measurement of the 8mm downwards deflection on the platform control console protection bar.

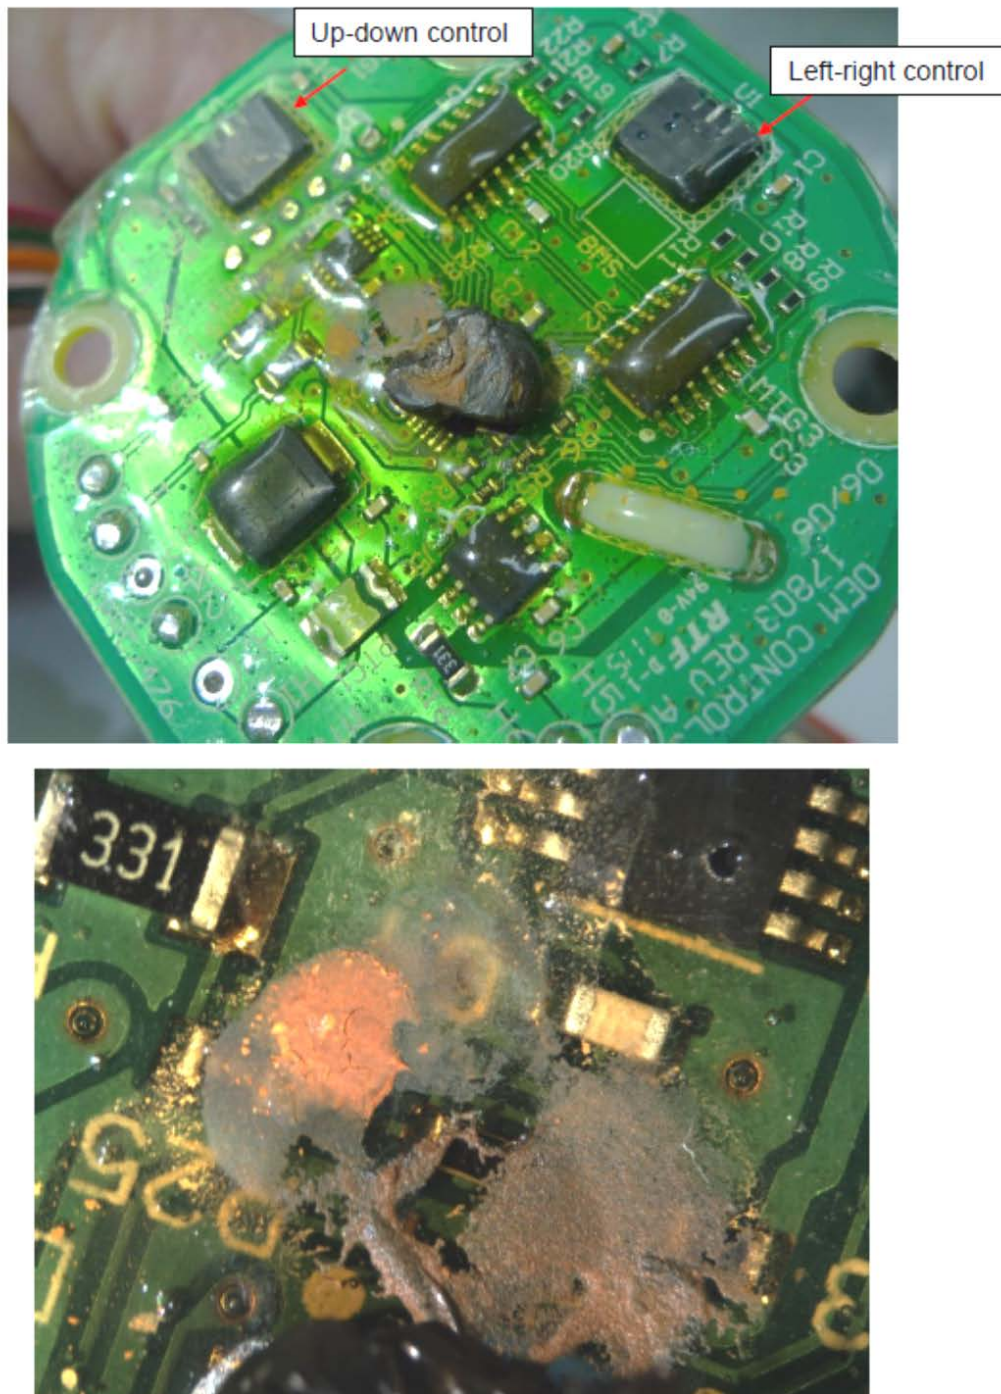
Figure 6 Views of the magnetic gate and the hall-effect sensor on the circuit board, note the difference in clearance between the two components.

Figure 9 The used circuit board condition, note the presence of corrosion and grease deposit.

- Operators and maintainers of MEWPs should ensure close inspection of the rubber protective covers of platform controls to identify deterioration such as cracking and splitting, which can allow dust and water ingress and cause corrosion on electrical control circuit boards.

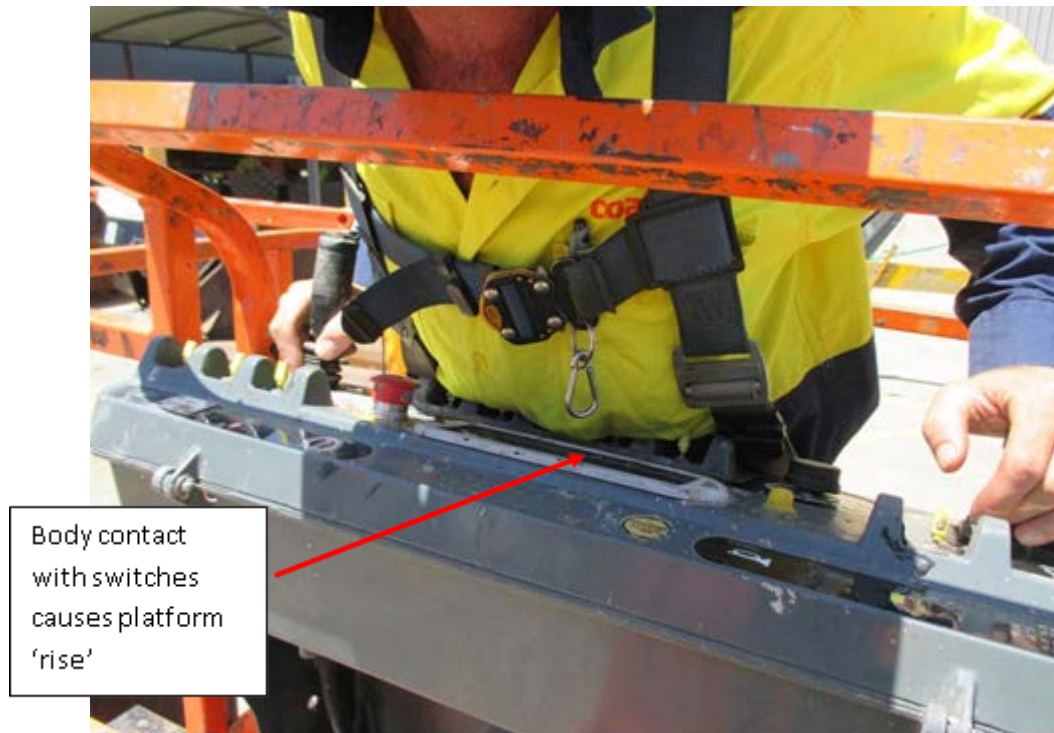
Figure 47: Simulation of an operator in forward leaning position and bodily contacting platform switches can activate platform 'rise'. In this position the left hand can apply forward motion to the lift swing joystick and activate platform 'rise'. The right hand can be placed on the drive/steer joystick. The operator's right foot was able to activate the footswitch to permit platform control function.

The platform lift/swing joystick control device (when the detent device is lifted on the joystick) is moved in a 'forwards' direction to achieve a 'rise' in the platform.
