Investigation Report

Injury resulting in death involving a mobile
bolter at the Myuna Colliery on

24 July 2008

Mine Safety Investigation Unit

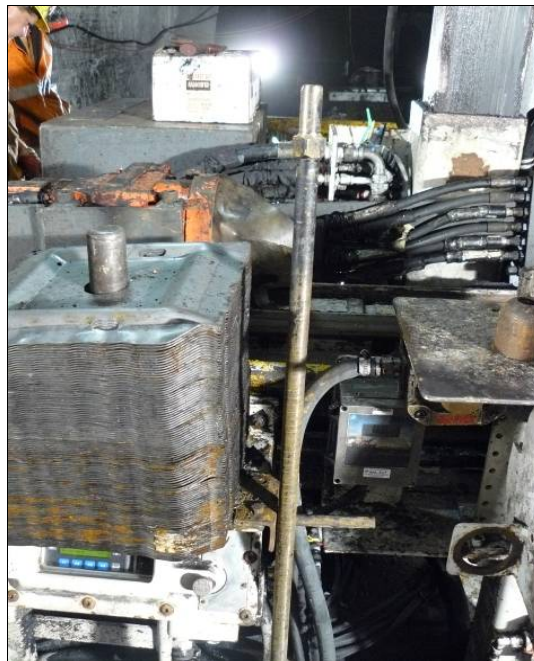
It appears that before or while he retracted the drill head the drill steel fell between the butterfly plates and the drill control box resting against a retractable hand railing above the drill head carriageways (see yellow round bar in second photo). When the drillhead was brought back it has pushed against the top of the drill steel placing it in tension and bending the drill steel.

The drill steel in the approximate position when it fell between the butterfly plates and the rib bolter control panel.

Note drill steel resting on bar installed post-incident.
