## 1. EXECUTIVE SUMMARY

At 8.30am on the 12 April 2002, Mr Christopher James Belfield, a term contract employee of Ergon Energy Corporation Limited, working at the BMA Blackwater Mine sustained fatal injuries when the jib of a vehicle loading crane (VLC) that he was operating at the time, struck him in the back and crushed him against the control panel.

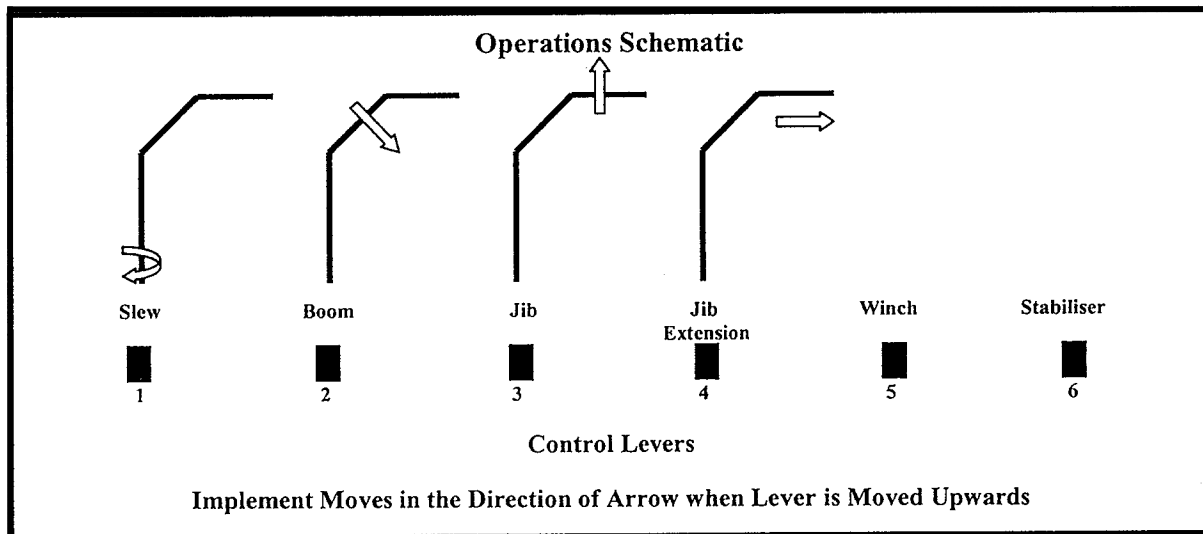
**Figure 1**

**One scenario**, raised by the BMA Blackwater Mine Investigation Team, was that Chris Belfield intended to retract the jib extension, which as can be seen from the Operations Schematic - Figure 1, would have required control lever 4 to be pushed downwards. If instead, he has inadvertently pushed control lever 3 down, this would have caused the jib to lower onto him.
