## **Compressed Air Breathing Apparatus T-Piece Failure**

**NSW Department of Industry & Investment**

19 December, 2011

**Report:** 11-2673768-1

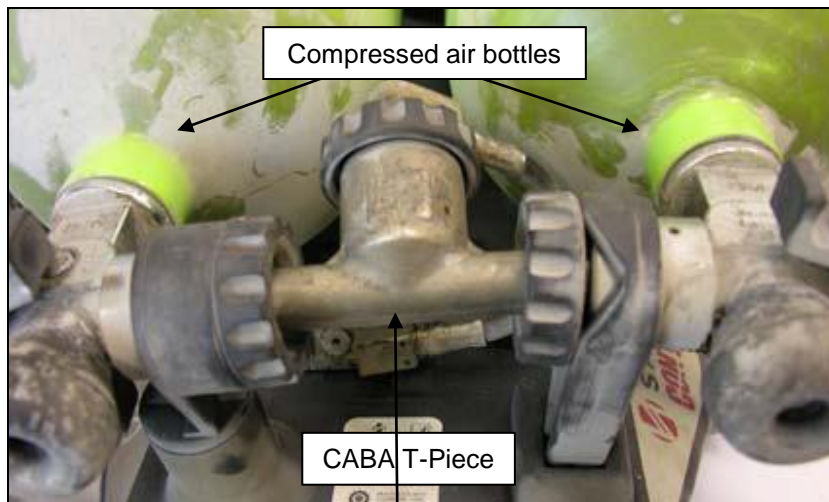
**Figure 3-** General photo of a failed CABA unit from 5/1/2011 showing the location of the compressed air bottles and T-piece.

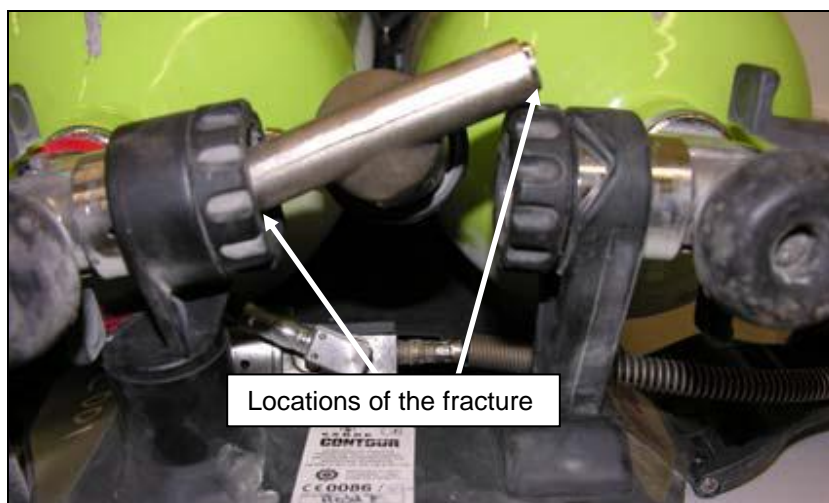
**Figure 4-** General photo of the failed CABA unit from 5/1/2011 showing the location of the fracture.

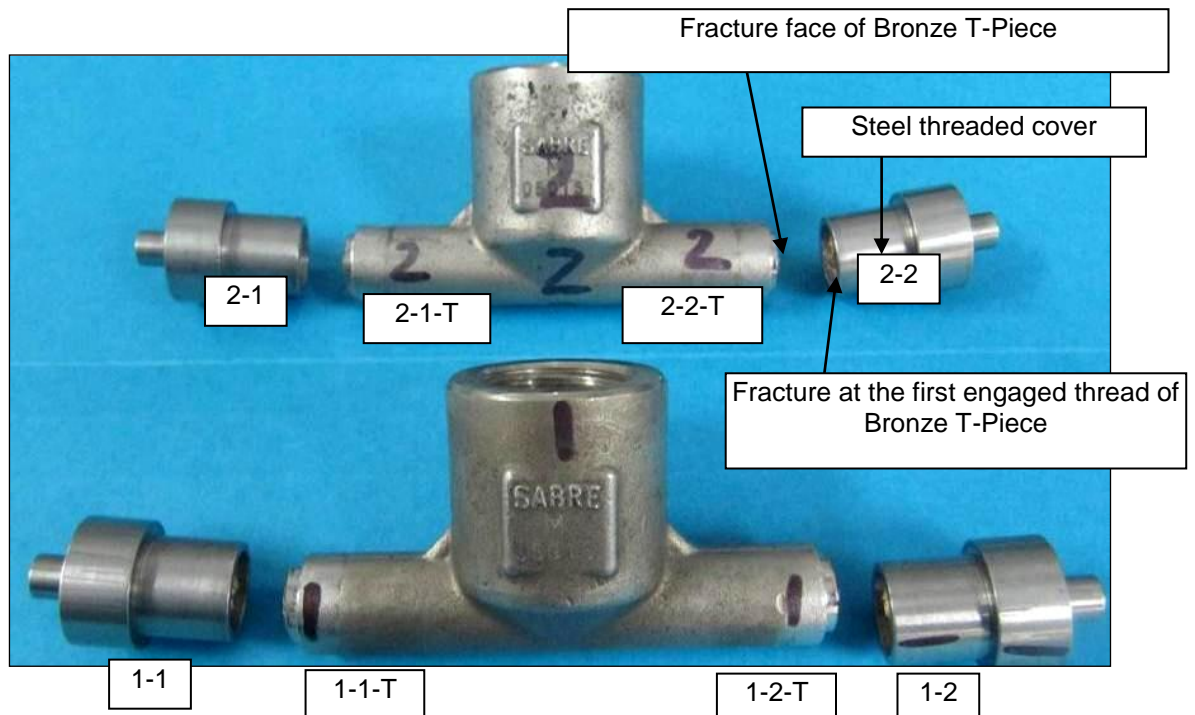
A general view of both failed T-pieces as received is shown in figure 5. The T-pieces consisted of a pipe forming the main body terminating at one end with two branches normal to the body each of which contained an external thread at their distal end. A steel connecting piece was screwed onto both branches of the Tee piece and were in turn connected to the compressed air bottles. Both T-pieces were fractured at the first engaged thread.

**Figure 5-** General view of the failed bolt and attached nut as received.

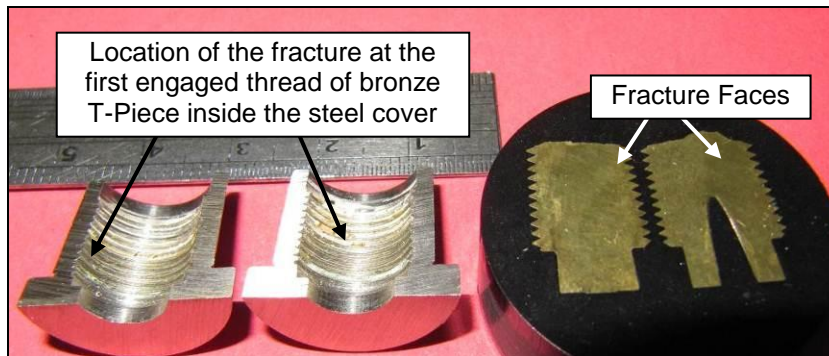
Figure 6 shows the location of the fracture at the first engaged thread. No deformation or bending was observed around the fracture on the threaded section of both T-pieces. All four fractures had occurred at the first engaged thread location representing a stress concentration effect. The stress concentration at the thread root reaches a maximum at the first engaged thread, because this thread tends to sustain the highest load of all of the remaining threads.

**Figure 6-** Showing a transverse section through the fractured bronze threaded section, inside the steel cover.

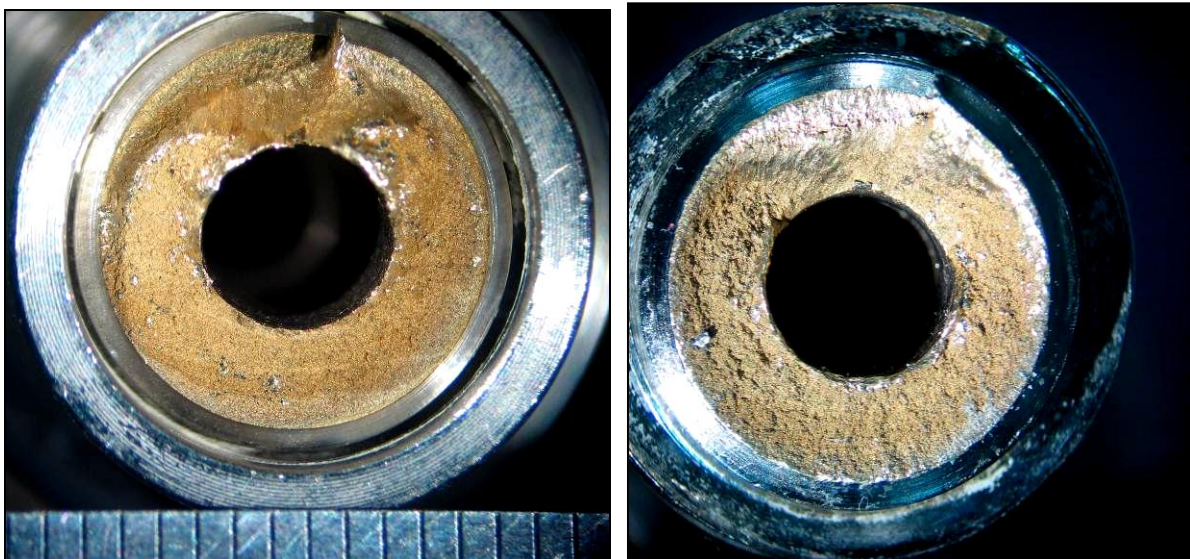
All eight fracture faces were examined by stereo microscope. All fracture faces exhibited a bright cleavage type fracture typical of brittle overload, over approximately 80-95% of the surface; see figures 7-10. No sign of prior cracking was observed.

**Figure 7-** View of sample 1-1(Left) and sample 1-1-T(Right) fracture faces, consistent with brittle fracture over approximately 80% of the cross section followed by a shear lip.

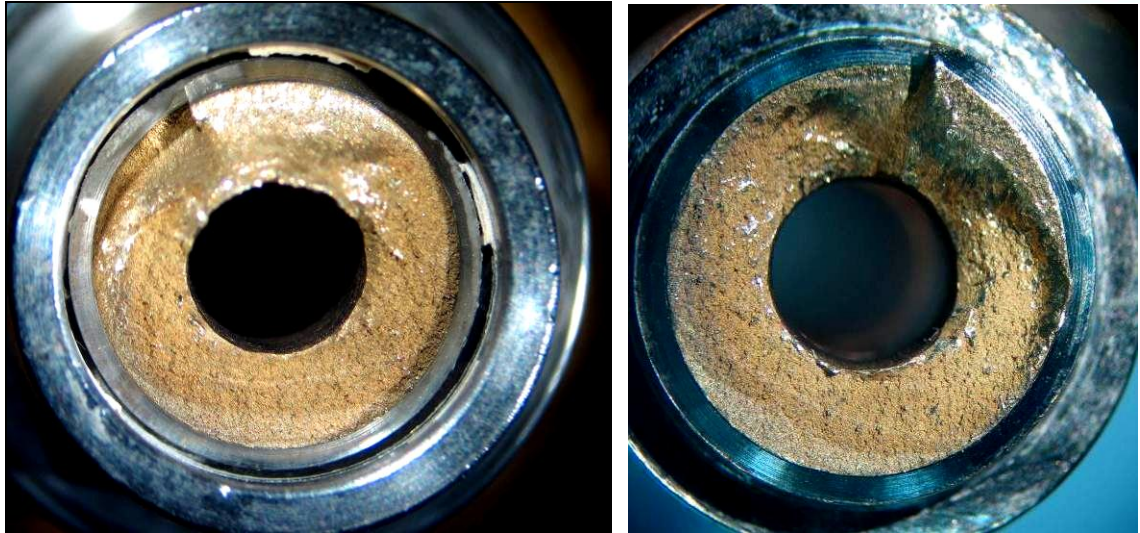
Samples 1-1, 1-2, 1-2-T, 2-1, 2-1-T exhibited several progressive zones of fracture over the initial 30% of the fracture face, suggesting that the brittle fracture occurred in several stages.. An SEM examination of the fracture face was conducted to determine the fracture mode. There was no evidence of corrosion contributing to the failures of the provided samples.

**Figure 8-** View of sample 1-2(Left) and sample 1-2-T(Right) fracture faces, consistent with brittle fracture over approximately 90% of the cross section followed by a shear lip

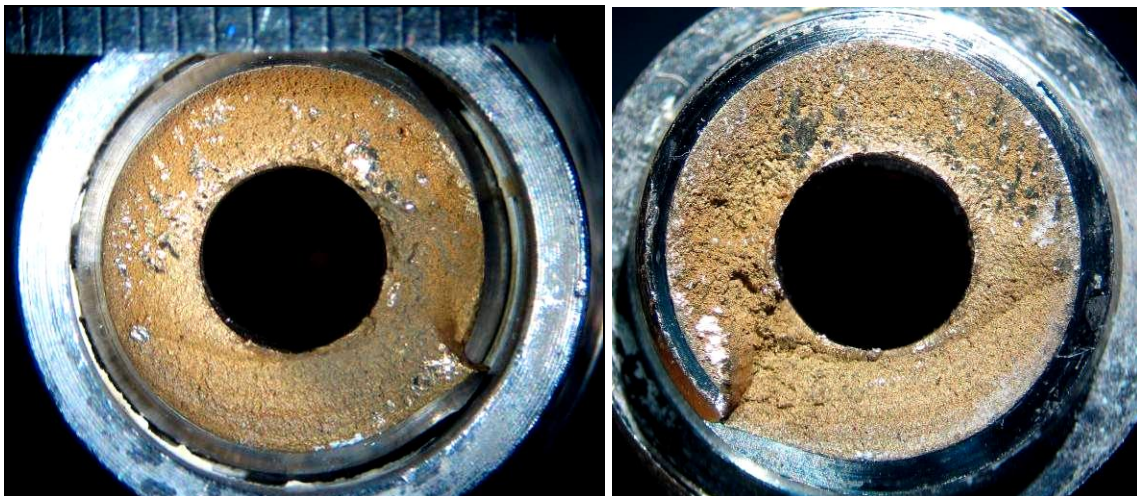
**Figure 9-** View of sample 2-1(Left) and sample 2-1-T (Right) fracture faces, consistent with brittle fracture over approximately 95% of the cross section followed by a shear lip.

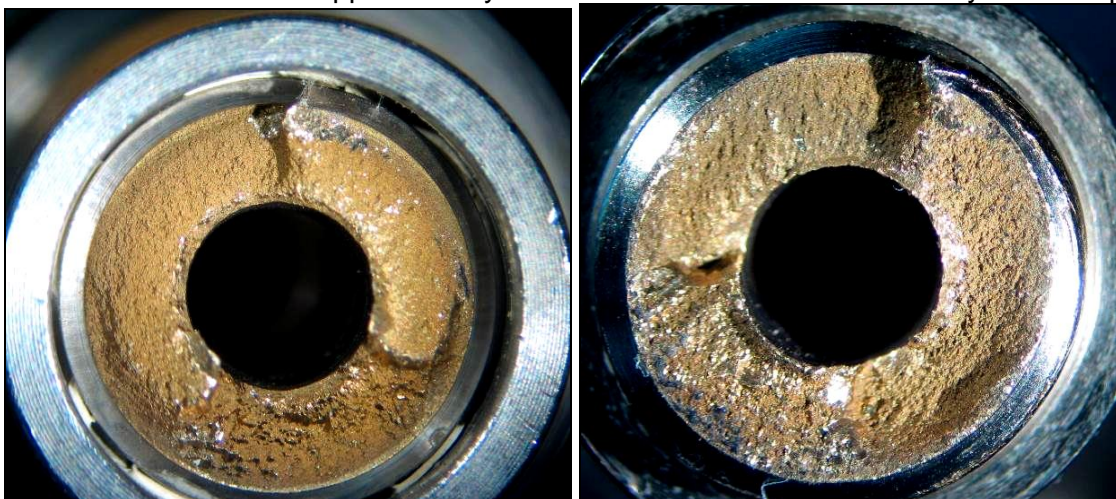
**Figure 10-** View of sample 2-2(Left) and sample 2-2-T (Right) fracture faces, consistent with brittle fracture over approximately 95% of the cross section followed by a shear lip.

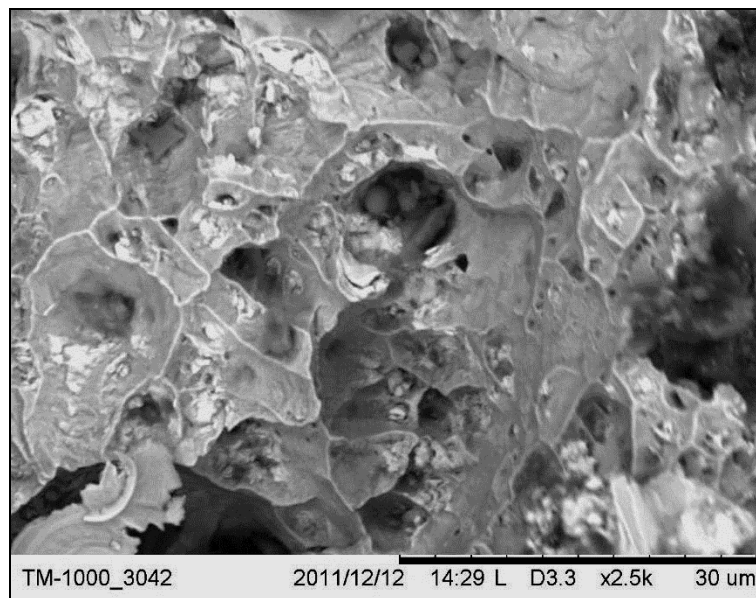
Secondary Electron Imaging (SEI) of the fracture face on sample 1-2-T, intersecting the region of progressive crack advance revealed a dendritic type fracture surface, see figure 11. No sign of fatigue striations were observed, consistent with the suggestion of crack advance due to brittle fracture in several stages.

**Figure 11-** SEM of the original fracture of sample 1-2, fracture face shows dendritic type fracture.

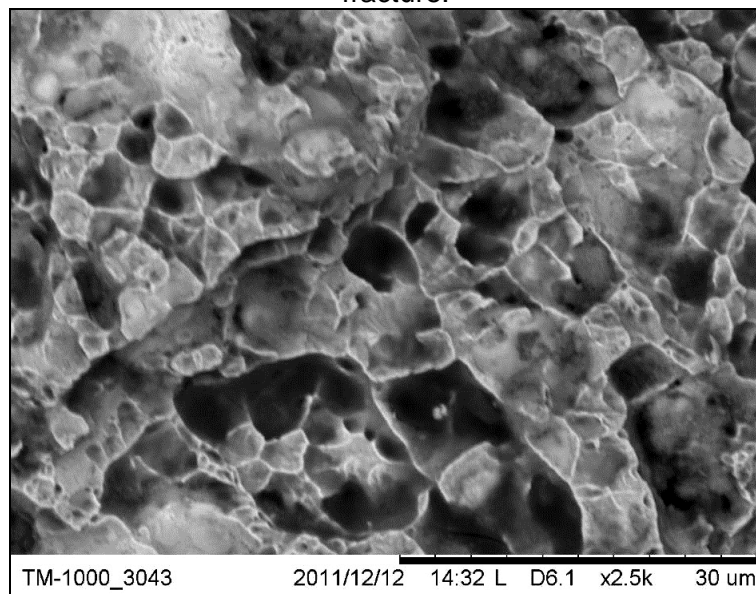
A trial fracture was created on a section through T-piece T11/00705/002. The sample was notched with a hacksaw before overloading by impacting the end with a hammer. The fracture face of the trial sample was examined under SEM. The fracture face exhibited a dendritic fracture similar to the original fracture of all T-pieces suggesting that they had also fractured under an overload situation, see figures 11 and 12.

**Figure 12-** SEM of the fracture face of trial fracture, showing dendritic type fracture.

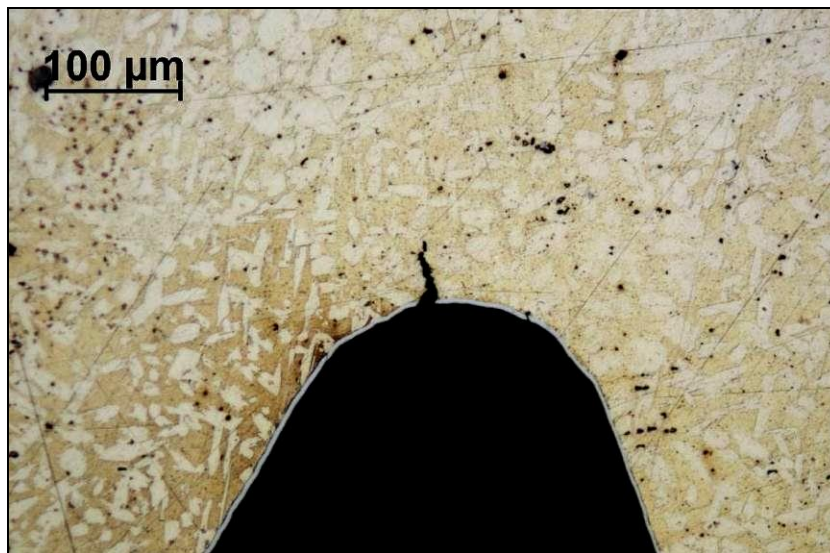
The T-piece sample exhibited a cast structure of alpha and beta (white etching) phases with a surface coating approximately 5µm thick (see Figure 13). A shallow interdendritic crack was present in the thread roots adjacent to the fracture position, see figure 11. No abnormal feature was observed in the microstructure.

**Figure 13-** Showing the fractured cross section of the T-piece at the threaded region, exhibited a structure of alpha and beta phases (**Magnification x200, Etchant: Acid Ferric Chloride**).

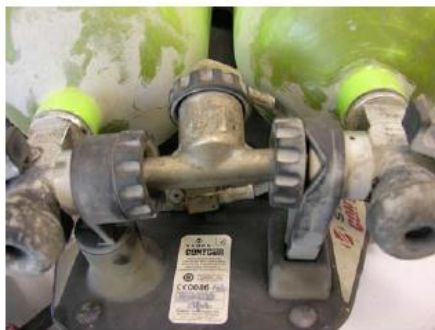
On one unit there was an obvious curve in the T-piece between the two bottles.

CABA unit showing curved connection - should be straight

- All mines should check this type of equipment for faults and contact their suppliers for further information.
- Review handling procedures for CABA units.

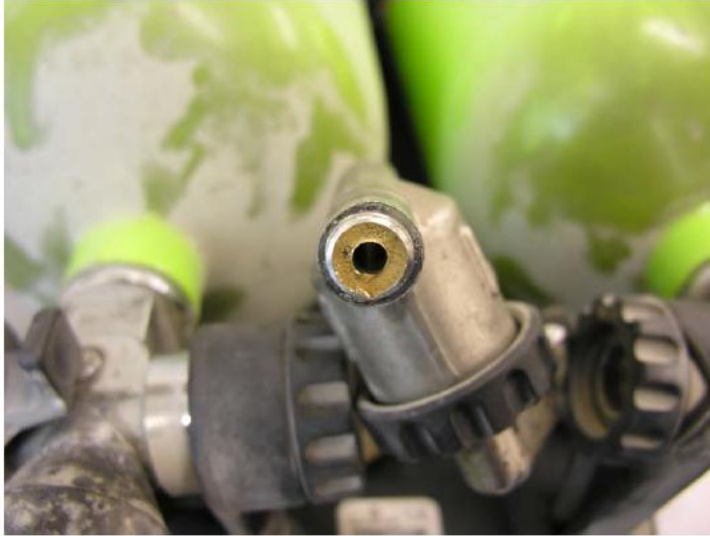
CABA unit showing broken connection
