Investigation report

Cause and circumstances of fatal injury to
Peter Thomas Jones at Chain Valley Colliery
on 3 June 2011

Extract of report prepared by the
NSW Mine Safety Investigation Unit

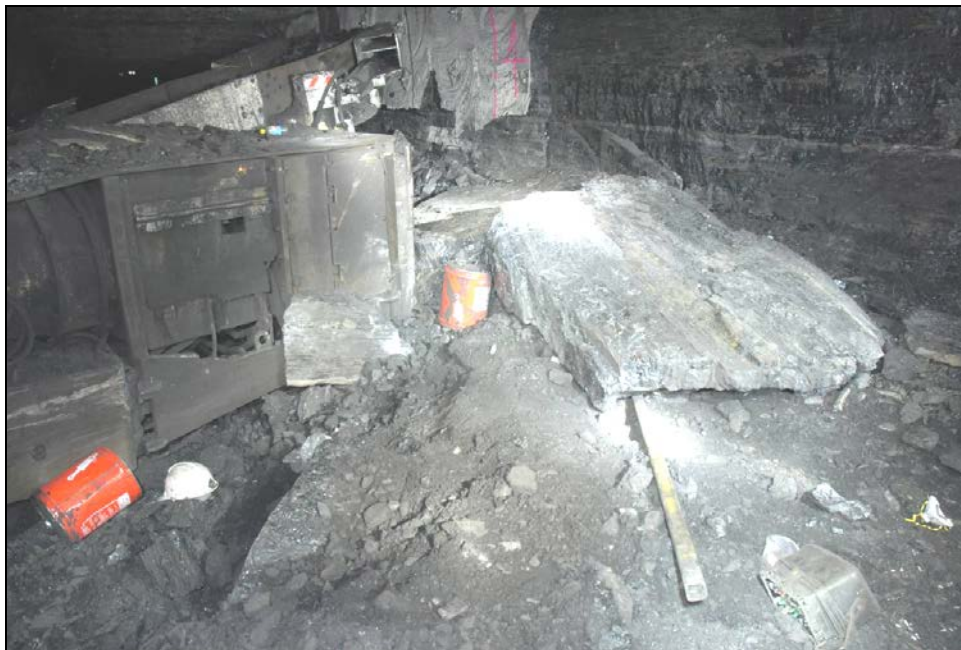
Photograph 2 Incident scene photographed by NSW Police Forensics on 3 June 2011.

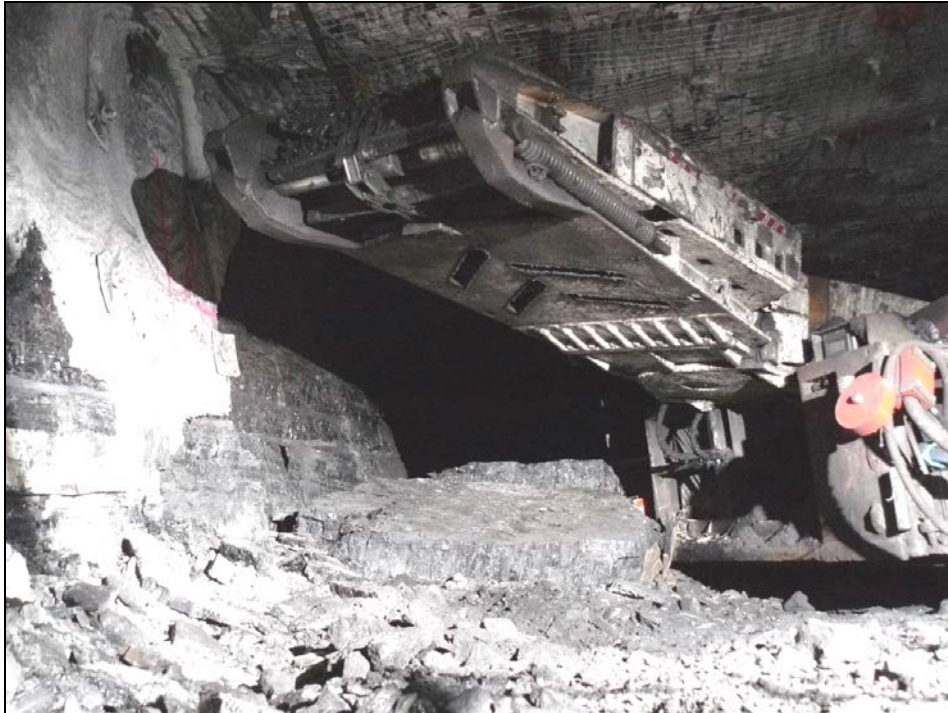
Photograph 5 Looking inbye of the fallen slab inbye of the continuous miner boom.

Photograph 5 shows the fallen rib slab adjacent to the left hand side of the continuous miner. Rib bolts and plates are evident in the still standing rib side.

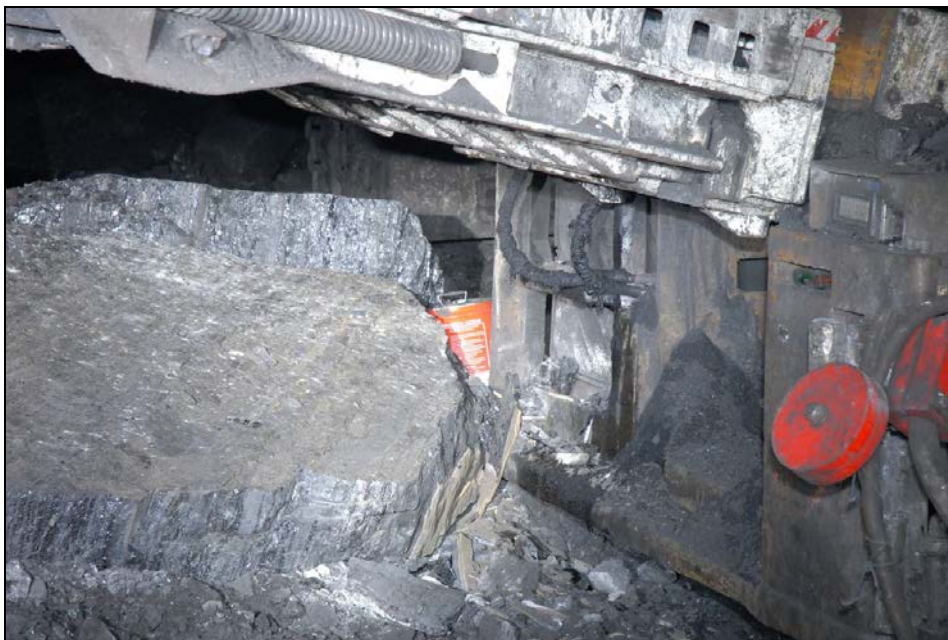
Photograph 6 Looking inbye of the fallen slab underneath the continuous miner boom.

Photograph 6 shows the fallen rib slab adjacent to the rear of the continuous miner and the red oil drum.

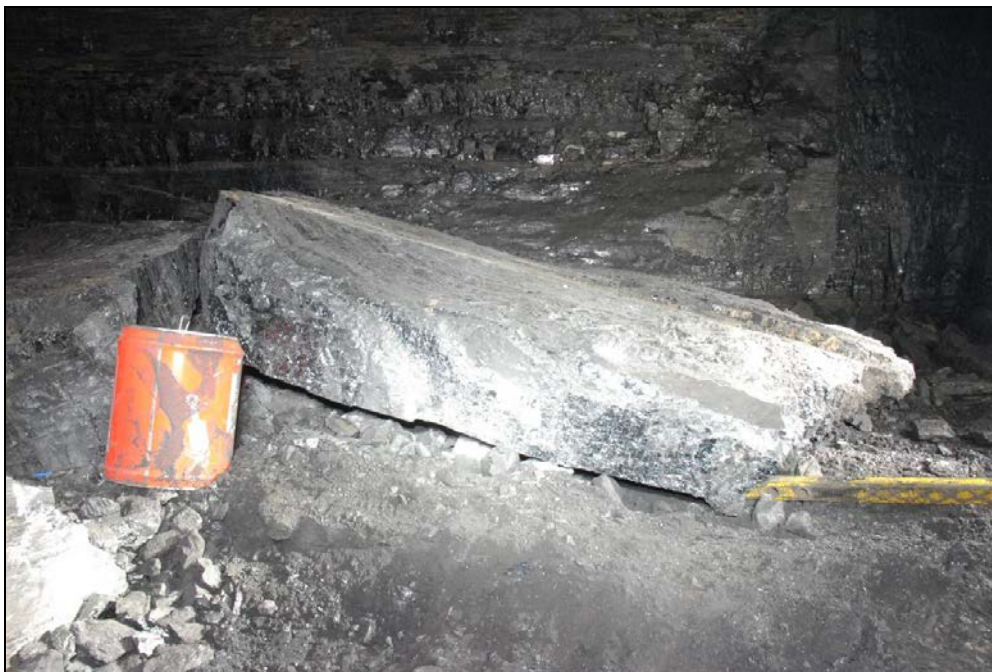
Photograph 10 View of slab showing the red oil drum and steel belt clamp on the right.

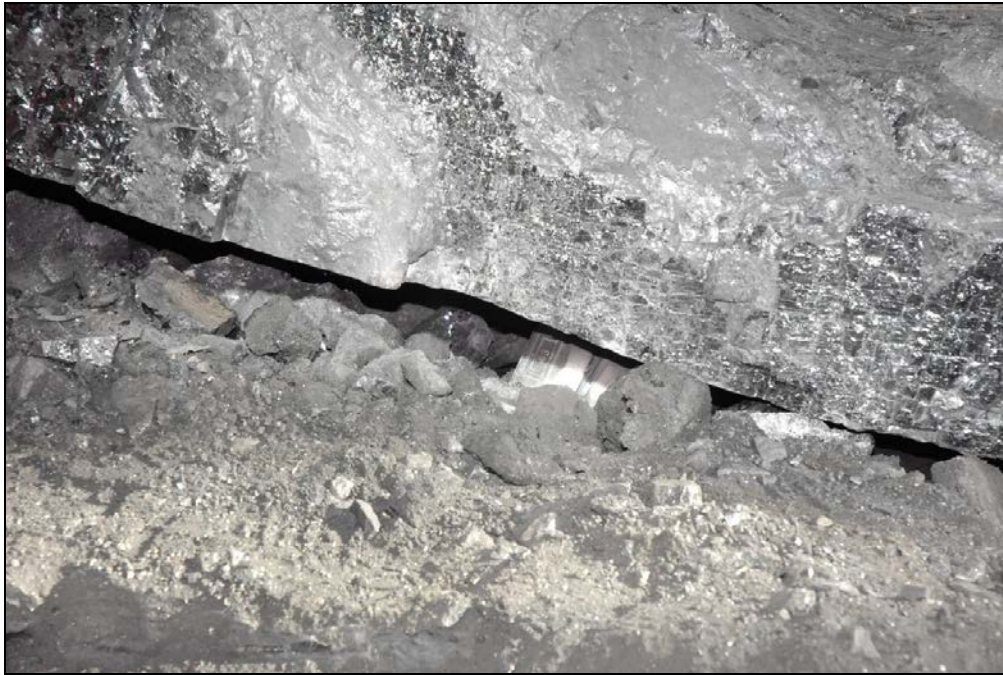
Photograph 11 View of slab showing the self rescuer of Mr Jones underneath the slab.

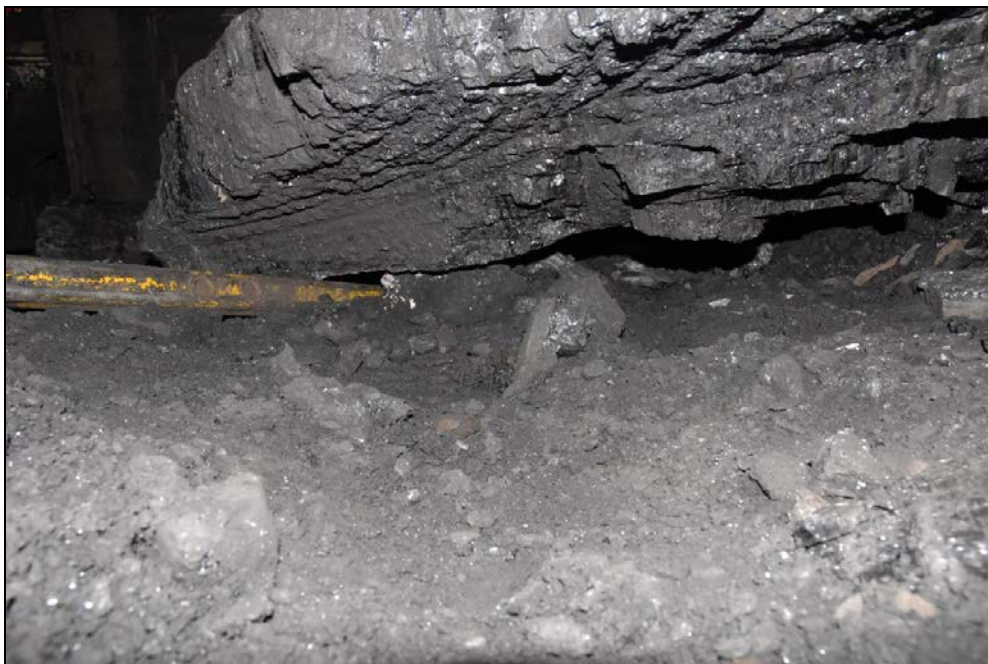
Photograph 12 Underside view of slab showing the position of steel belt clamp.

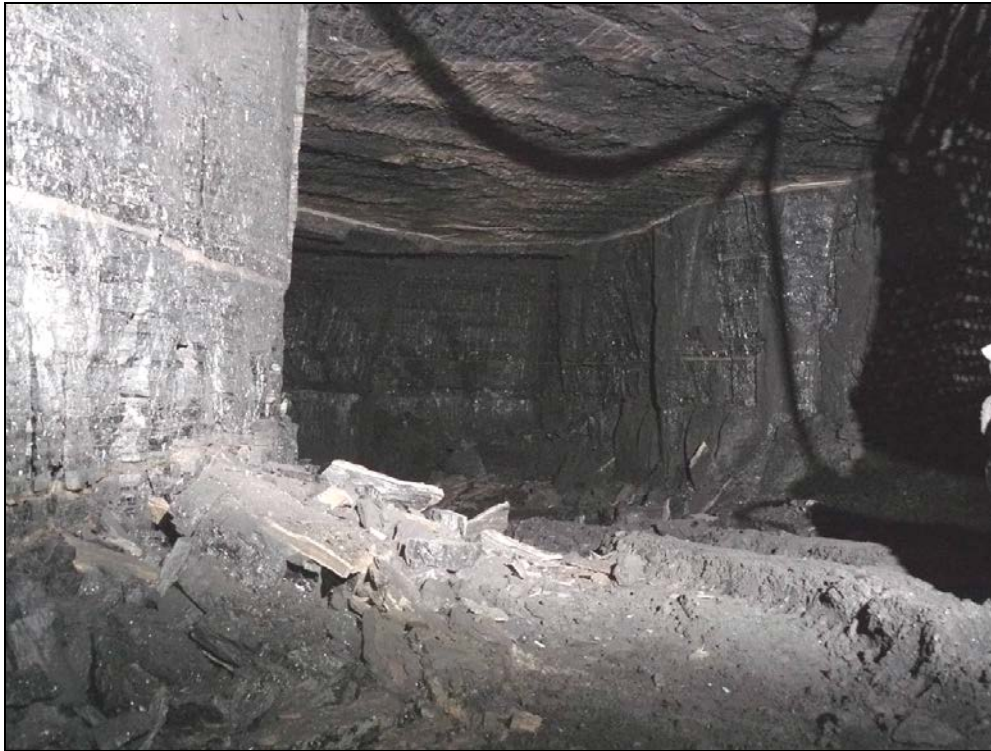
Photograph 13 Looking into the left hand rib pocket that had been extracted by Mr Jones before extracting the right hand pocket. First left hand pocket in B Heading between 5 and 6 cut-through.

The roof and ribs in the left hand rib pocket show no major deformation. In the foreground there appears to be fallen roof rock material.

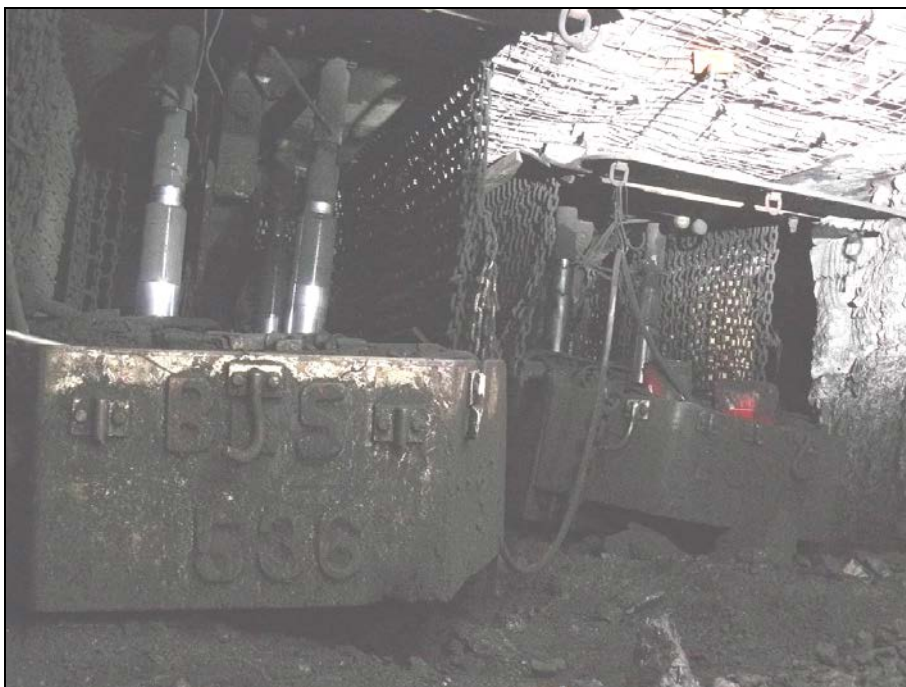
Photograph 14 Looking inbye showing the position of the 2 breaker line supports in B Heading.

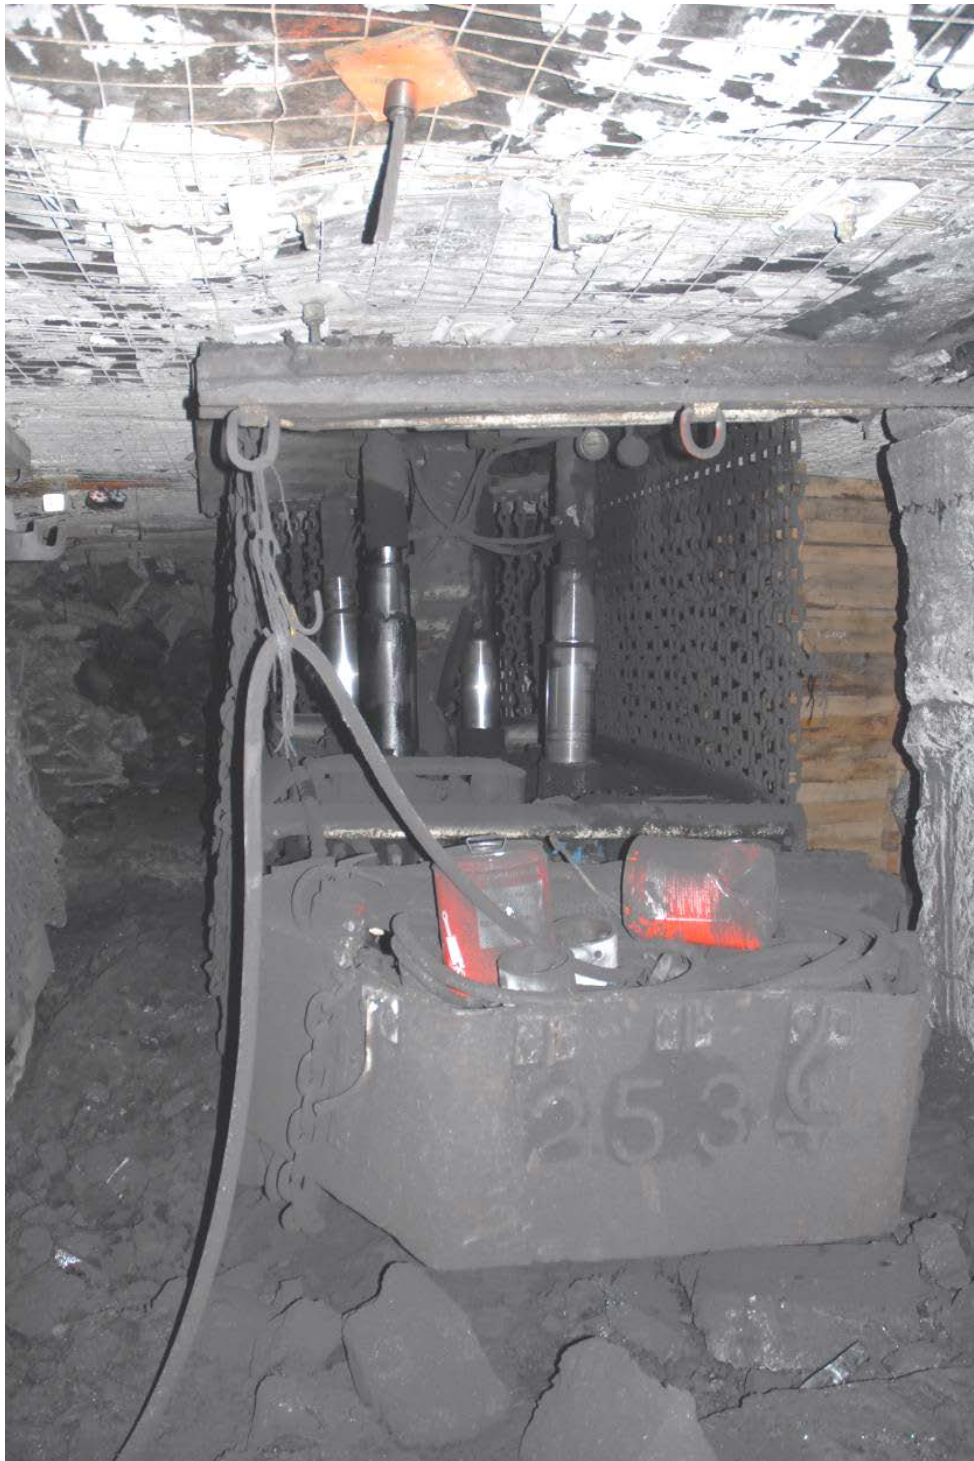
Photograph 15: Visible to the right of the breaker line support is the wooden link n lock chock built at the entrance to 6 cut-through B to C heading. A secondary roof support cable bolt and plate is in front on the breaker line support at the top of the photograph.

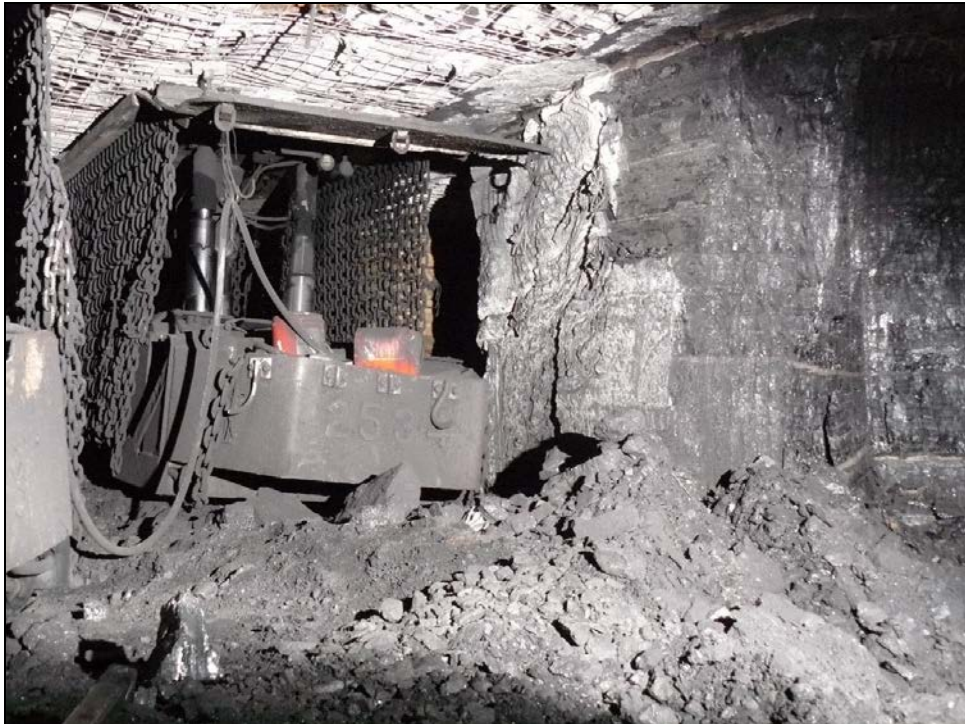
Photograph 16 Looking inbye of the right hand side breaker line support in relation to the start of the right hand side rib pocket.

Photograph 16 shows the floor material in front of the right hand side breaker line support.

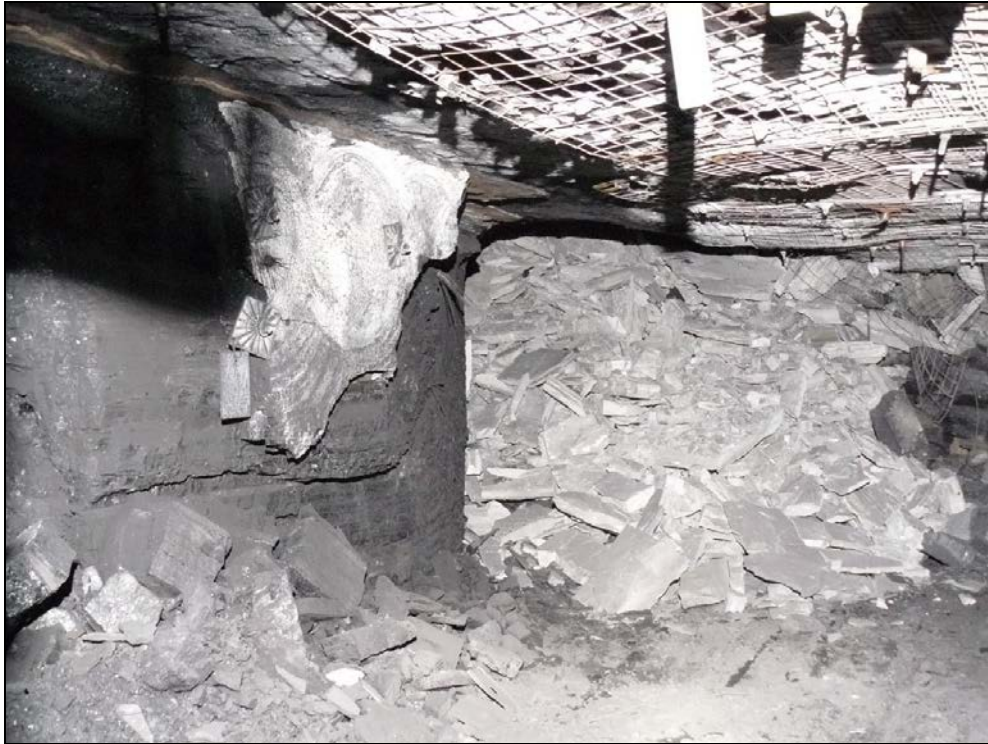
Photograph 18 View looking inbye of 6 cut-through inbye the breaker line support position showing rib support in left hand side rib and goaf edge at 6 cut-through in B Heading.

Photograph 18 shows the rib support effectively holding the white stone dusted rib side piece in place.

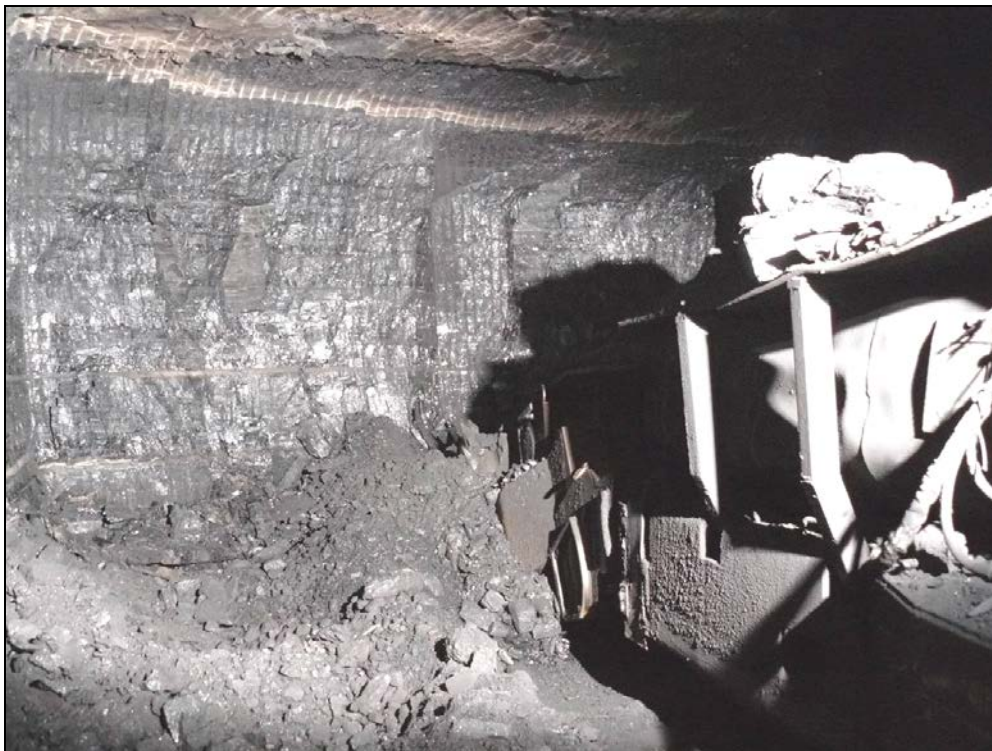
Photograph 19 Looking into the first right hand rib pocket showing the extent of over width extracted against the continuous miner.

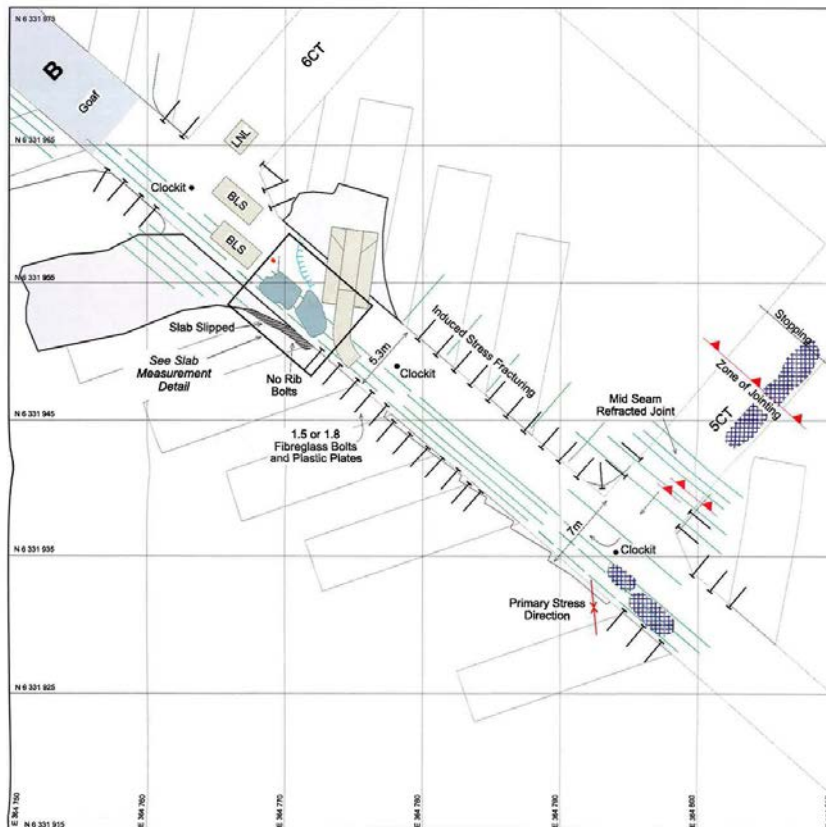
Figure 3 SCT Report Figure 2 Surveyed Incident scene.

SCT Operations' report (Figure 3) is a plan of the surveyed incident scene. It shows the left hand lift proposed position and the actual mined position. The actual mined left hand pocket was about 2.5 metres inbye of the design location. The right hand side rib pocket was oversize to the design. The plan also shows the position of the mobile roof supports and the rib support. An extract from the report has been included below. It explains the probable causal factors and mode of failure at the scene of the incident:

The rib side is considered to have toppled over as a single block which broke into two main fragments weighing approximately 1.3 tonne and 1.9 tonne respectively. The entire slab toppled over while the miner Mr Jones was operating (an Eimco Dash 3 miner) directly adjacent the area of failure. The failed slab was bounded by joint planes, both vertical and inclined, forming a wedge shape. The inbye side of the slab has the previous lift forming another parting surface. The C clay band forms the upper boundary. The entire slab was supported on a thin 10 cm thick column of coal as defined by the intersection of the joints. The only additional support came from a row of rib bolts but the remaining 4.8 metres of slab had no rib bolt support.

The final impetus causing the rib failure, while Mr Jones was present, is to be considered to be vibration and loosening of the heaved floor coal by the machine, destabilising the thin column of coal supporting the slab.

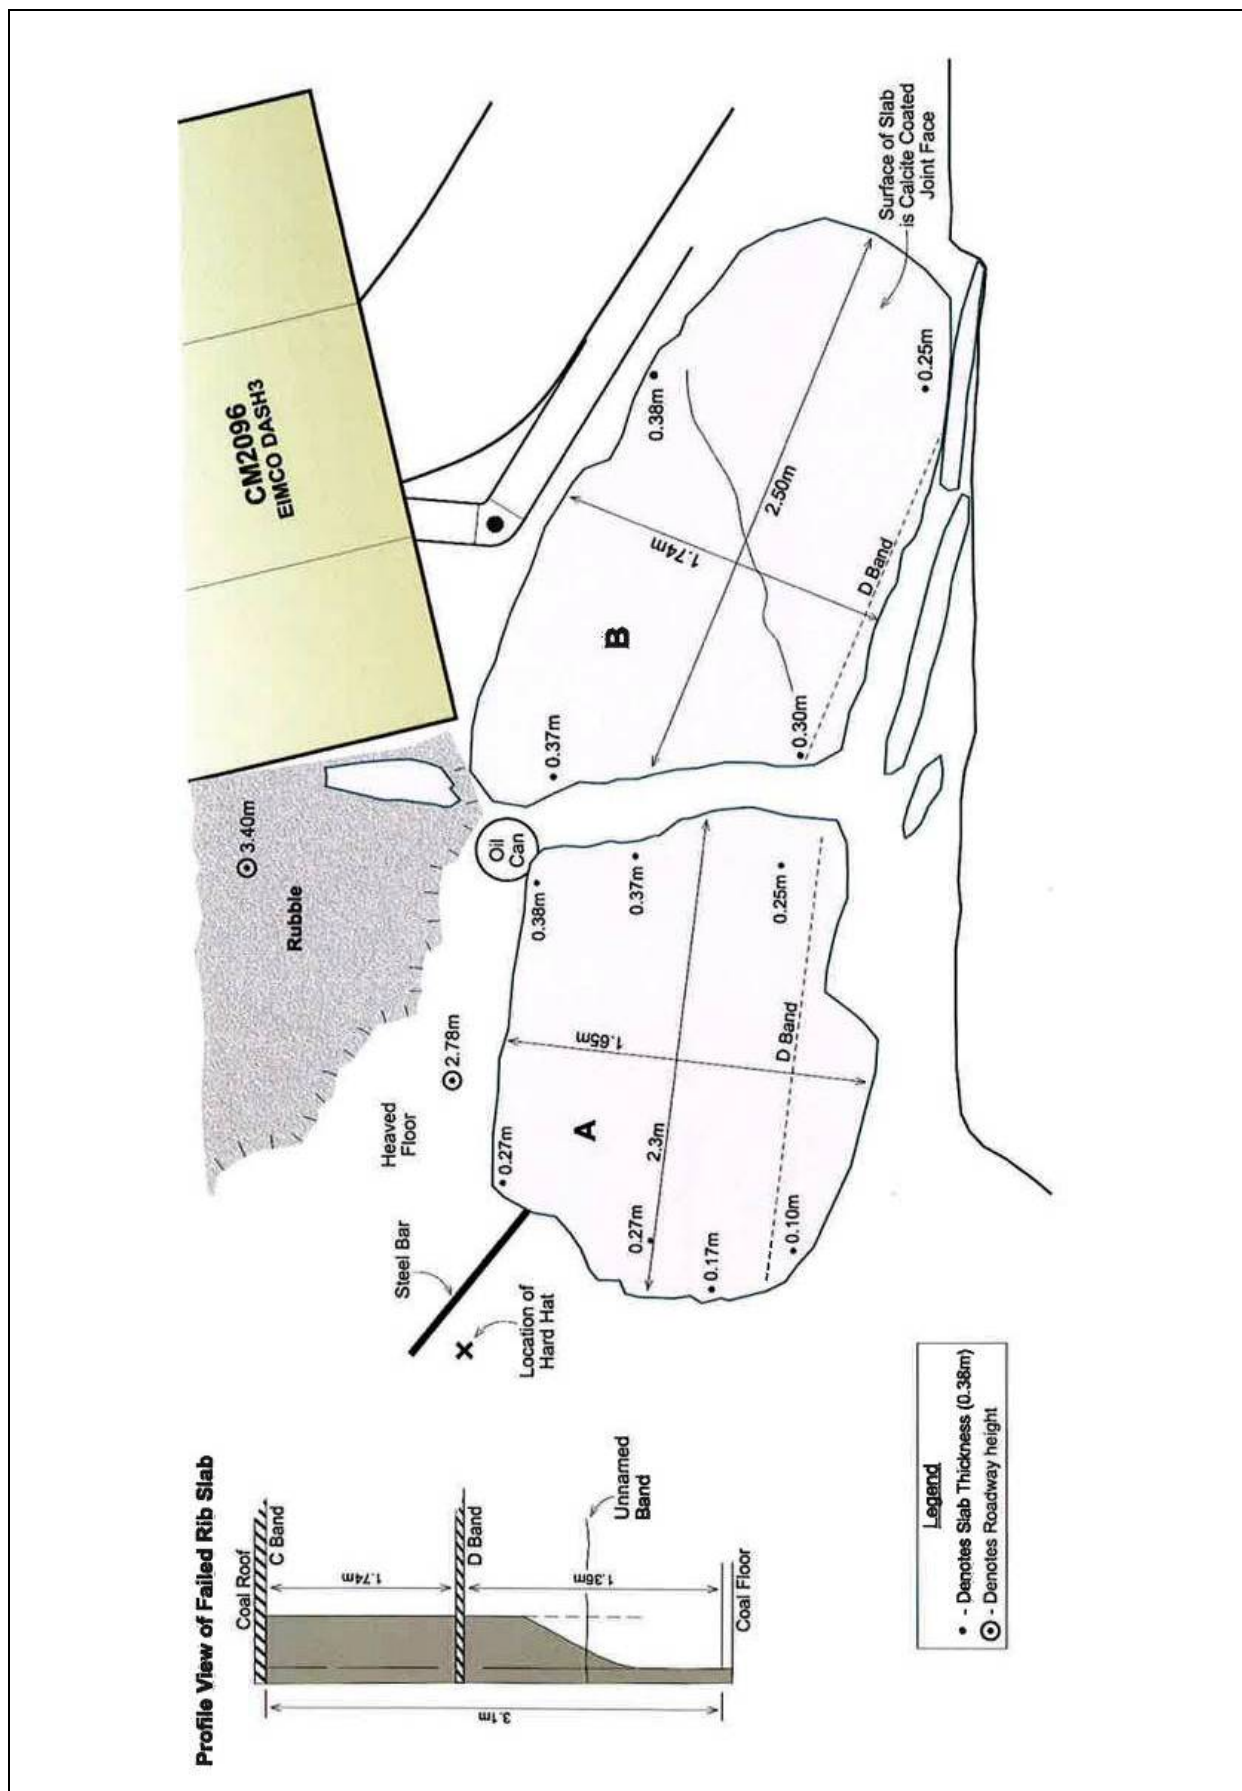
Figure 4 SCT Report Detailed slab measurements

SCT personnel also included in their report a plan depicting the dimensions of the slab that crushed Mr Jones. Incorporated into this plan is a profile view of the left hand rib depicting the wedge shape described above. The plan also shows the relative size of the slab compared to the continuous miner and the roadway.

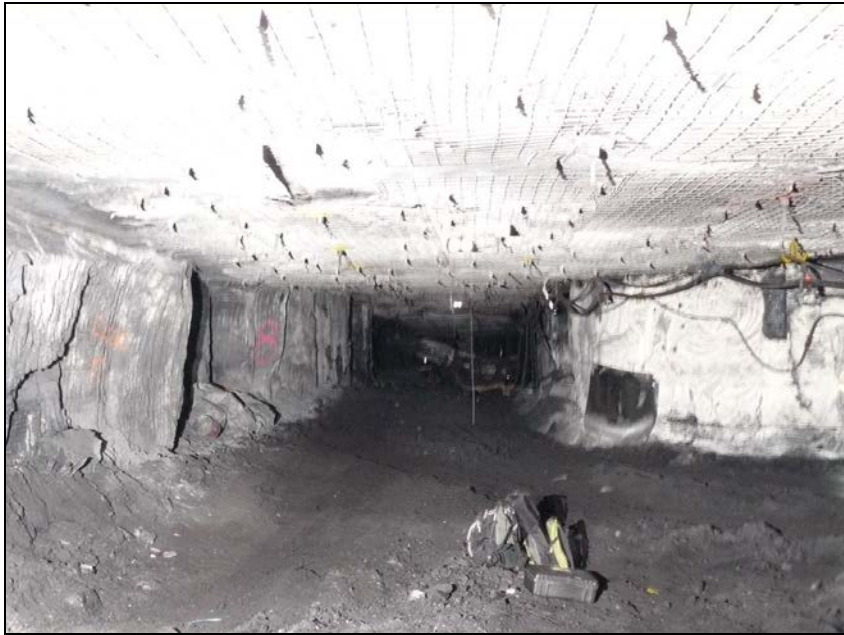
Photographs 1 and 21 identify the unbolted section of rib at 5 cut-through B Heading West 6 Panel. It can be seen in Photograph 1 that the unsupported section as significant rib slabbing and appears ready to fall in similar circumstances to the slab that crushed Mr Jones. It also appears that a person had spray painted the words "CLOCK IT" on the rib side indicating that a clockit is to be installed in the roof.

Photograph 21 Looking inbye at 5 cut-through of the left hand rib noting that a significant distance of rib does not contain any rib bolts.

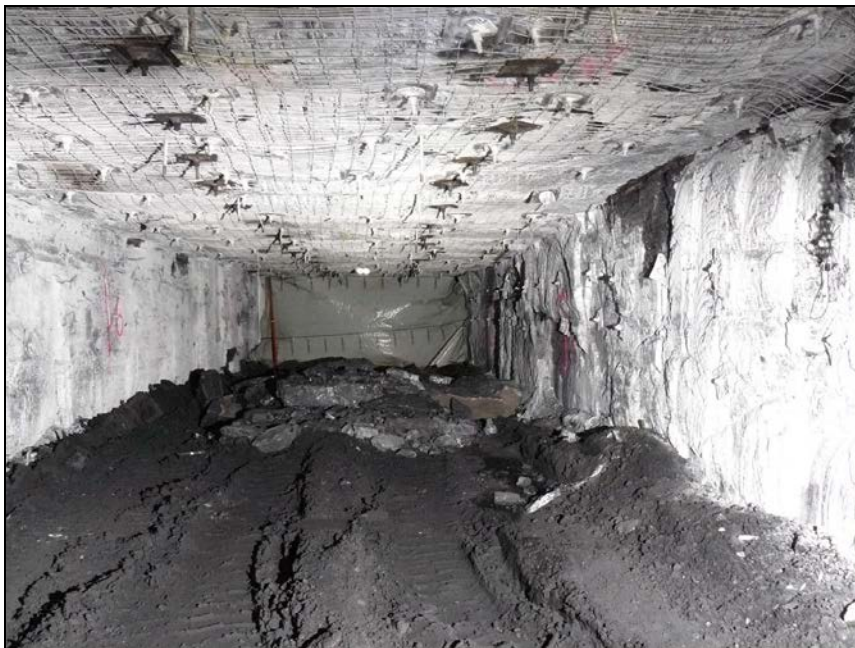
Photograph 22 Looking inbye in D Heading showing a large rib slab on the floor in the centre of the photo, which appears to have come from the removal of a rib slab on the night shift before the incident.

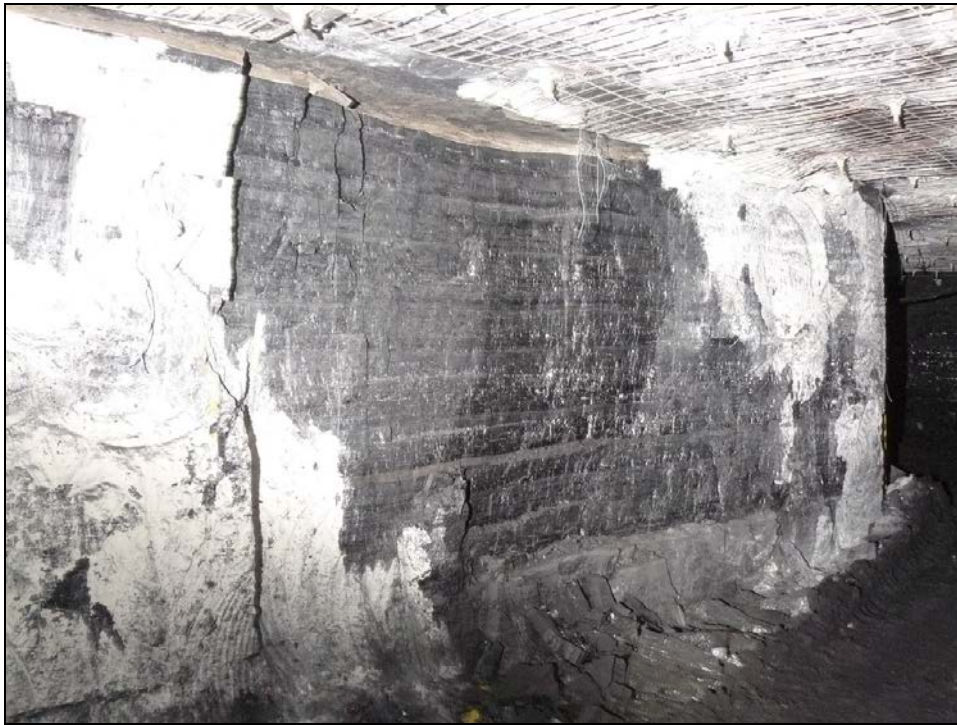
Photograph 23 Looking inbye in D Heading showing a large unsupported area of rib side in a shuttle car wheeling road.

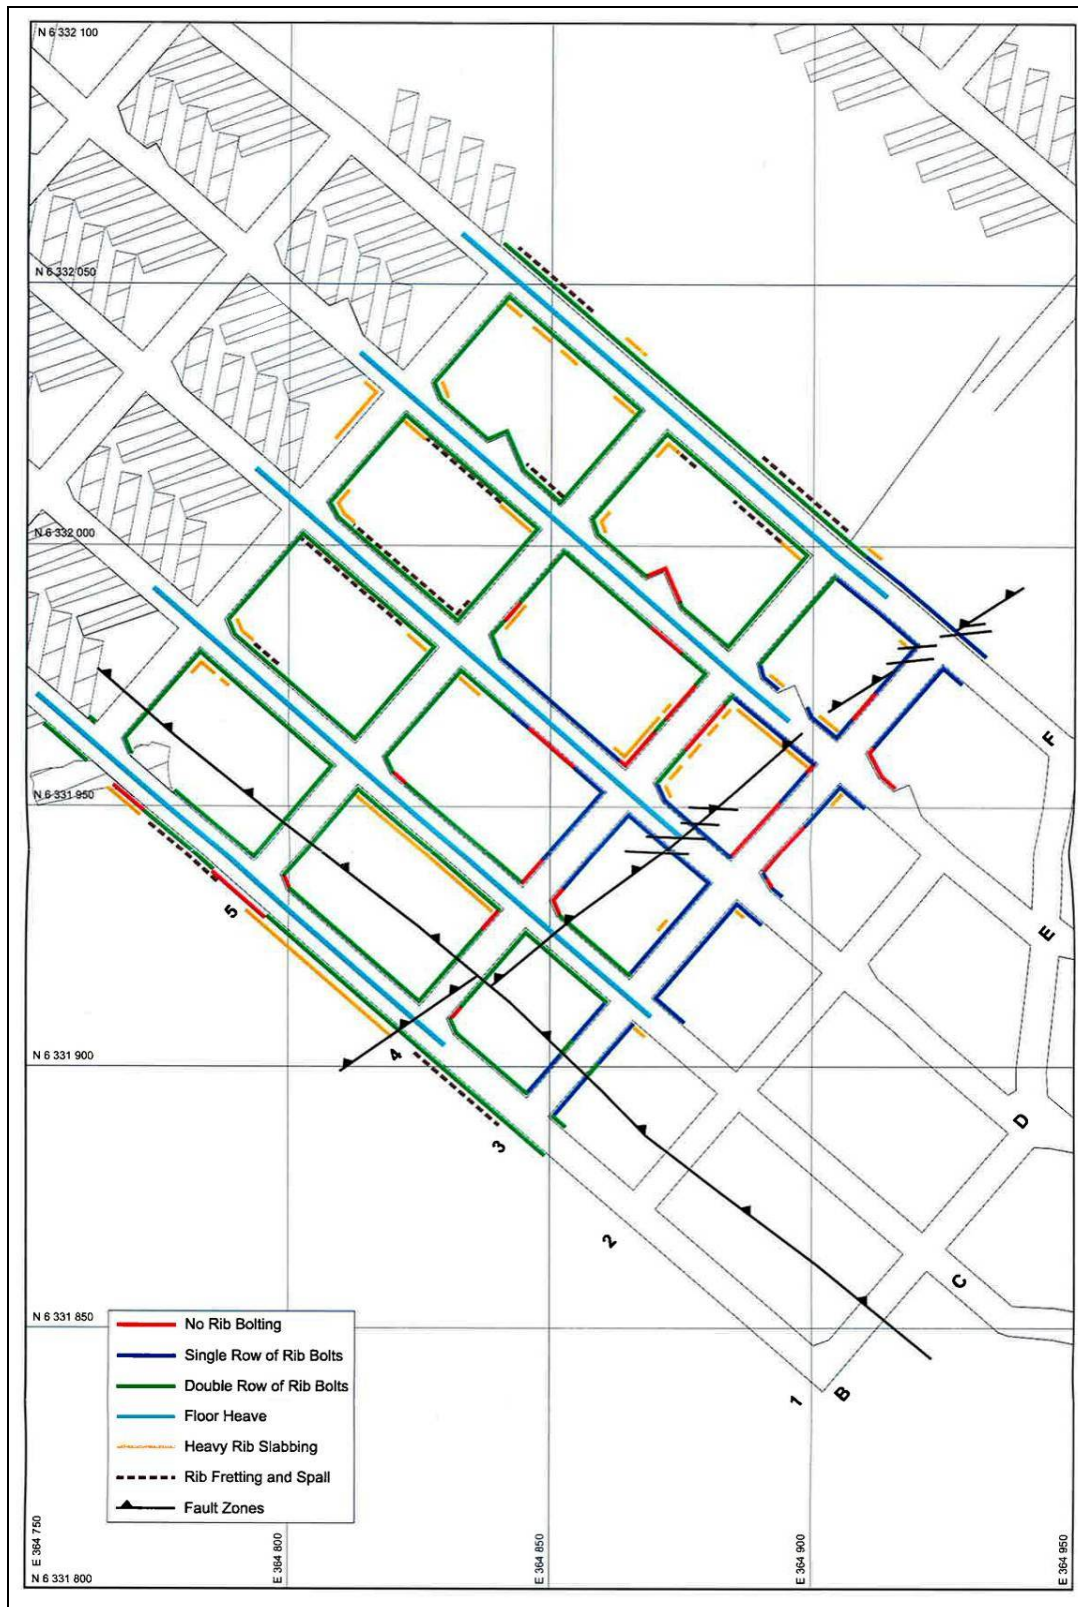
Figure 11 SCT Figure 3 Mine plan showing mapping undertaken by SCT Operations.

Mapping conducted by SCT focussed on recording the distribution of geotechnical condition and installed rib support present between 3 cut-through and 6 cut-through on all headings. Figure 3 shows the distribution and density of rib bolting within the panel together with the presence of rib slabbing, location of floor heave, presence of rib fretting and spall. Roof condition was noted to be very good and no change in roof condition was noted apart from the roof cavities and gutters noted in the Chain Valley Colliery Geotechnical Plan.

All headings in West 6 Panel (B–F) had significant levels of floor heave. This is mainly caused by abutment pressures experienced during pillar extraction. Rib bolting and strata failure presenting as rib spall are also mapped. Below is an extract from the report describing the West 6 installed support and rib failure rate:
