THE INVESTIGATION OF A COAL MINE EXPLOSION	5. 1
	FORENSIC SCIENCE EXAMINATION OF RECORDS AT MOURA NO.4 MINE EXPLOSION, 1986	5. 1
5.1	Investigation of a Coal Mine Explosion	5. 1
5.2	Methods of Examination at the Mine	5. 1
5.3	Use of Forensic Pathology in Coal Mine Explosion Investigation	5. 2
5.4	Forensic Science Examination of Records at Moura No.4 Mine Explosion 1986	5. 4
5.4.1	Forensic Science	5. 4
5.4.2	Forensic Pathology	5. 5
5.4.3	Recovery of the Victims at Moura	5. 6
5.4.4	Post Mortem Reports	5. 7
5.5	Examination of Records	5. 8
5.5.1	Classification of the Incident	5. 8
5.5.2	Approach to the Scene: Immediate Actions	5. 9
5.5.3	General Characteristics of the Explosion	5.10
5.5.4	Observed Personnel Effects	5.11
5.5.5	Condition of Deceased Miners after Explosion	5.14
5.5.6	Observed Material Effects	5.14
5.6	Discussion	5.16
5.7	Summary	5.16

MINE EXPLOSION ANALYSIS.	6. 1
6.1	Investigation Techniques	6. 1
6.2	Australian and Overseas Forensic Research	6. 2
6.2.1	Estimating Overpressures from Damage to Structures	6. 3
6.2.2	Displacement of Objects	6. 3
6.2.3	Heat Damage	6. 4
6.3	Modelling of Explosions	6. 5
6.3.1	Physical Models	6. 5
6.3.2	Mathematical Models	6. 6
6.4	Reanalysis of

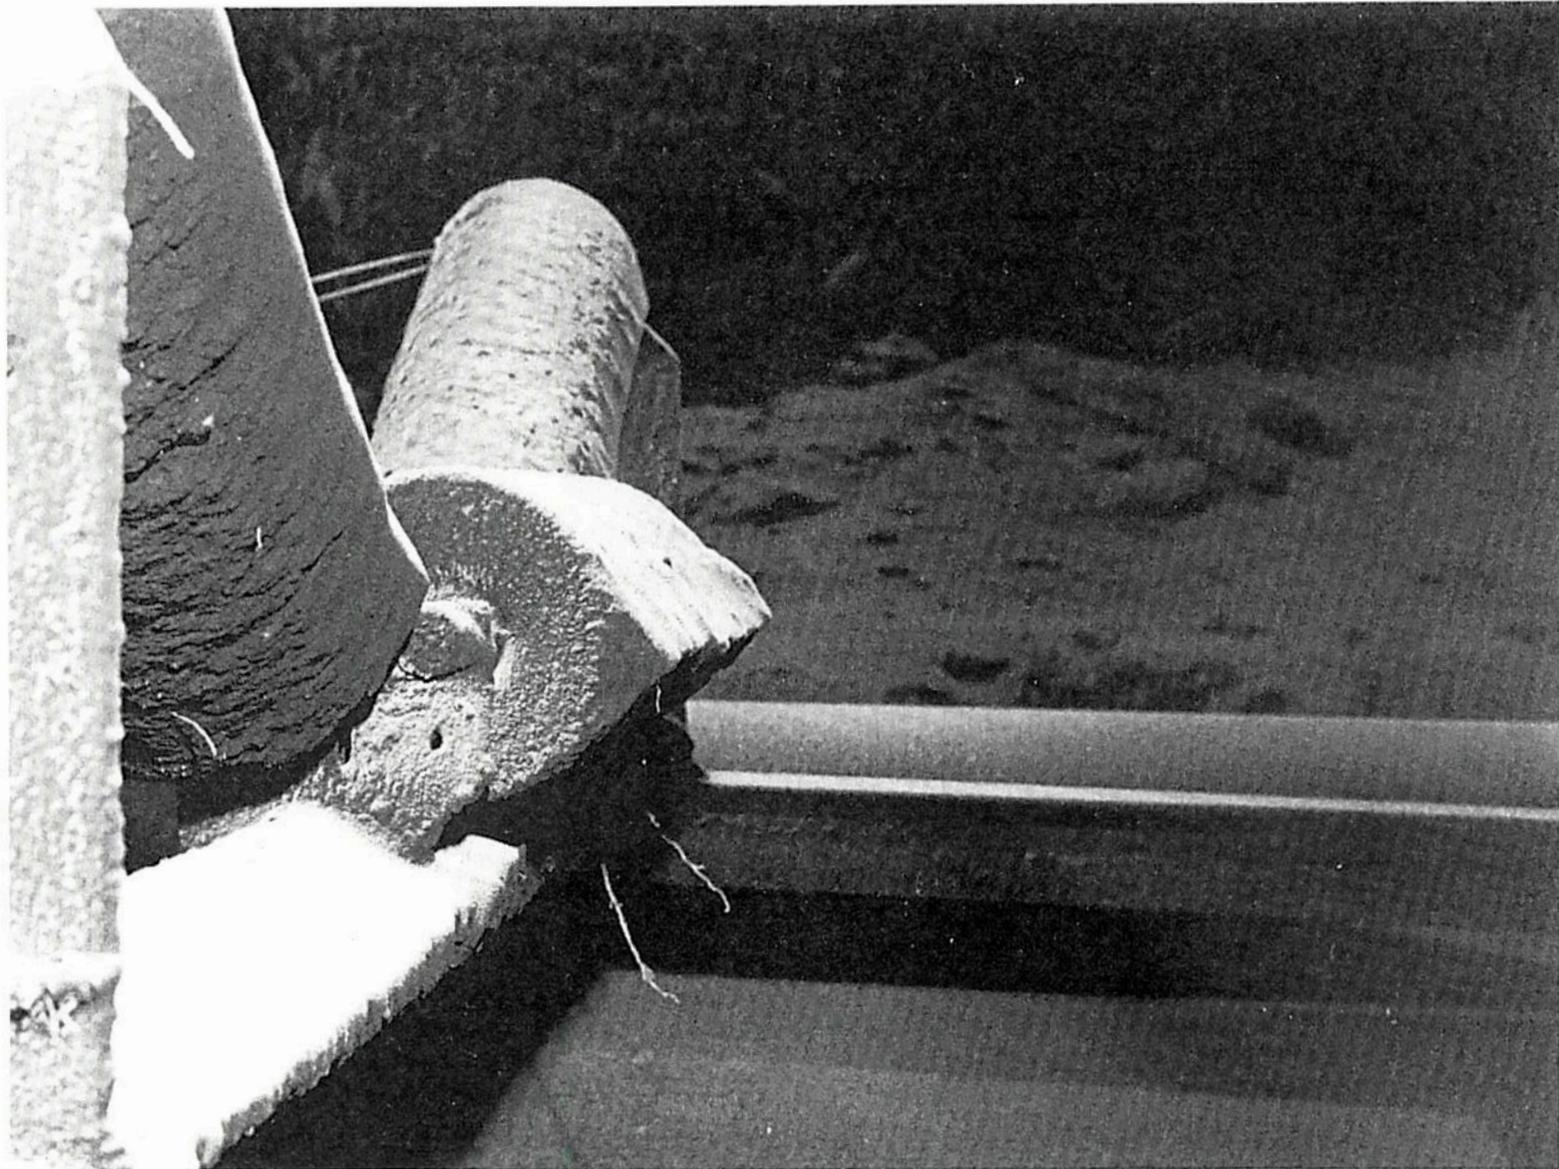
Plate 1

Deposition of dust on top conveyor rollers No. 3 Belt Road, looking outbye of 21 Cut-Through.

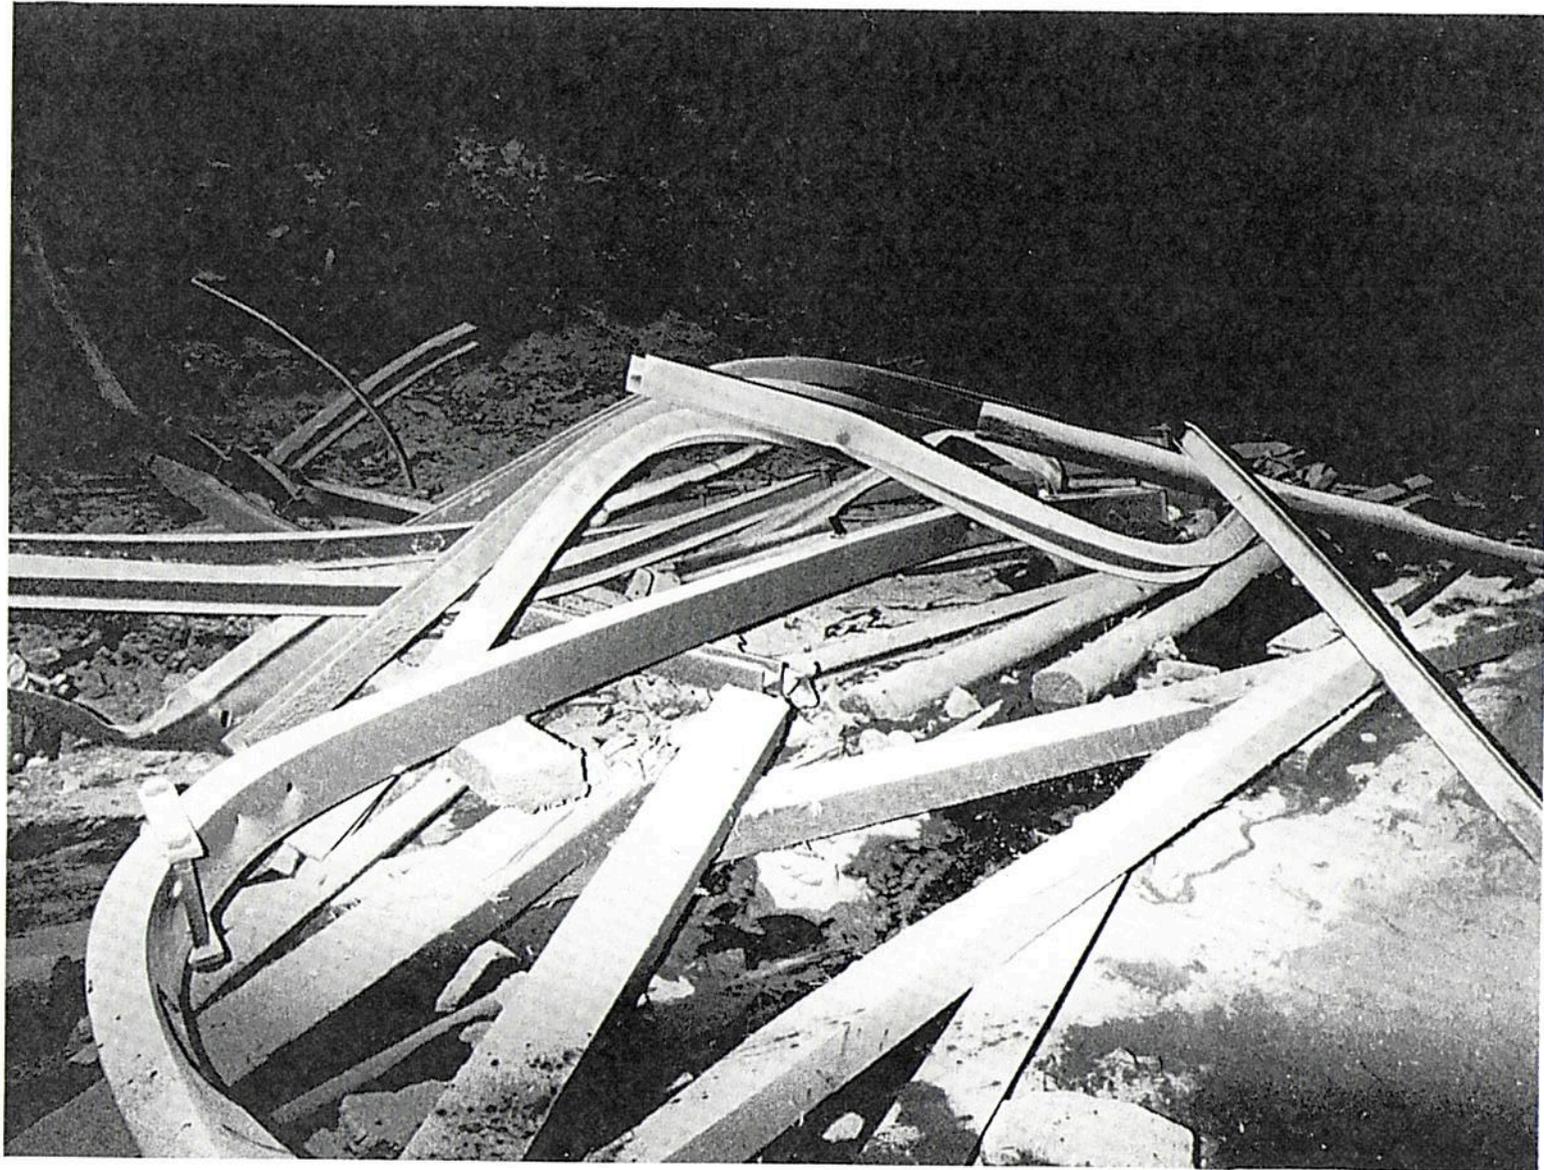
Plate 2

Blast damage to steel and timber from "Taj Mahal" structure looking inbye in No. 4 Supply Road between 21 and 22 Cut-Through.

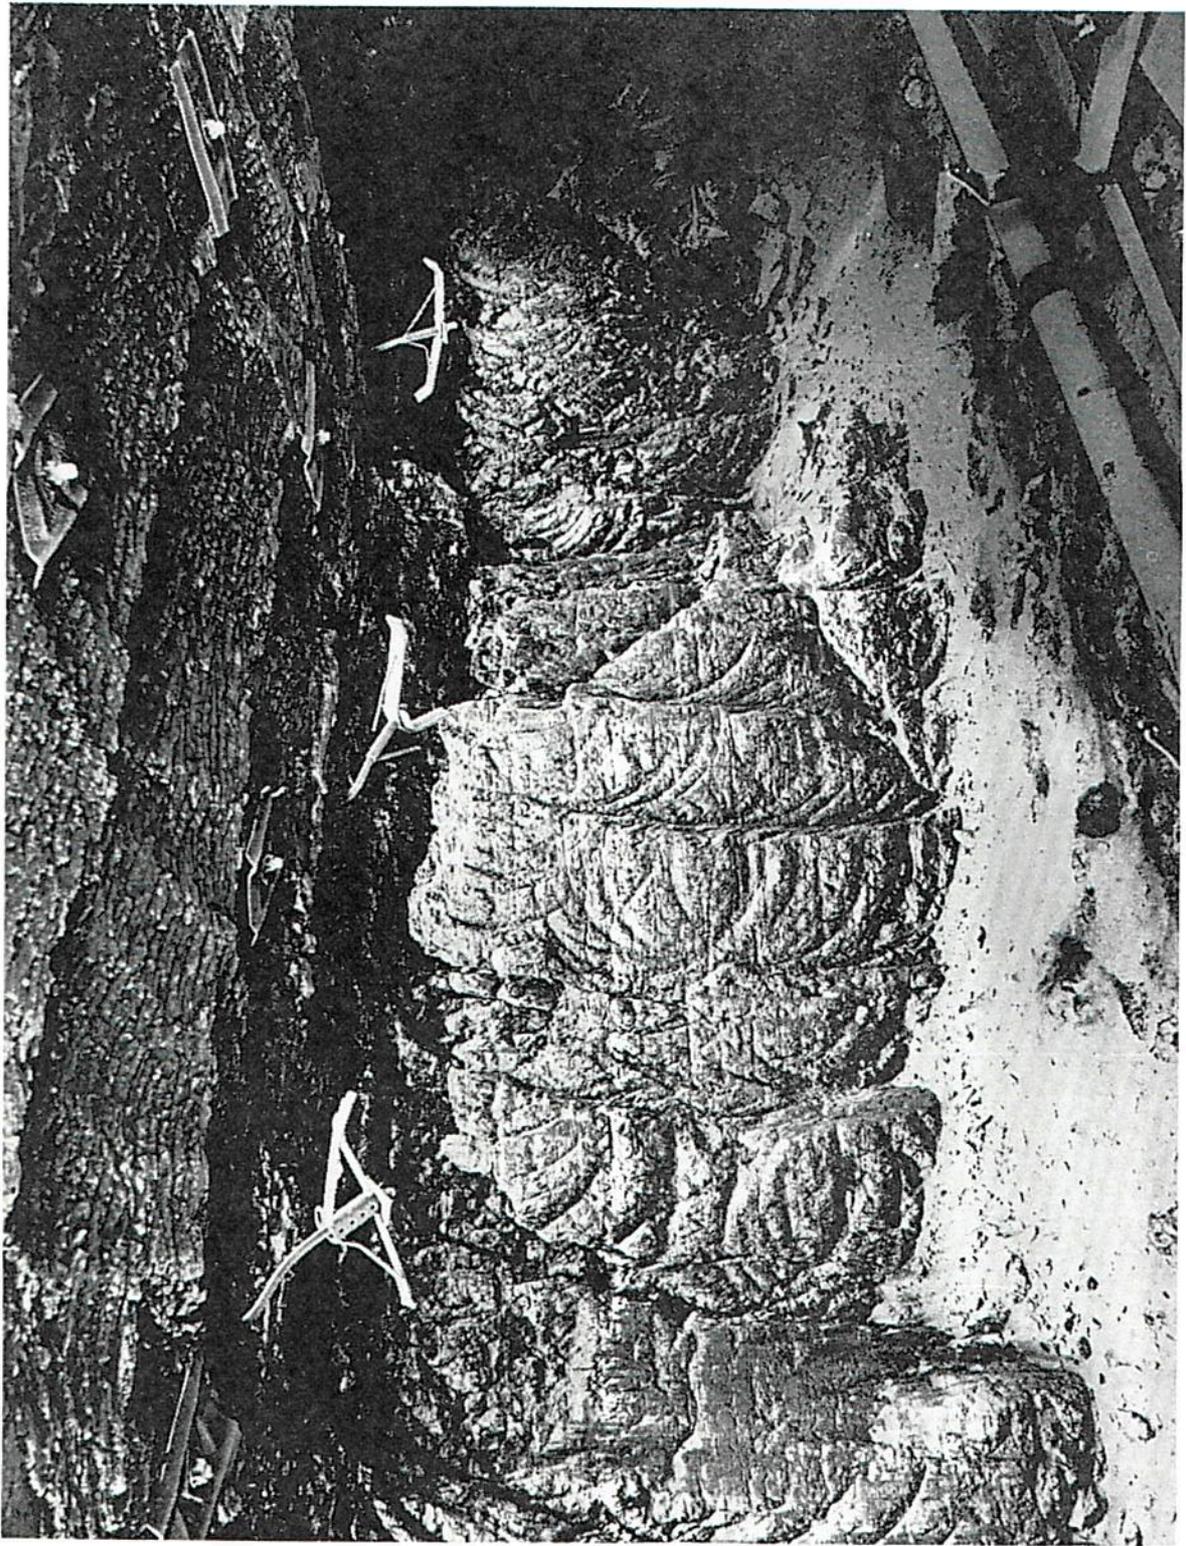
Plate 3

Water barrier hooks between 23 and 24 Cut-Through on No. 3 Belt Road bent in outbye direction by force of blast.

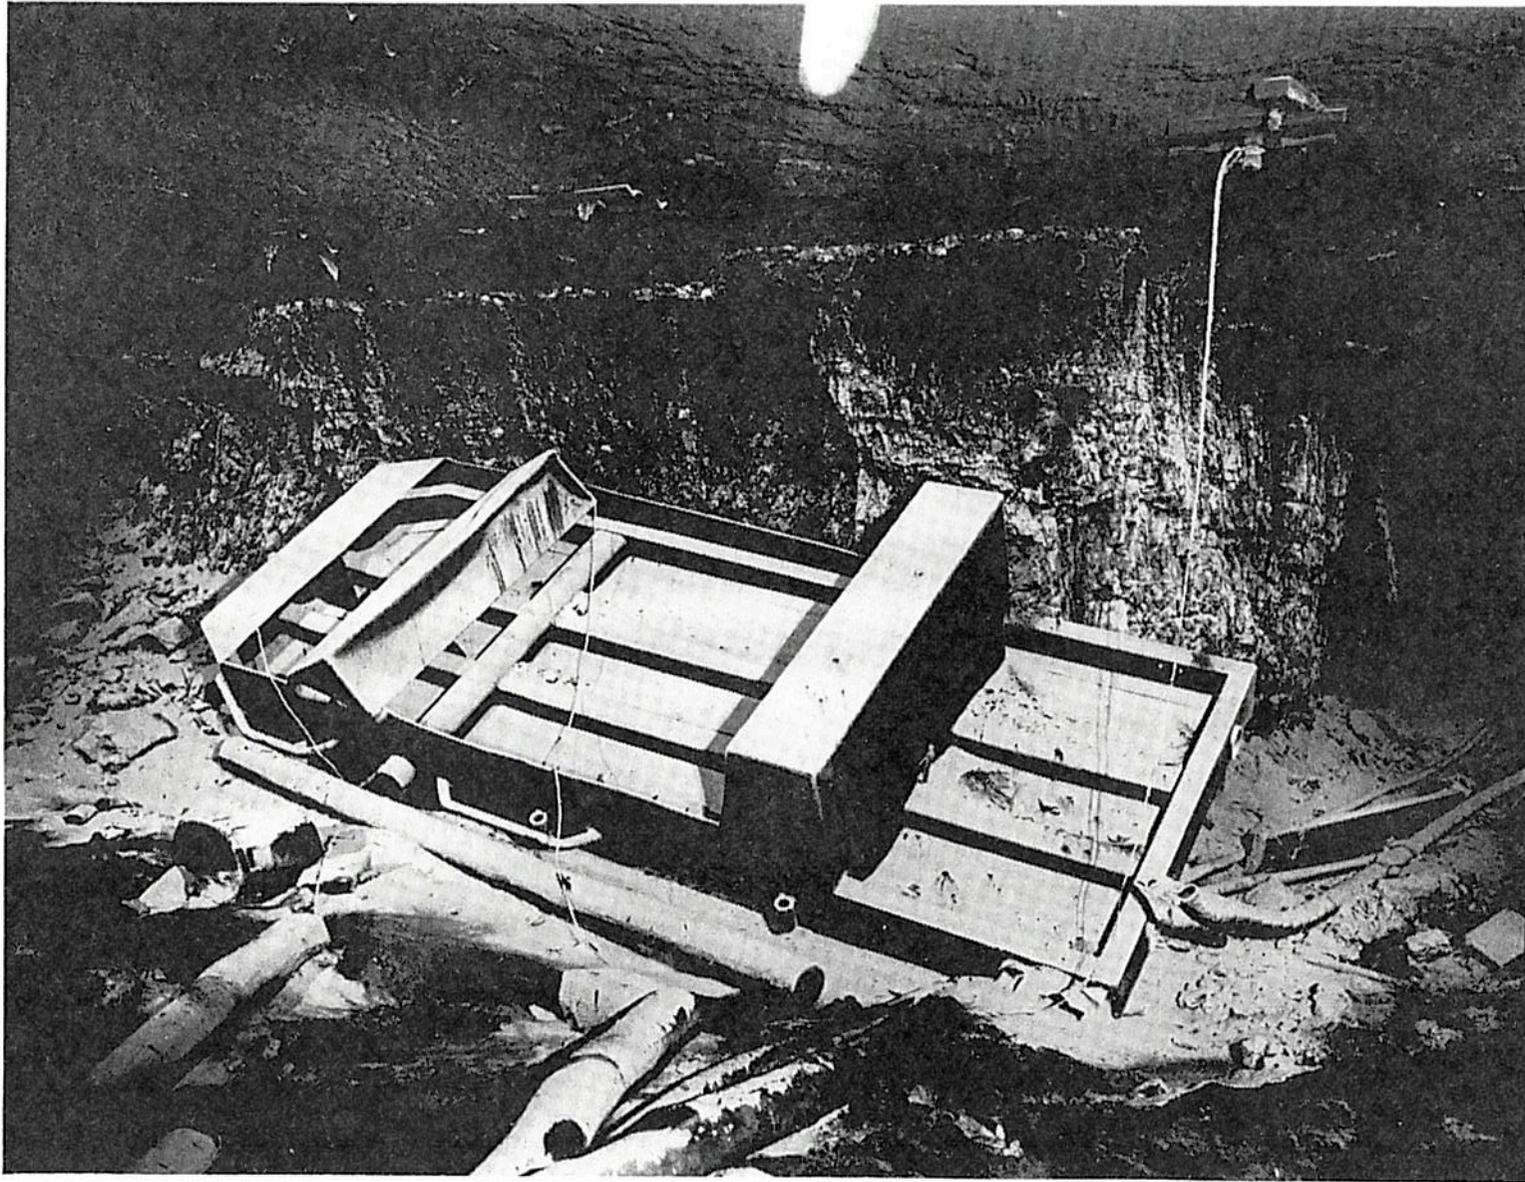
Plate 4

MPV Tray at junction of 25 Cut-Through and No. 4 Supply Road. Moved and overturned by force of blast.

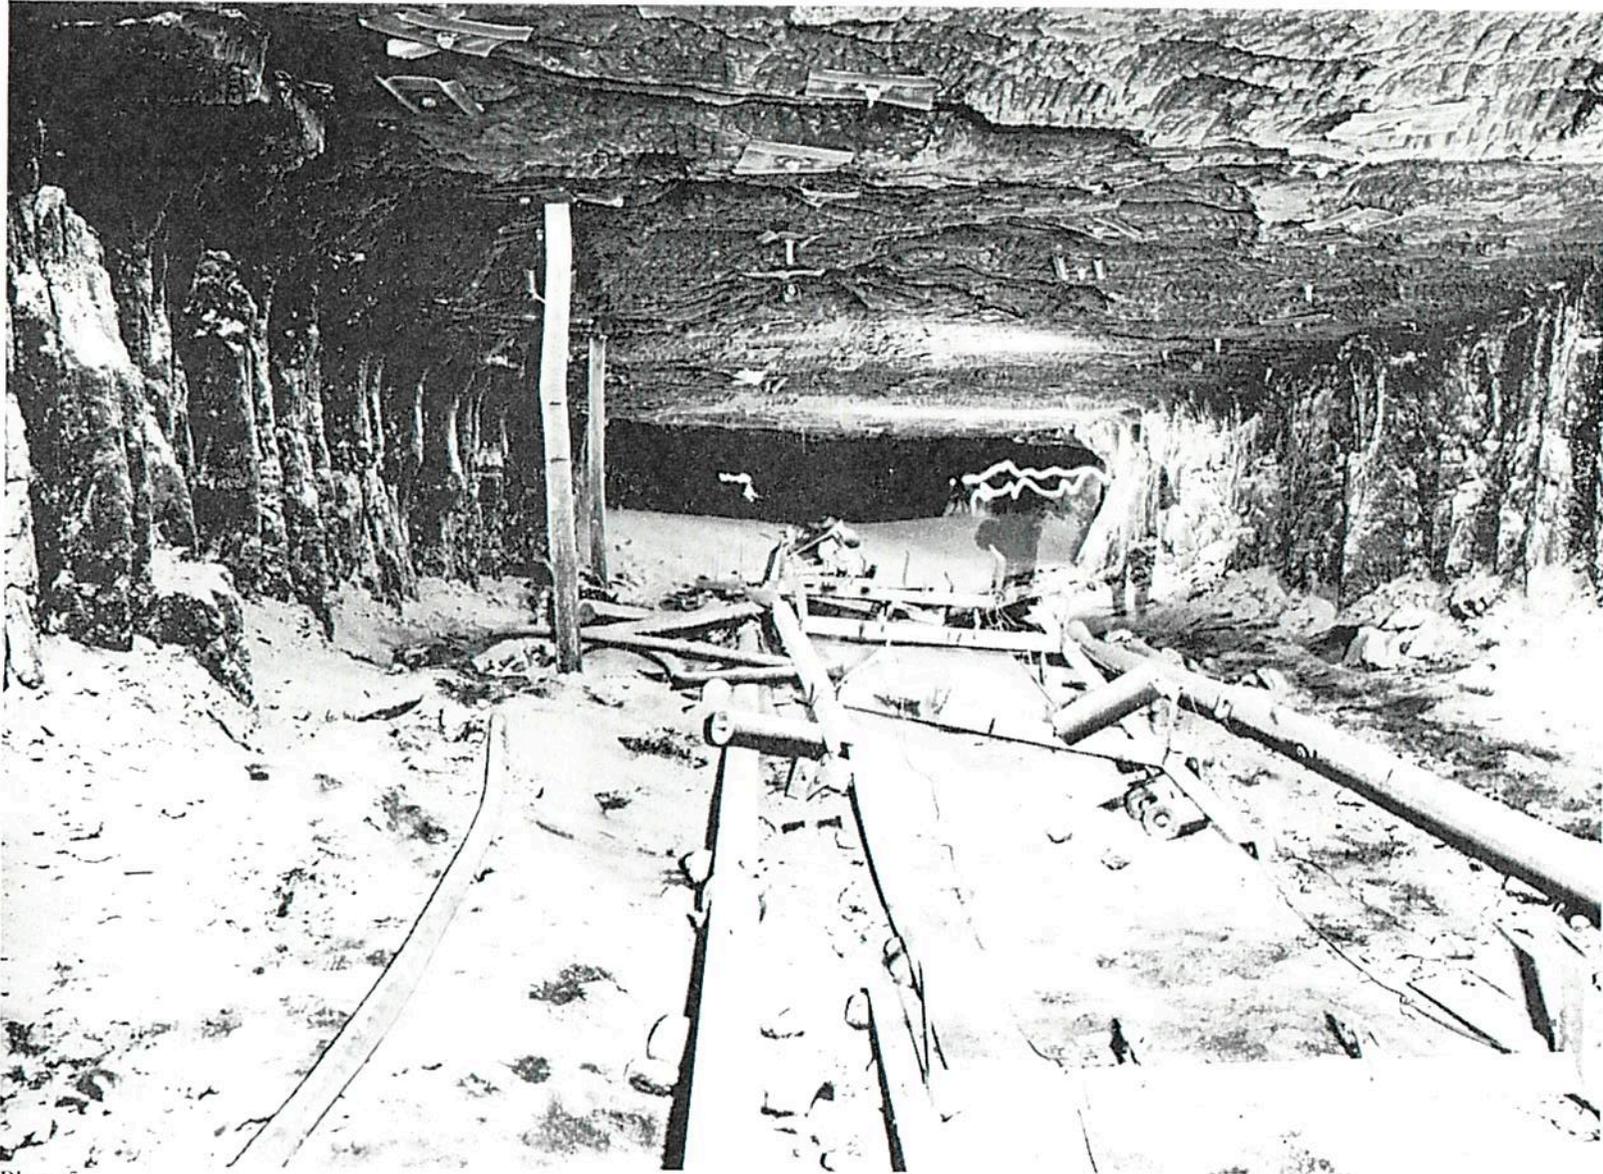
Plate 5

Belt conveyor in No. 3 Belt Roadway between 23 and 24 Cut-Throughs looking inbye. Top belt and rollers of conveyor removed by the force of the explosion. Light coloured deposit is fly ash used to suppress a fire.

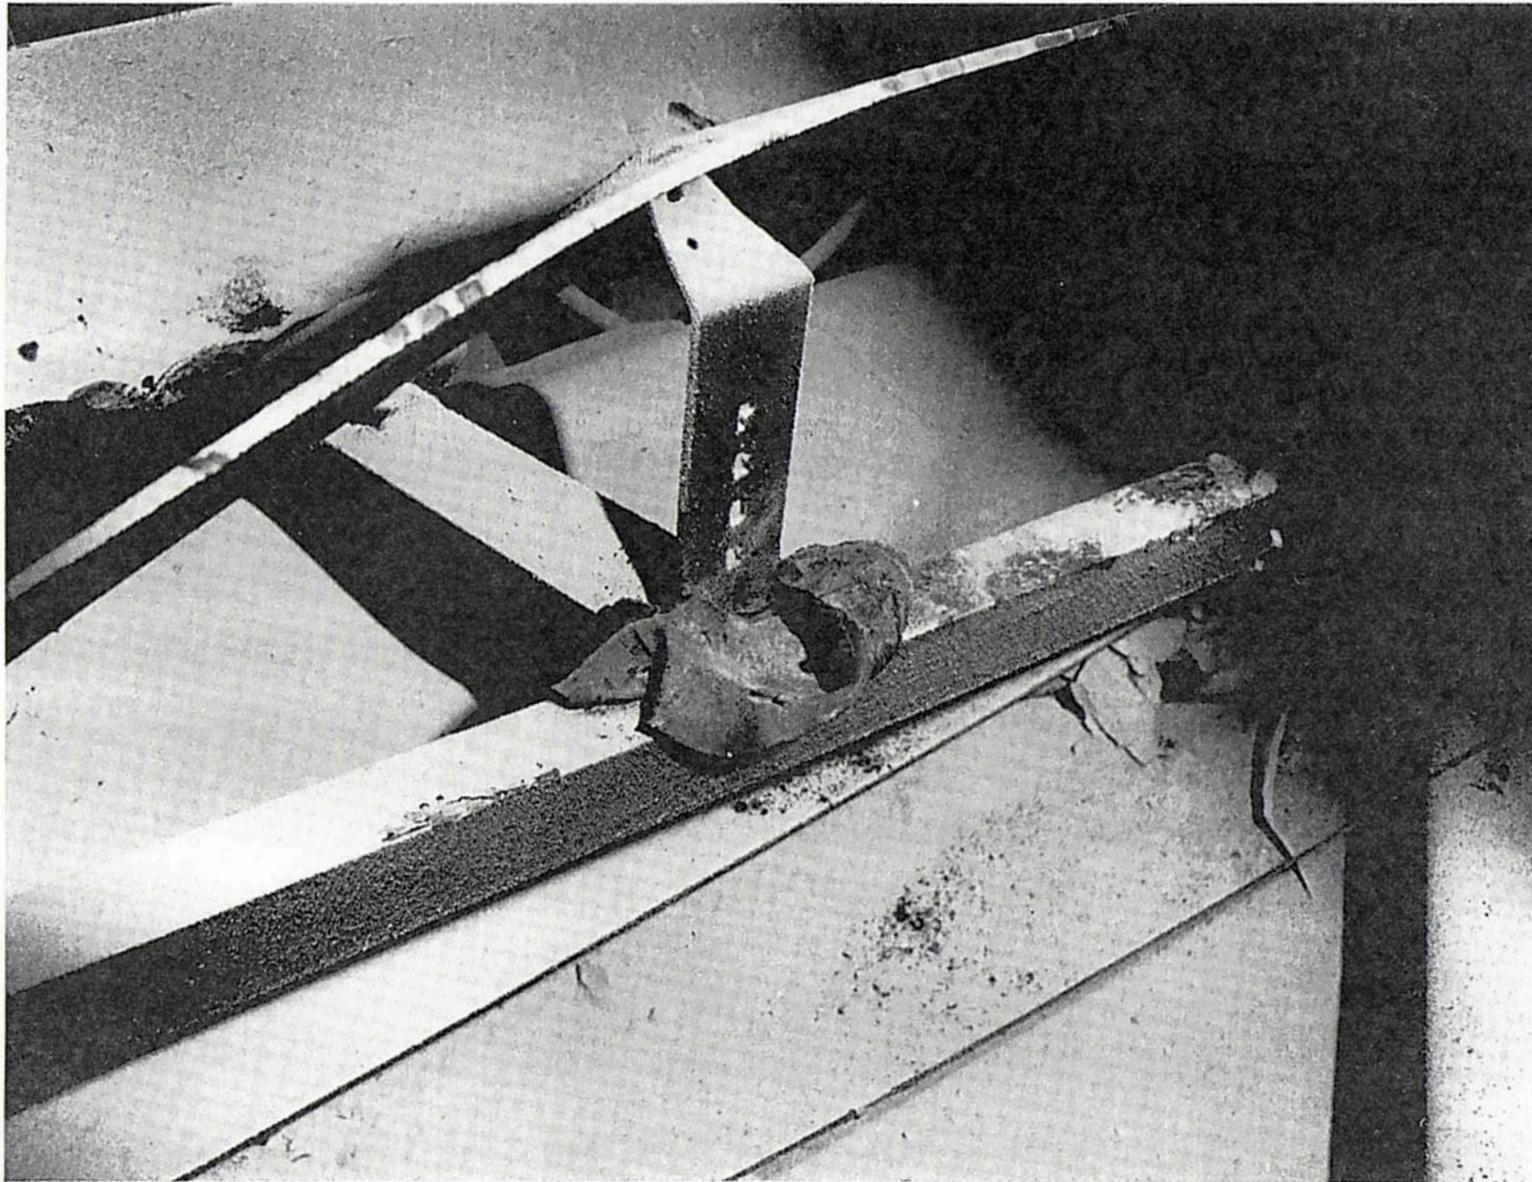
Plate 6

Safety Helmet softened by heat and projected by explosion to a position on the conveyor in No. 3 Belt Road 13m outbye of 25 Cut-Through.

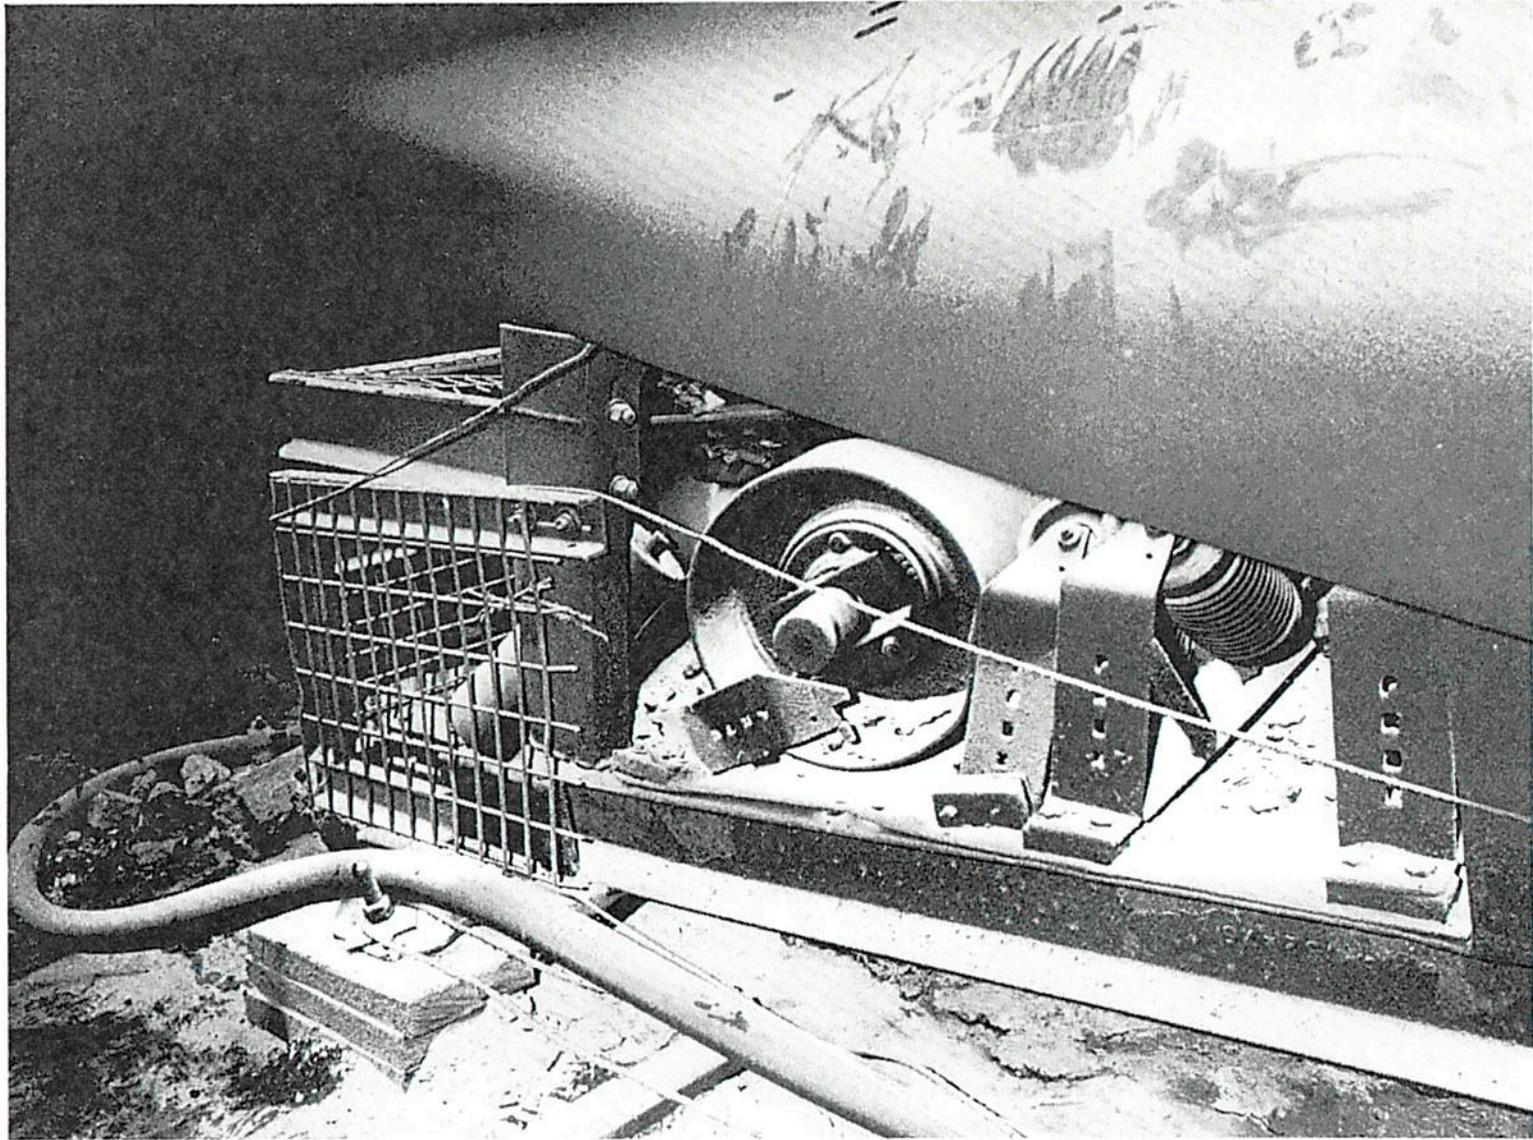
Plate 7

Tail end of belt conveyor and return drum moved outbye during the explosion.

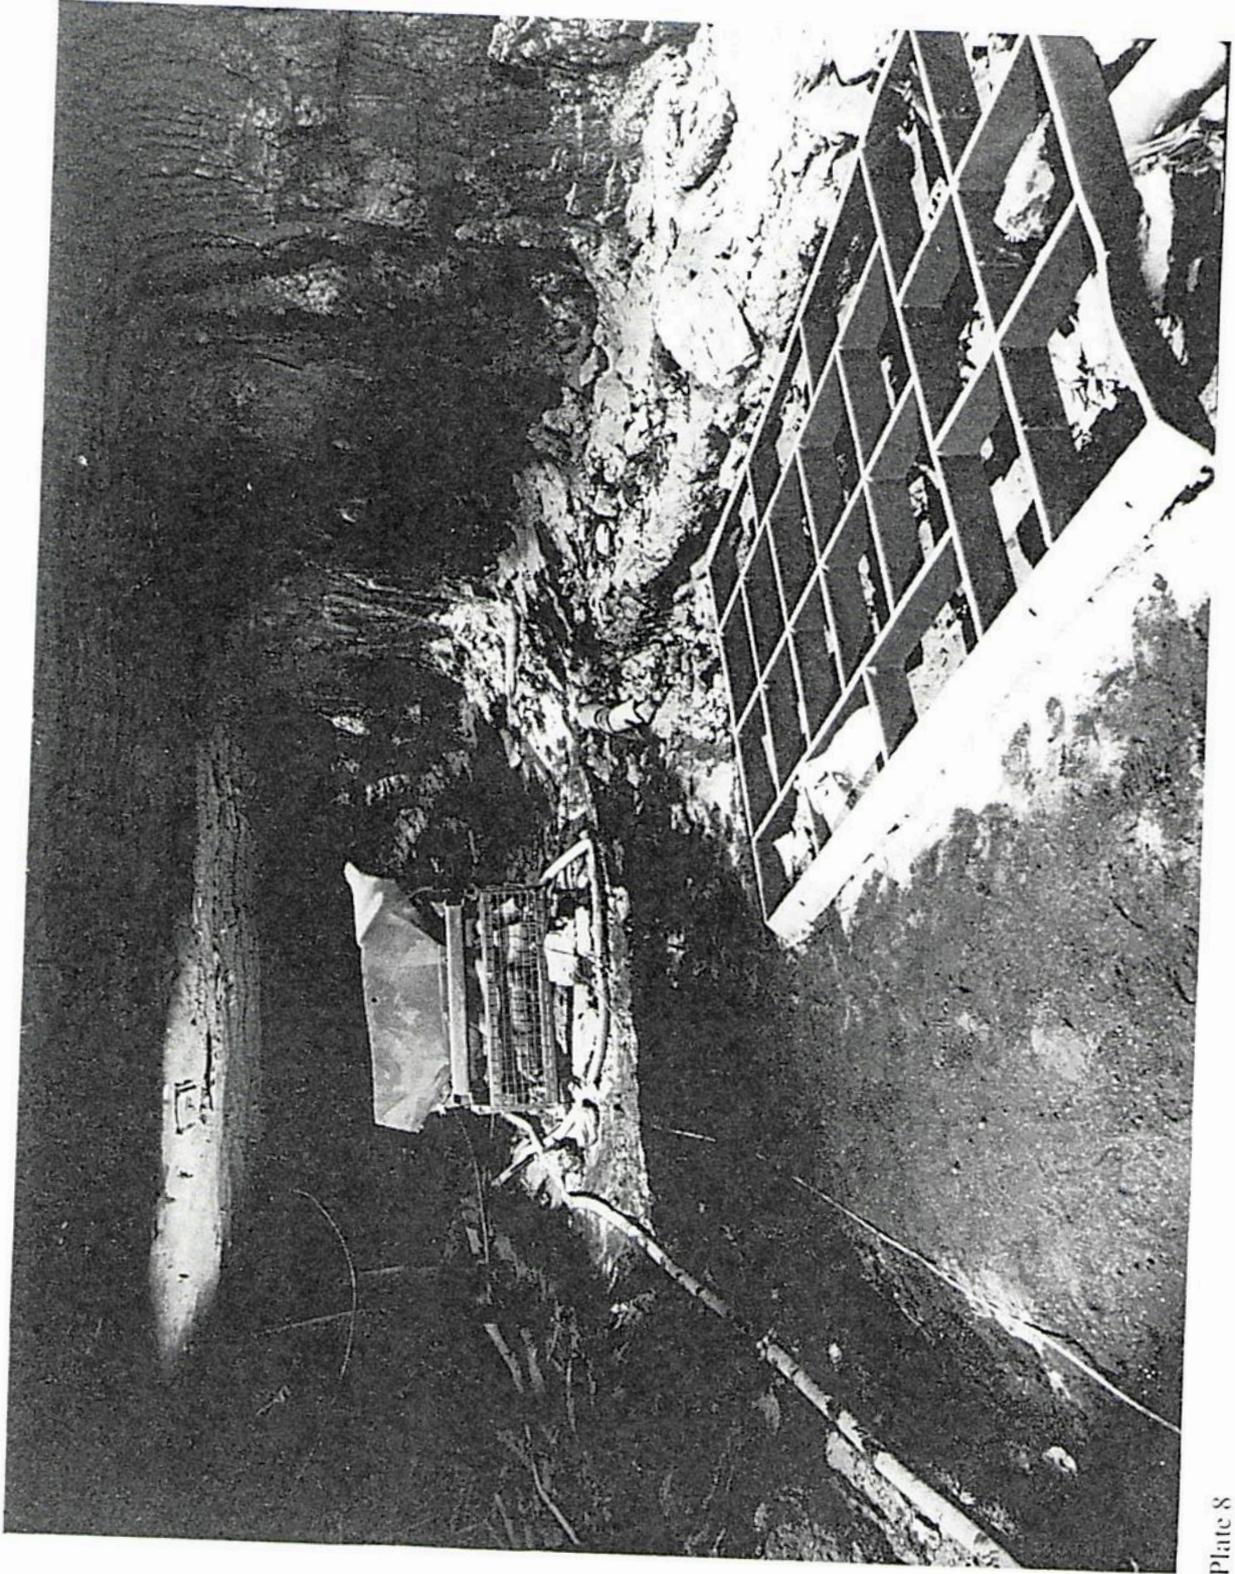
Plate 8

Grizzly (0.71 mass) moved inbye from normal position at return end of No. 3 belt conveyor during the explosion.

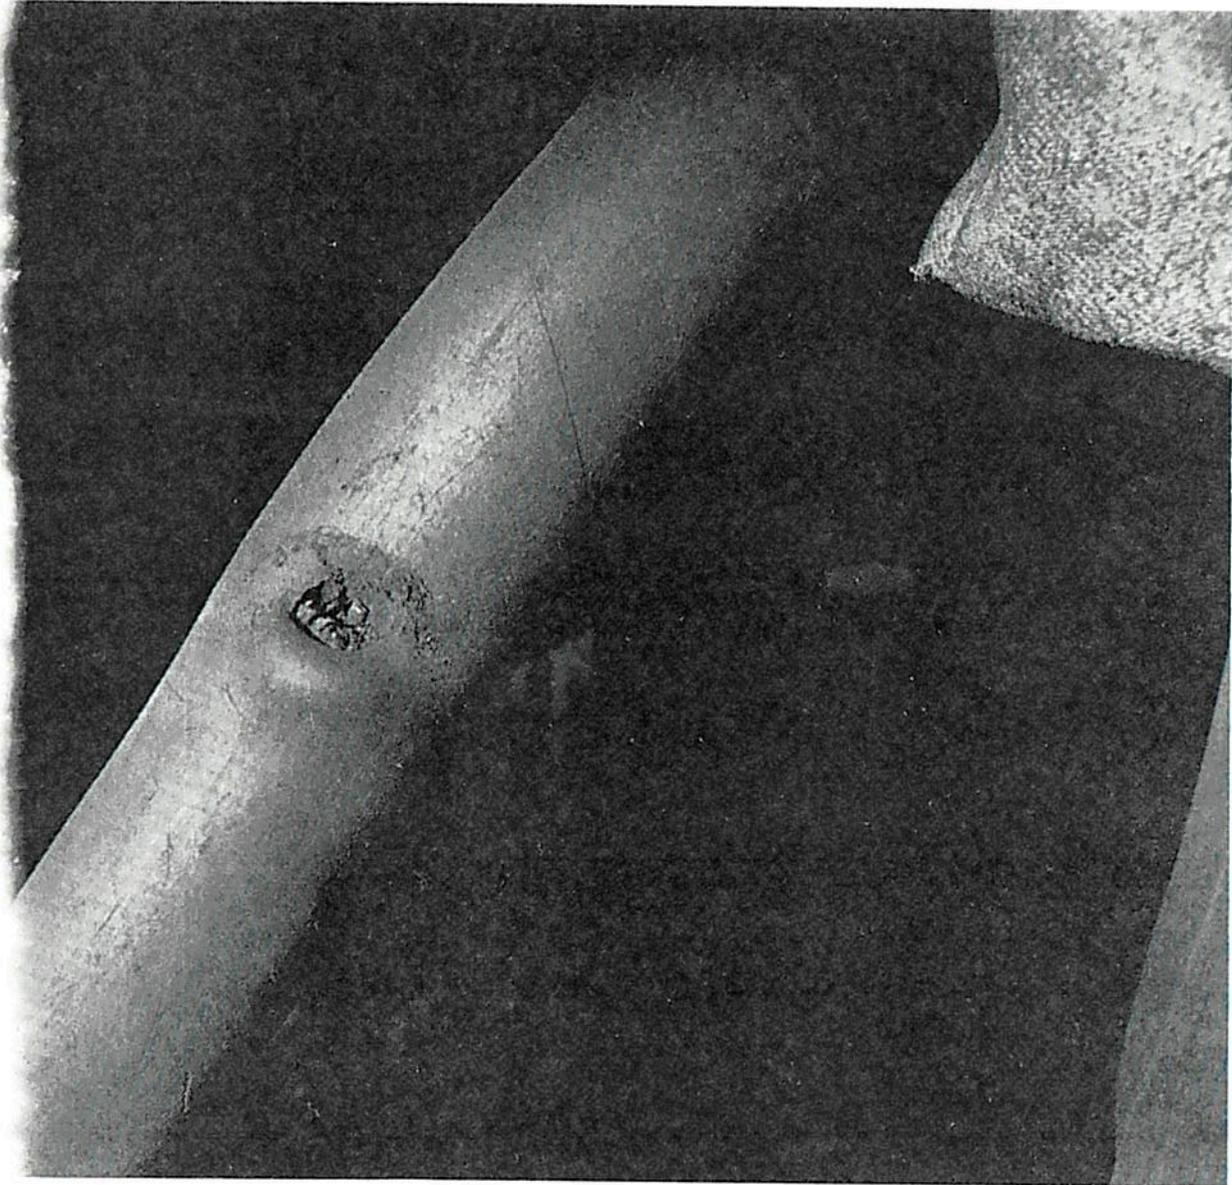
Plate 9

Damaged power cable in 26 Cut-Through showing penetration of cable by a piece of wood.

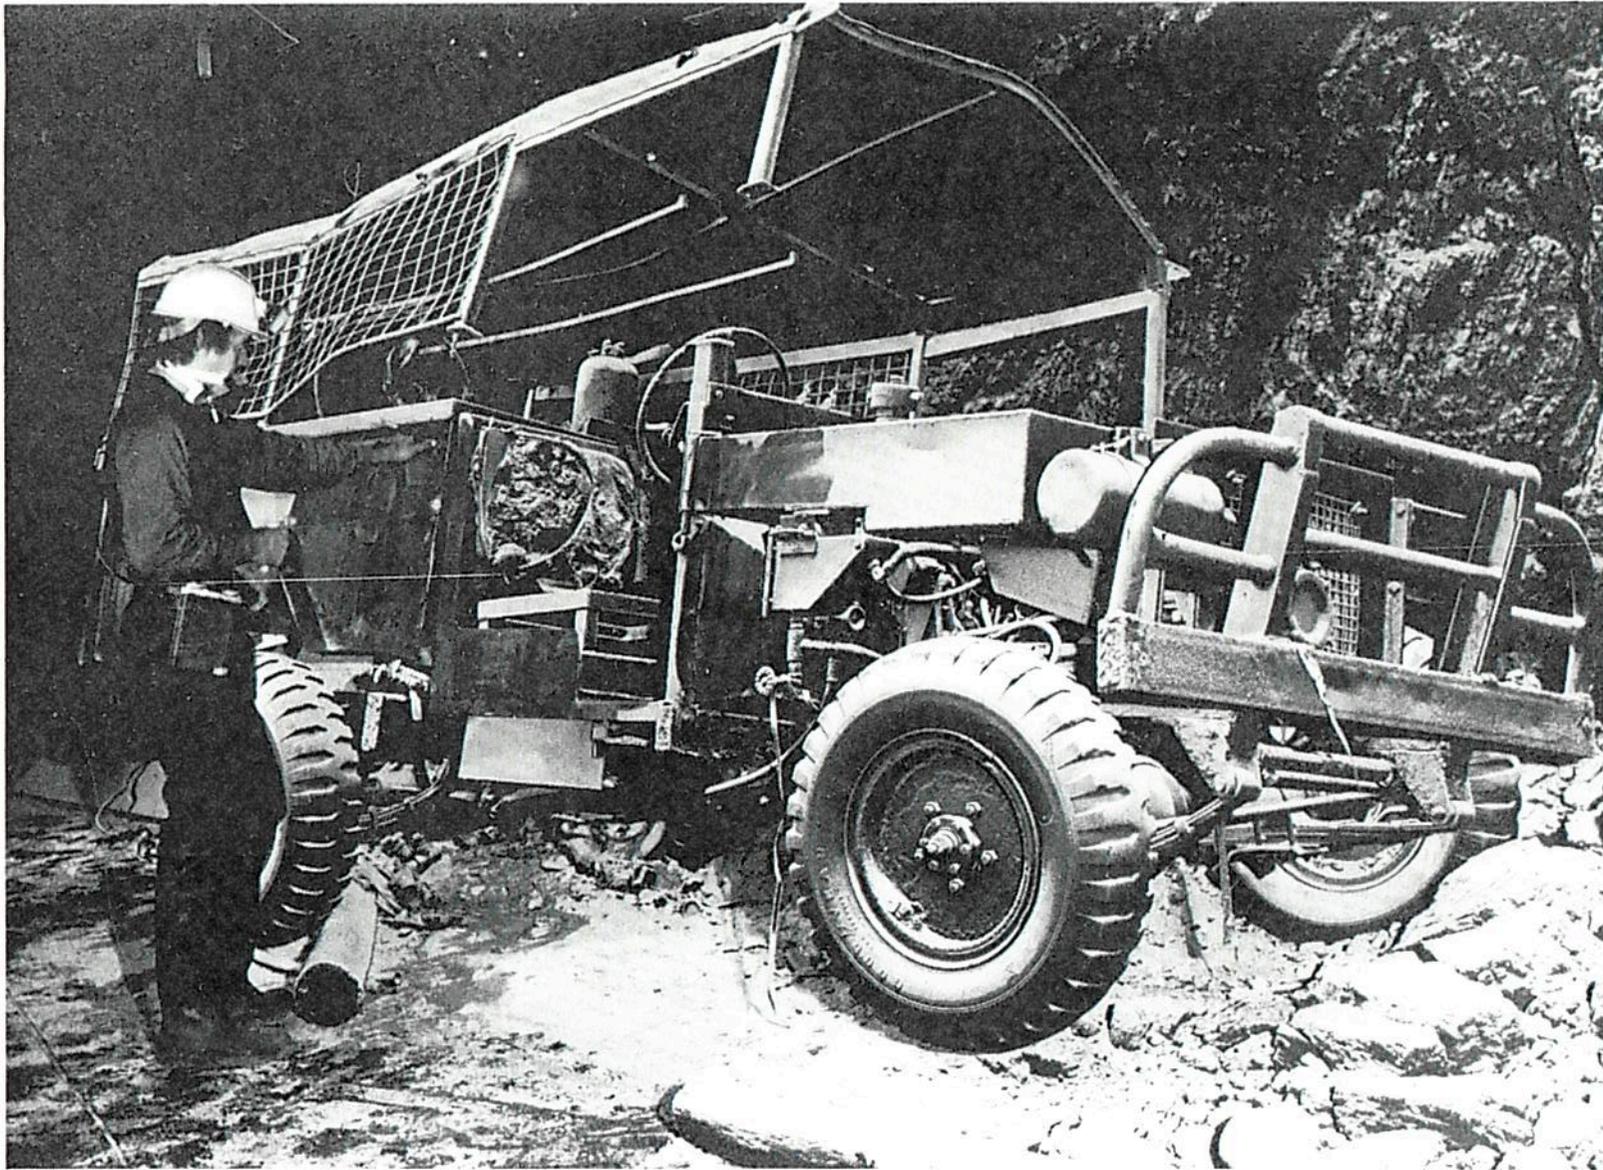
Plate 10

Mine Rover in No. 4 Supply Road inbye of 26 Cut-Through. Canopy of vehicle held by roof bolt plate and fabric on seat burnt.
