OUTBURSTS AT COLLINSVILLE — A CASE STUDY

ABSTRACT

The Aus. I.M.M. Southern Queensland Branch, The Occurrence, Prediction and Control of Outbursts in Coal Mines Symposium September, 1980

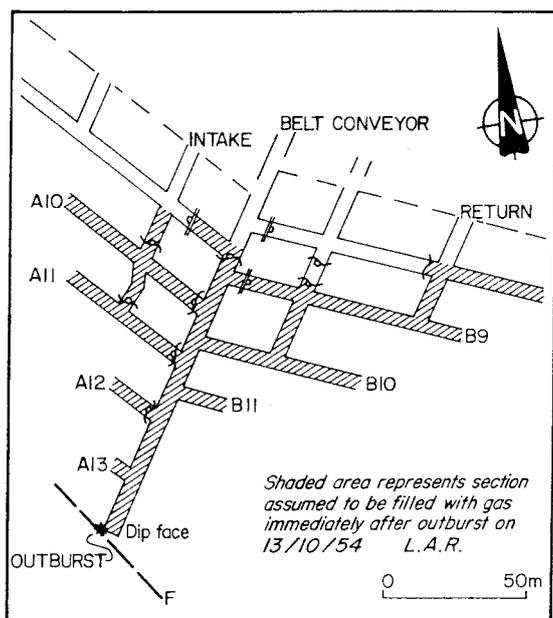
Fig. 2 - No. 1 State Mine Dip Workings

The death of all seven men was caused by asphyxiation in an atmosphere of carbon dioxide (Q.G.M.J. 1954). The gas released backed up against the ventilation to A9 level and went to level B6 on the return side. See figure 2. A dirty grey haze was reported immediately after the outburst. This haze was thought to be caused by condensation as the warm mine air was cooled by the expanding carbon dioxide gas.

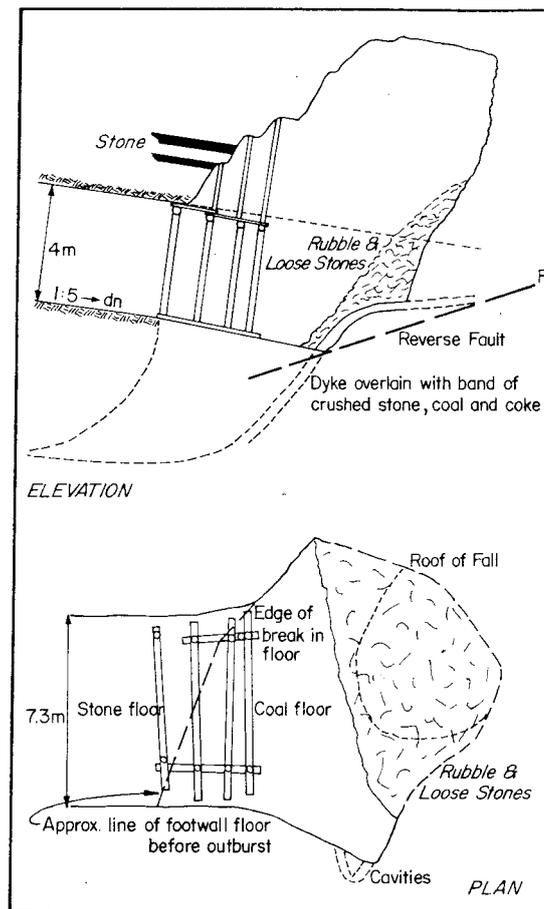
Fig. 3 - Outburst cavity - 13.10.54 (after Rogers, 1955 internal report)

A reverse fault with a throw of nine metres up ahead of the working face intersected a steeply dipping normal fault. A dyke also occurred in this area. See figure 3.

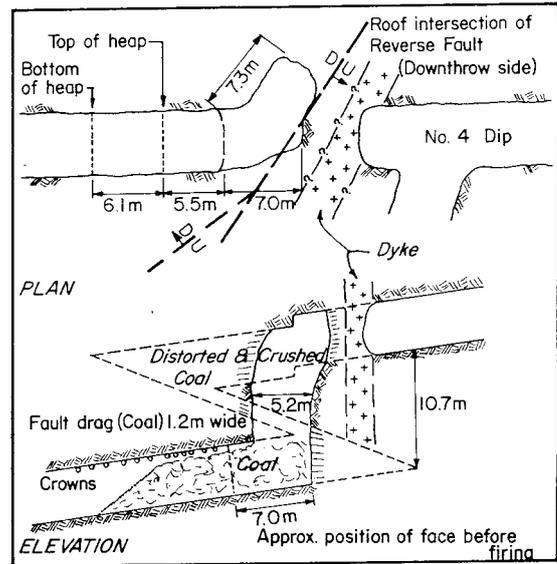
Fig. 4 — Outburst cavity — 4.3.60
(after Ogg, 1960, State Mine internal report)

The first and largest outburst of this series occurred on March 4th, 1960 and approximately 800 tonnes of material (Williams and Rogis, 1980) were dislodged. See figure 4.

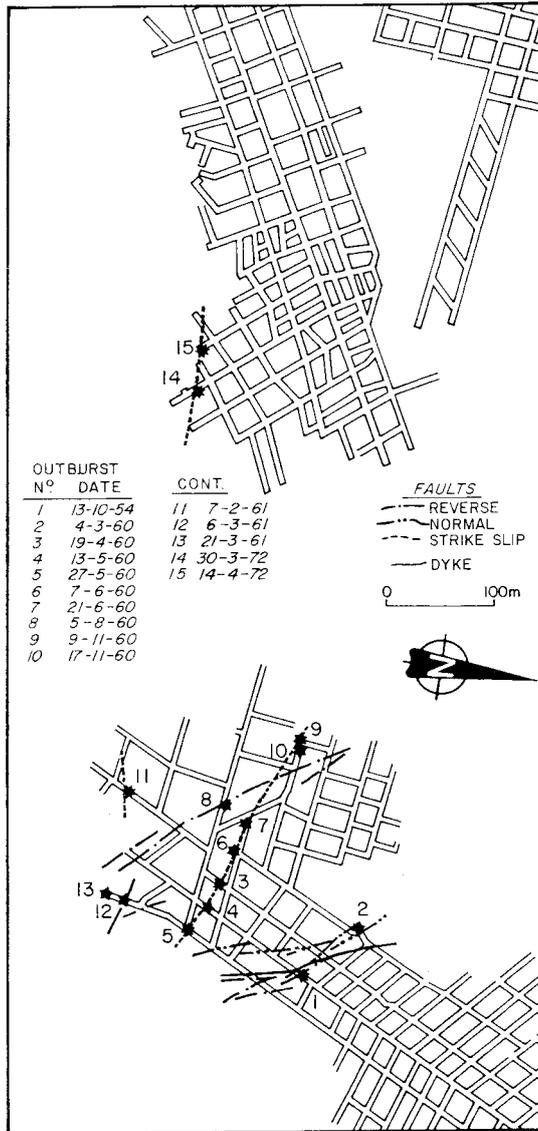
Fig. 6 — Outburst locations, No. 1 State Mine and No. 3 Mine

Seven other outbursts occurred in a 300m zone during 1960 and 1961. See figures 5 and 6.

Mining at the No. 3 mine was generally in conditions considered as being outburst free. In the early 70's while mining the deeper parts of the Bowen seam near the outburst area in the old State Mine, two small outbursts were encountered. See figure 6.

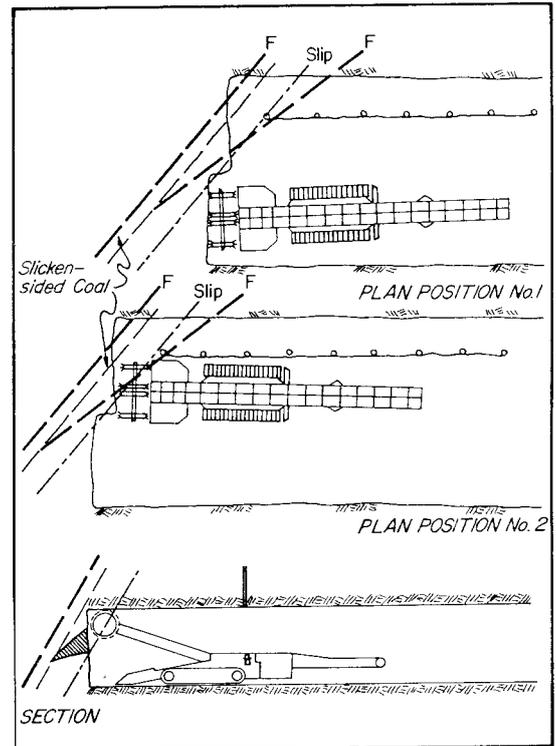
Fig. 7 — Outburst in No. 3 Mine, 30.3.72

The gas emission values (method by Hargraves, 1963) were generally below $0.5\text{cm}^3/\text{g}$ and the area considered outburst free. In the deeper cover (240m) in the south-eastern section of the workings the emission values rose to $0.75\text{m}^3/\text{g}$ and up to $1\text{g}/\text{cc}$. Two small outbursts occurred in this area where the drivage intersected a strike slip fault. See figure 7.

As continuous miners were used, the outbursts occurred with men at the face. This caused some alarm. The section was difficult to work and was subsequently abandoned.

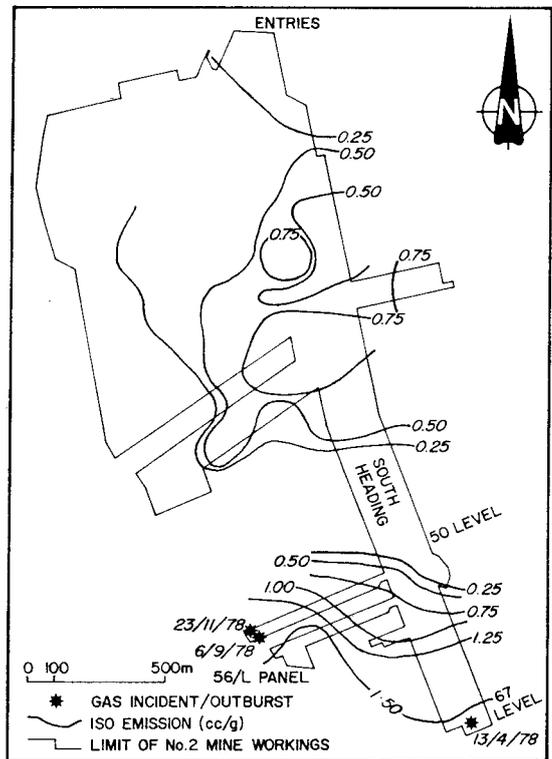
Fig. 8 - Outburst locations and gas emission in No. 2 Mine

tion was upgraded by the installation of a second axial-flow fan. Although the headings had been standing for such a length of time and gas had continually been given off, emission values increased at a faster rate than expected and were up to 0.35cm³/g within one pillar length. After mining through this zone emission values fell back to less than 0.10cm³/g and mining advanced, to 59 level (250m Cover) before values rose again. At this point the seam section and roof condition also changed. See figure 8.

Two of the six outbursts occurring in this area contained coal. The combined gas and coal outbursts occurred in a panel heading being driven west from the main development and at the site of a 6 metre reverse fault. The gas outburst occurred in the main development headings, with gas being emitted from the floor of the working section accompanied by floor heave. Each outburst was adjacent to a geological disturbance. The occurrence of one of the gas outbursts and the two gas and coal outbursts are described in the next section of the paper. See Figure 8.

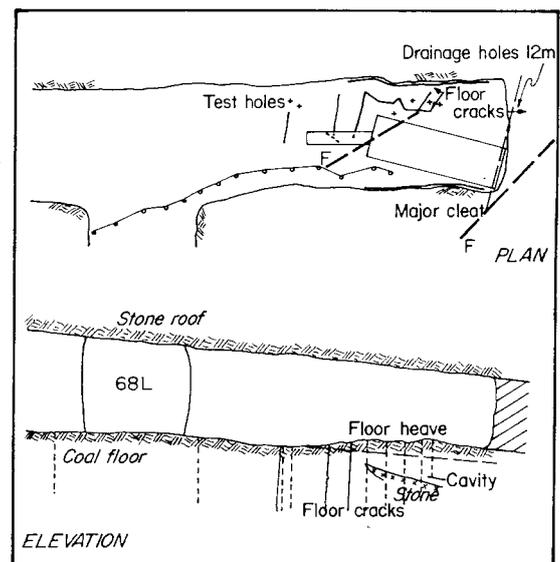
Fig. 9 -- Gas emission site 13.4.78

The outburst occurred at 11.15am on the day shift as the continuous miner was cutting coal from the west side of the face. See figure 9. Fifteen (15) cars of coal had been mined and emission readings taken in the top section (only) gave readings of 0.42, 0.47 and $0.34 \text{ cm}^3/\text{g}$.

Ventilation at the face was $5.1 \text{ m}^3/\text{sec}$. On inspection it was evident the gas had been emitted from floor cracks associated with a floor heave of approximately 0.6 metres. It was not possible to determine the volume of gas given off. A gas emission taken in the face after the outburst gave $0.51 \text{ cm}^3/\text{g}$.

Mining bottom coal at the site exposed a reverse fault with an upthrow of 0.95 metres. This fault had been intersected 40 metres back from the face in the top section of the seam. It was proven that floor holes had not been bored in this area.

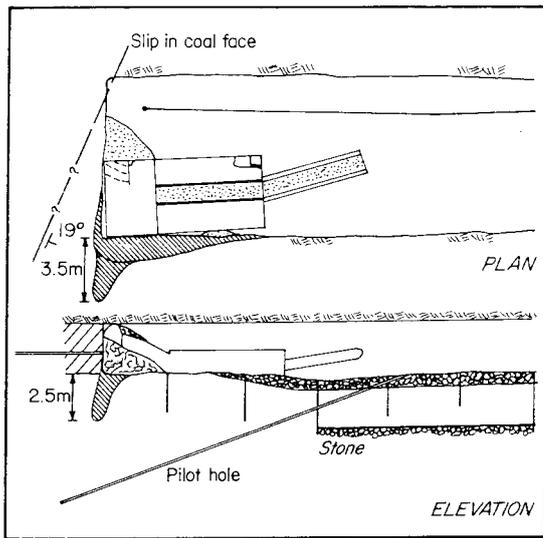
The continuous miner was cutting coal with the head against the roof when the outburst occurred and no doubt this restricted the blast. See Figs. 10 and 11.

No warning noise was heard by the crew. They left the face when coal stalled the conveyor on the miner and spilled out over the head. 2420m³ of gas was given off in 3.5 hours following the outburst.

Exploration drilling proved a 6 metre downthrow reverse fault ahead of the face and this was later mined.

After this outburst, the additional measures were adopted for mining in areas where the seam gas emission exceeded 1 cm³/g.

1. Three pilot holes were maintained 15 metres in advance of the face. The rib holes were flanked slightly outward.

2. A minimum air ventilation of 9.5m³/sec was maintained.
3. The face was kept as square as practicable with a maximum advance per cut of 1.35m.
4. Housekeeping was maintained at a high standard in the face area.
5. Siebe Gorman compressed air units were purchased to replace AUER 16B. These were kept on the machines and in a box at the last cut-through. Subsequently, Medic Air bottles were installed on the continuous miners.

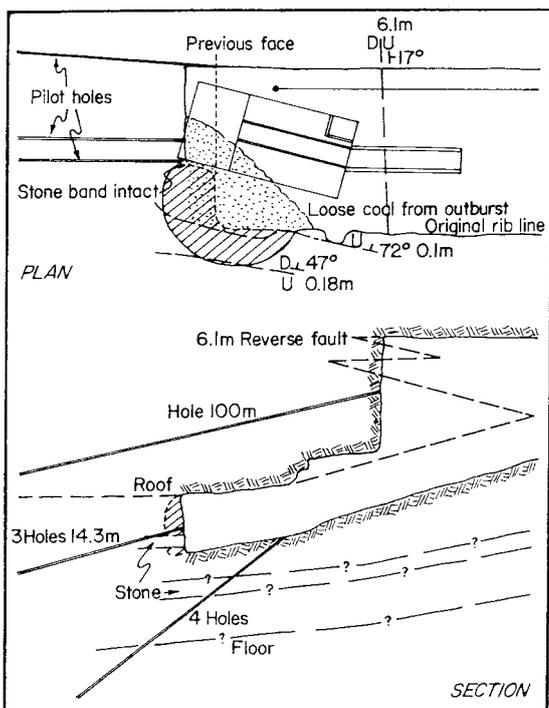
Fig. 13 — Outburst, 23.11.78

This outburst occurred on 53 level during the afternoon shift. The level had penetrated into a six metre reverse down throw fault and had advanced approximately nine metres under the lip. This is the same fault from which the outburst occurred in 53½ level on the 6th September, 1978. See Figures 8 and 13. The previous shift had reported the coal as being very disturbed in the interval 0.8 to 1.3 metres below the roof. The entire face was very "drummy". Difficulty was experienced in drilling the gas emission holes as the drill kept bogging in the soft coal. There was an increase in gas activity at the end of the day shift and the gas emission had been 0.93 cm³/g.

Emission values the previous day had been 0.30 cm³/g and a small cone shaped burst occurred in the left hand rib emitting 230m³ of gas.

Approximately 19 tonnes of outburst coal was recovered.

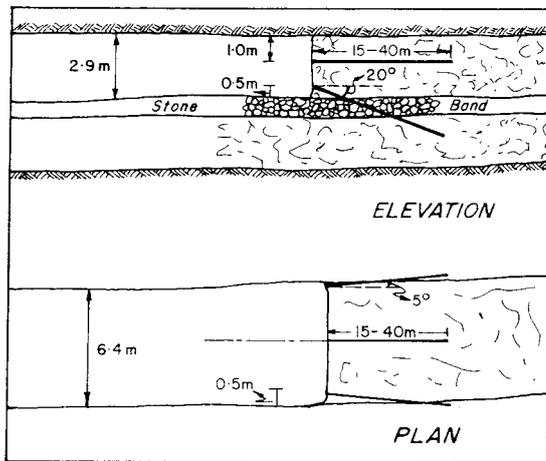
Fig. 17 — Layout of bleeder holes

Three 80mm diameter holes were drilled in advance of the face for a distance of up to 40 metres. One hole was on the bord centre line, with one flank hole either side. The flank holes were angled out at 5° , with all holes being drilled parallel to the roof. Within three days after drilling, it was possible to mine to the extent of the holes before high gas was encountered. See figure 17.

The holes were drilled for two reasons. They allowed gas to drain from the area to be mined, and they gave a warning of any major faulting.

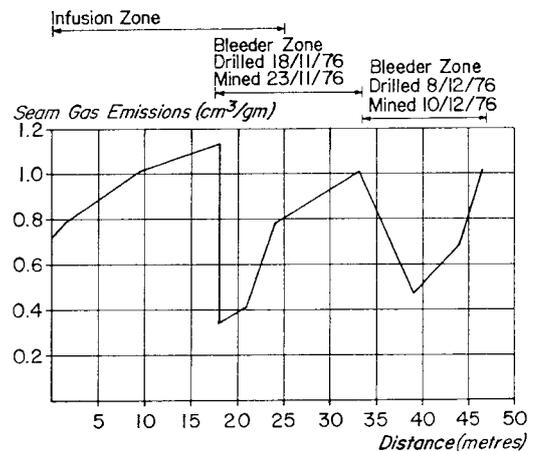
Fig. 18 — Comparison of the effects of infusion and bleeder holes

Tests with bleeder holes were implemented when water infusion was found to be impractical. Comparisons were done between the two methods, and it was found that while infusion allowed mining for an average of only 15 metres, it was possible to mine to the extent of bleeder holes. See figure 18.

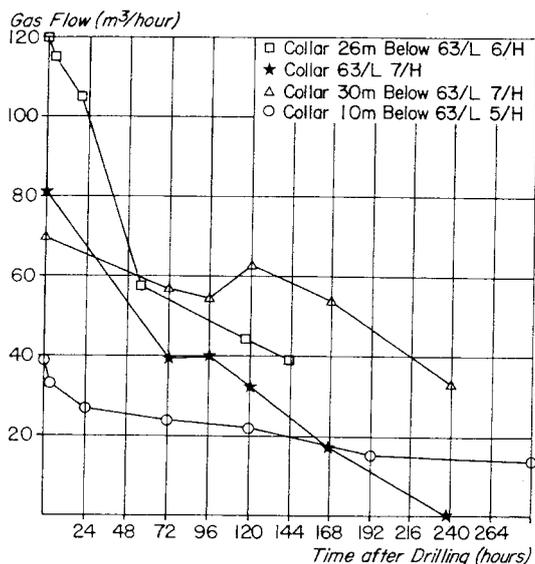
Fig. 19 — Flow from bleeder holes (80mm dia)

The dip roadways were normal to the cleat and were driven first. Because of natural bleed-off along cleat into the dip roads, no holes were required before mining the levels. When holes were drilled in the levels, that is, parallel to the cleat, gas flow was negligible. Holes drilled on the dip roadways showed considerable variation. See figure 19.

Despite the flow variations, it was possible to predict with considerable certainty when a site could be mined. This is illustrated by the curves in Figure 19. Flow rates

decreased steeply for the first 72 hours, after which the curves flattened out. At the point, where the curves levelled, water would begin to flow from the face holes. It was found that once this water flow commenced, it was possible to mine to the extent of the holes before obtaining high gas emission values.

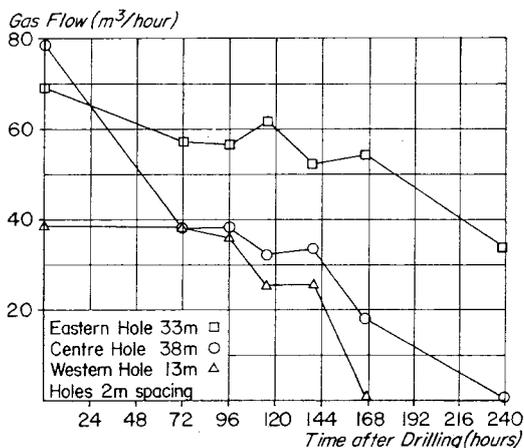
Fig. 20 — Flow from bleeder holes in No. 7 heading below 63 level

As well as the variations in flows on different faces, there was other differences as shown by figure 20 which indicates variations in flows recorded on three holes drilled parallel and in the same horizon on the same face.

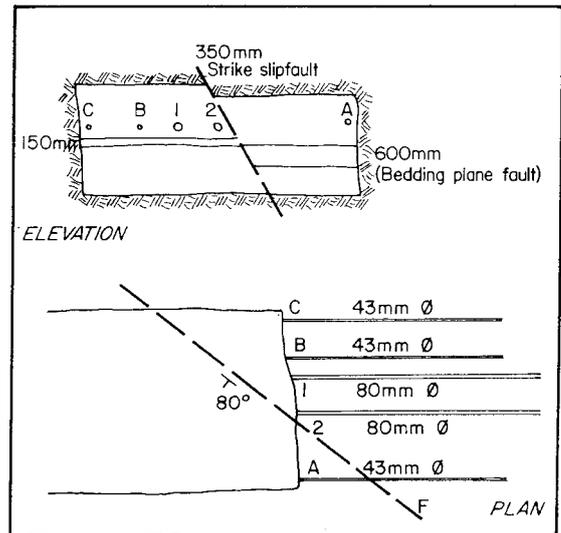
Fig. 21 — Gas drainage site 53 level west

Small scale tests were conducted on gas drainage during 1978 in 53L West Panel where previously bleeder holes and pulsed infusion shotfiring had failed to reduce the emission values. See figure 21. Driveage in this panel is parallel to the main cleat of the seam and consequently presented the most difficult conditions for trials.

In one case following the failure of pulsed infusion shotfiring, gas drainage methods lowered the emission values from $1.08 \text{ cm}^3/\text{g}$ to $0.77 \text{ cm}^3/\text{g}$ inside two hours and mining was able to advance 6 metres before values again rose in excess of $1 \text{ cm}^3/\text{g}$.
