QUEENSLAND GOVERNMENT
DEPARTMENT OF NATURAL RESOURCES, MINES AND ENERGY
RESOURCES SAFETY AND HEALTH

INVESTIGATION REPORT

FATAL ACCIDENT

**FAIRFIELD QUARRY
CLERMONT, QLD.**

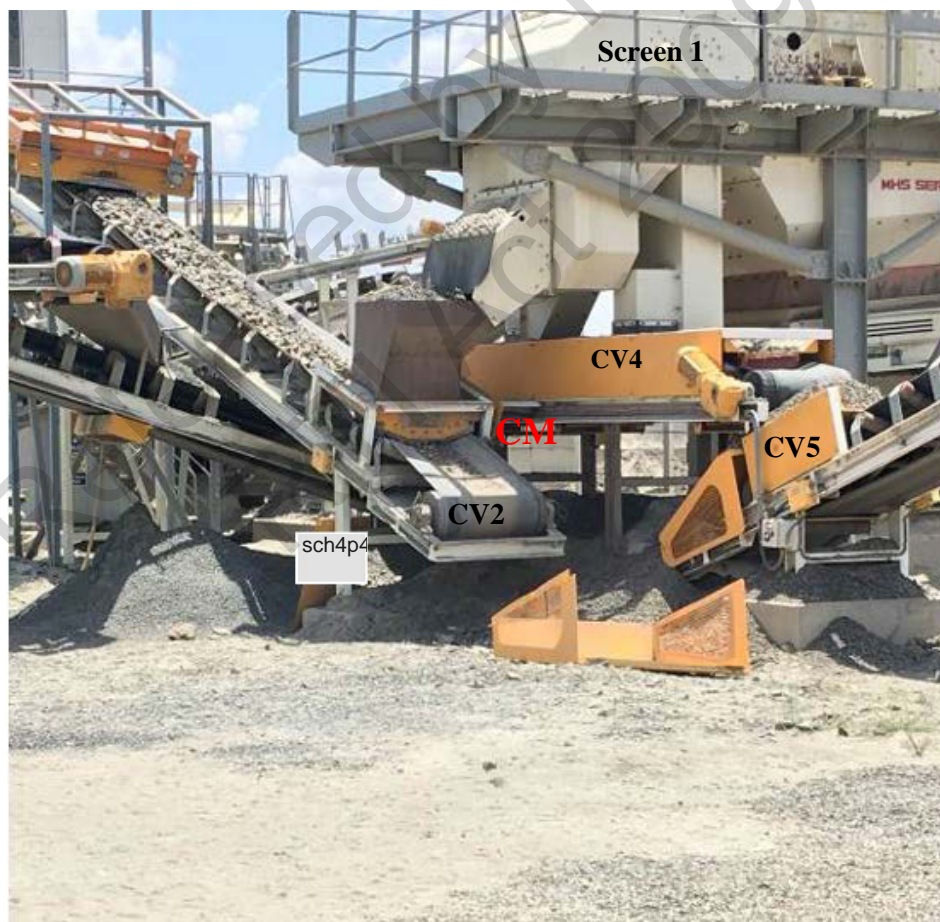
Mr MILNE was adjacent to the tail pulley on the right hand side (RHS) of CV2, between the conveyor and CV4/Screen 1. He was standing on loose aggregate in an area approximately 570 mm in width. sch4p4(6) Personal info was on the left hand side (LHS) of CV2.

IMG_1250: Overview of Accident Site showing CV2 tail pulley area, and location of CV2 tail pulley guard (Photograph has been cropped. Positions of personnel shown by their initials.)

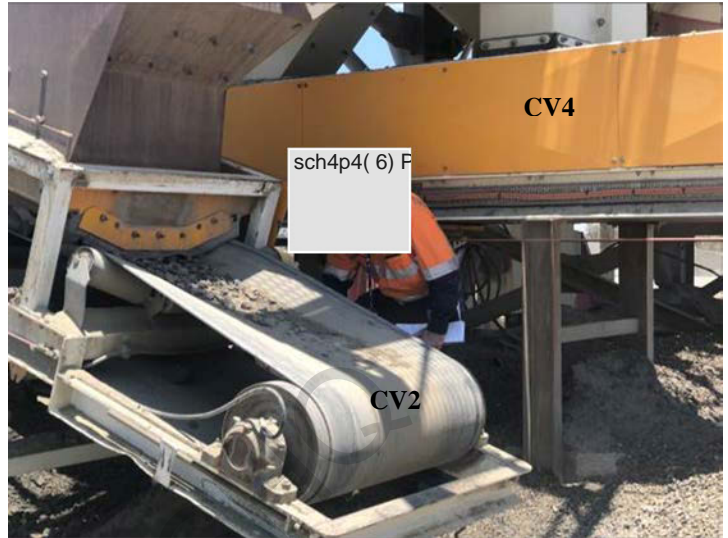
IMG_1287: Re-enactment of approximate position of Mr MILNE between CV4/Screen 1 and CV2 prior to the accident.

There was dry, loose spillage rock around CV2 tail pulley area. The gap between CV2 and CV4/Screen 1 was approximately 570mm.⁵¹ This is where Mr MILNE was standing prior to the accident.

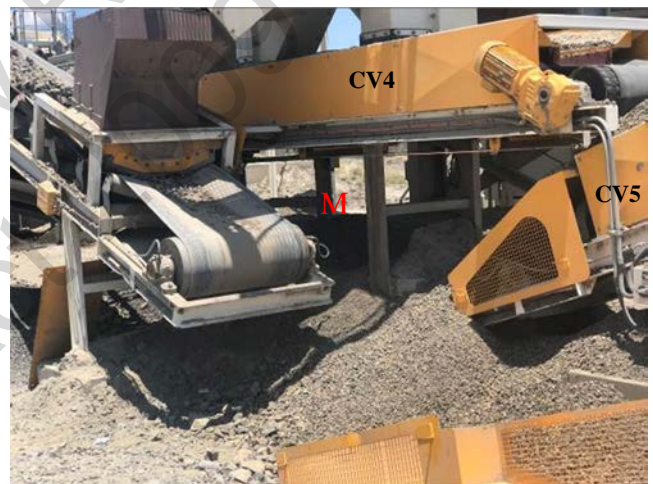
IMG_1269: Tail pulley of CV2. Rear guard is in foreground.

This bolt was not installed in the CV2 rear panel guard and the LHS lug was broken off.⁶⁵

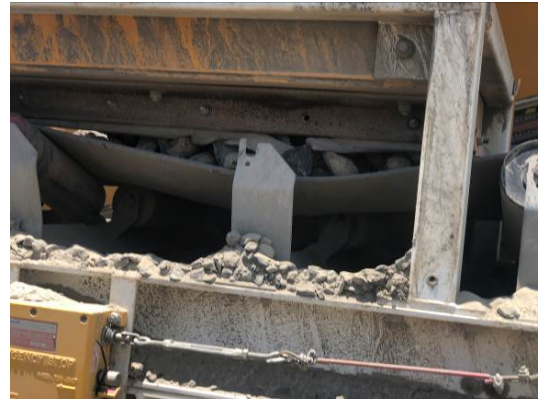
CV2 had an idler missing under the transfer chute, which had caused the belt to skew to the LHS. The skirting on the CV2 transfer chute was worn.⁵³ This missing idler and worn skirting allowed rocks to fall from the conveyor.

Where the conveyor was missing the idler, the outside idler mount was bent and the inside idler mount was missing (underneath the conveyor). There were no clips securing the idlers to the cradle frame.⁵⁴ The idlers under the transfer chute were carrying idlers, not impact idlers.

IMG_1276: Material falling off CV2 at transfer chute. Idler missing and skirting worn.

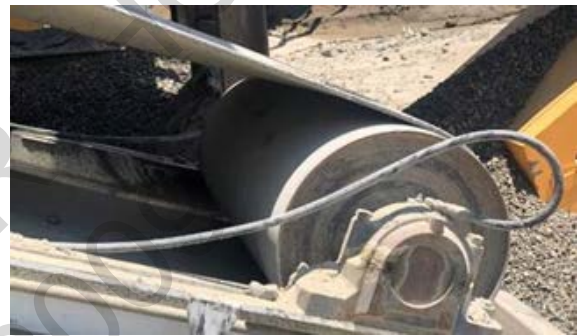
IMG_1270: Tail Pulley of CV2. Gouging visible from belt rubbing against structure. (Photograph cropped)

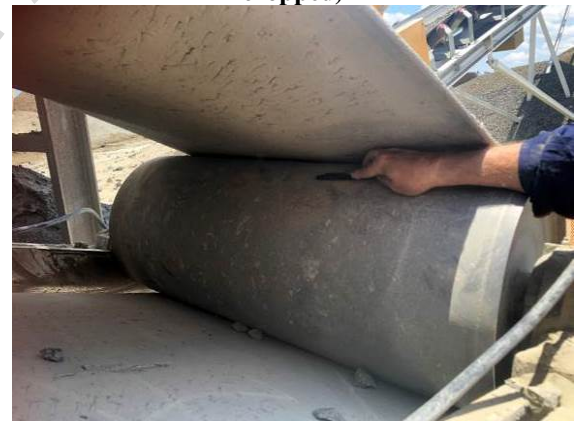
There were rocks on the return side of CV2. The size of one rock was approximately 100 mm in length.⁵⁷ The

IMG_1321: RHS of CV2 Tail pulley looking towards Screen 1. Rocks on belt. Cuts in belt and indentation marks on tail pulley.

Screen 1/CV2 transfer chute was filled with rock. The CV2 belt had cuts in it and the tail pulley had wear/indentation marks.

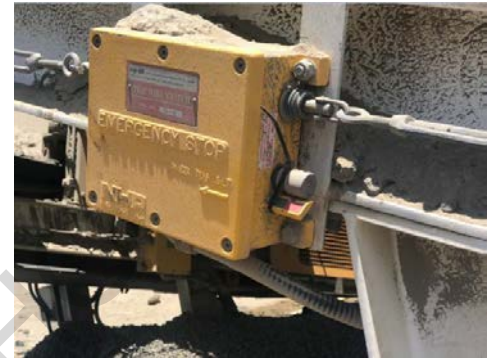
The RHS CV2 pull wire switch operating shaft (Control Room side) was extended in the activated position.⁶¹ This is the pull wire
sch4p4(6) Personal stated he activated to stop the conveyor.⁶²

IMG_1299: Pull Wire Switch on CV2

The CV2 pull wire switch reset buttons on both the LHS and RHS had cable ties on them. During the investigation (post accident 05/12/2018), a cable tie was removed. The pull wire switch reset button went to the active position and the conveyor would not start.⁶³

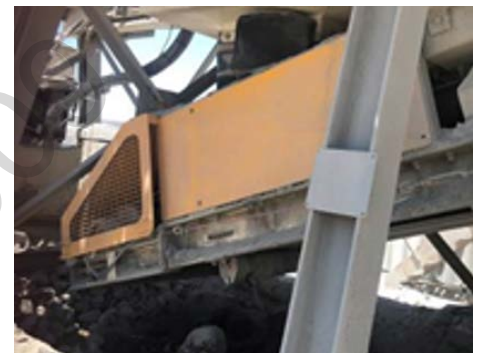
Around the Fixed Plant and Chieftain Screen, in addition to CV2 tail pulley, there were a number of guards not installed at nip

IMG_1212: Side view of CV3 tail pulley guard (photograph cropped)
