# **Investigation report**

**Report into a fatality at Goonyella Riverside Mine on 5 August  
2017**

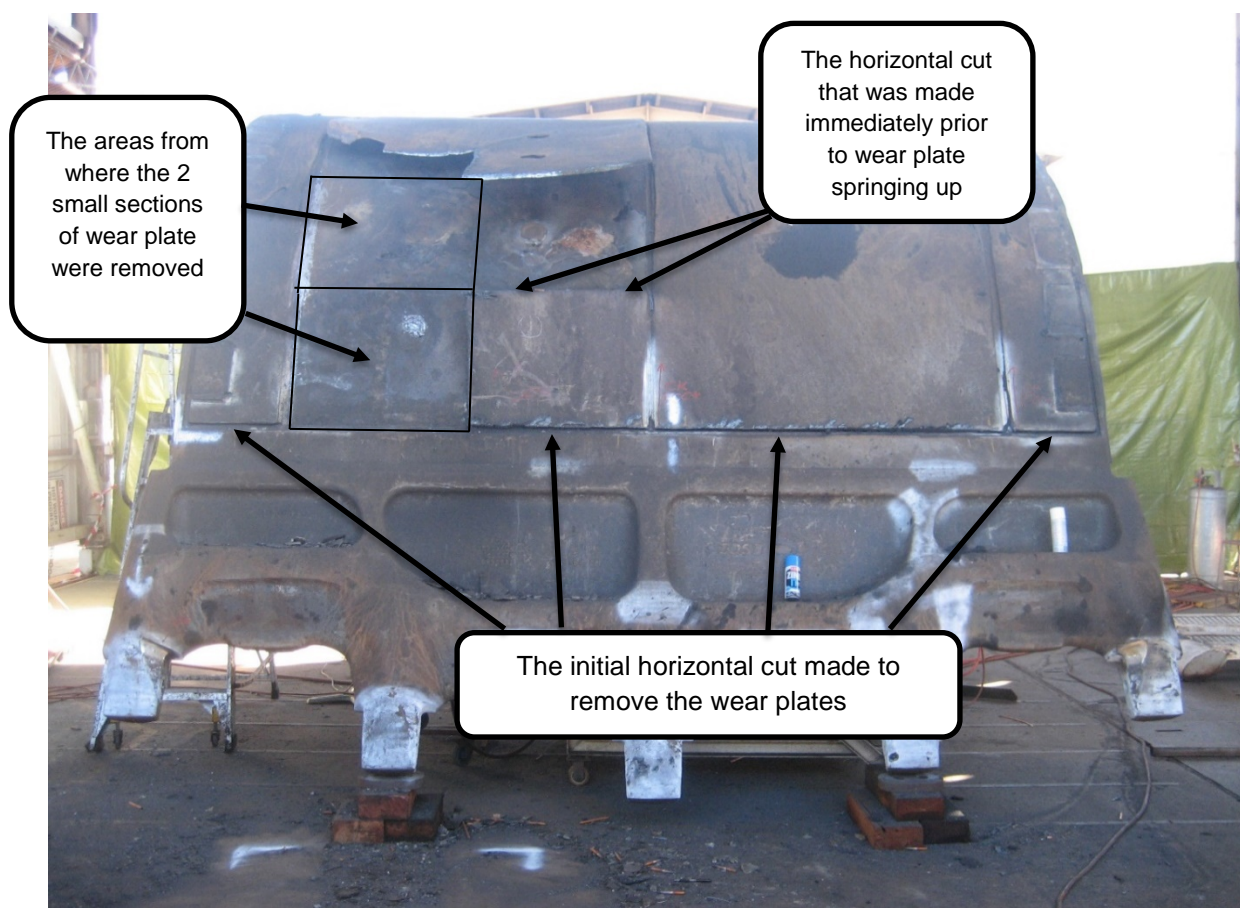
**Figure 5 - Excavator bucket #1 post incident occurring**

Mr Springer then made a horizontal cut across the right hand side of the left wear plate as seen in **Figure 5** below, and this is when the plate has suddenly sprung up.

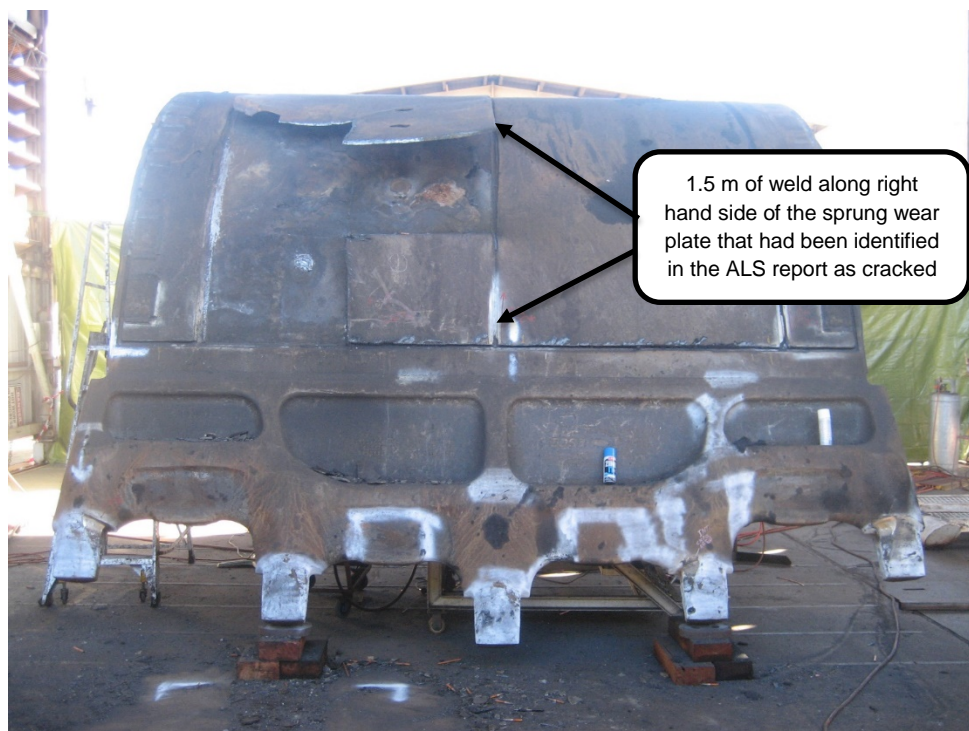
**Figure 8 - Showing the pre-existing cracked weld on bucket #1**

There was no evidence of whether the bucket's ALS condition monitoring report had been considered when determining the method of removing the external floor wear plates. This report had identified that most of the weld along the right hand side of the left wear plate that Mr Springer was removing at the time of the accident (refer to **Figure 8** below) was cracked. If this had been considered prior to the work being undertaken, it may have meant the sequential method of dissecting the large wear plate into the smaller pieces would have been different.

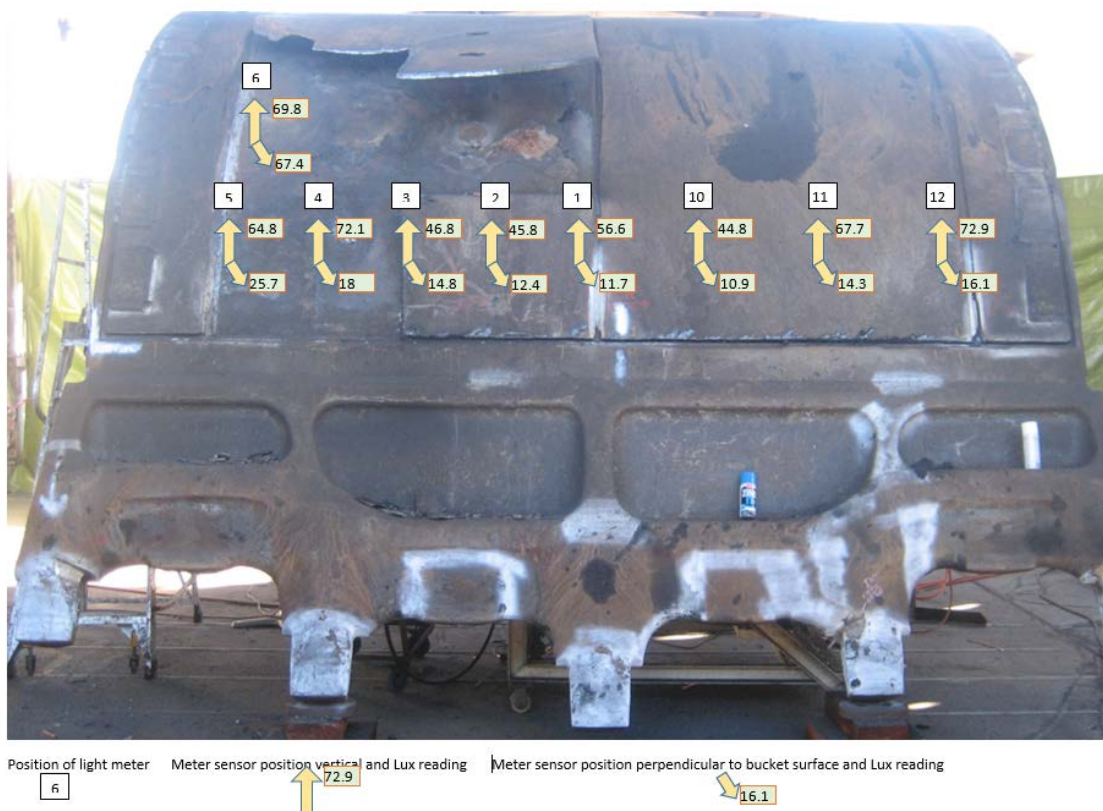
**Figure 9 - Positions and results of the lux / illumination testing**

Illumination testing was conducted as part of the investigation to establish if there were adequate lighting for the maintenance work activities. The results show that the levels of illumination in the area where Mr Springer was working on the night of the incident were between 7% and 46% of the minimal level required by AS/NZS 1680.2.4:2017. This may have contributed to Mr Springer not noticing the pre-existing crack in the weld running along the right hand side of the wear plate that he was removing at the time. It is reasonable to consider that Mr Springer may have thought this weld was intact at the time and holding the wear plate in position.

The level of illumination can be attributed to the fact that the bucket Mr Springer was working on was placed at the very southern end of the workshop as seen in **Figure 2** on page 4. This meant most of the permanently fixed lights in the workshop were to the north of the bucket, and none were shining directly onto the side of the bucket that Mr Springer was working on.

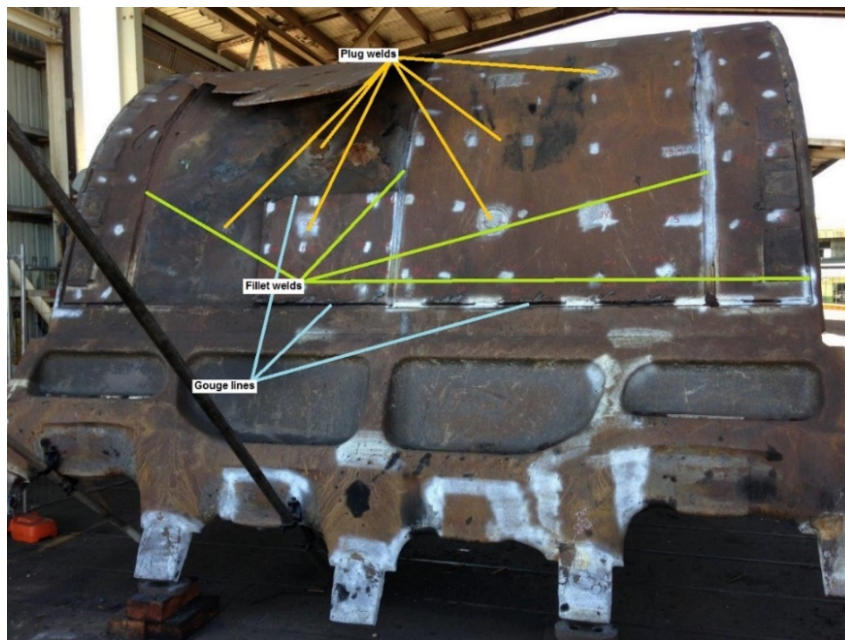
**Figure 11 - Welding and gouging**

- A fillet weld around the outer edges
- 8 x plug welds throughout the central areas (See **Figure 11**)

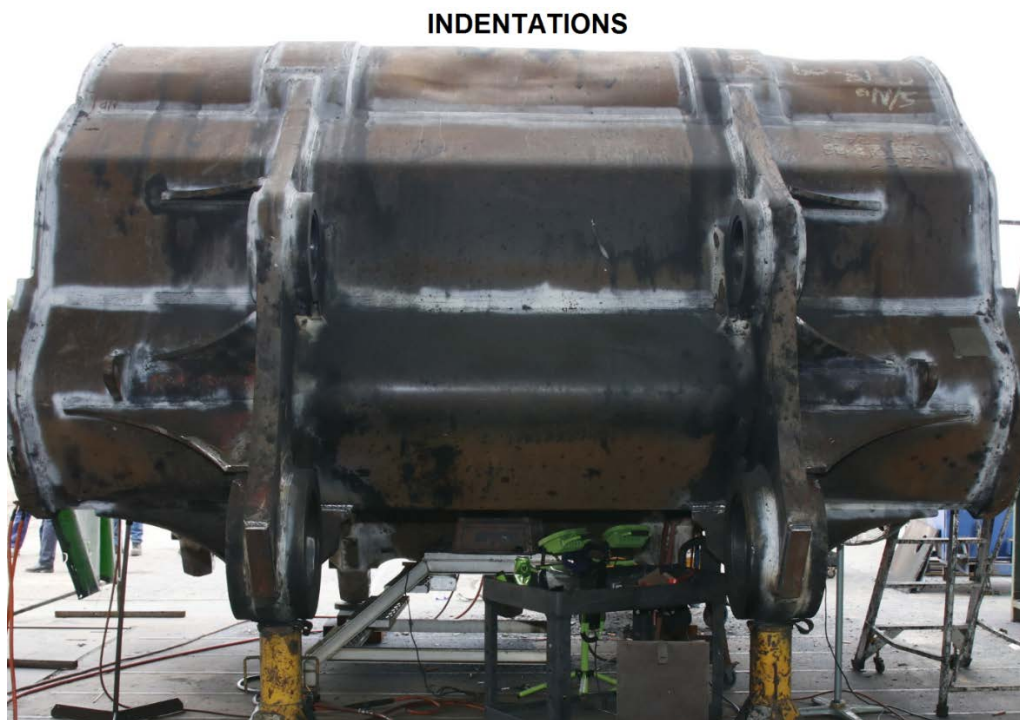
**Figure 12 - Indentation on back wall**

Plate A was indented in at least six areas and was worn unevenly. A wide range of thickness of the wear plate was found from near new to totally worn away. The majority of the plug welds were cracked and were no longer holding the plate to the bucket structure. A large portion of the vertical part of the fillet edge welds were cracked as well. Horizontal welds only showed minor cracking.

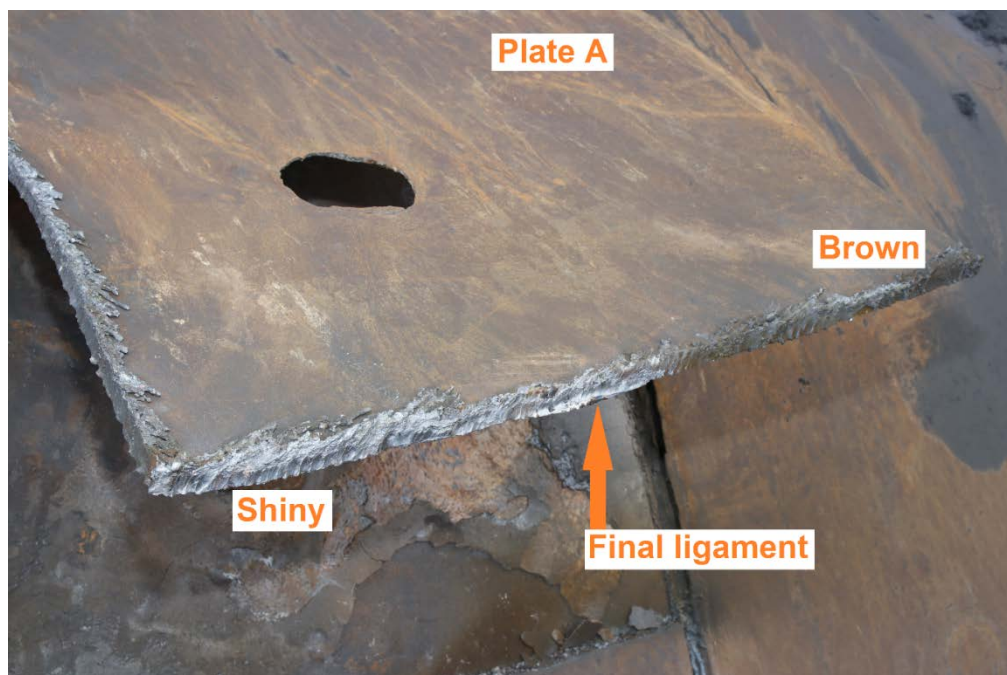
**Figure 14 - Final horizontal gouge line**

Mr Springer was gouging Plate A horizontally, approximately 1.7 m from the top when it rapidly released and he was struck. Approximately one half of this horizontal gouge line had a shiny, freshly gouged appearance (See **Figure 14**). The other half was brownish in colour and appeared to be coated with gouging fumes and debris. Near the convergence of the shiny and brown areas is a small ligament that hadn't been gouged, but appears to have failed in shear. It is postulated that this ligament was the last to fail before the plate was released.

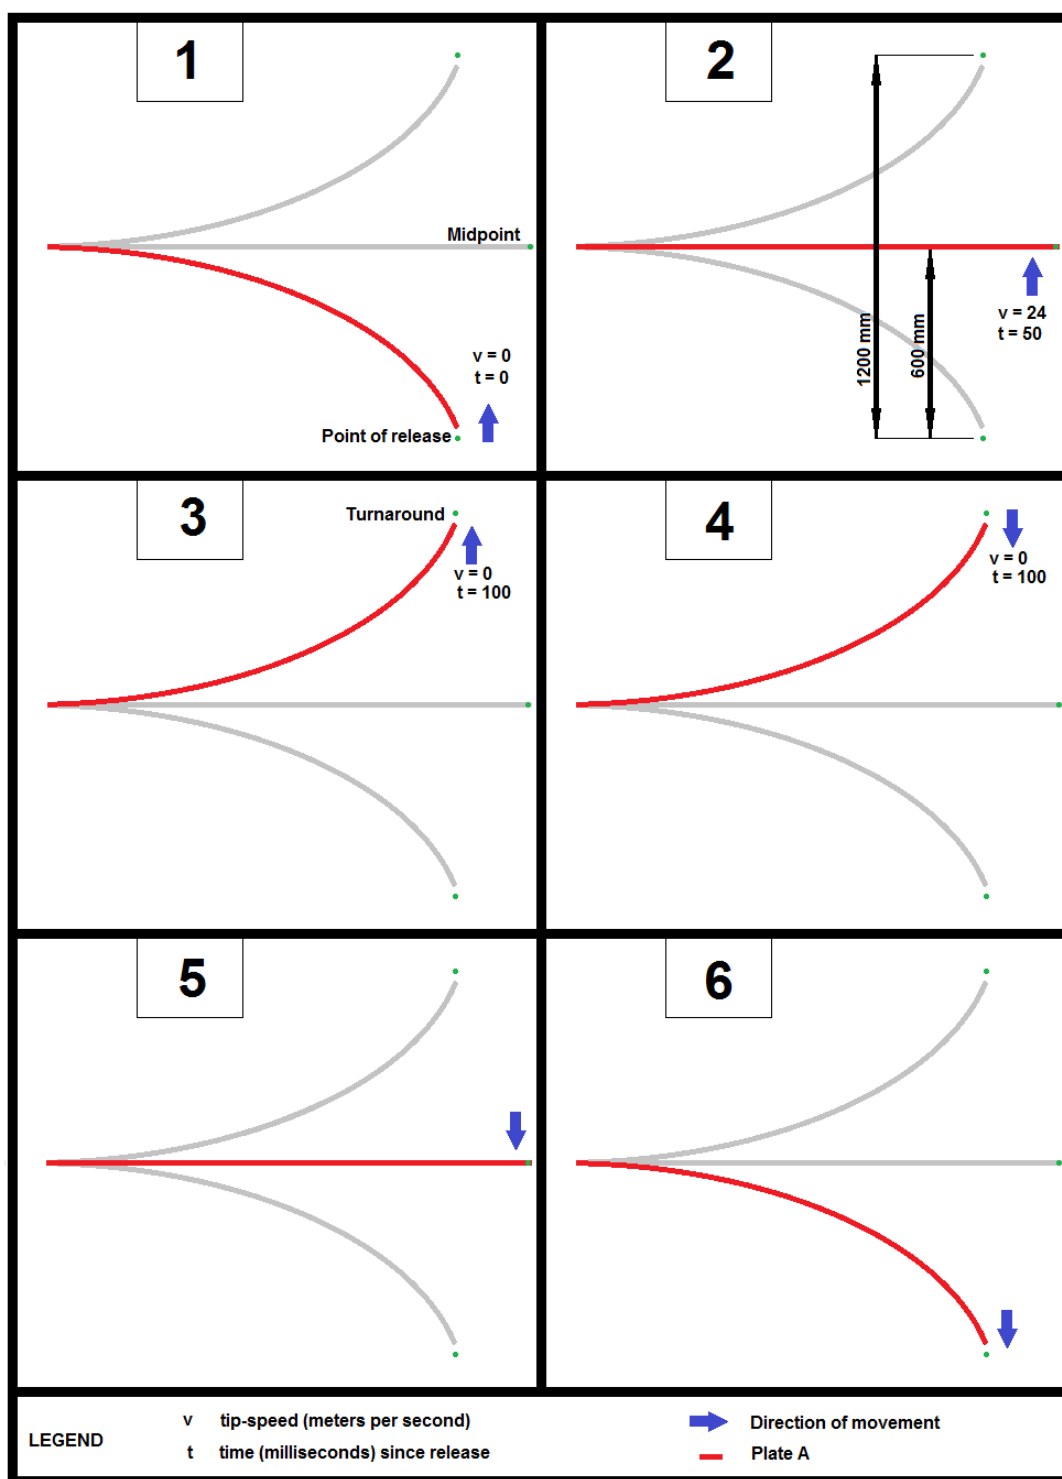
**Figure 15 - Plate Movement**

The distance is much higher than the expected distance predicted during the risk assessment.

During the first cycle, the tip moved from the point of release to the midpoint in approximately 50 milliseconds. The average human reaction time to a visual stimulus is approximately five times that at 230 – 250 milliseconds. This indicates that it would have been impossible for a person to move out of the way once the plate sprung back.
