**Department of Mineral Resources  
New South Wales**

**EXPLOSION AT ENDEAVOUR COLLIERY  
28 JUNE 1995  
SUMMARY OF INVESTIGATION**

MDG No. 1007

MAY, 1996

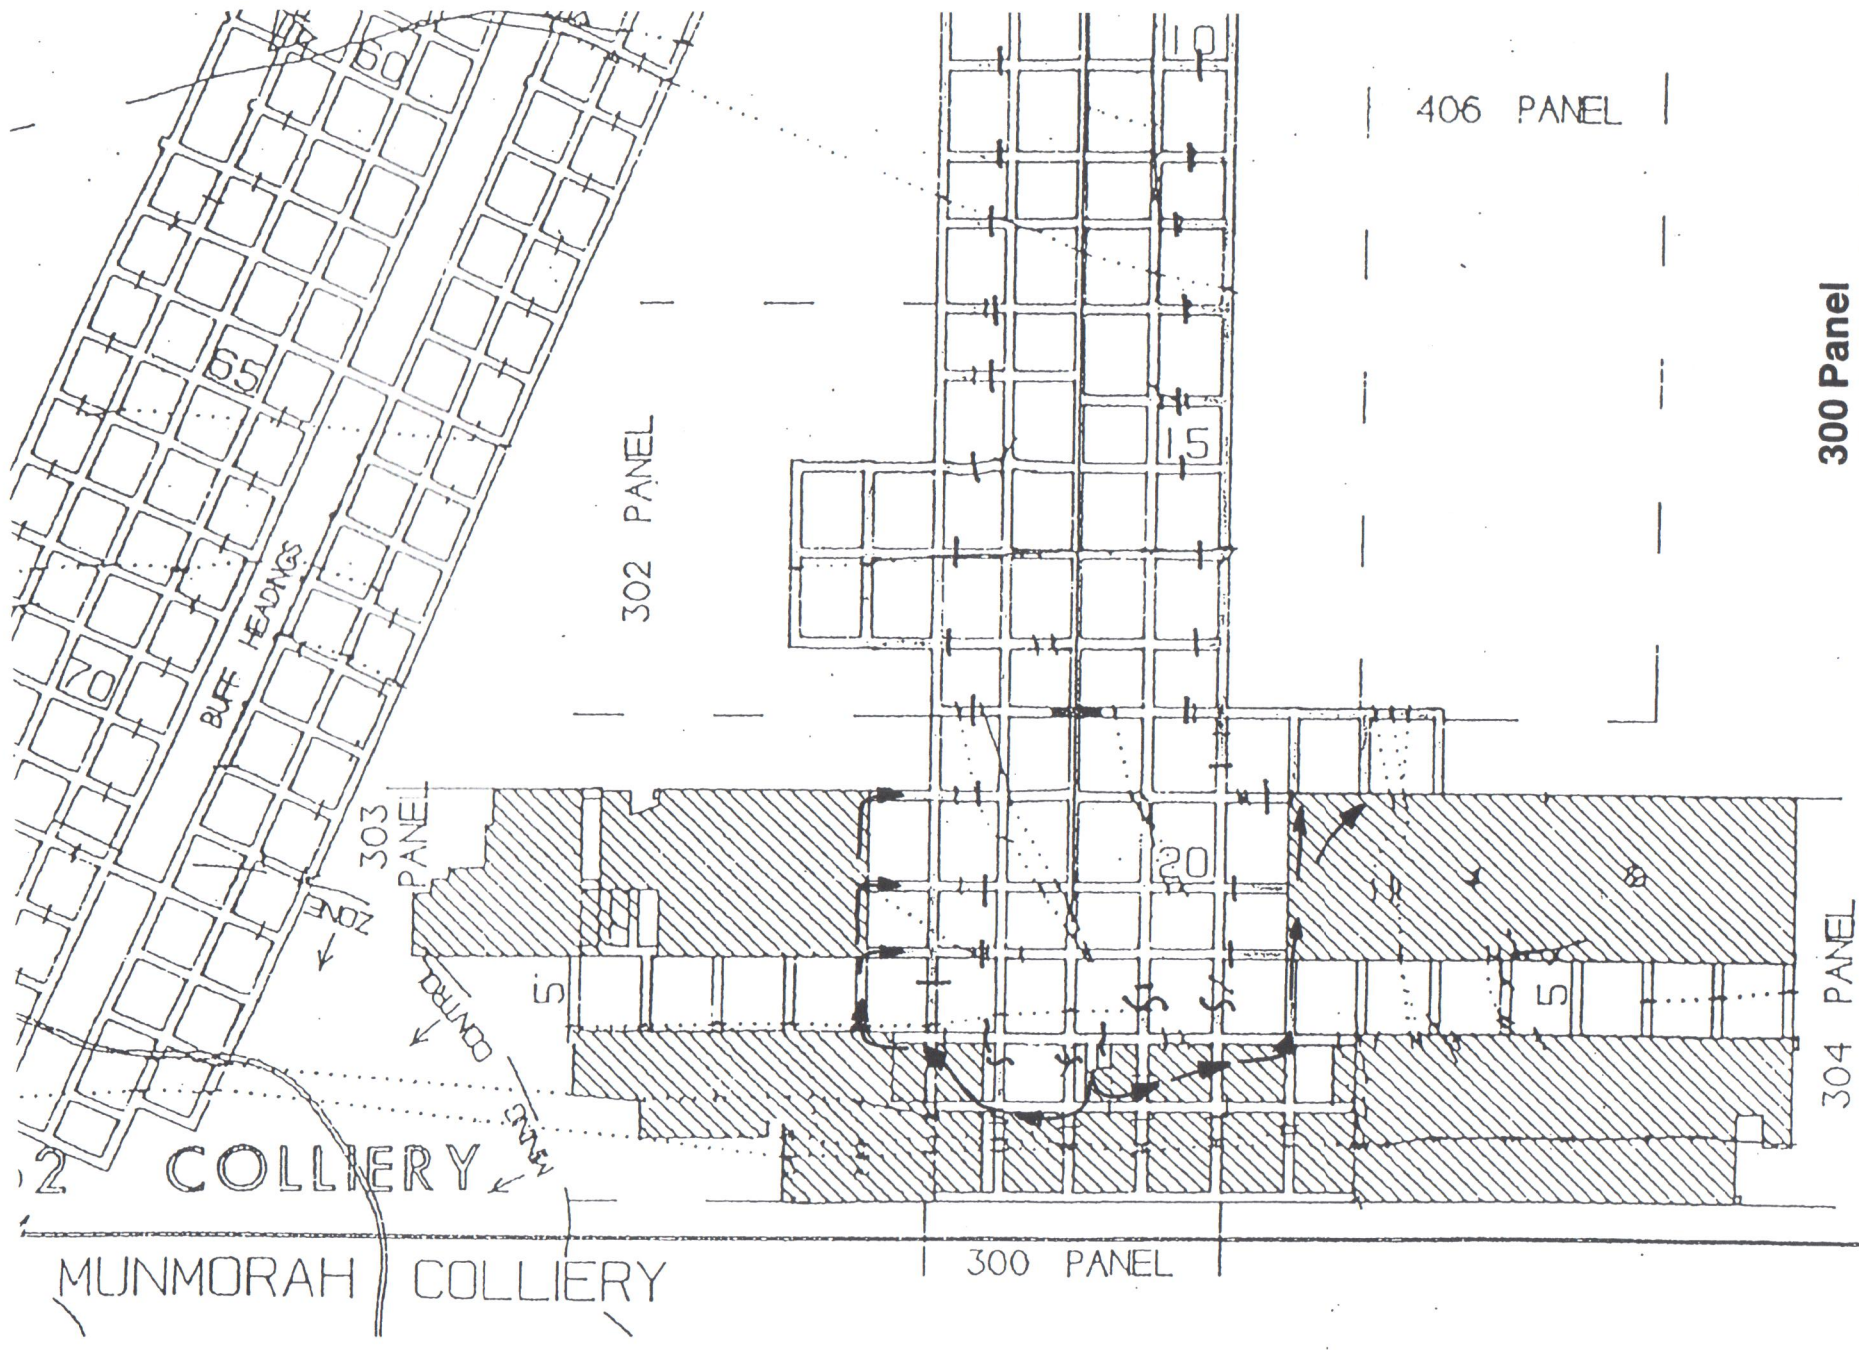
**300 Panel**  
**Likely Ventilation Path**  
**Prior to Explosion**

On the day of the incident the airflow path considered mostly likely was as shown in one of the attached plans. Once ventilating air had passed over the continuous miner into the goaf, pressure differentials caused the air to split and flow to both returns. With this particular type of layout, that is two flanking returns, an area of pressure equalisation exists in the goaf. At this point (the neutral point) pressure differentials between the two return paths are zero and ventilation ceases. The location of the neutral point may be altered by manipulating pressure differentials but it cannot be eliminated. Methane, if present, would tend to accumulate at the neutral point.
