# Gleision Mine Incident

15 September 2011

A factual report by the Health and Safety Executive

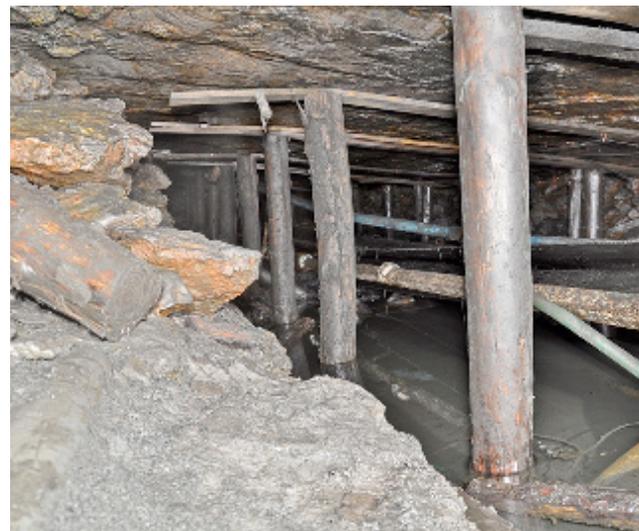
**Figure 3** The entrance to the H1 roadway from the Main Drift, taken after the inrush; some water and silt can be seen beneath the conveyor towards the bottom right

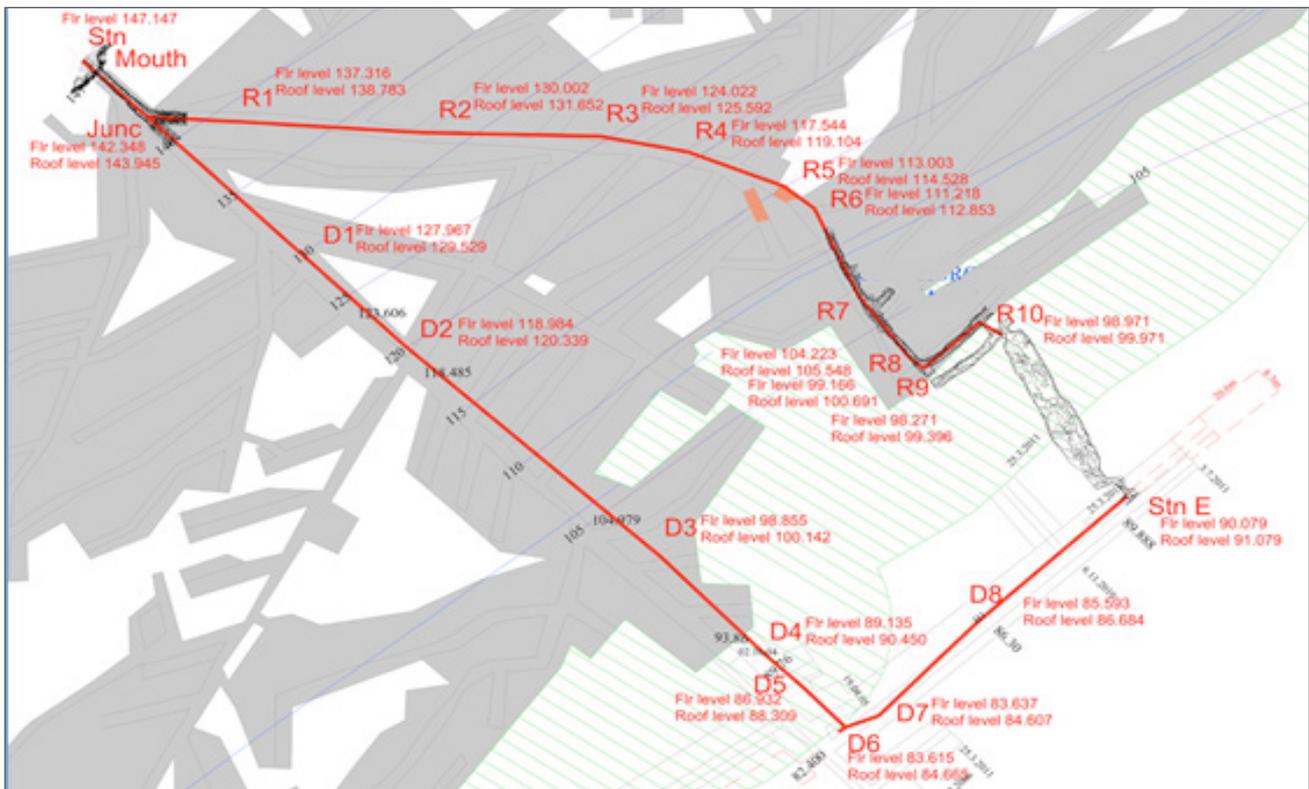
74 The survey also showed, however, that the limit of extraction at the bottom of an area of coal mined in the 1980s, which held the water that subsequently flowed through the inrush stall, was about 7 m further downhill towards the inrush stall than shown on the mine plan. This probably resulted from incomplete or inaccurate measures of the limits of the excavations being passed

**Figure 7** The route resurveyed showing that the mine plan was generally accurate. R10 and Stn E are the top and bottom of the inrush stall, which appears semi-shaded as it was derived from the laser scan. The bottom edge of the semi-shaded area between R9 and R10 is the actual limit of excavation of coal from the Old Central Workings in the 1980s; it is 7 m further south-east than shown on the mine plan

onto the mine surveyor by the mine manager(s) in the 1980s. However, given the intention was to drive into these old mine workings, this difference is not significant, as explained in paragraph 163.

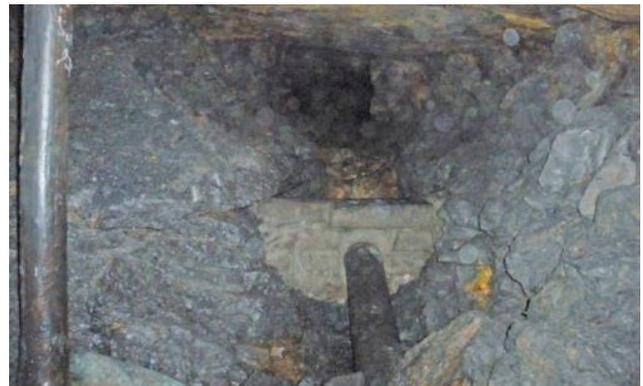
**Figure 9** The dam and black pipe at the Lower Monks on the Main Drift

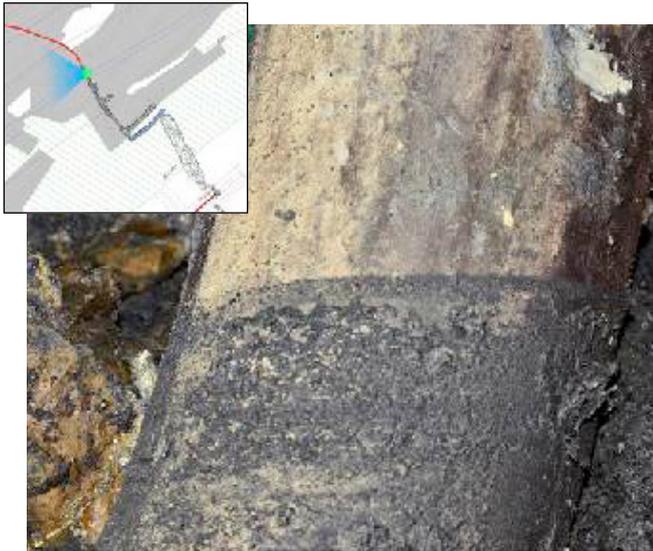
**Figure 10** Tide mark on wooden prop in the Top Road approximately 214 m from the mine entrance. The level of the mark is at 109 m above sea level

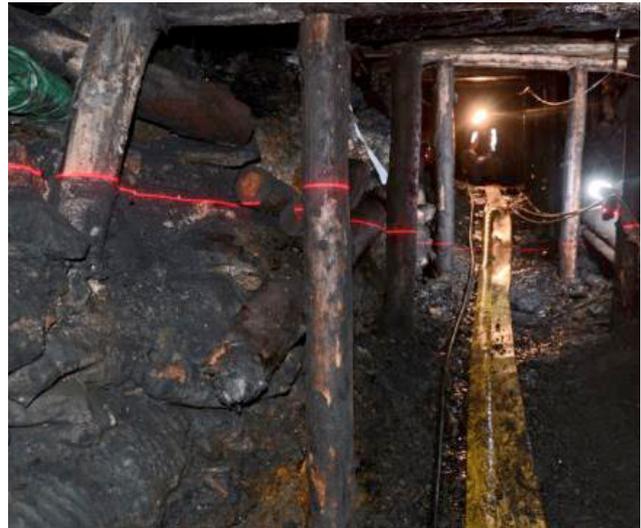
**Figure 11** A laser level picks out the tide marks in the Top Road within the Old Central Workings

101 At around 215 m conditions changed very noticeably. The roof was dripping wet and all exposed surfaces were stained black and covered in mud and slimy silt. There were clear tide marks on the wooden props and mineralisation lines on the roadside packs – see Figure 10 (the insets illustrate the position from which the picture was taken). This all pointed to an indication of the water level in the Old Central Workings before the inrush. It was also the highest level that the water could have reached as this was the level of the overflow to the black pipe at the Lower Monks level in the Main Drift mentioned in paragraph 84. While tide marks are a clear indication of the high water level they are not necessarily an indication that water was at that level all the time.

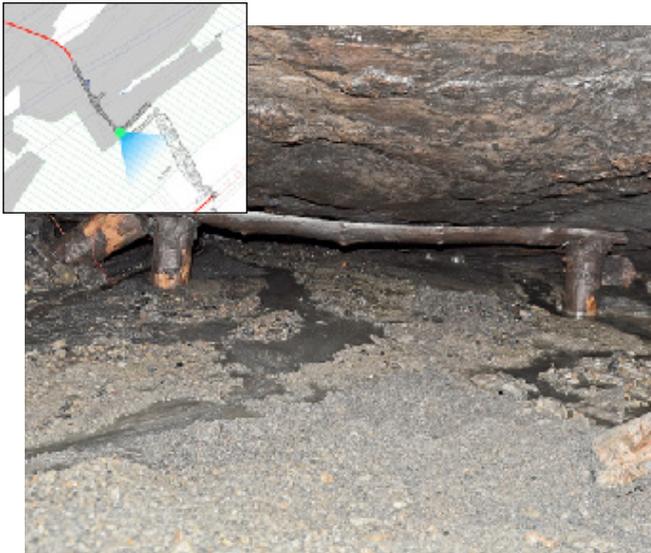
**Figure 12** Silt and debris at the bottom of the Top Road

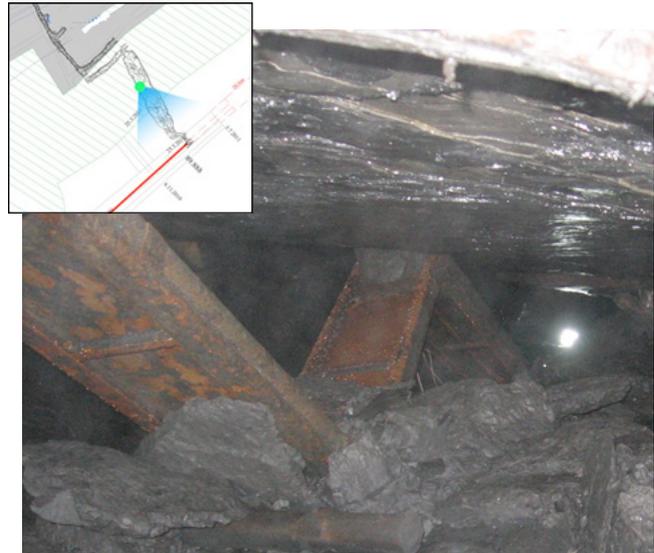
**Figure 13** In the inrush stall looking down towards the bottom

rescuers during the search and rescue attempt. This gave investigators their first proper view inside, and they saw that the inrush stall had been mostly destroyed by the force of the water rushing through it. Most of the wooden roof supports, loose coal, rocks from the stone pack, and equipment that had been in the stall, had been washed down the right hand side of the stall. It had accumulated at the bottom of the stall and filled it for several metres floor to roof along with a tangle of assorted debris.

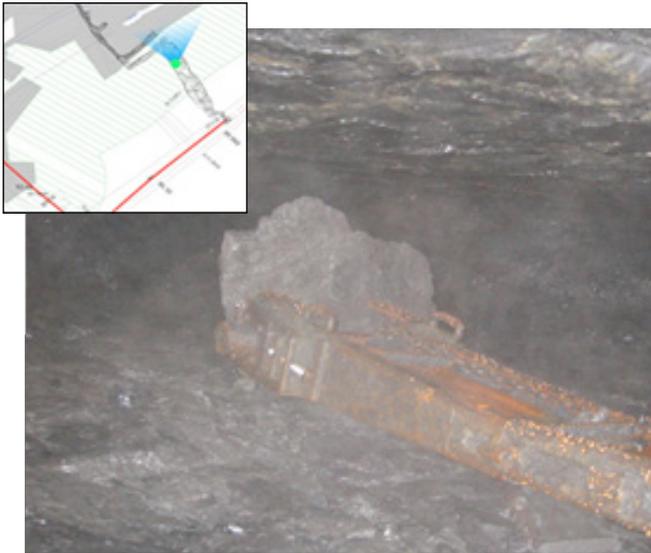
**Figure 14** The top end of the armoured face conveyor that had been driven back about 4 m by the force of the water

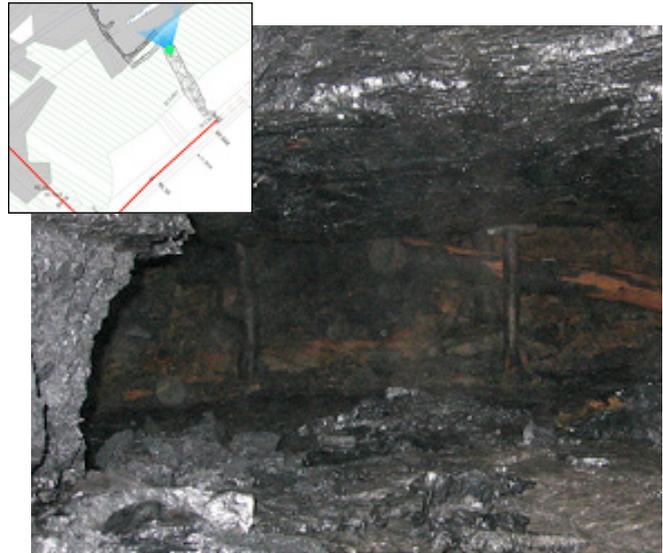
112 Continuing up the left-hand side of the stall, the investigators reached the coal face and saw for the first time the breach in the coal pillar that had been in place between the stall and the Old Central Workings. The coal seam height was between 700 mm and 800 mm. The thickness of the remaining coal pillar when breached was about 2 m and the width of the breach was 2.5 m at the narrowest point and 3.0 m at the widest.

**Figure 15** The breach at the top of the inrush stall into the Old Central Workings. The props set and the stone packs built when coal was extracted from there in the 1980s can just be seen through the breach

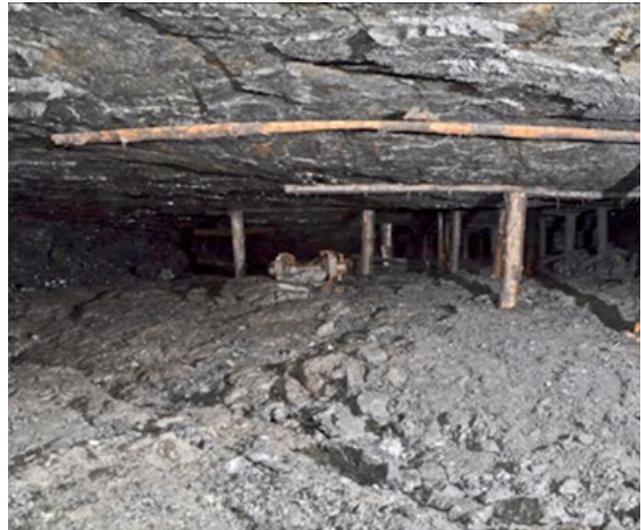
**Figure 17** View into the inrush stall from the position of the breach

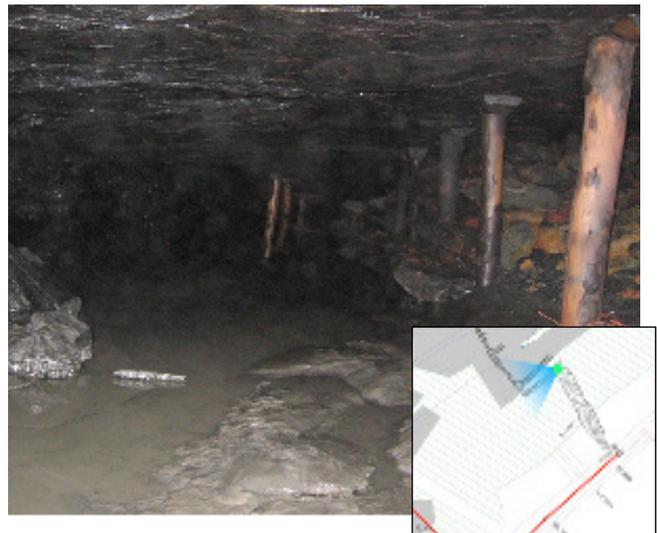
**Figure 18** Looking from the breach along the bottom edge of the Old Central Workings back towards the bottom of the Top Road. Wooden props and stone packs are intact. Only some of the silt seems to have been washed away within a few metres of the breach

indicating a relatively slow rate of flow towards the breach.
