MINE SAFETY INVESTIGATION UNIT

INFORMATION RELEASE

Fatality

Date	Incident occurred on 30 November 2013
Event	Collision between haul truck and light vehicle
Location	Ravensthorpe Open Cut Mine, Ravensthorpe, NSW

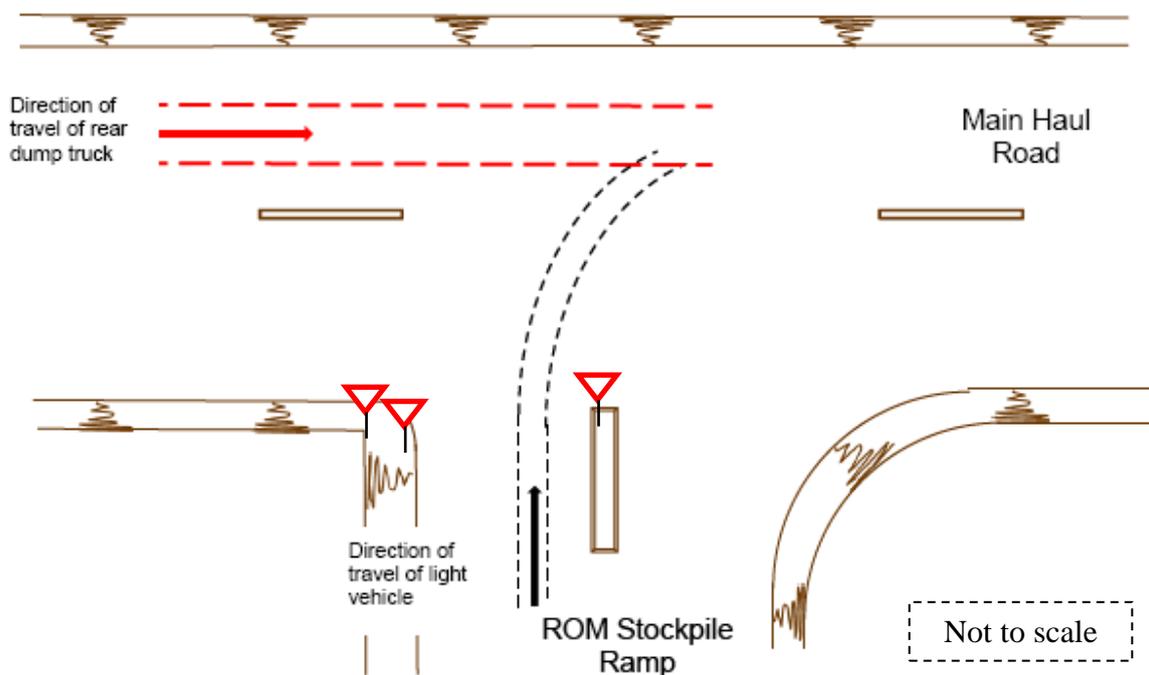
Illustration of intersection – does not depict actual scene *Sketch by Investigation Unit*

The stockpile ramp entered at right-angles to the main haul road. The stockpile ramp had a short dividing centre windrow at the intersection.

'Give Way' signs were posted in the centre windrow and the windrow on the left side of the ramp at the intersection.

The cross-point on the centre of the haul road was marked by a gap between two small windrows in each direction with two white marker posts and 'Keep Left' signs in each windrow.
