MINE SAFETY INVESTIGATION UNIT

INFORMATION RELEASE

Double fatality

| Event | Major rib burst in an underground coal mine |

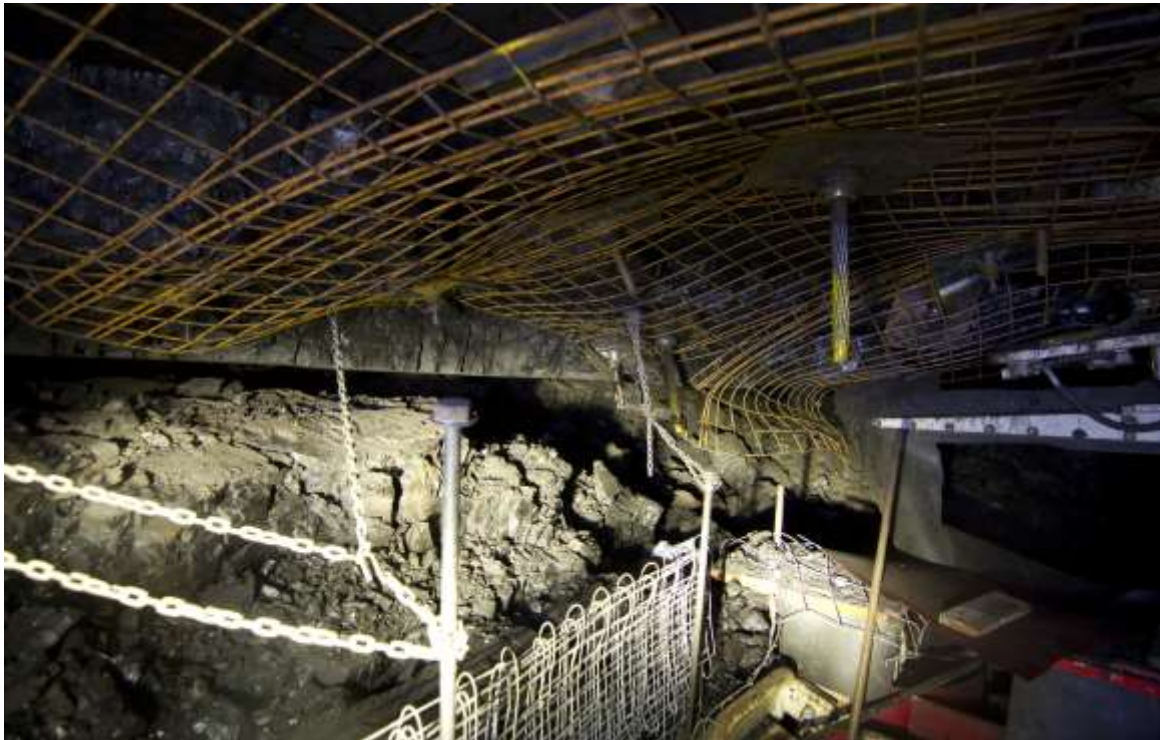
Rib on the left of the bolter miner after the workers were recovered. - Photograph by Investigation Unit

Two of the workers were on the left hand side of the bolter miner when a major burst of coal from the rib occurred. During this event a large section of the left rib that was supported with various lengths of bolts and mesh lost confinement and moved sideways into the roadway where the two men were working. Rib material engulfed both men who died at the scene.

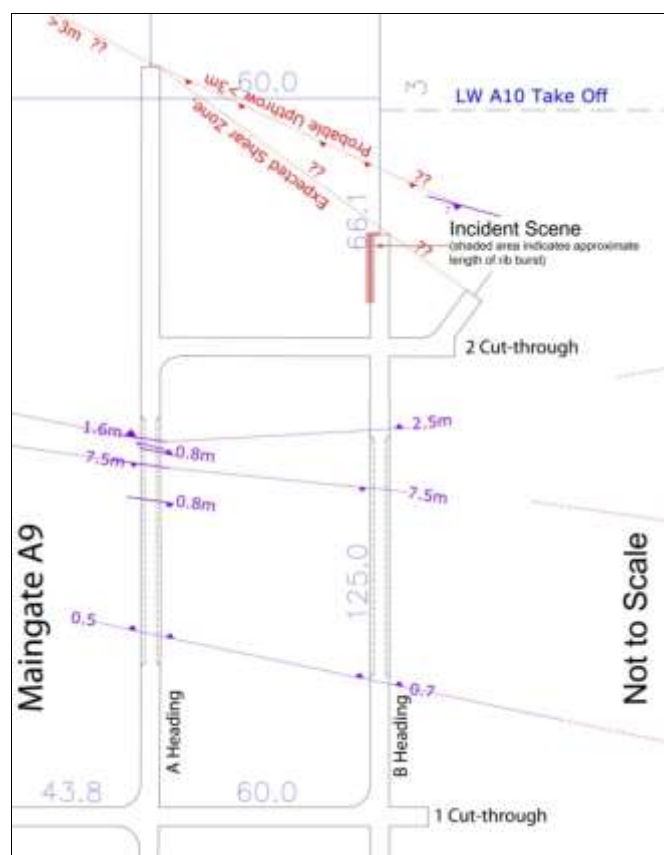
Plan of the incident site supplied by the mine.

The incident occurred at 9.05 pm on 15 April 2014. The incident site was in maingate A9, B heading about 25 metres inbye from the second cut-through. It was about 10 kilometres from the mine entrance and 555 metres below the surface. At this depth the rib and roof strata of the coal seam is subject to significant stress.

This particular heading is in a geologically disturbed zone near an upthrow fault and shear zone. The workers were mining toward the upthrow fault when the incident happened.

Steel mesh and bolts supported the roof and ribs at the incident site. A combination of steel mesh and chemically anchored roof bolts and cable bolts supported the roof. A combination of steel mesh, chemically and mechanically anchored bolting systems supported the rib. The extent and nature of the bolting is yet to be confirmed.
