Investigation report

Report into the deaths of James Mitchell and
Phillip Grant at the Austar Coal Mine,
Paxton, NSW on 15 April 2014

Report prepared by the NSW Mine Safety
Investigation Unit

October 2015

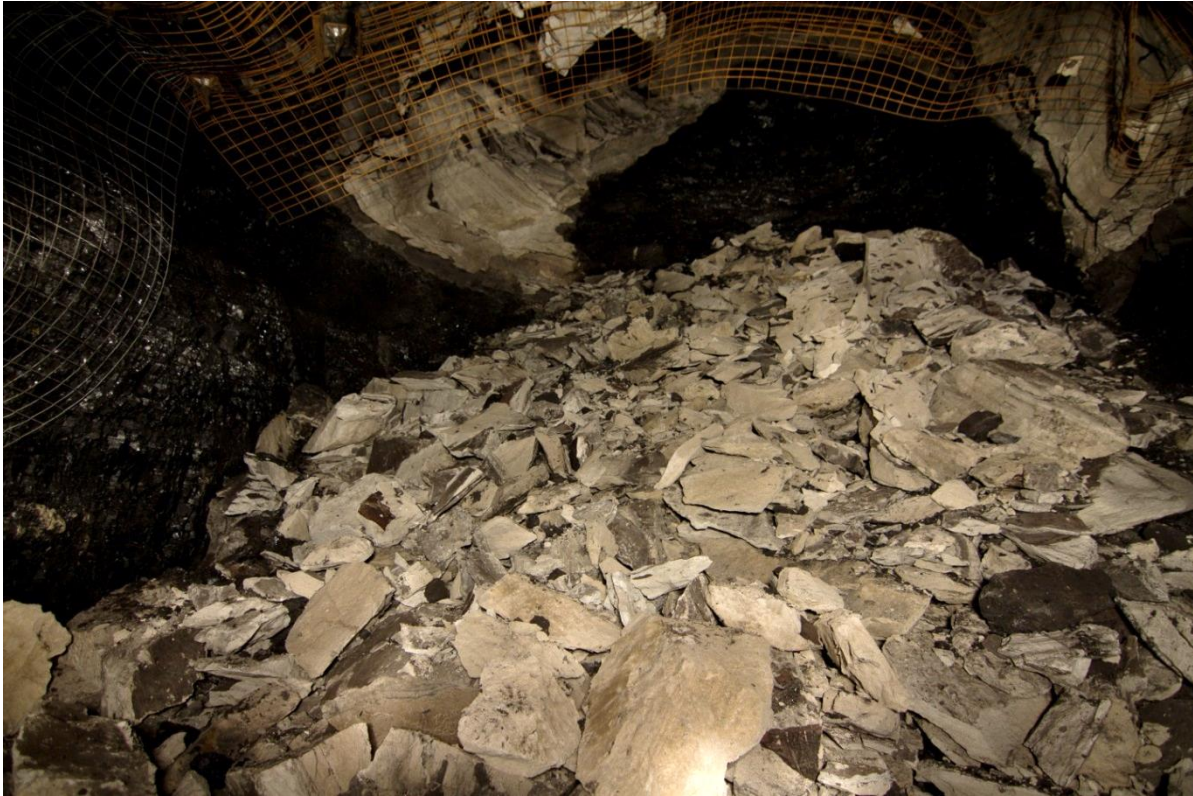
Figure 6 Heading A face, intersection with the unanticipated fault.

As a result of the fault struck in Heading A, the decision was taken to change the design and sequence of the panel layout so that the fault's characteristics could be proved. The decision was taken to drive 15 metres from Heading B down 2 cut-through toward MG A10 and then breakaway at an angle of 45 degrees to the left. This is shown in the Authority to Mine (ATM) in Figures 7 and 8.

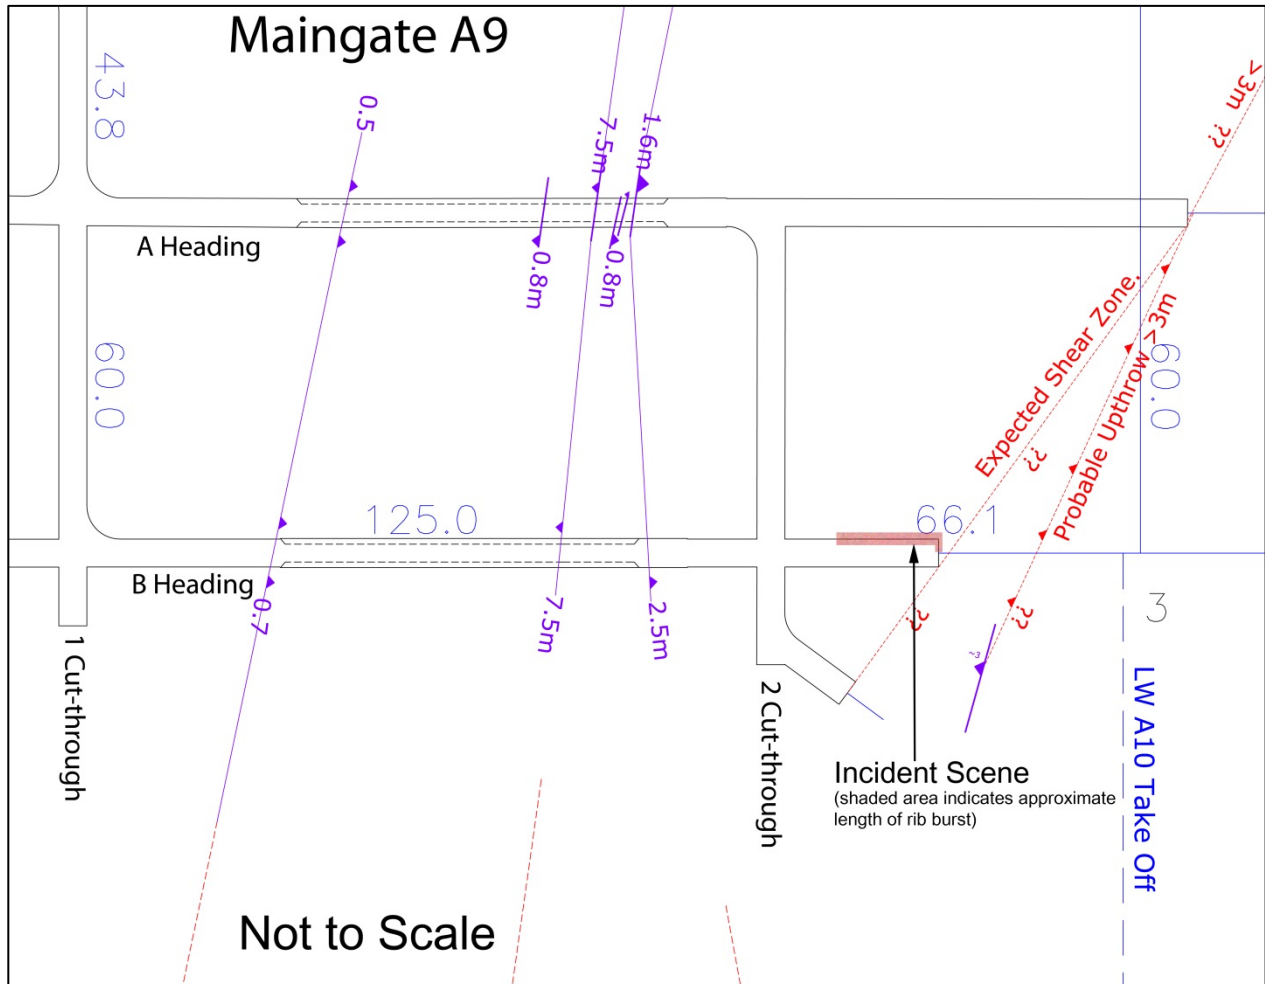
Figure 10 Plan showing layout and some geological features of MG A9.⁴⁷

Figure 10 shows the incident scene in MG A9. It also depicts the faulting between 1 cut through and 2 cut through and the anticipated location of the fault struck in Heading A inbye of 2 cut through.

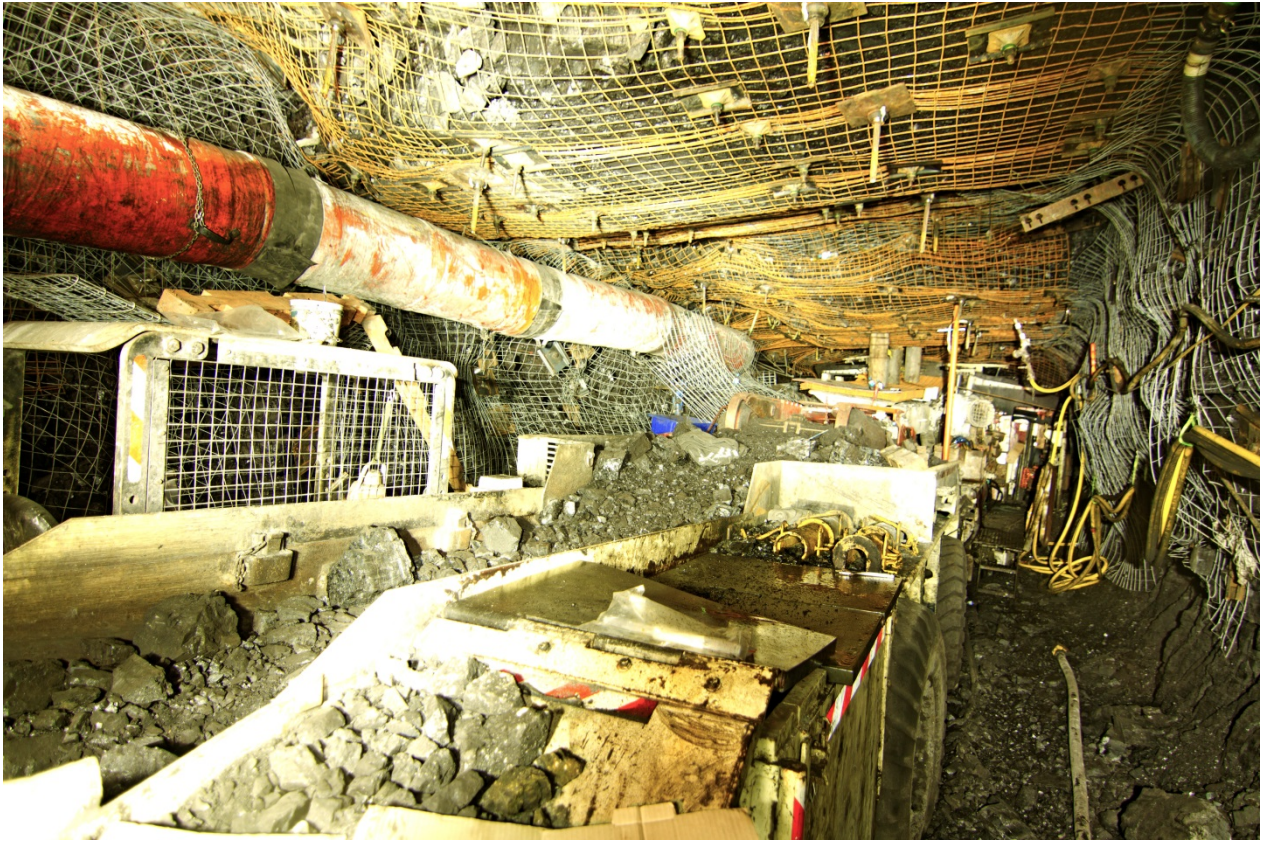
Pictured in Figures 11, 12 and 13 is the incident scene from various perspectives. Figure 11 gives an overview from behind the shuttle car. Figure 12 was taken from the same side as Mr Mitchell and Mr Grant were on, after their bodies and the material that was covering the bodies was removed. Figure 13 shows the incident scene from the other side of the miner and gives a good view of the marker band in the Greta seam known as the 'dosco band' which according to Professors Galvin and Hebblewhite presented a smooth and dominant shear surface and appears to have acted as a shear failure plane.⁴⁸

Figure 11 The incident scene showing the location of the shuttle car and continuous miner CM 35 before recovery of Mr Grant and Mr Mitchell. Note severe rib deformation on the left-hand side of the rib.

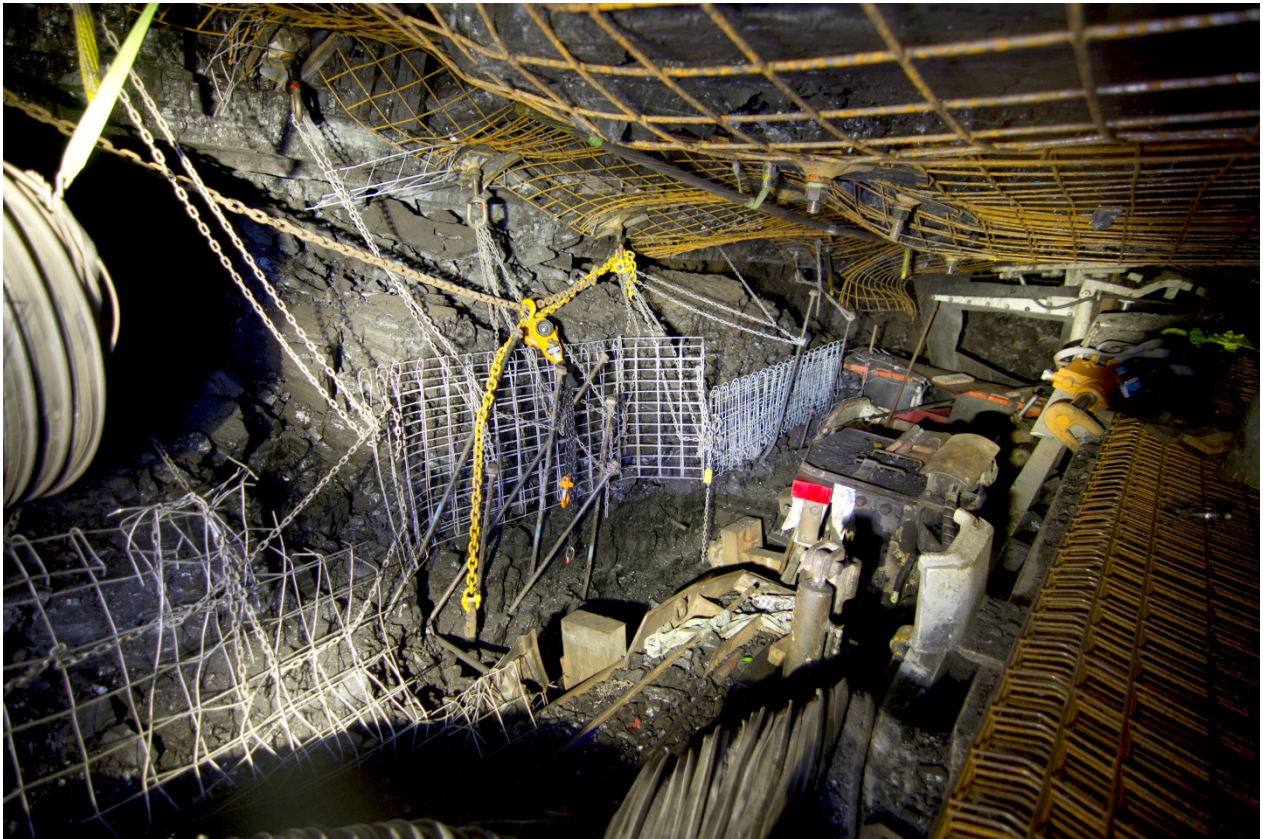
Figure 12 Incident scene showing the left-hand rib after the recovery of Mr Grant and Mr Mitchell.

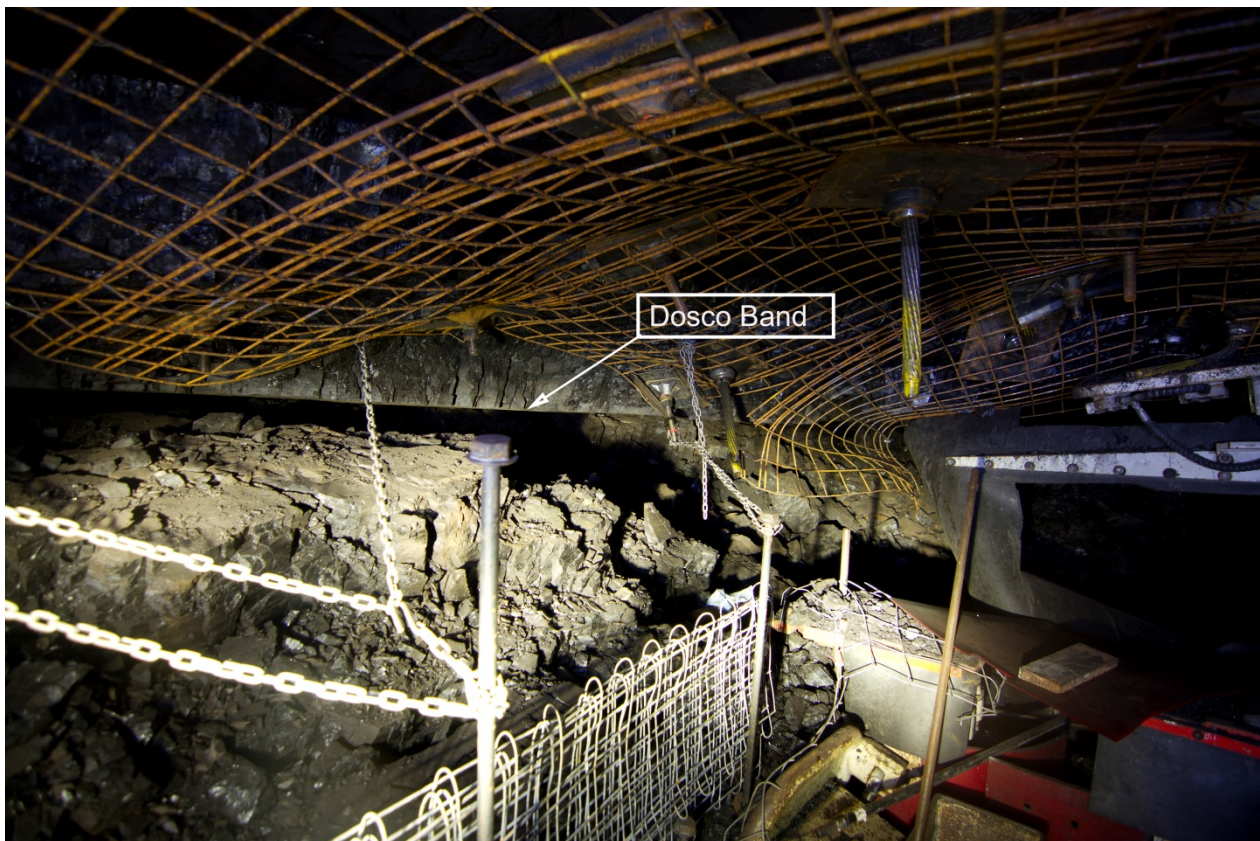
Figure 13 Incident scene showing the left-hand side of continuous miner after recovery of Mr Grant and Mr Mitchell.

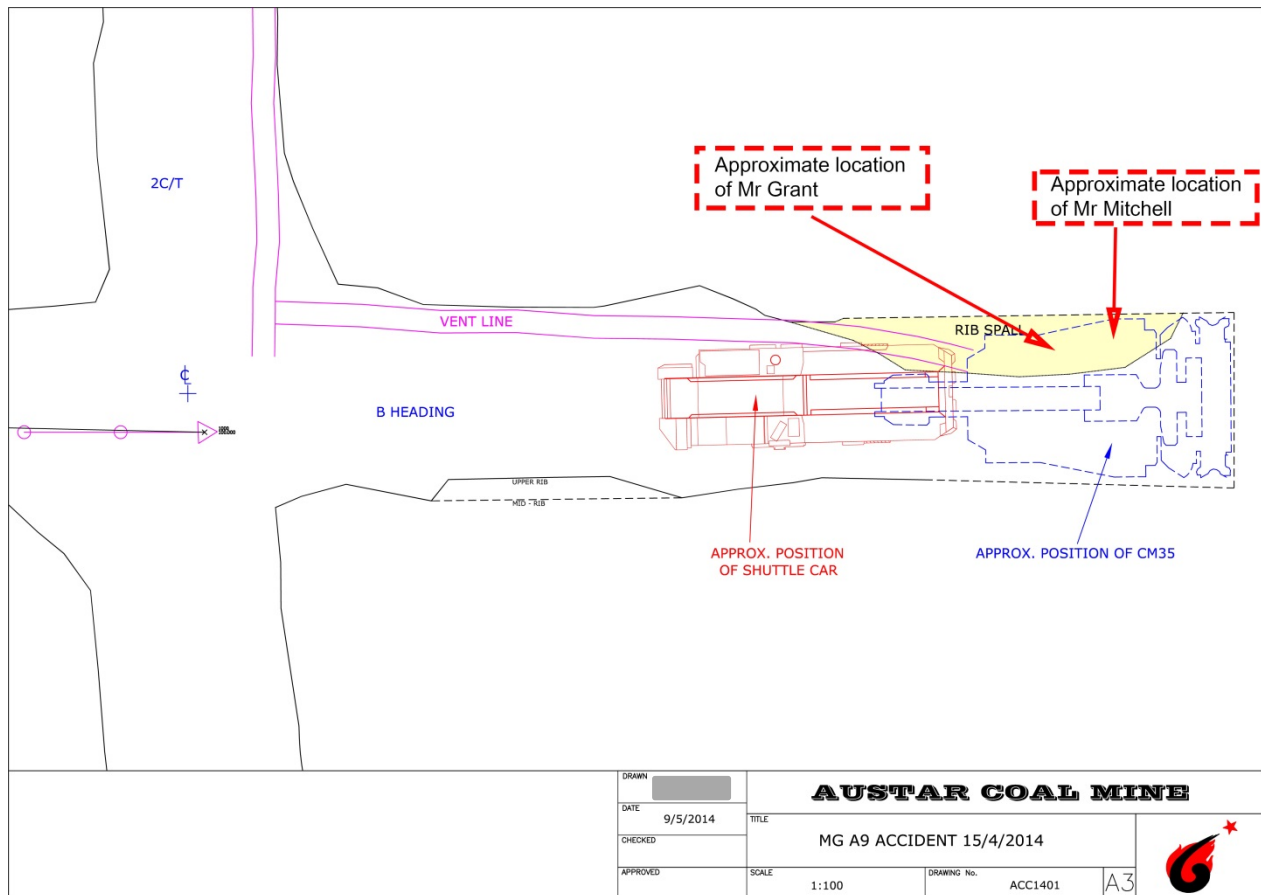
Mr Mitchell and Mr Grant were both at the point where the rib burst occurred and were buried as a result of the burst. Figures 11 above and 14 below show CM 35 and the shuttle car in B Heading immediately after the incident.

Figure 14: Plan of the incident.⁴⁹

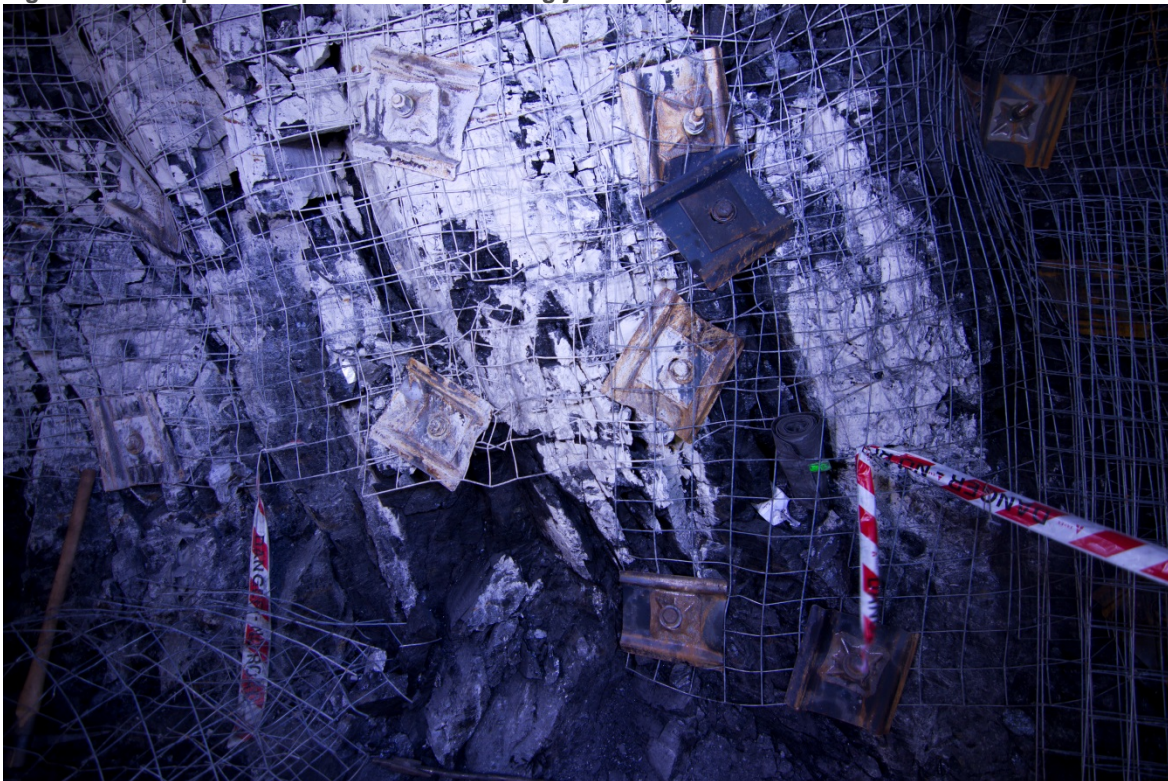
Due to the soft broken nature of the ribs at Austar it was common for the operators of the bolting rigs to encounter problems when setting the rib supports. All operators spoken to insisted that if a chemical or mechanical anchor was not properly secured, a new bolt would be installed next to it. This contention is supported by observation of the support outbye of the incident as demonstrated in Figure 24 below.

Figure 25 Example of rib bolts LHS of B Heading just outbye of the incident.

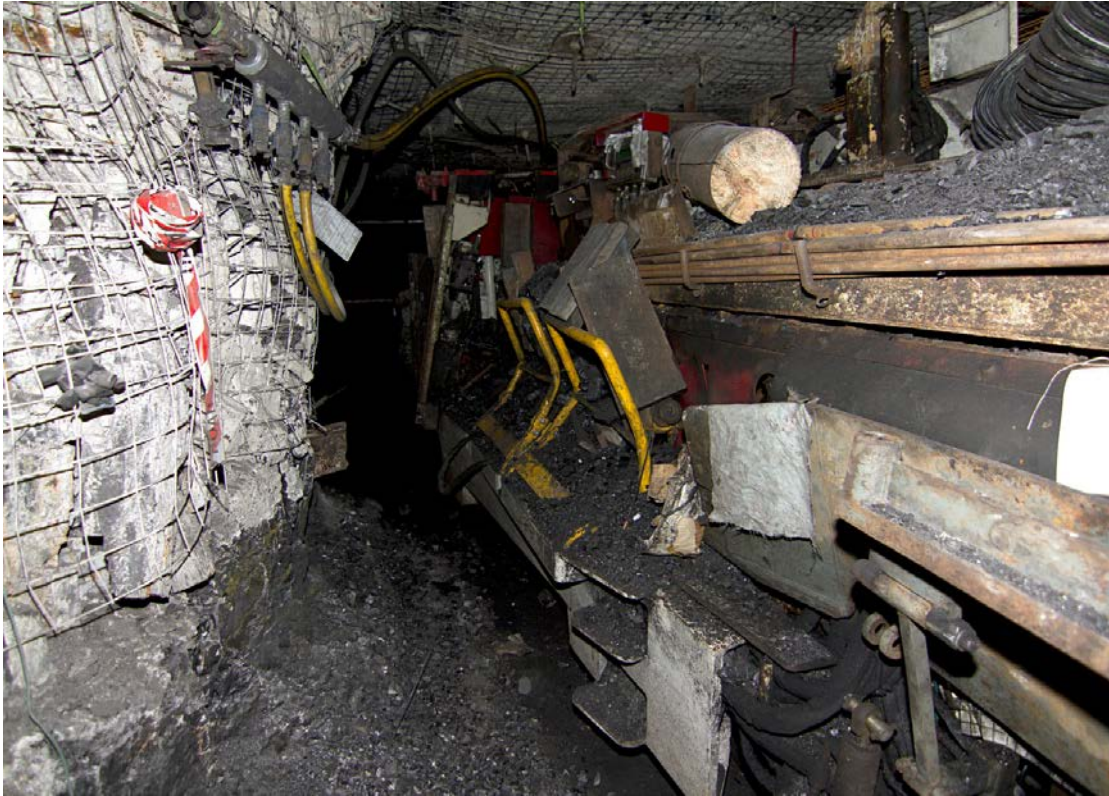
Figure 28 CM 35 post incident; note the bent handrails and rib guard.

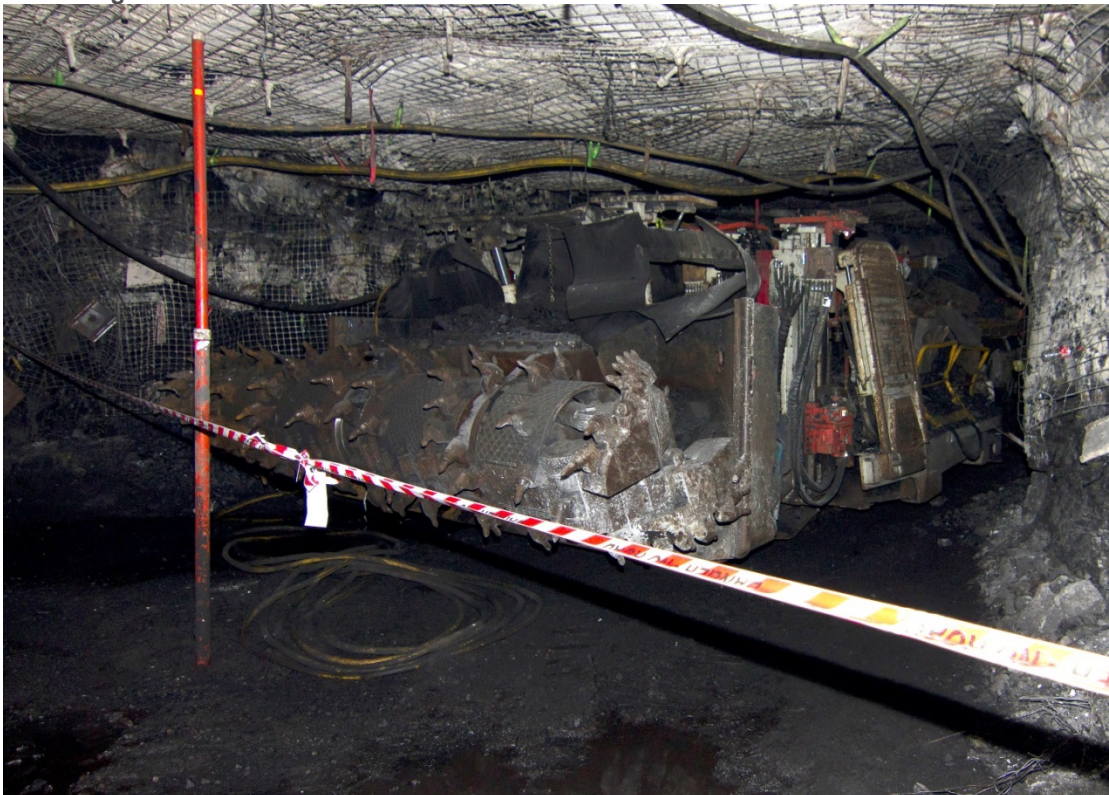
Figure 29 CM 35 after being moved from the incident; note rib guard is bent into the machine, the inflection measuring 110 mm.⁸²
