**NSW
Resources
Regulator**

INVESTIGATION REPORT

REPORT INTO THE DEATH OF MR QUINTON MOORE

Bengalla mine on 3 November 2018

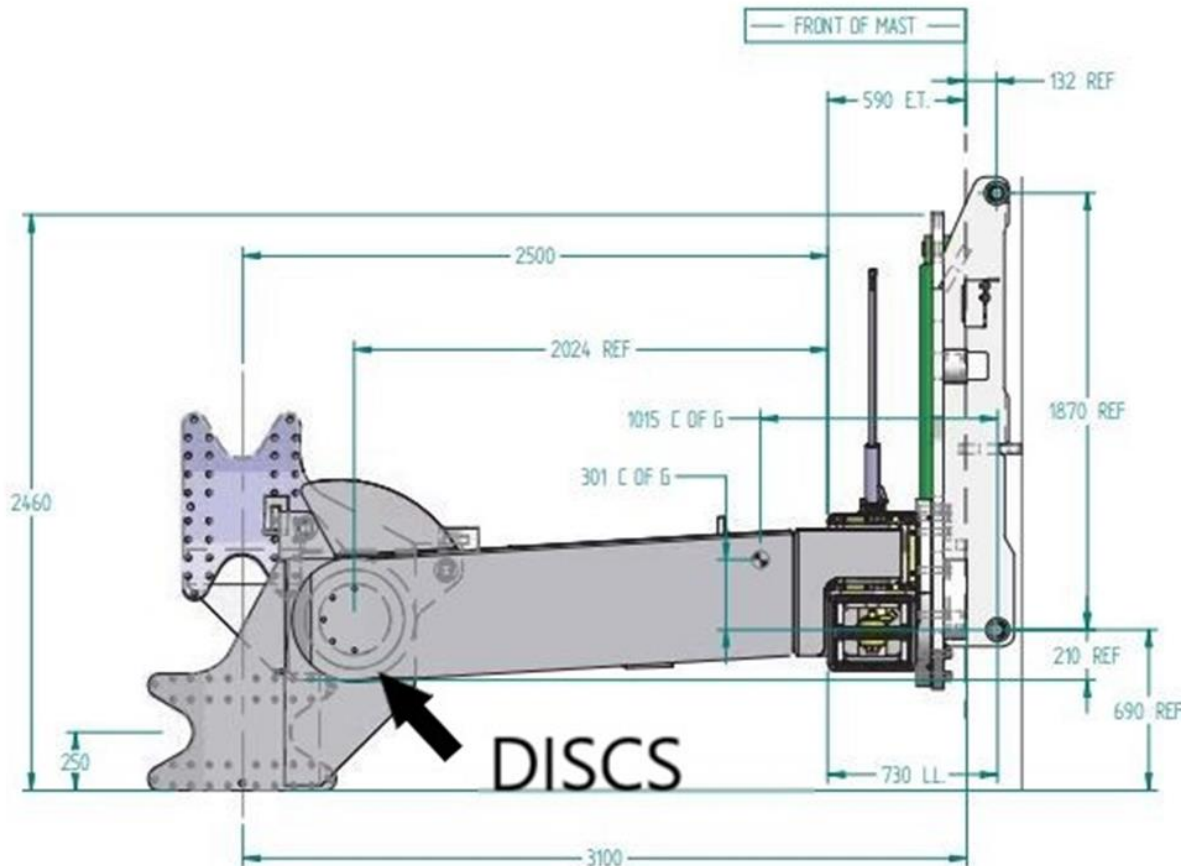
Figure 7 Grabs on tyre handler THL001

The grabs (refer to figure 7) are capable of rotating 90 degrees. The tyre handler attachment, including the grabs, are hydraulically operated. They have a lifting capacity of 8,000 kilograms. The tyre handler was last serviced by Crowne on 9 August 2018, with no repairs or rectifications being reported. In 2008, the grabs and teeth supplied by the OEM were changed by the mine to the grabs and teeth on the tyre handler at the time of the incident. The mine was unable to identify or locate any documentation regarding why or who made these modifications.

Responsibility for checking the teeth on the grabs rested with the tyre handler operator and was recorded in the tyre handler's prestart book prior to operation. In September 2018, workers reported issues with the grabs not rotating in sync, and in October 2018, eight days prior to the incident, workers were required to tighten the hex screws to the discs of the grabs after they became loose. The use of the tyre handler is supported by an operation and maintenance manual. Tyre handlers were not to be parked on a grade, without wheel chocks being applied. A copy of the operator safety warning plate, located inside the cabin of the tyre handler stated, 'no person should stand or pass under load of lifting mechanism.' Instruction No. 19 provides that the lifting mechanism should be fully lowered and wheels chocked when leaving the tyre handler. It warns a failure to follow these instructions can cause serious injury or death.

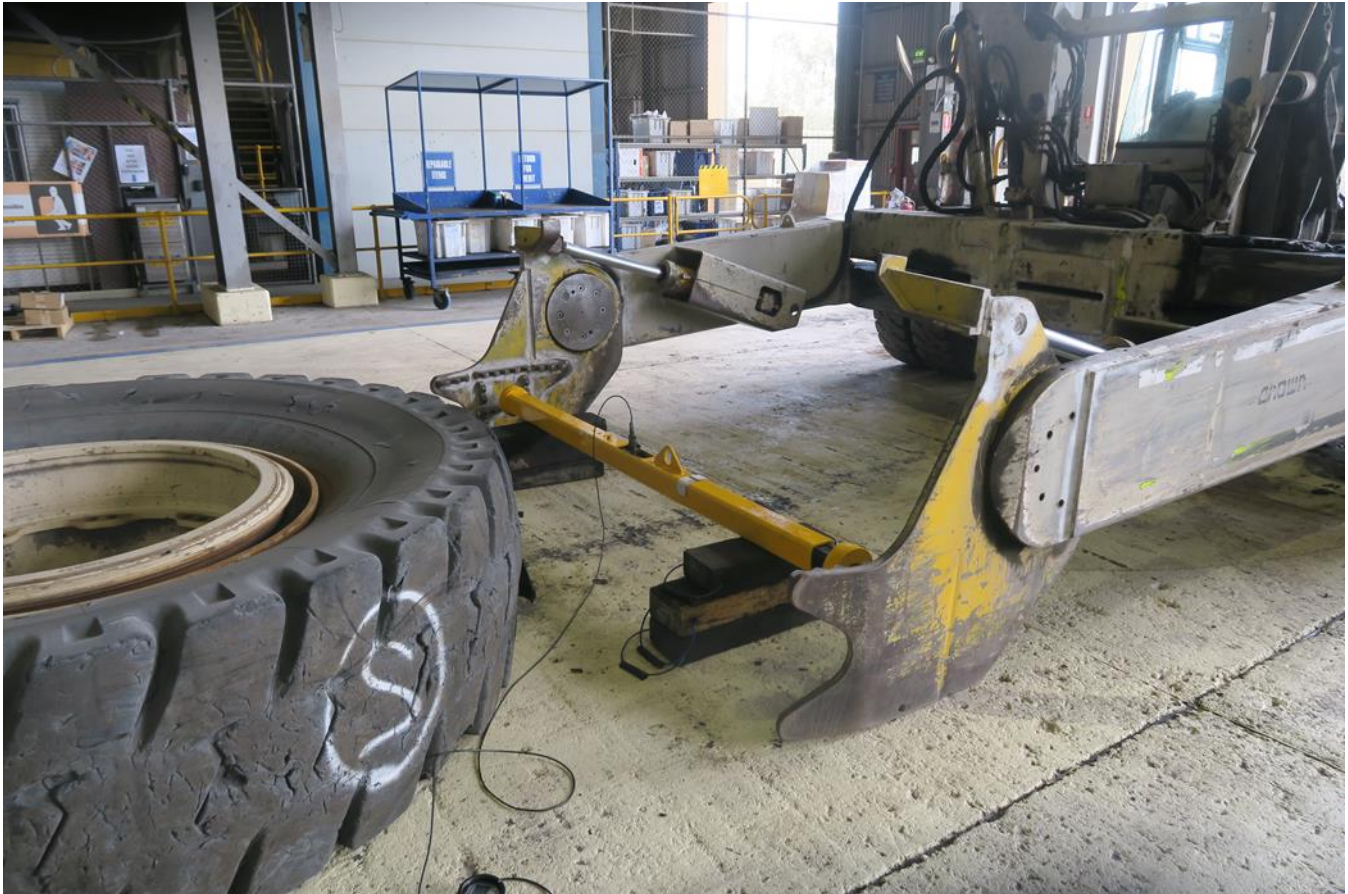
Figure 14 Clamp force pressure test on THL001 by Cascade

The hydraulic auxiliary circuit at the valve bank, which controls the Cascade tyre grab attachment, was tested. The oil pressure supplied by the lift truck should be approximately 210 bar (3050psi), however, it was only measuring 148 bar (2046psi). This resulted in a clamp force cylinder pressure of 123 kilonewton. The likely cause of this was reported to be either a defective/incorrectly fitted relief valve or pump wear.

Cascade's report concluded hydraulic pressure supplied to the grab attachment was not likely to be a potential cause of the tyre dislodging from the grabs.

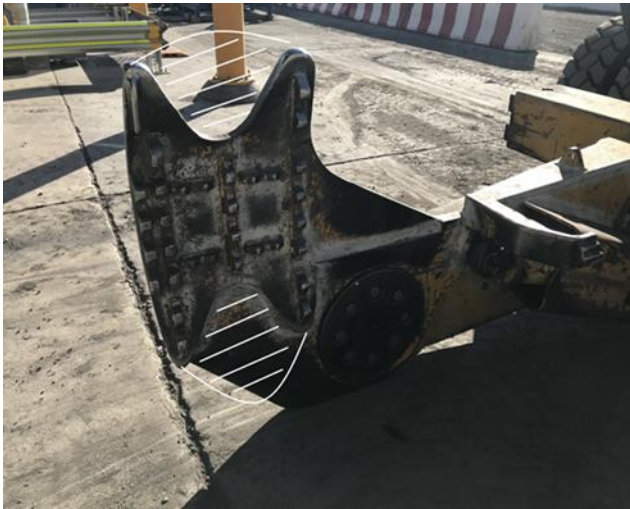
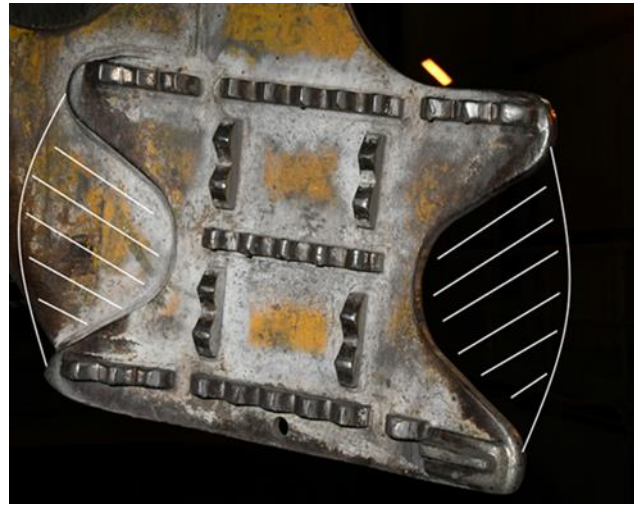
Figure 20A & 20B Grab of tyre handler from M04 and grab from tyre handler THL001

The grabs on tyre handlers (refer to figure 20A and 20B) owned by the mine were fitted with the same shaped OEM grabs referred to in the ACARP report, however, the teeth pattern was found to be modified. The area represented by shaded white, indicates the portion of the grabs, with what the report claims, reduces a grab's gripping surface area on tyres.

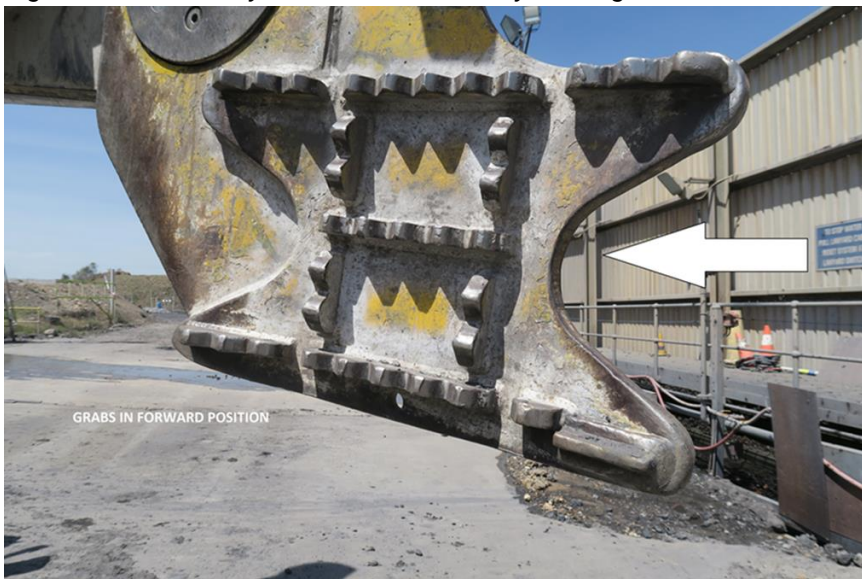
Figure 25 Grabs on tyre handler as found by investigators

The report noted the current OEM of the grabs, Cascade, declined to participate in the study. During an examination of the scene, the tyre handler grabs were found to be in the horizontal position as shown in figure 25.

Information received during the investigation identified neither the mine, Marathon Tyres or Cascade Australia, prescribe an orientation the grabs should be in while handling tyres either vertically or horizontally. This was left to the determination of operators.

The ACARP report suggests grab orientation when handling tyres may affect the ability to retain a tyre within the grabs. If CMP Engineering's theory of preferred grab orientation is applied, it is reasonable to conclude the orientation of the grabs at the time of the incident did not provide the highest level of support. However, the investigation was unable to determine if this materially contributed to the tyre falling from the grabs.

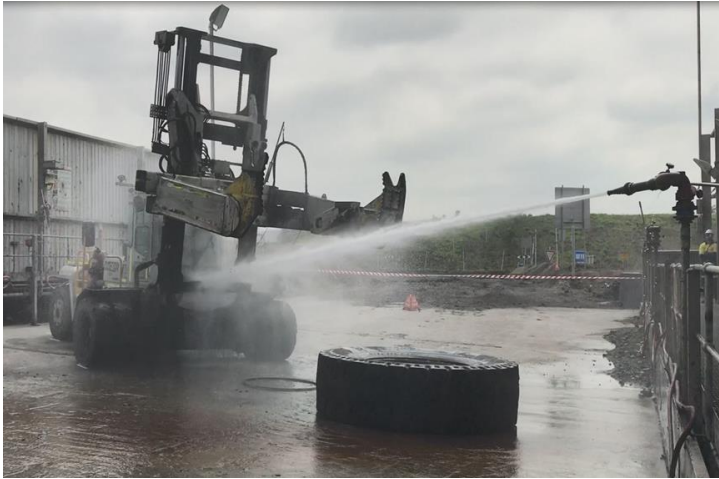
Figure 26 Photo of tyre location after falling from grabs during test 1

The tyre was horizontally positioned in the grabs and rotated to the vertical position (opposite position as found by investigators at the time of the incident). The tyre was then exposed to high pressure water. The test resulted in the tyre falling from the grabs (refer to figure 26).

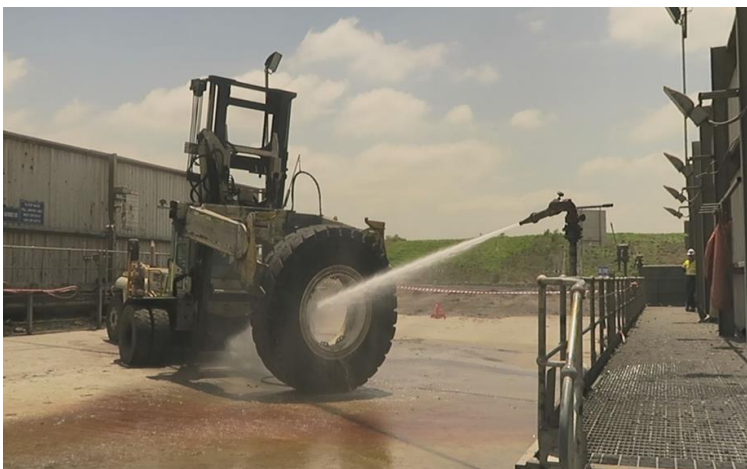
Figure 27 Photo of tyre location after falling from grabs in test 2.

Test 2. The tyre handler was repositioned as per test 1. The tyre was held with the grabs in the horizontal orientation as found following the incident. The tyre was then subjected to high pressure water from the cannon for a period not exceeding three minutes. The tyre fell from the grabs, however the tyre remained horizontal after catching on the teeth of the grabs (refer to figure 27).

Data logging measured during the tests identified that when the hands of the grabs were set at the distance measured by investigators after the incident, between 20 and 30 kilonewton (kN) of pressure was applied to the tyre. When the experienced operator assisting during the tests was asked to subjectively secure the tyre, the pressure applied was measured at 70kN, almost double the force.
