KIANGA COAL COMPANY PTY. LTD.	
PROPOSED WORKINGS	
N° 1 UNDERGROUND	
SCALE - 1 : 2500	DATE - 0/0/75.
DRAWN - G. D. Jaques	Ref. N° 245 A

The Following Notes are hand written notes from Kianga Deputy Rod Stafford.

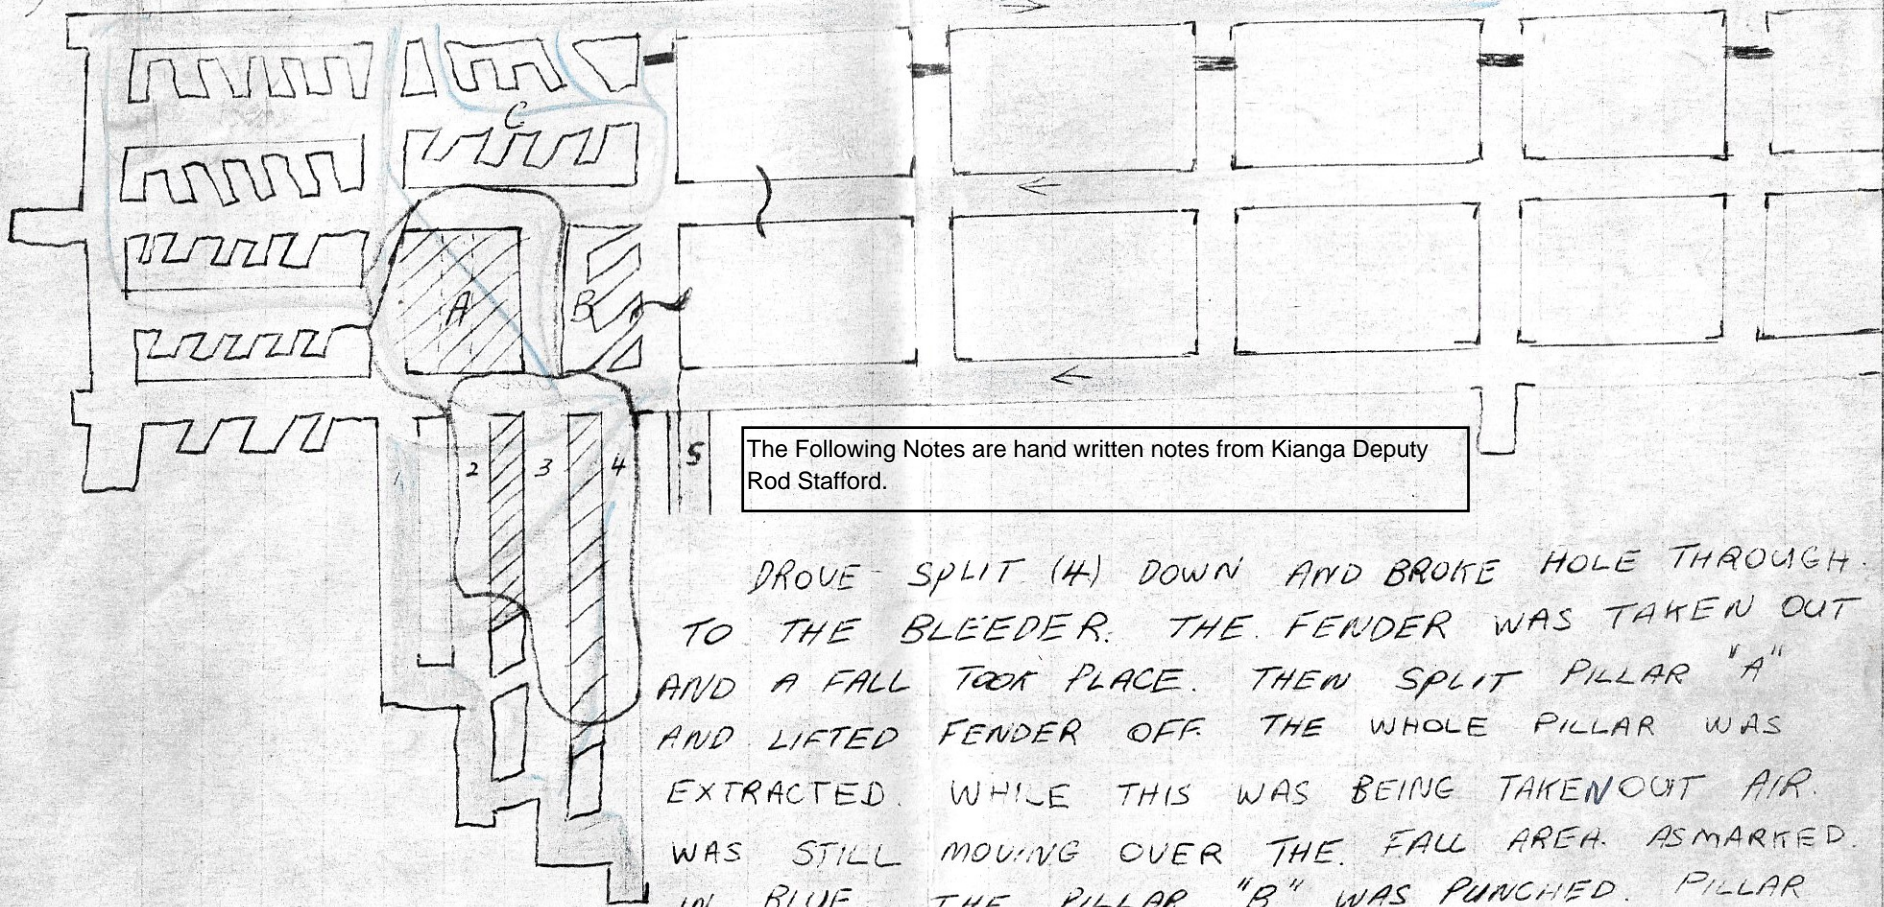
1/A

DROVE SPLIT (4) DOWN AND BROKE HOLE THROUGH TO THE BLEEDER. THE FENDER WAS TAKEN OUT AND A FALL TOOK PLACE. THEN SPLIT PILLAR "A" AND LIFTED FENDER OFF THE WHOLE PILLAR WAS EXTRACTED. WHILE THIS WAS BEING TAKEN OUT AIR WAS STILL MOVING OVER THE FALL AREA AS MARKED IN BLUE. THE PILLAR "B" WAS PUNCHED. PILLAR "C" WAS SPLIT AND PUNCHED AND HOLES PUNCHED THROUGH TO THE RETURN AIRWAY. THE MINER WAS THEN MOVED DOWN TO THE M/S ROADWAY AND SPLIT NO 5 WAS DRIVEN DOWN AND A HOLE PUNCHED THROUGH TO THE BLEEDER. THE FENDER WAS EXTRACTED AND A FALL TOOK PLACE. SPLITS NO 6 & 7 WERE DRIVEN DOWN IN THE SAME MANNER. AND FALLS TAKEN PLACE AS MARKED ON NEXT SHEET.

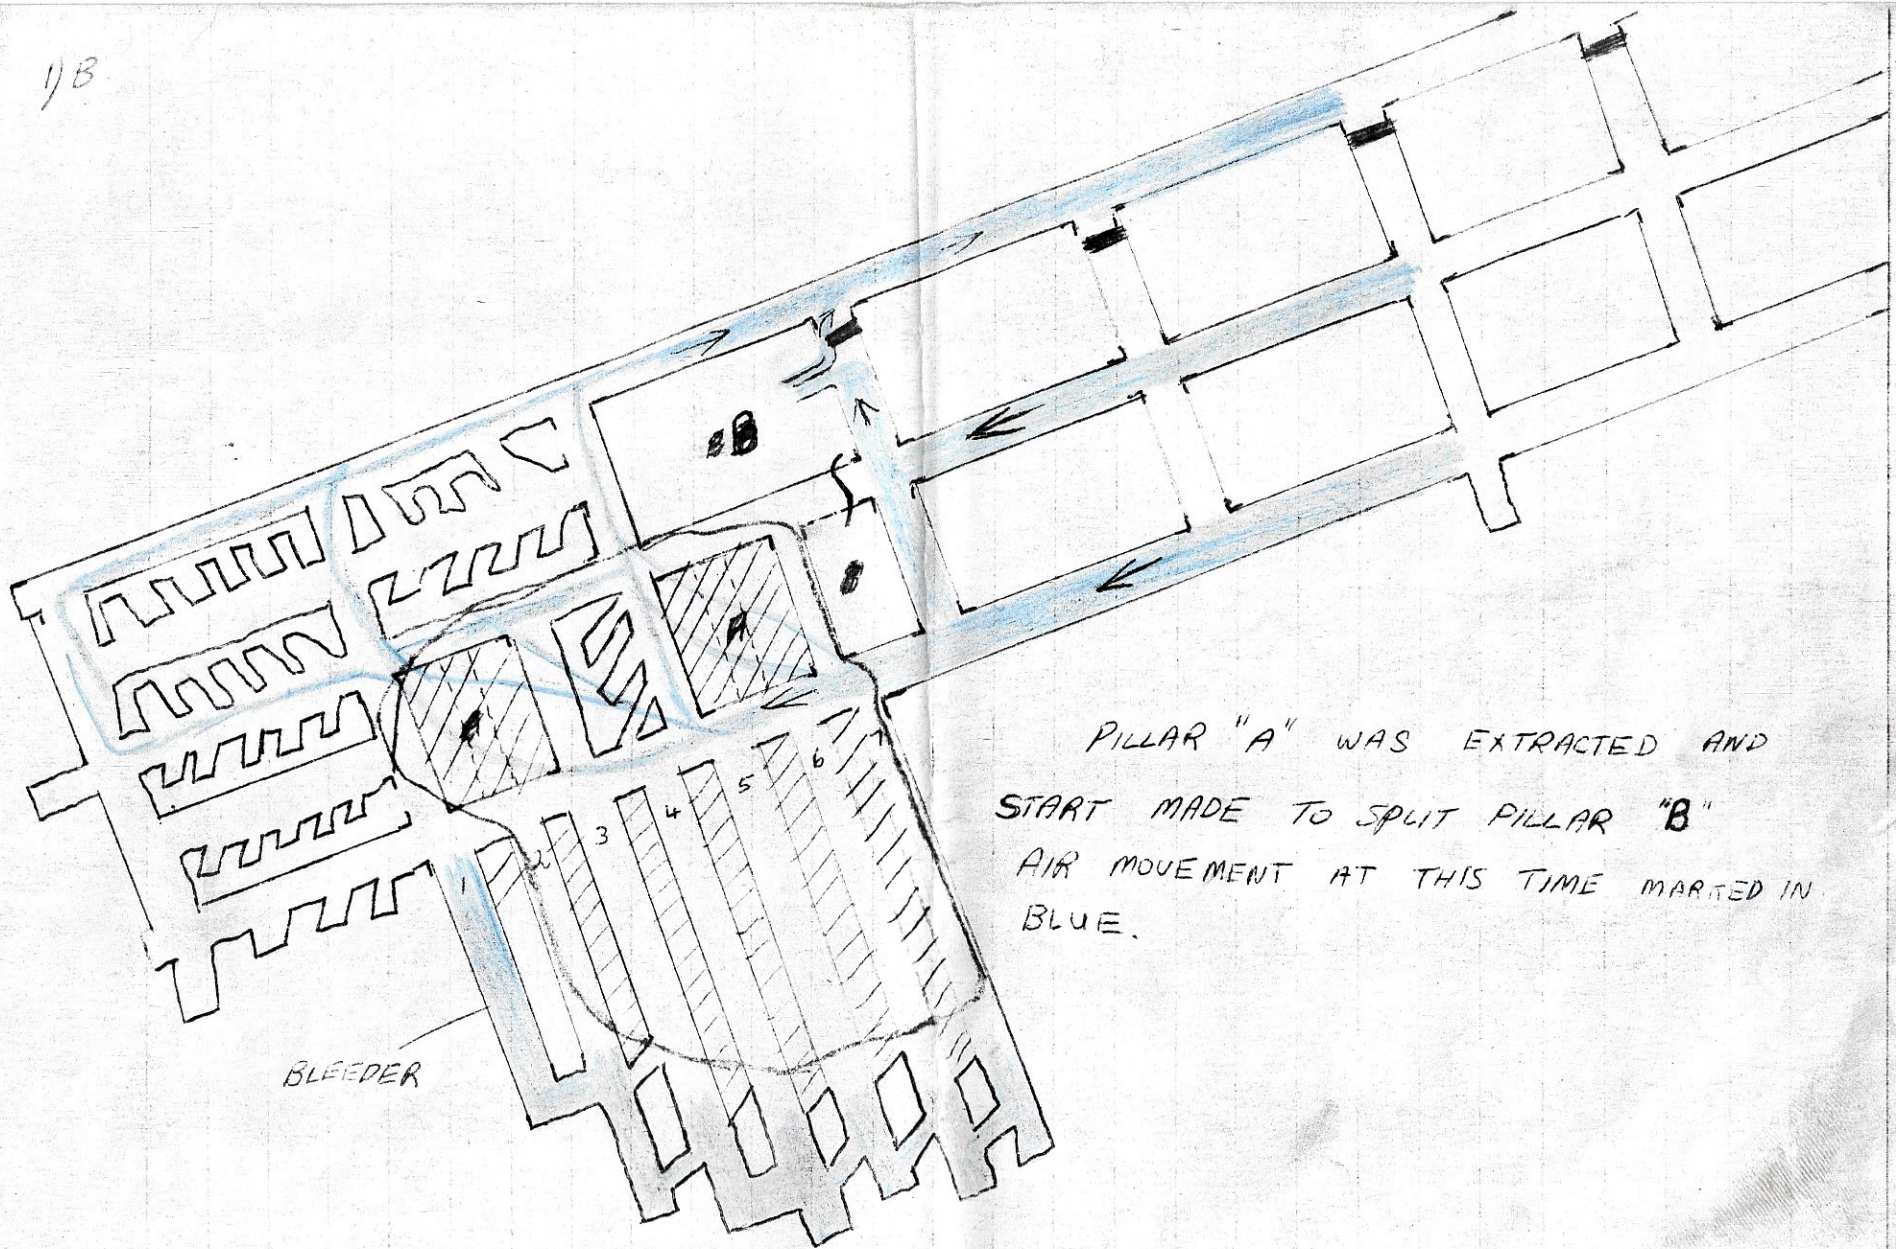
1/B

PILLAR "A" WAS EXTRACTED AND
START MADE TO SPLIT PILLAR "B"
AIR MOVEMENT AT THIS TIME MARKED IN
BLUE.

58 CH₄ 19 14 6 CH₄

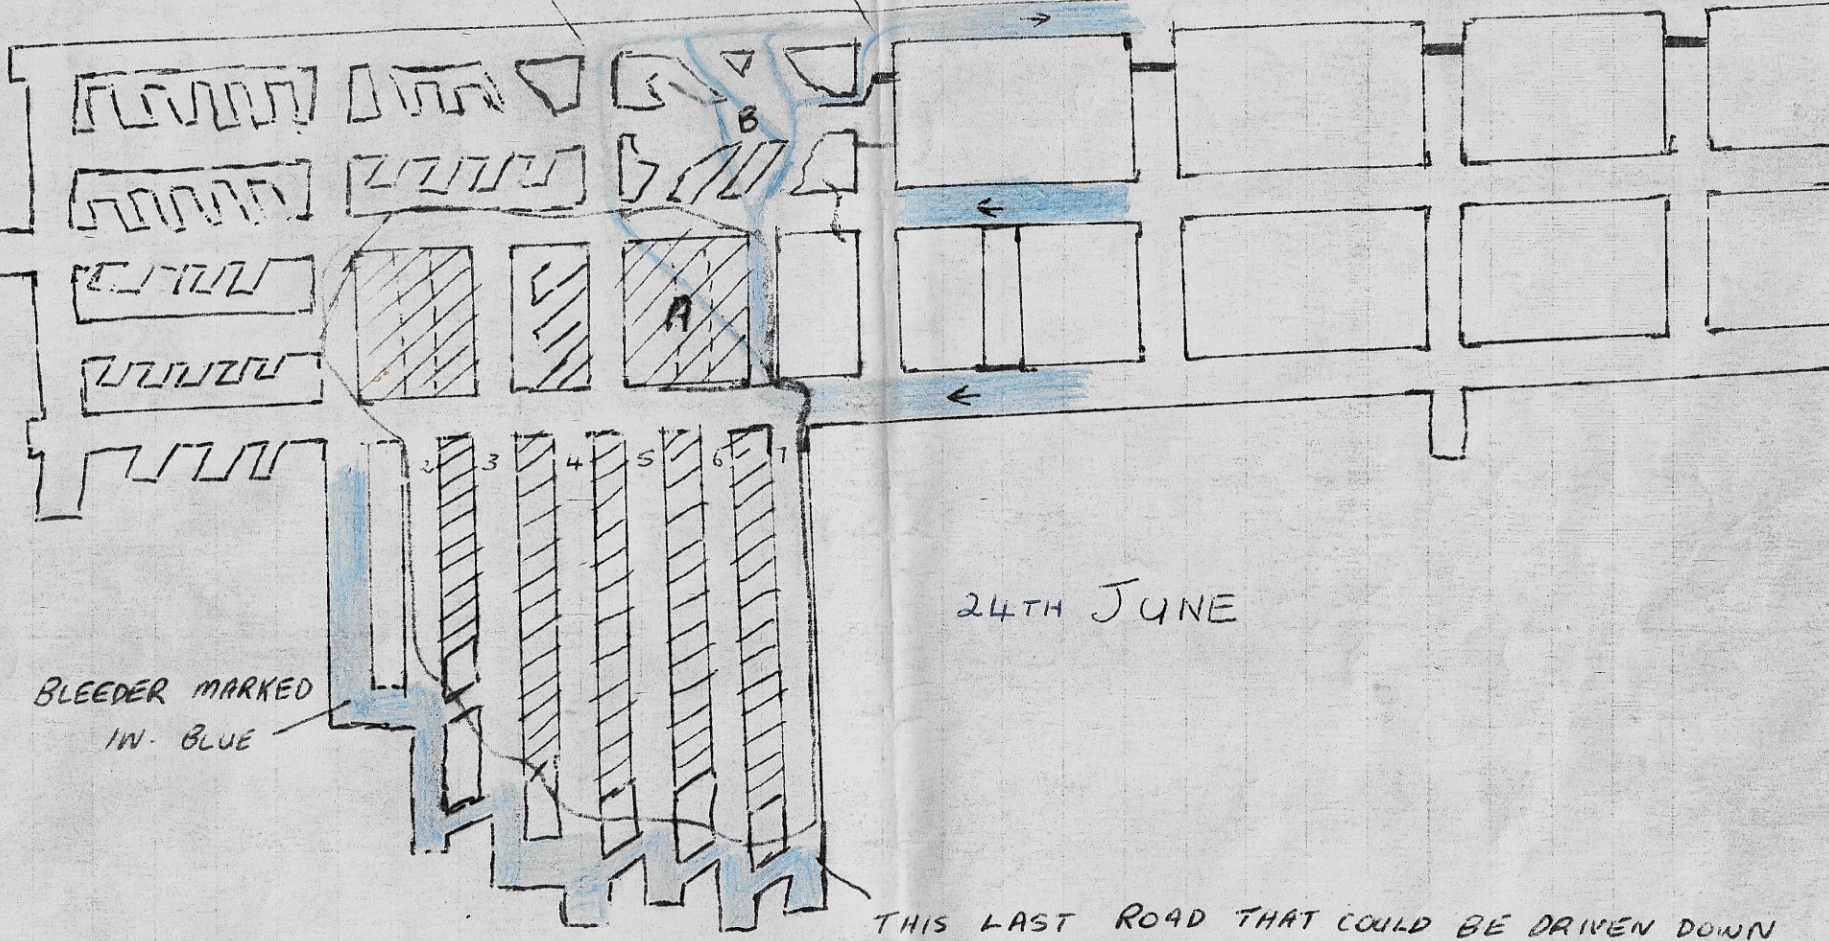
1) C

24TH JUNE

THIS LAST ROAD THAT COULD BE DRIVEN DOWN

INTO THE SOLID WAS BROKE THROUGH TO THE BLEEDER. THE FENDER WAS EXTRACTED AND A FALL TOOK PLACE. PILLAR MARKED "A" WAS THEN TAKEN OUT IN LIFTS. THE PILLAR BETWEEN THE BELT ROAD AND RETURN AIRWAY WAS SPLIT, MARKED "B". THIS WAS PUNCHED AND HOLES PUNCHED THROUGH TO THE RETURN. THIS ALLOWED THE VENTILATION TO SHORT CIRCUIT THE GOAF AREA. (AIR MOVEMENT MARKED IN BLUE) THEREFORE THE CH₄ BUILT UP IN THE GOAF AREA. THIS WAS BECAUSE THE FALL BETWEEN THE M/S ROADWAY AND THE BLEEDER HAD CHOKED ITS SELF OFF AND THE VENTILATION WAS TAKING A SHORTER CIRCUIT TO THE RETURN AIRWAY. CH₄ READINGS MARKED

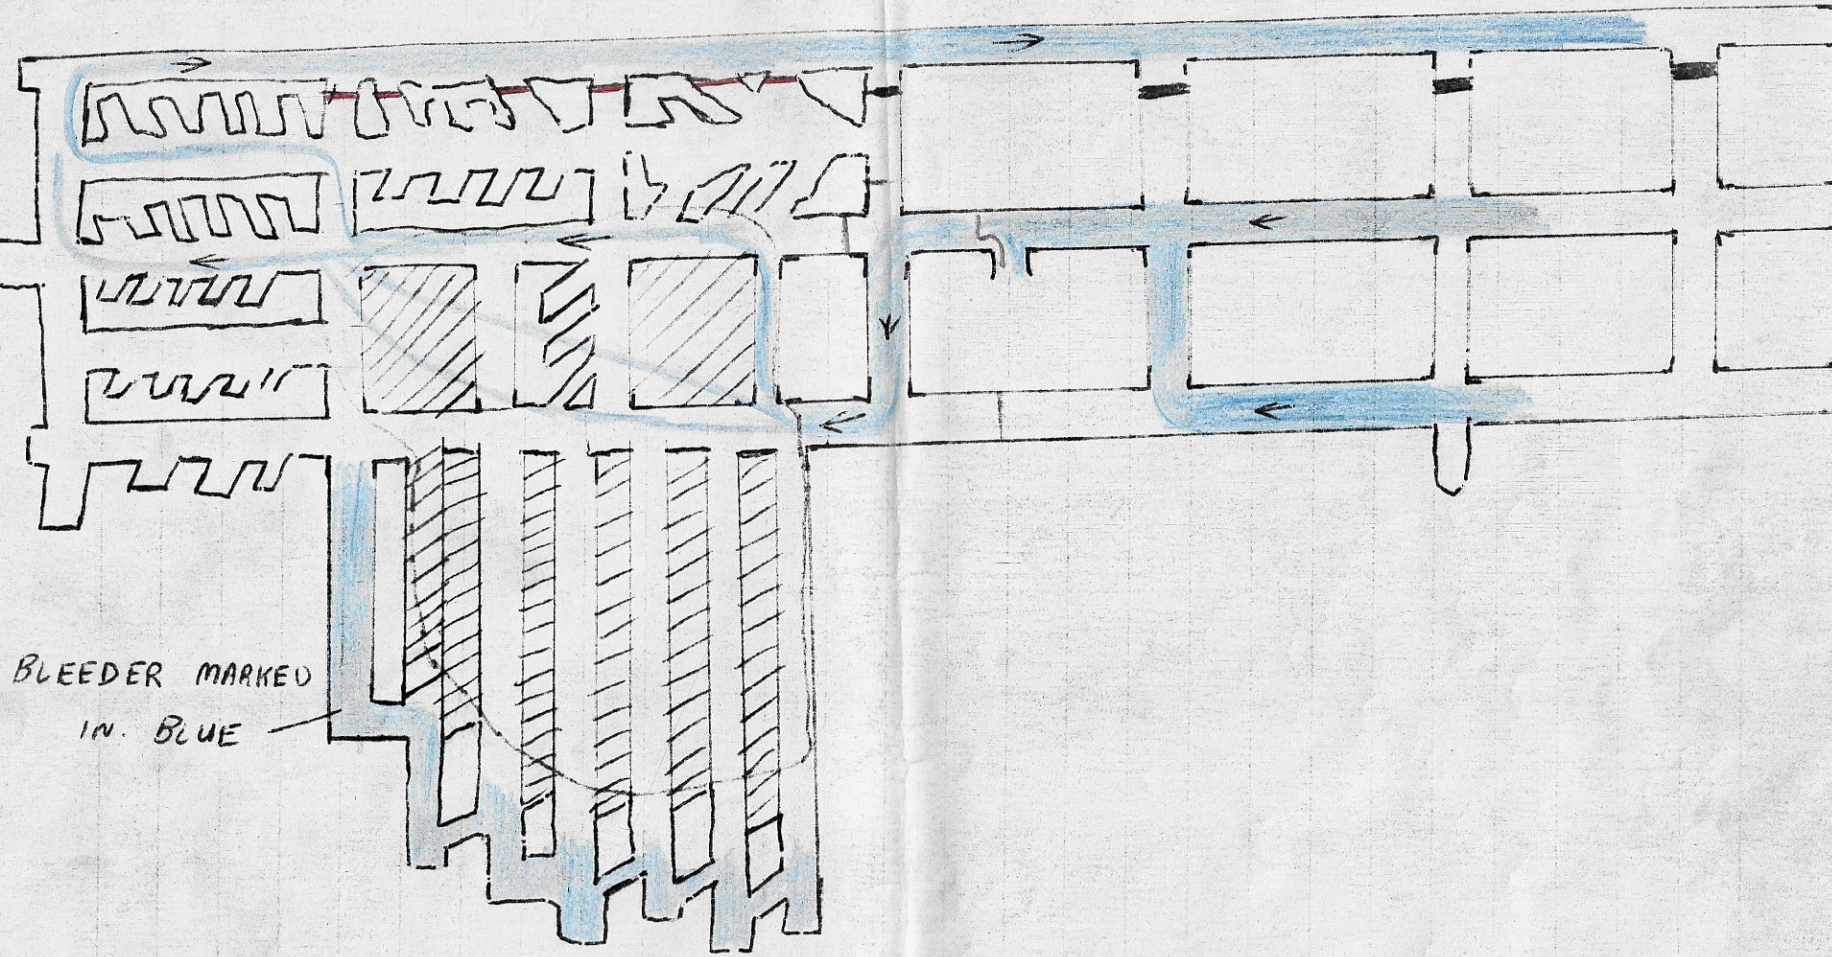
2)

ON THE AFTERNOON OF JUNE 24TH MYSELF AND TWO MINERS ERRECTED
 BRATTICE (MARKED IN RED) ACCROSS THE HOLES WHICH HAD BEEN PUNCHED ^{THROUGH} PILLAR.
 TO RETURN. THIS CLEARED THE CH₄ FROM THIS AREA. THE DIRECTION OF THE
 AIR FLOW. MARKED IN BLUE, NO VENTILATION FLOWED THROUGH THE BLEEDER
 SYSTEM DOWN THE BOTTOM. A ROAD WAS REQUIRED TO BE DRIVEN DOWN AND
 A HOLE PUNCHED THROUGH TO THE BLEEDER TO LET IT SERVE ITS PURPOSE.
 IN THE MEANTIME A FALL TOOK PLACE BETWEEN THE BELT ROAD AND

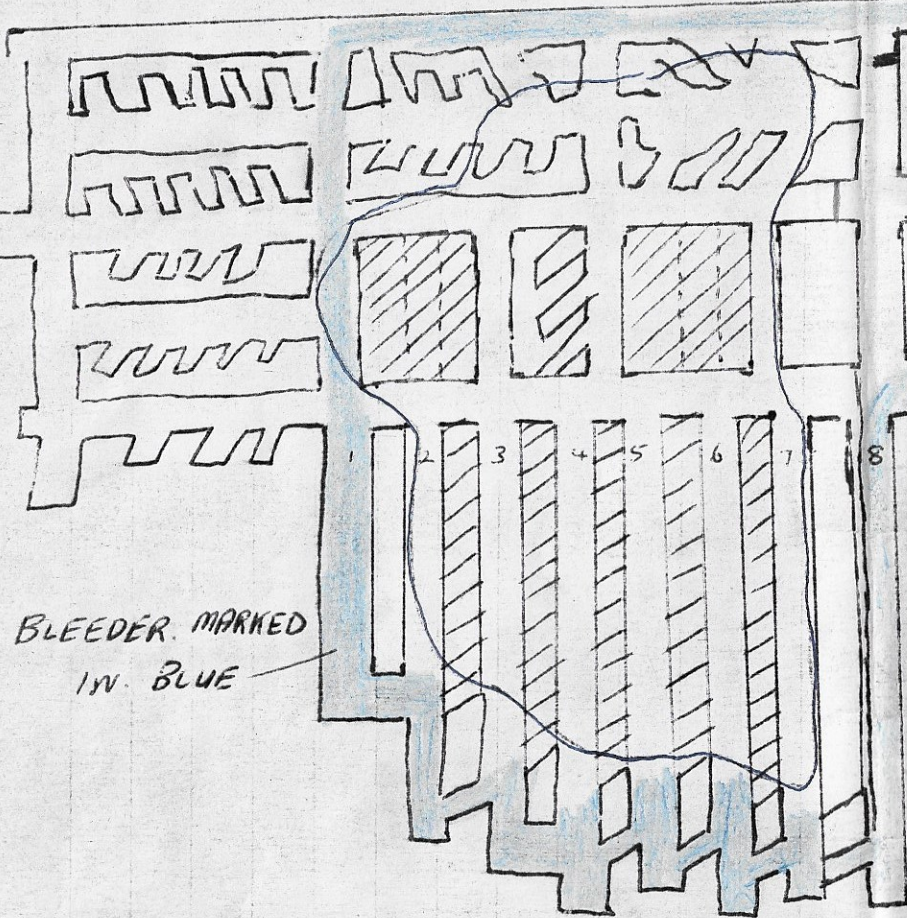
3)

I THINK THIS HOLE WAS BROKEN THROUGH
TO THE BLEEDER ON 2ND OR 3RD JULY AND
~~LAST~~ ~~AUGUST~~.
THE LAST OF THE FENDER TAKEN OUT BY 4TH JULY
BEFORE WE WENT ON STRIKE ON THE 7TH 8TH 9TH
JULY

THE RETURN AIRWAY (WHERE BRATTICE WAS ERRECTED) THIS CLOSED OFF THE OPENINGS
AND STOPPED THE AIR FROM SHORT CIRCUITING.
AFTER JUNE 24TH SPLIT PILLAR A BETWEEN BELT ROAD AND M/S ROAD AND THEN
^{SPLIT "B"}
DROVE DOWN HILL AND BROKE A HOLE THROUGH TO THE BLEEDER. THIS MADE THE
AIR CIRCUIT MARKED IN BLUE. THE FOLLOWING COUPLE OF SHIFTS THE FENDER
WAS TAKEN OUT AND THE ROOF FELL UP TO M/S ROADWAY. THE AIR WOULD NOT PASS
OVER THIS FALL AND THEREFORE SHORT CIRCUITED TO THE RETURN. UNTIL THE NEXT ROAD
WAS DRIVEN DOWN AND BROKEN THROUGH TO THE BLEEDER. TWO MORE ROADS WERE

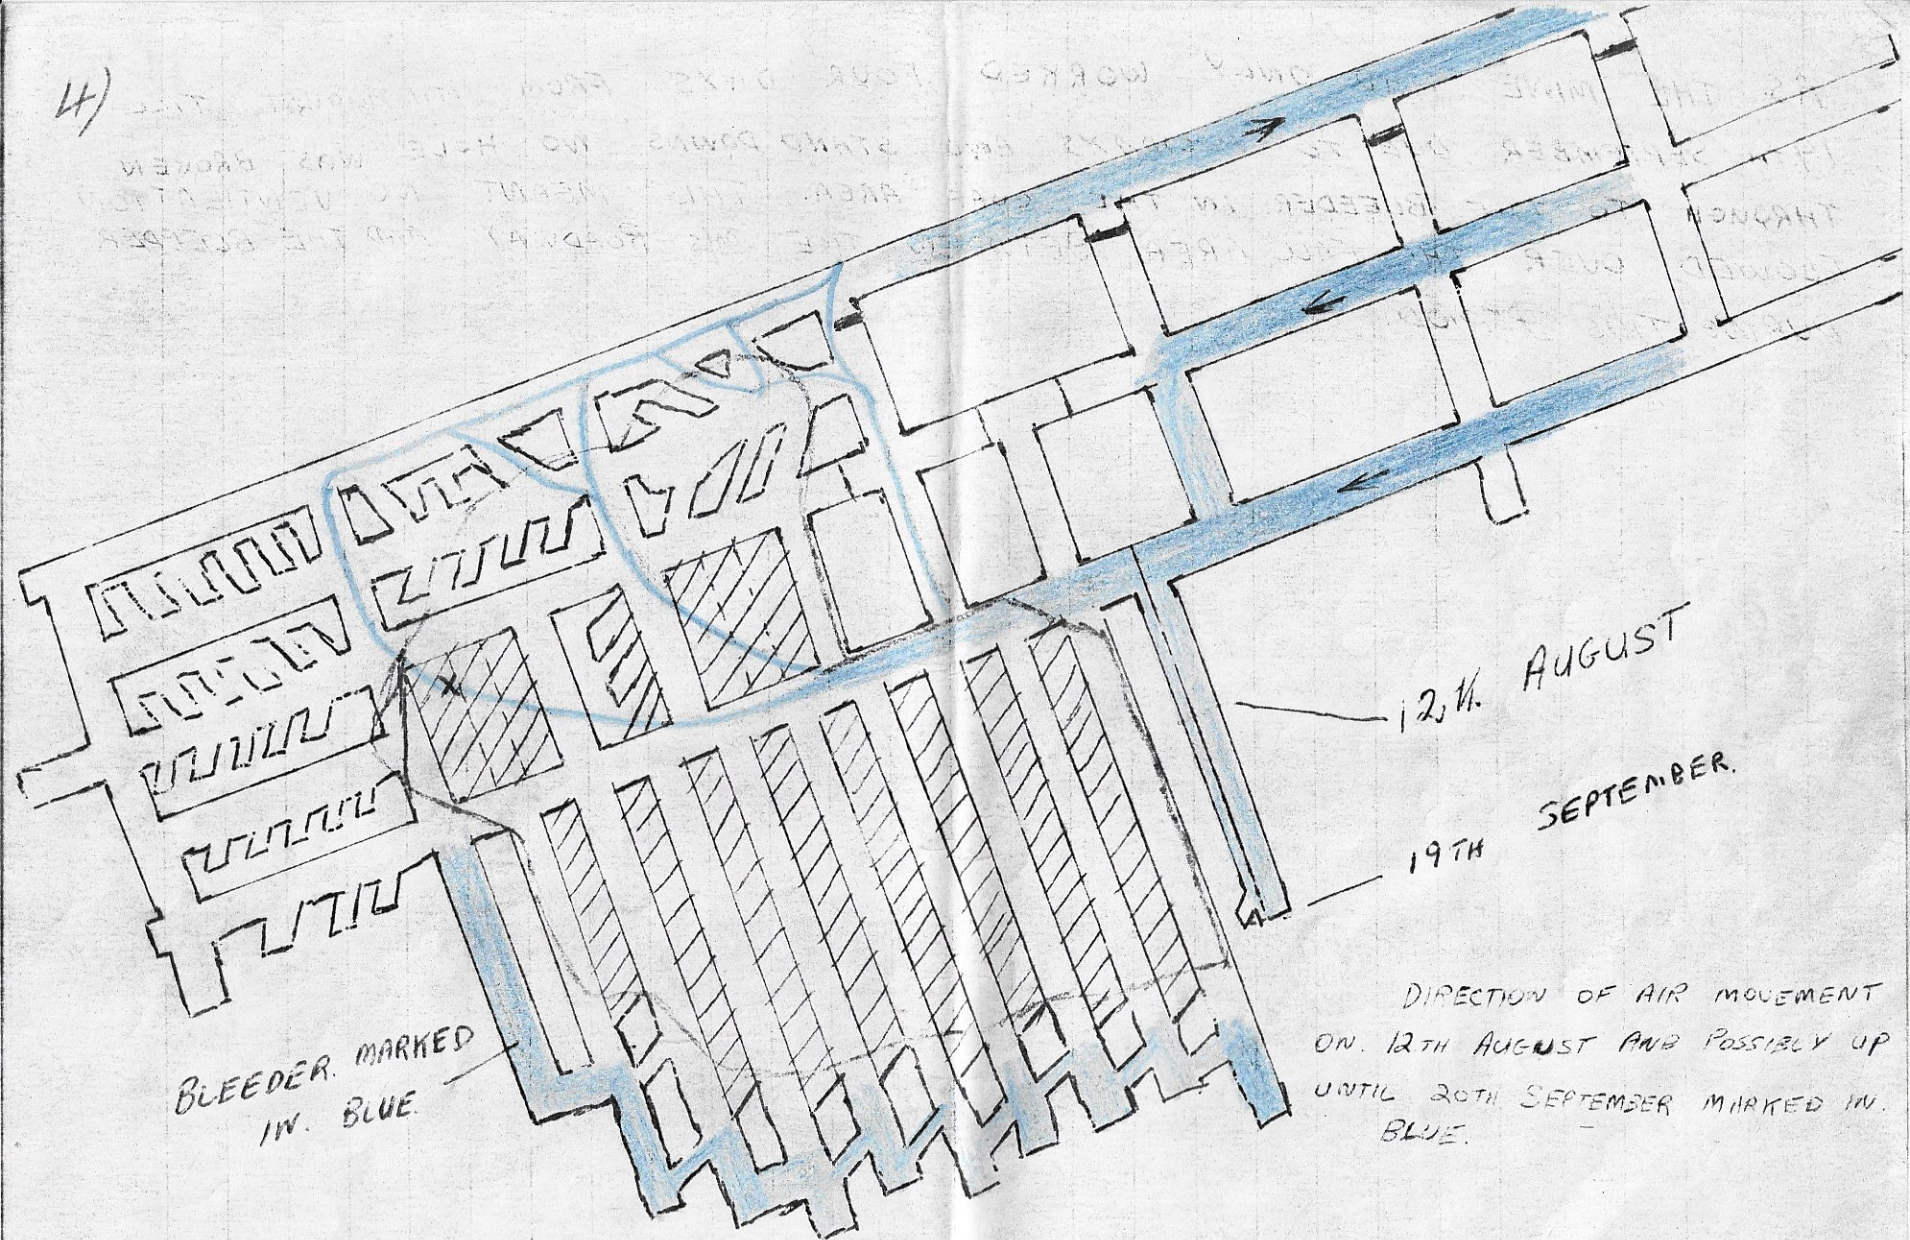
4)

12th AUGUST

19th SEPTEMBER

DIRECTION OF AIR MOVEMENT ON 12th AUGUST AND POSSIBLY UP UNTIL 20th SEPTEMBER MARKED IN BLUE.

DRIVEN DOWN TO THE BLEEDER, THE LAST ONE BROKE A HOLE THROUGH TO THE BLEEDER. ON 6th AUGUST. AIR PASSED THROUGH THE BLEEDER IN THE GOAF AREA UNTIL 8th AUGUST WHEN THE LAST OF THE FENDER WAS TAKEN OUT AND THE ROOF FELL. THIS BLOCKED THE FLOW OF AIR THROUGH THE BLEEDER. AN OTHER ROAD WAS STARTED DOWN HILL ON 11th AUGUST (OVER)

AS THE MINE HAD ONLY WORKED FOUR DAYS FROM 11TH AUGUST TILL 19TH SEPTEMBER DUE TO HOLIDAYS AND STAND DOWNS. NO HOLE WAS BROKEN THROUGH TO THE BLEEDER IN THE COAF AREA. THIS MEANT NO VENTILATION FLOWED OVER THE FALL AREA BETWEEN THE M/S ROADWAY AND THE BLEEDER. DURING THIS PERIOD.

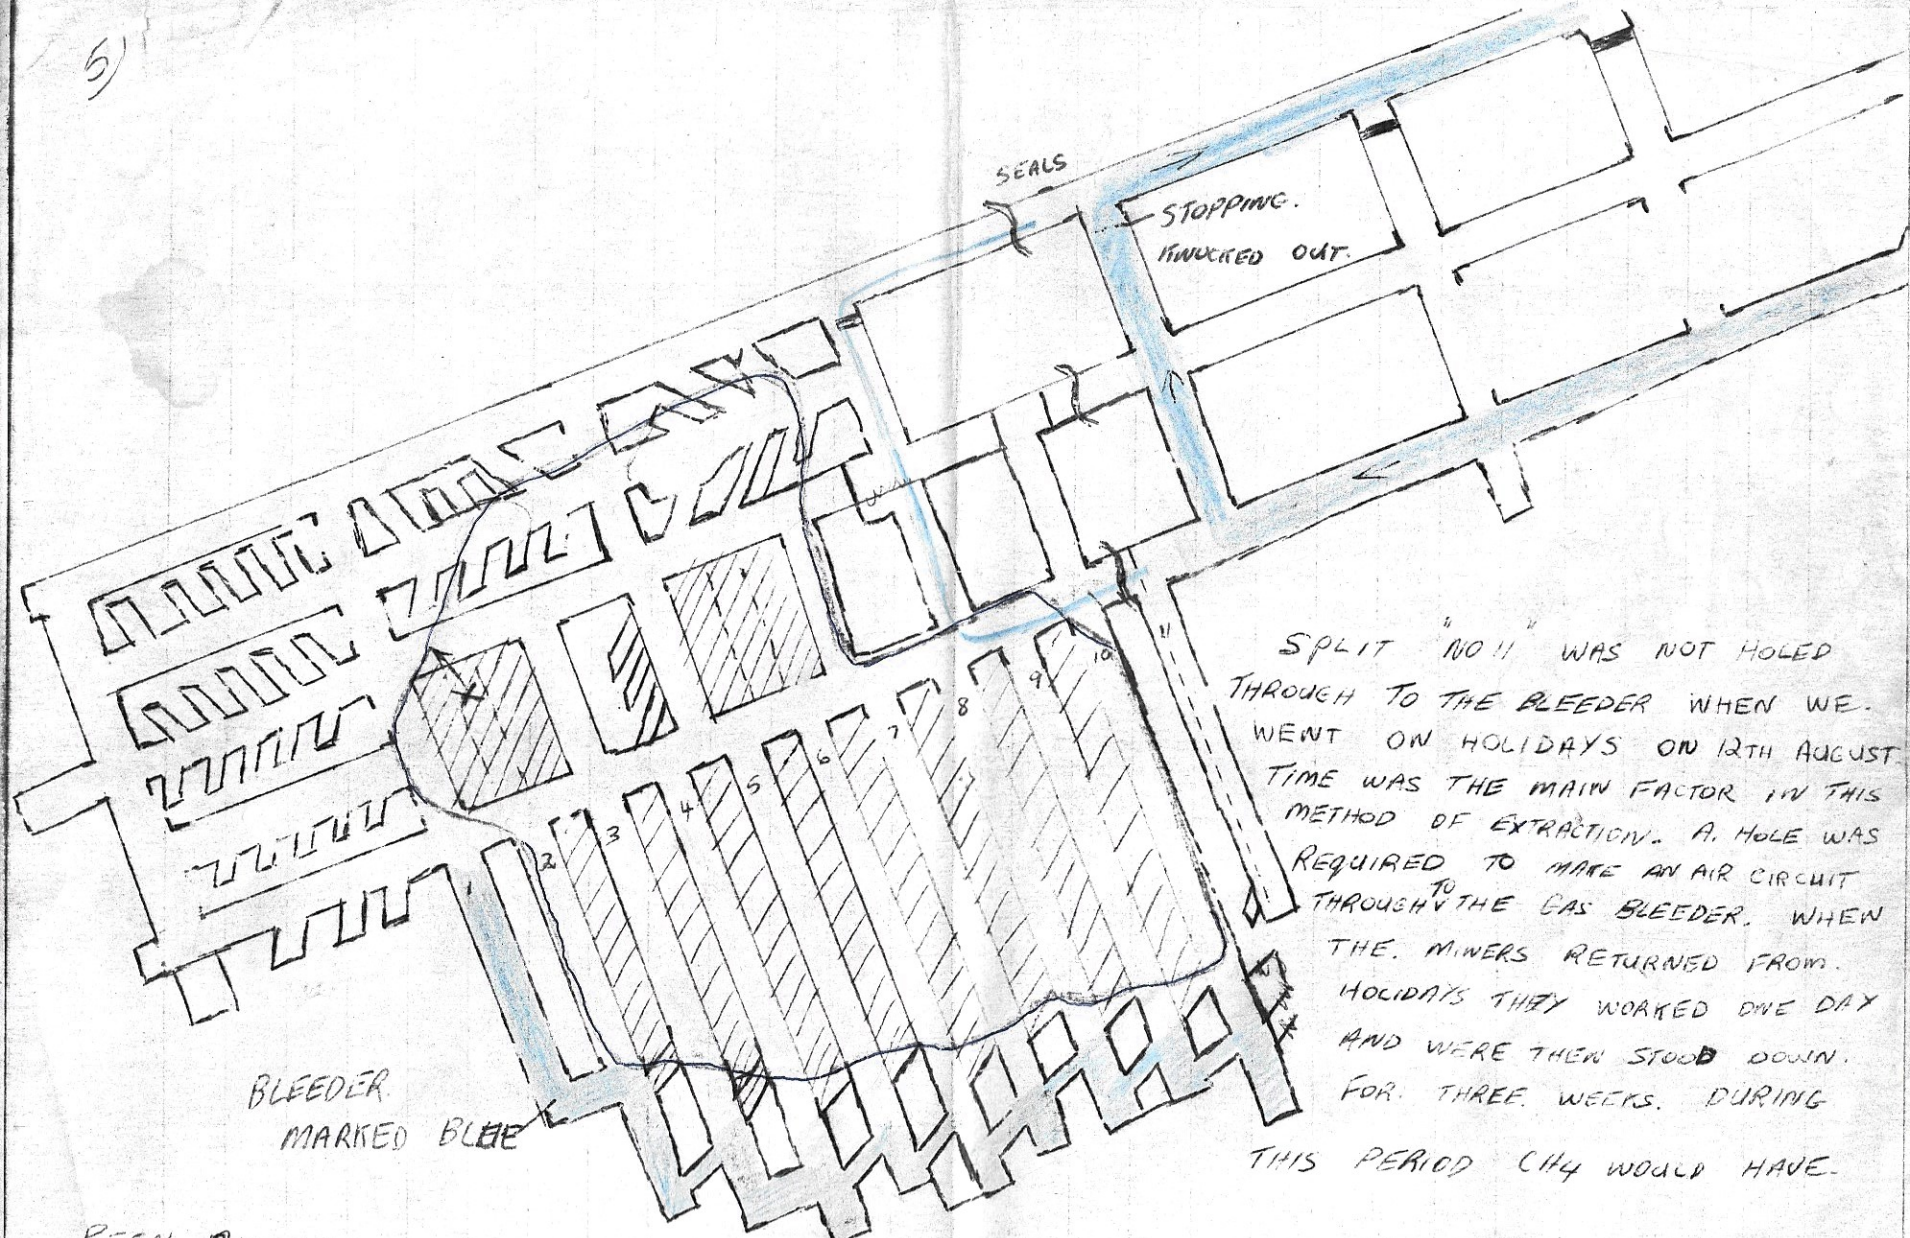
5)

SPLIT "NO 11" WAS NOT HOLED THROUGH TO THE BLEEDER WHEN WE WENT ON HOLIDAYS ON 12TH AUGUST TIME WAS THE MAIN FACTOR IN THIS METHOD OF EXTRACTION. A HOLE WAS REQUIRED TO MAKE AN AIR CIRCUIT THROUGH TO THE GAS BLEEDER. WHEN THE MINERS RETURNED FROM HOLIDAYS THEY WORKED ONE DAY AND WERE THEN STOOD DOWN FOR THREE WEEKS. DURING THIS PERIOD CH4 WOULD HAVE

BEEN ACCUMULATING IN THIS GOAF AREA WHERE THERE WAS NO AIR MOVEMENT. THIS ACCUMULATION WOULD BE BLEEDING OUT INTO THE AIR CURRENT MARKED ON SHEET (14)
