Discussion Paper

Safety of Persons in Proximity to Underground Coal Mine Openings

Prepared by: Mark Parcell.
Mark@MineSafetyInstitute.com.au
www.minesafetyinstitute.com.au
17th of June 2014.

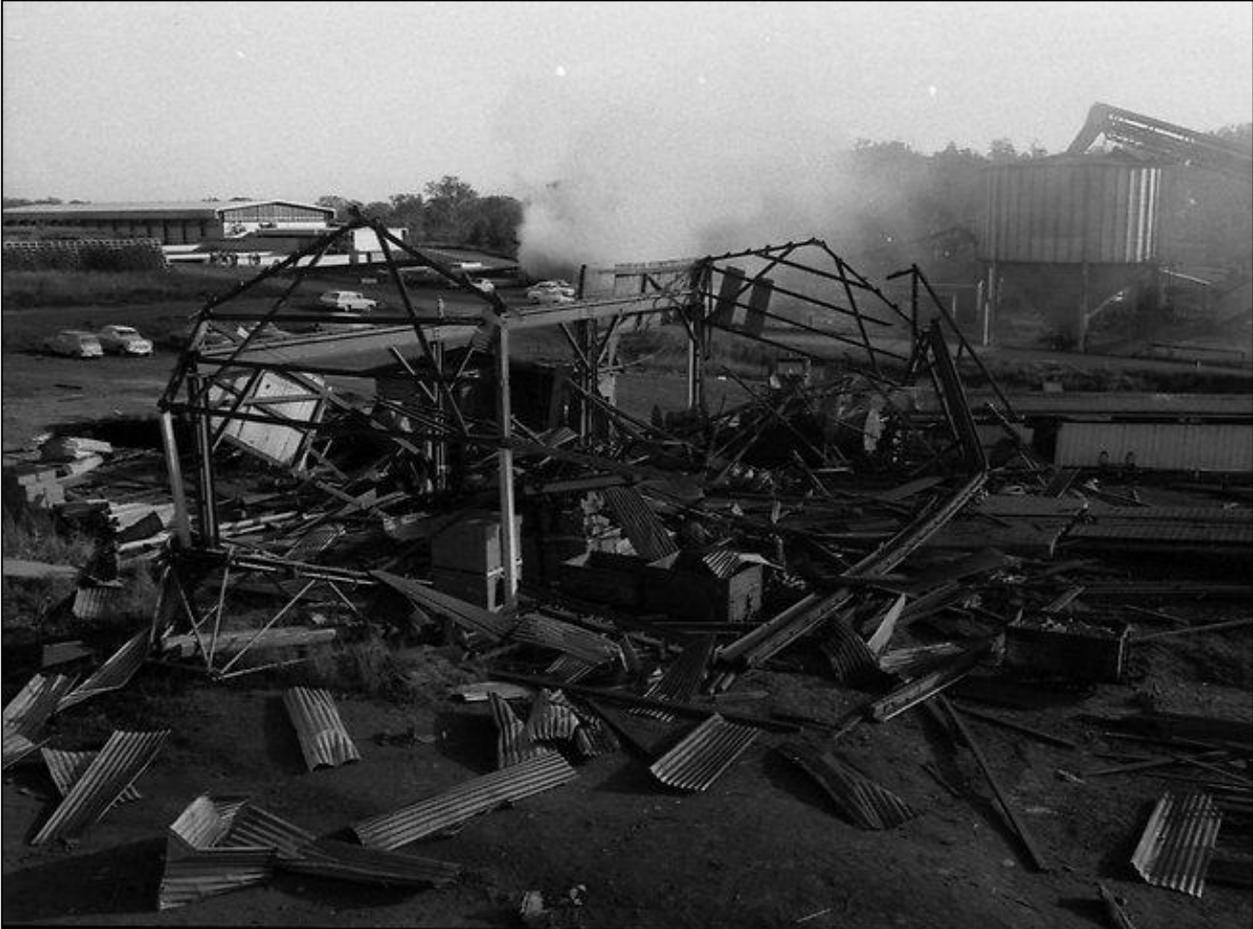
Photo 1 – On the 31st of July 1972 the Box Flat Colliery, near Ipswich Queensland, exploded killing 17 men. Three of them were standing at the surface near the mine opening.

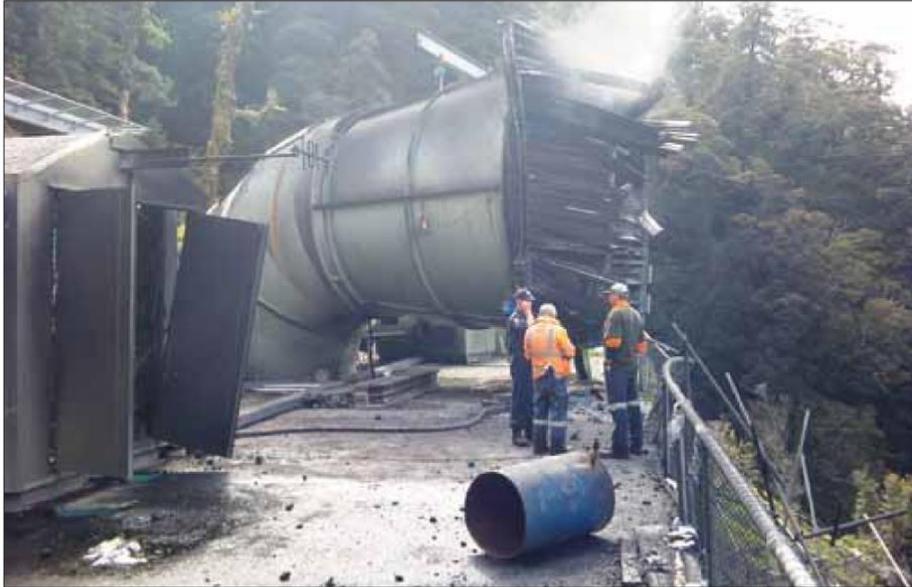
Figure 8.10: The surface fan after the first explosion

Despite rescuers not entering the mine following the initial explosion on the 19th of November 2010, rescue workers were in close proximity of mine openings and further fatalities were lucky not to occur during subsequent explosions. Figure 8.10 from Volume 2 of the Pike River Royal Commission Report² (below) shows three men standing in close proximity to the return shaft at Pike River (and another person taking the photo), already damaged by the first explosion.

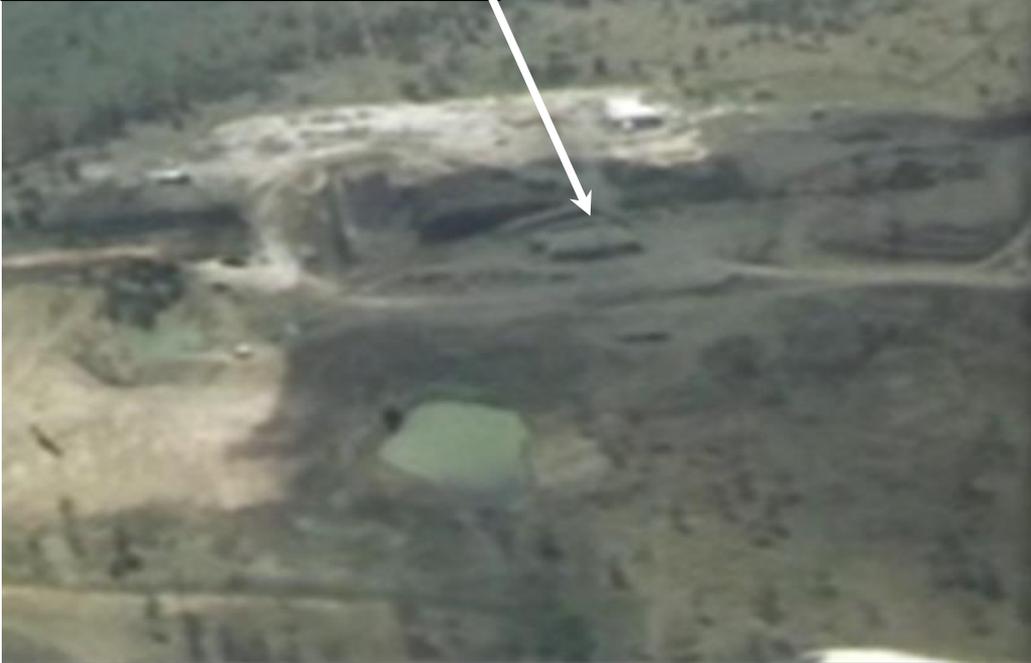
Kianga No. 1 Mine administration – covered by dust and debris violently ejected from the mine following the coal dust explosion (1975).

Where possible mine surface buildings should be positioned out of the direct path of any underground explosion.

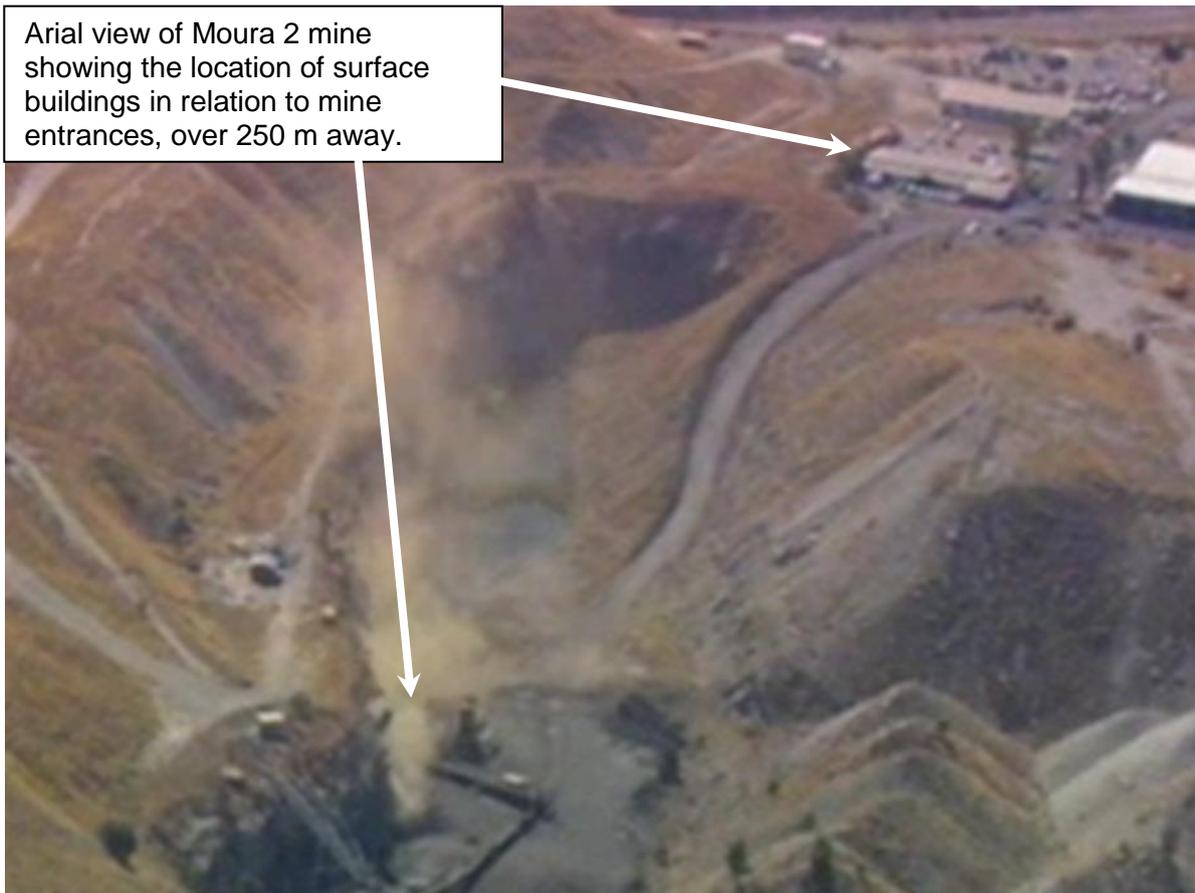
Contamination of the atmosphere around the surface buildings continued after the main blast with smoke continuing to issue from the underground tunnels. This made the Emergency Control Room unfit to use and, as a result, gas analysis equipment was relocated to a safe position several kilometres away in the open cut mine office complex.

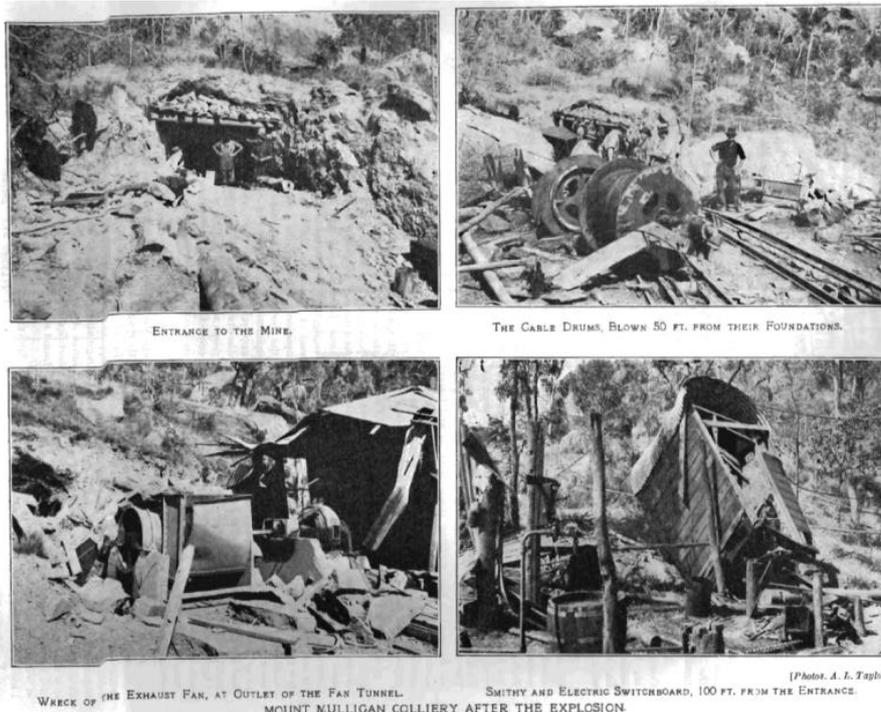
A pair of jig drums, with shafting, bearings, and foundation, weighing approximately 3 tons, and placed immediately above the tunnel entrance, were hurled from their positions down the incline way for a distance of 50 ft. The switch-house, standing about 25 yds. from the pit mouth and to the left of the road, was overturned, and the switchboard was moved from its foundations. The smithy adjoining was completely demolished. The grass for some distance further away was burned, probably by the flame from the explosion.

George Morrison was working On the surface near the pit mouth when he was slightly injured by the blast coming from the tunnel mouth.

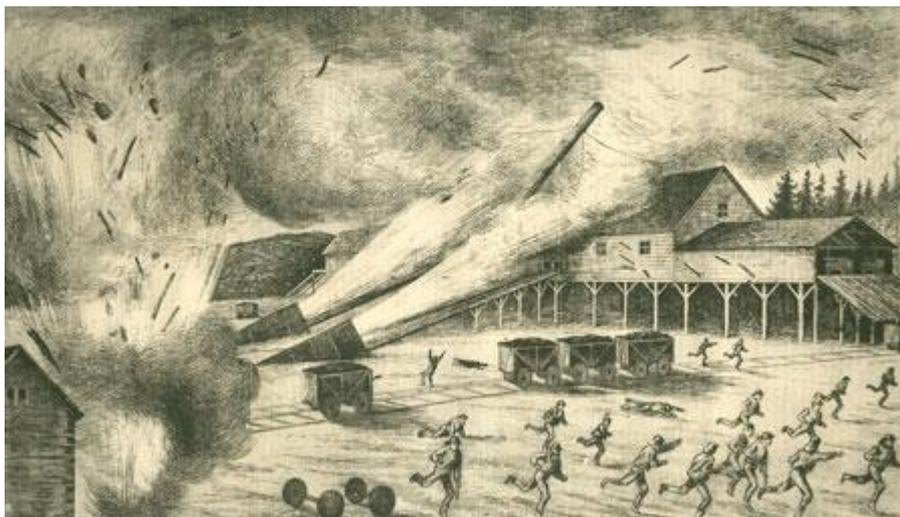
An eyewitness account described: "She looked up and saw men in the distance somersaulting high in the air". Margie Guthro hurried to the pit, learned instantly that her two uncles, surface workers, had been caught and burned to death.

All the buildings that covered the No.4 mine portal were burning. The wives of some of the men trapped in the burning buildings had always corrected anyone who referred to their husbands as "miners" – as if to emphasize, "No, dear, my Leonard is a surface worker", she could keep her man out of danger. But, this time, surface workers were killed.

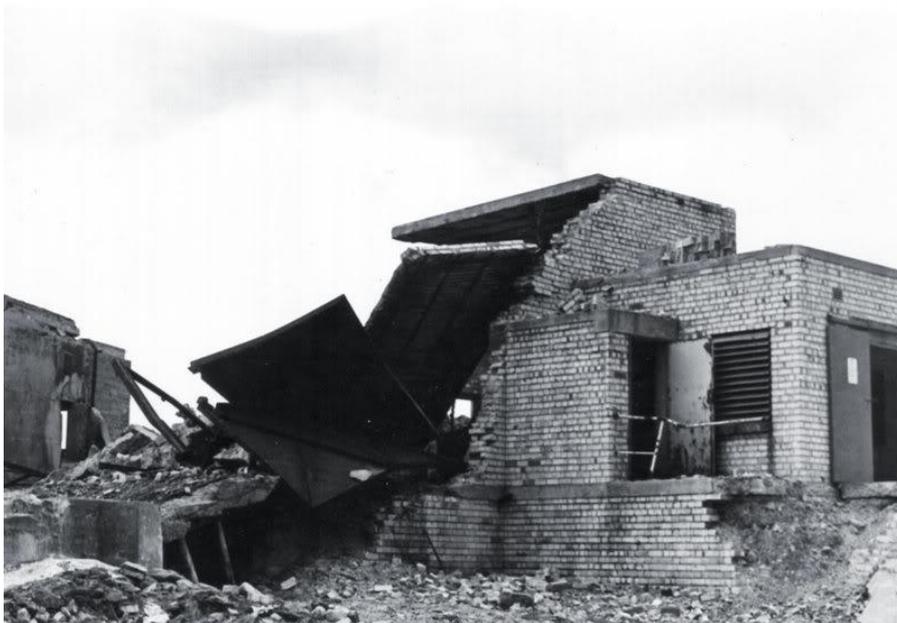
The policeman was blown fifty yards, his box nearly demolished. A heavy trolley used for carrying miners in and out of the shaft shot out like a missile and smashed into a wall lining the top.

Four Africans near the top of the shaft were killed and eight injured, one of whom Fred Bezuidenhout pulled away. The injured man died later.

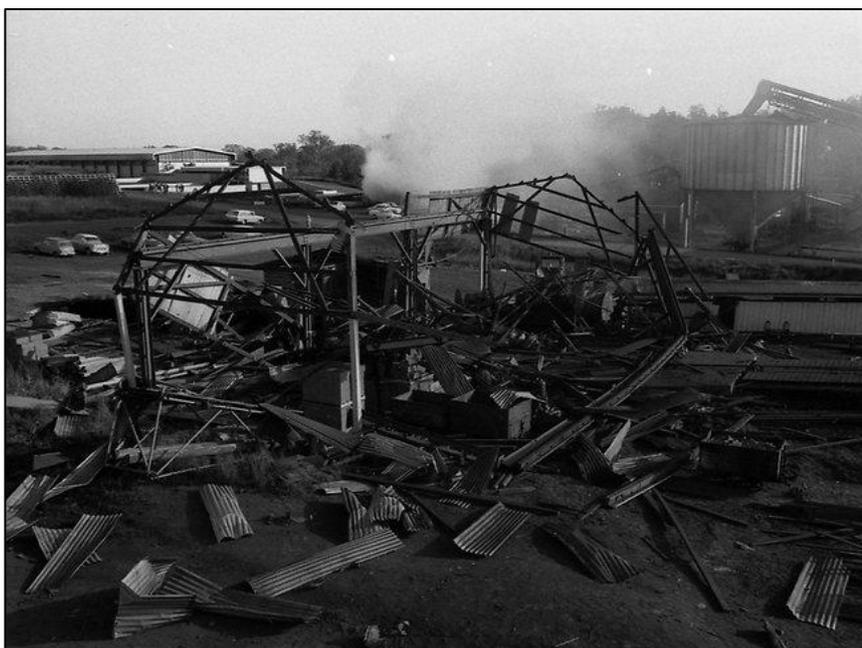
Box Flat Colliery, Ipswich Queensland. 31st July 1972.

On the 31st of July 1972 3 men were killed standing in proximity of a mine entrance at the time of the Box Flat mine explosion near Ipswich. The explosion also killed 14 men underground.

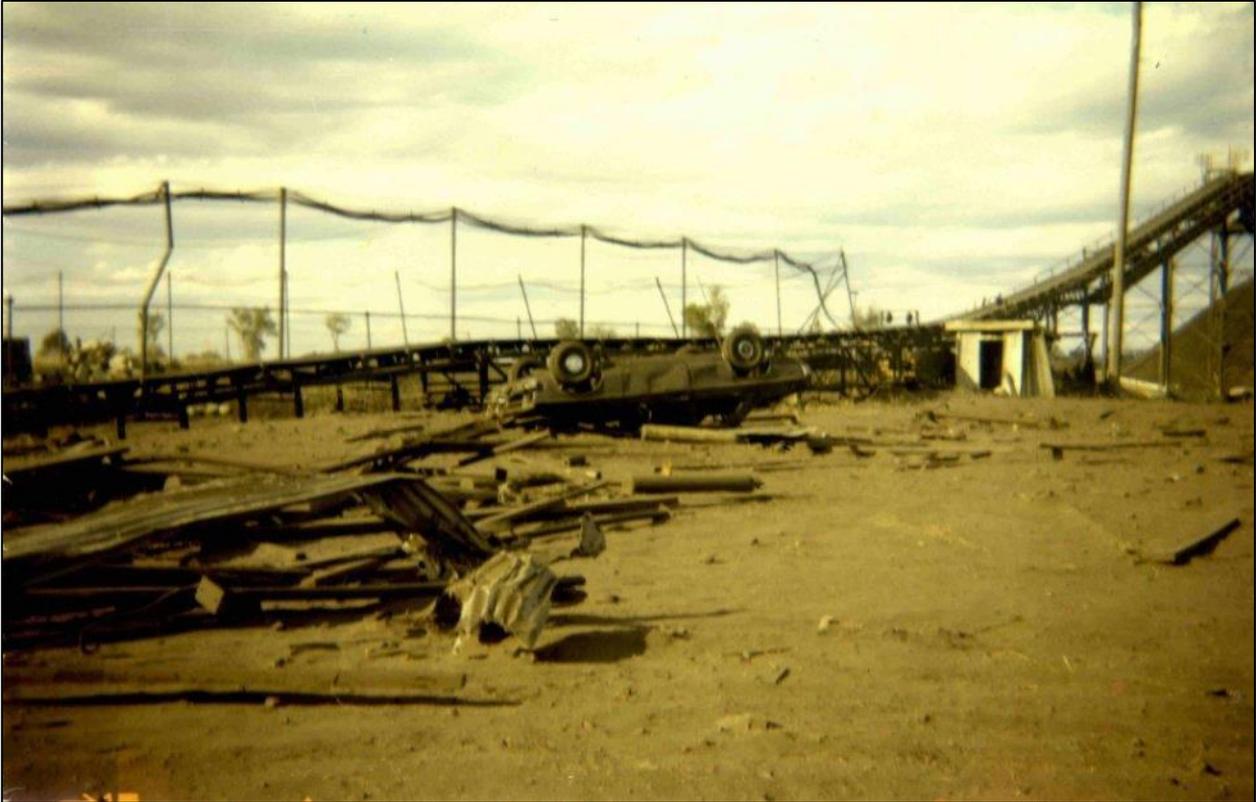
Kianga No. 1 Underground Mine explosion 20th September 1975

In 1975 surface equipment and infrastructure was destroyed in the Kianga disaster, near Moura in Central Queensland which claimed the lives of 13 men underground.

The Kianga No.1 Underground Mine Accident Warden's inquiry specifically recommended:

| <p>(f) Where possible mine surface buildings should be positioned out of the direct path of any underground explosion.</p> |

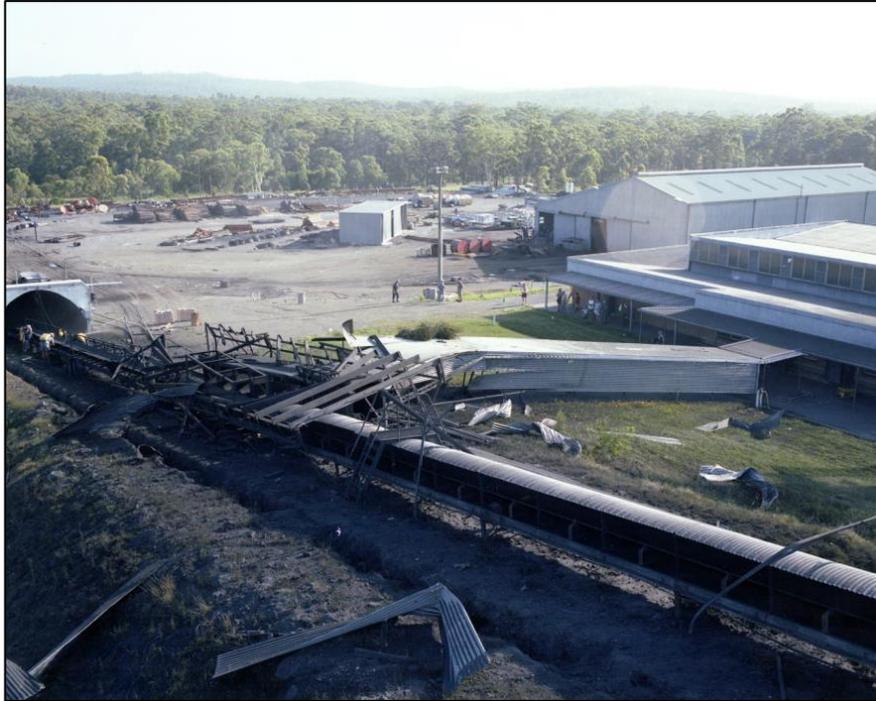
West Wallsend, NSW, 8th of January 1979.

In January 1979 surface infrastructure was severely damaged in the West Wallsend mine explosion. Fortunately no one was killed in the explosion, either on the surface or underground. However, significant infrastructure damage occurred.

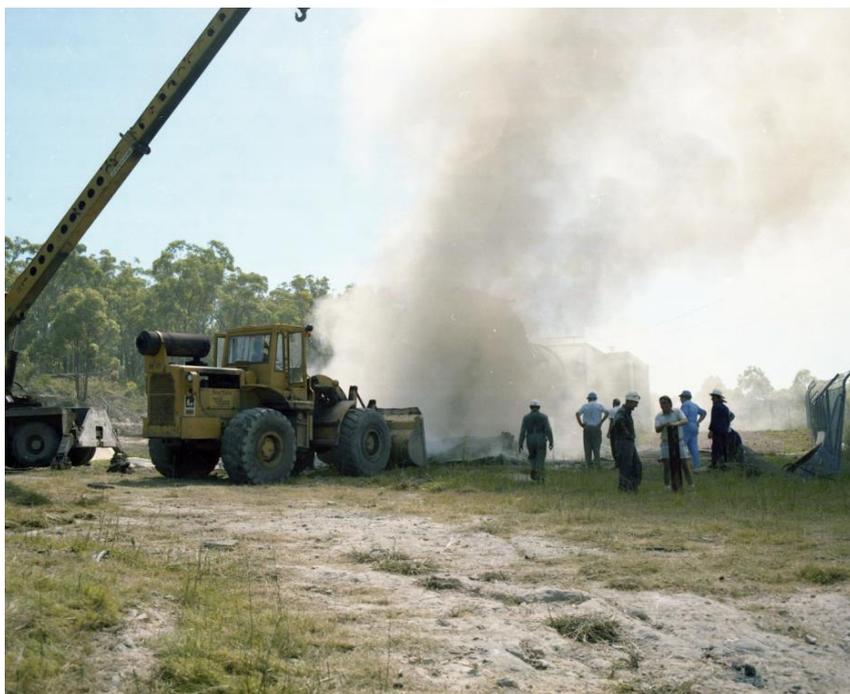
Persons were engaged in a range of activities following the explosion in close proximity to mine entrances. Had there been a secondary explosion, multiple fatalities would almost certainly have resulted.

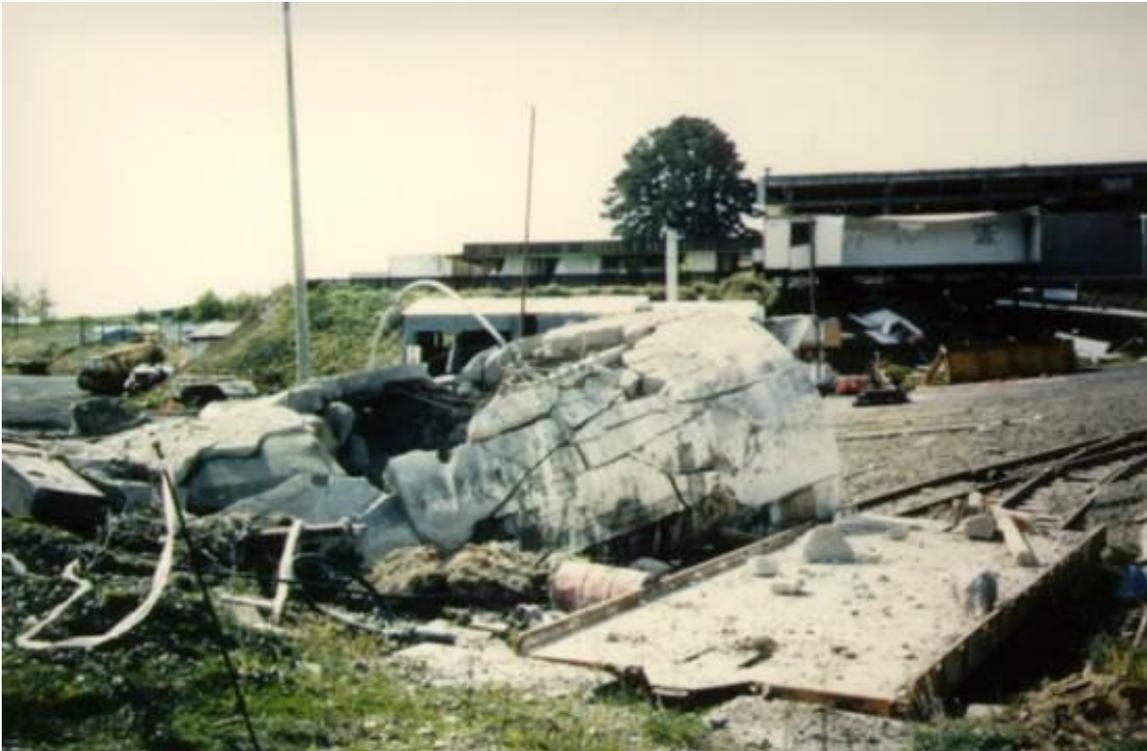
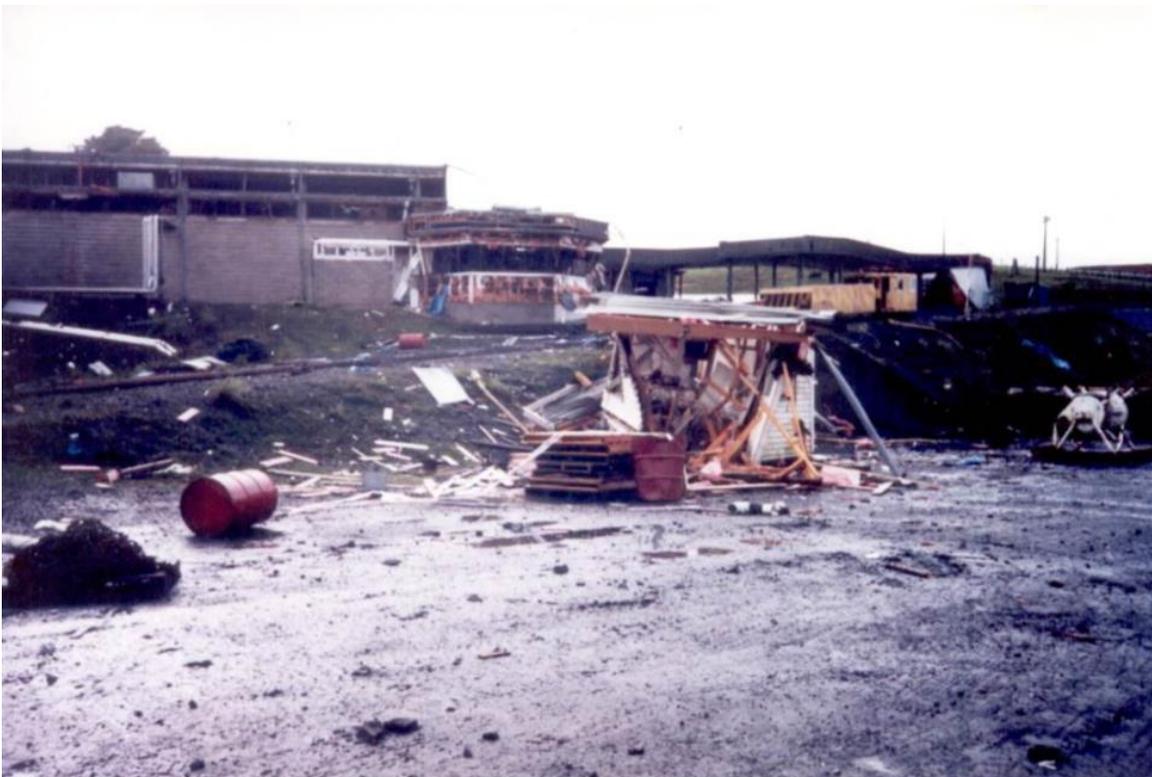
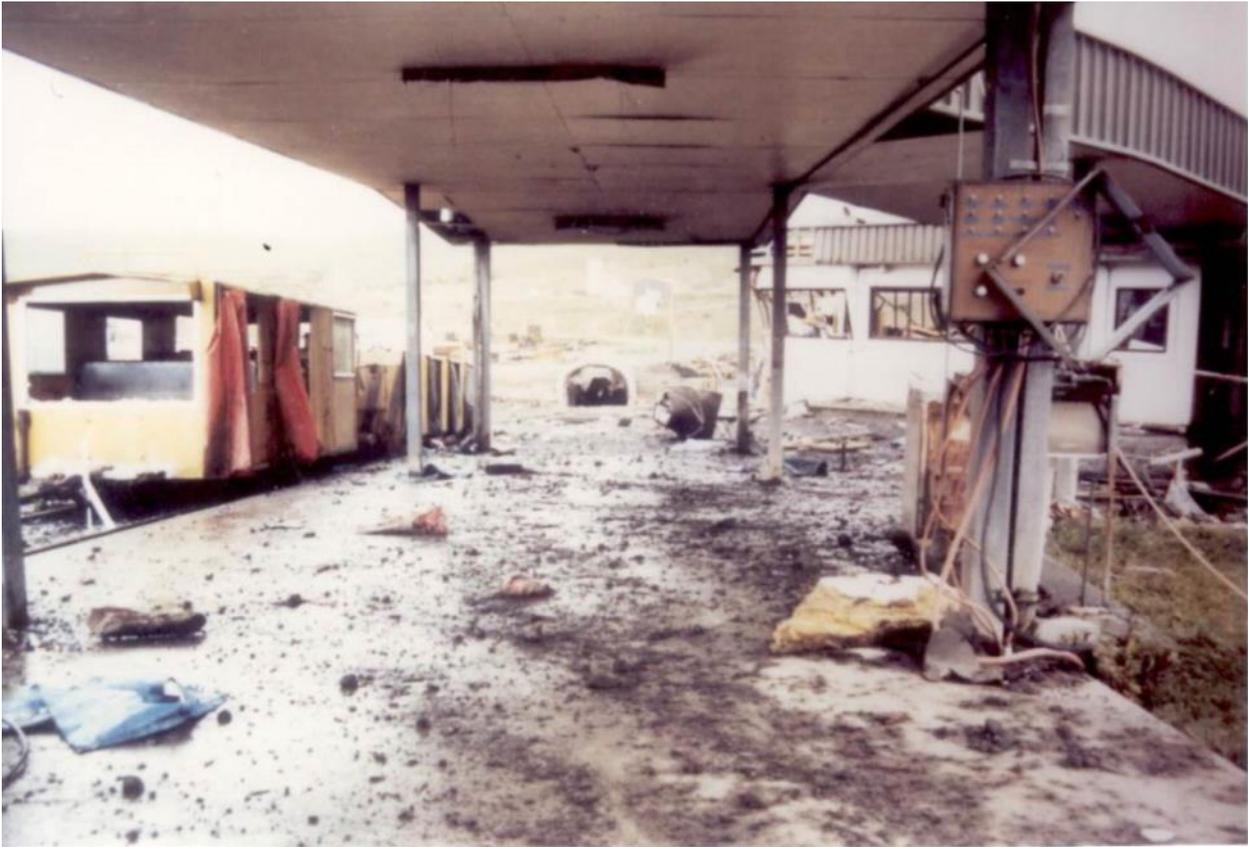
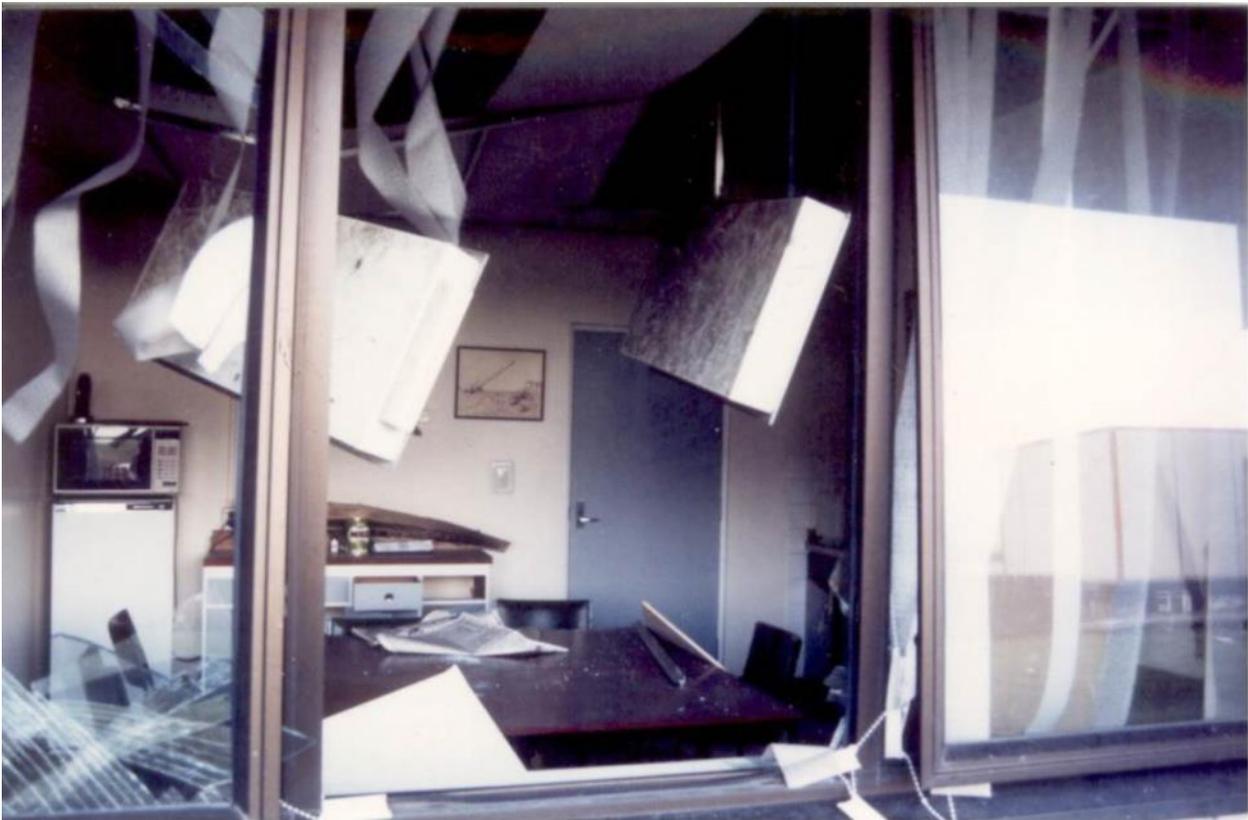
Huntly West Mine, New Zealand 23rd of September 1992.

The Huntly West Mine is probably the most graphic example of what not to do. Mine infrastructure was constructed in direct line with the mine openings. Fortunately the risk of explosion had been identified prior to the explosion and the surface buildings (and the mine) evacuated prior to the explosion (by order of the Chief Inspector).

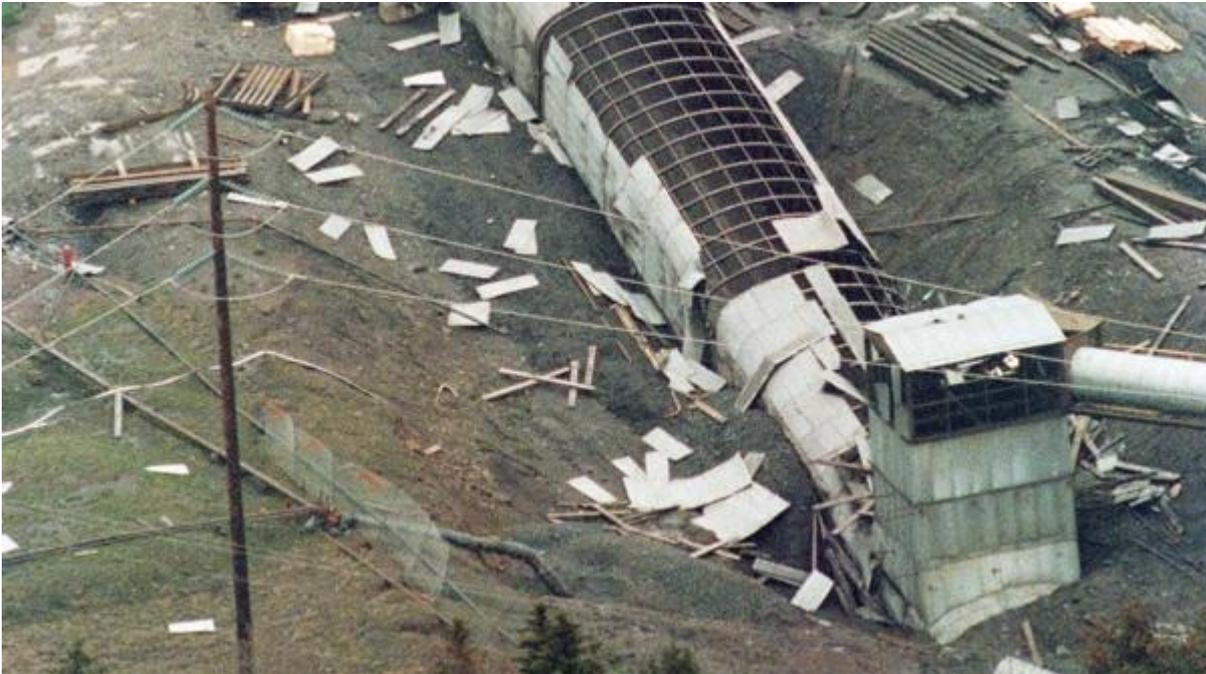
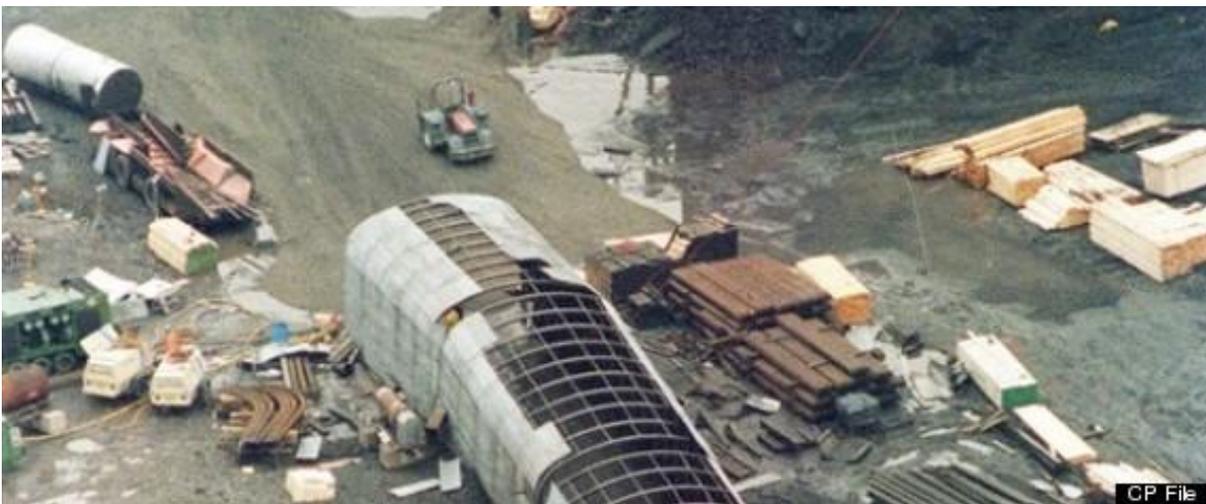
Westray Mine, Nova Scotia, Canada. 9th May 1992

An explosion at the Westray mine in Nova Scotia, Canada killed 26 miners. Substantial damage occurred at the surface of the mine.

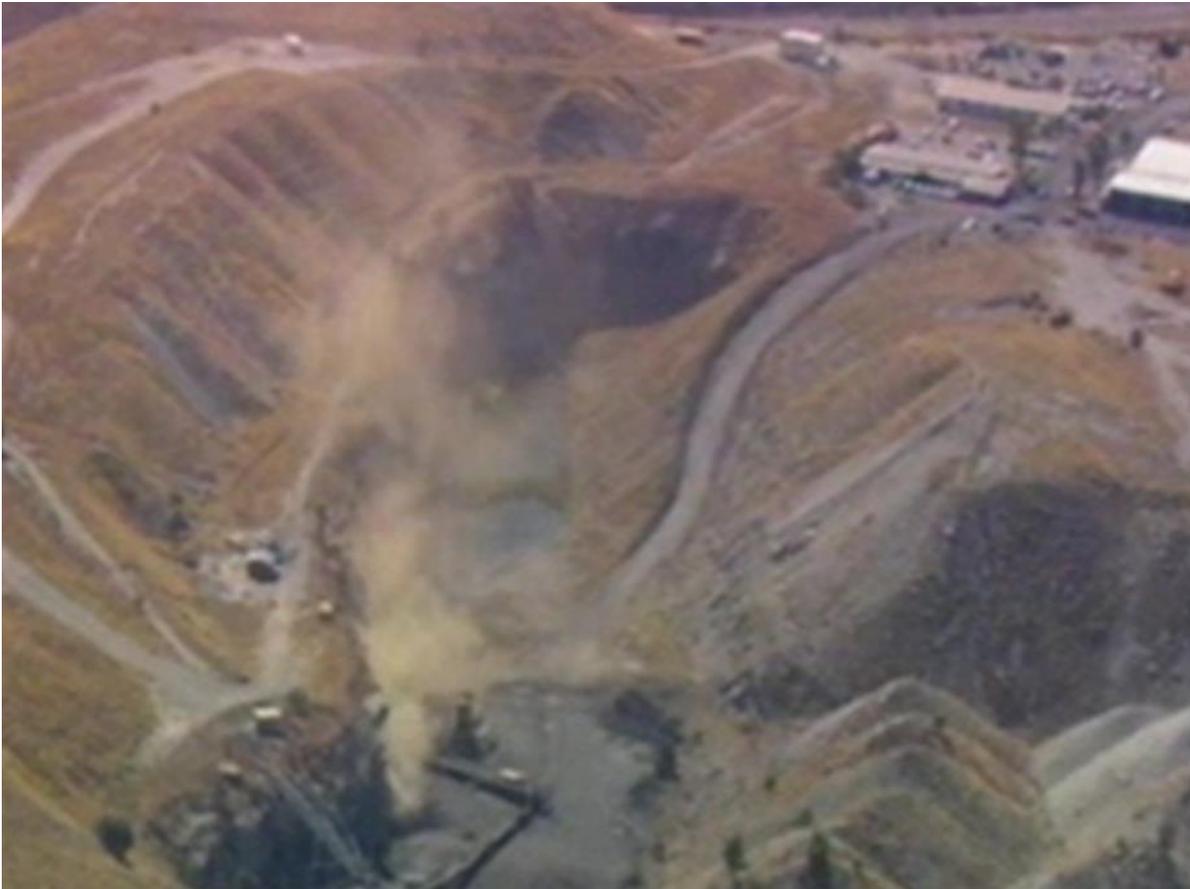
Moura No.2 Underground Mine. 7th of August 1994.

In 1994 at the Moura No.2 Mine disaster, emergency coordinators were forced to evacuate from the surface buildings following the second explosion.

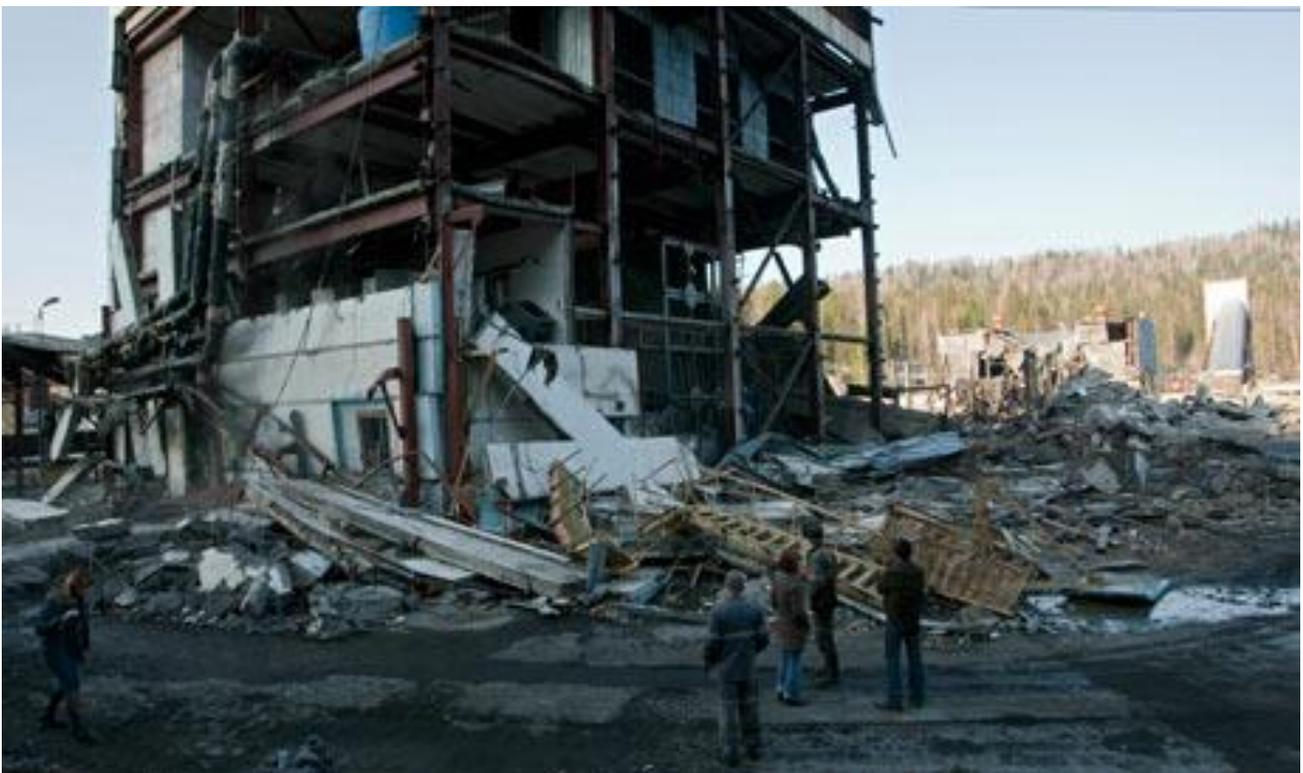
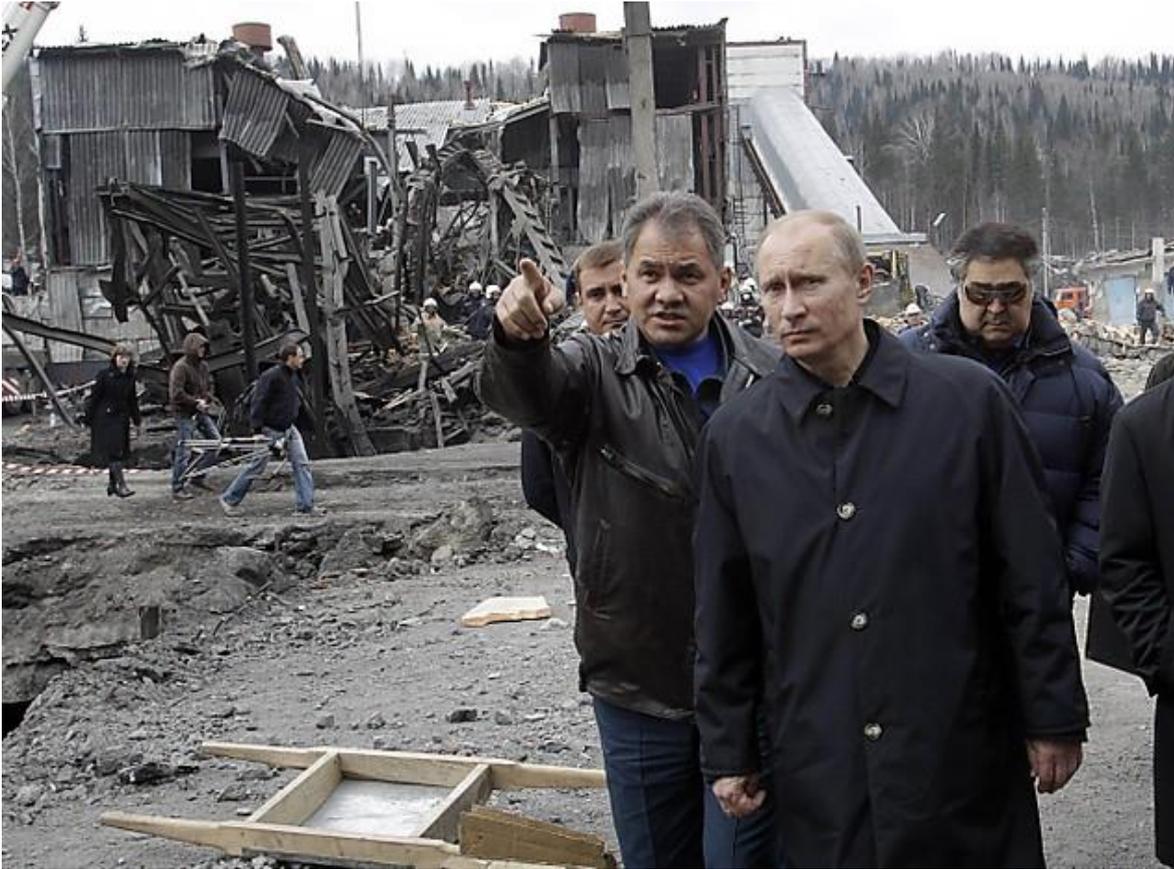
Rescue efforts were suspended after the second blast. By 18 May 2010, 66 people were confirmed to have died, at least 99 injured and 24 remained trapped underground. Mine infrastructure around mine openings was also destroyed.

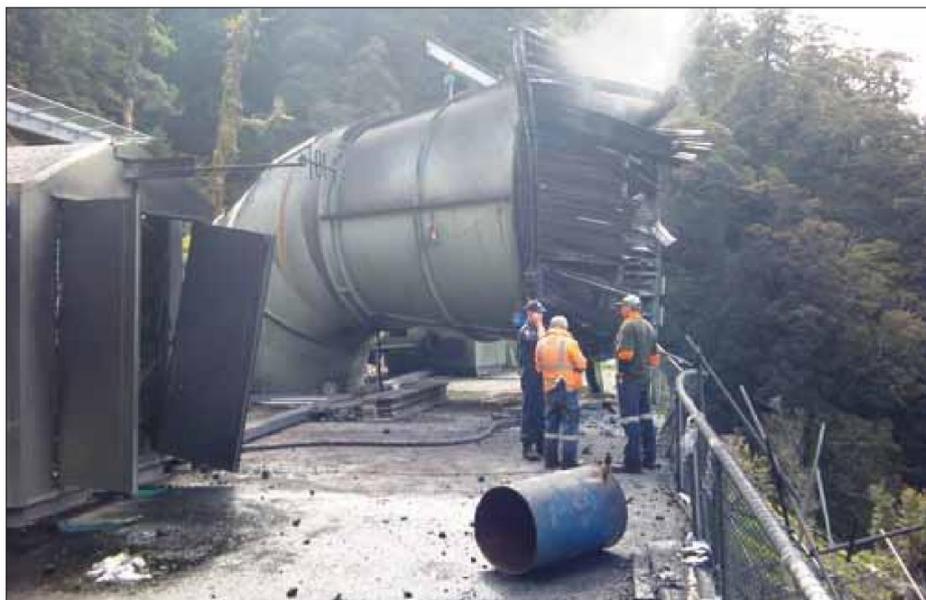
Figure 8.10: The surface fan after the first explosion

In the Pike River Mine Disaster, mine rescuers were prevented from entering the mine but people were not restricted from being in proximity to mine entrances. It is arguable that it was only luck that prevented fatalities of persons on the surface at Pike River.

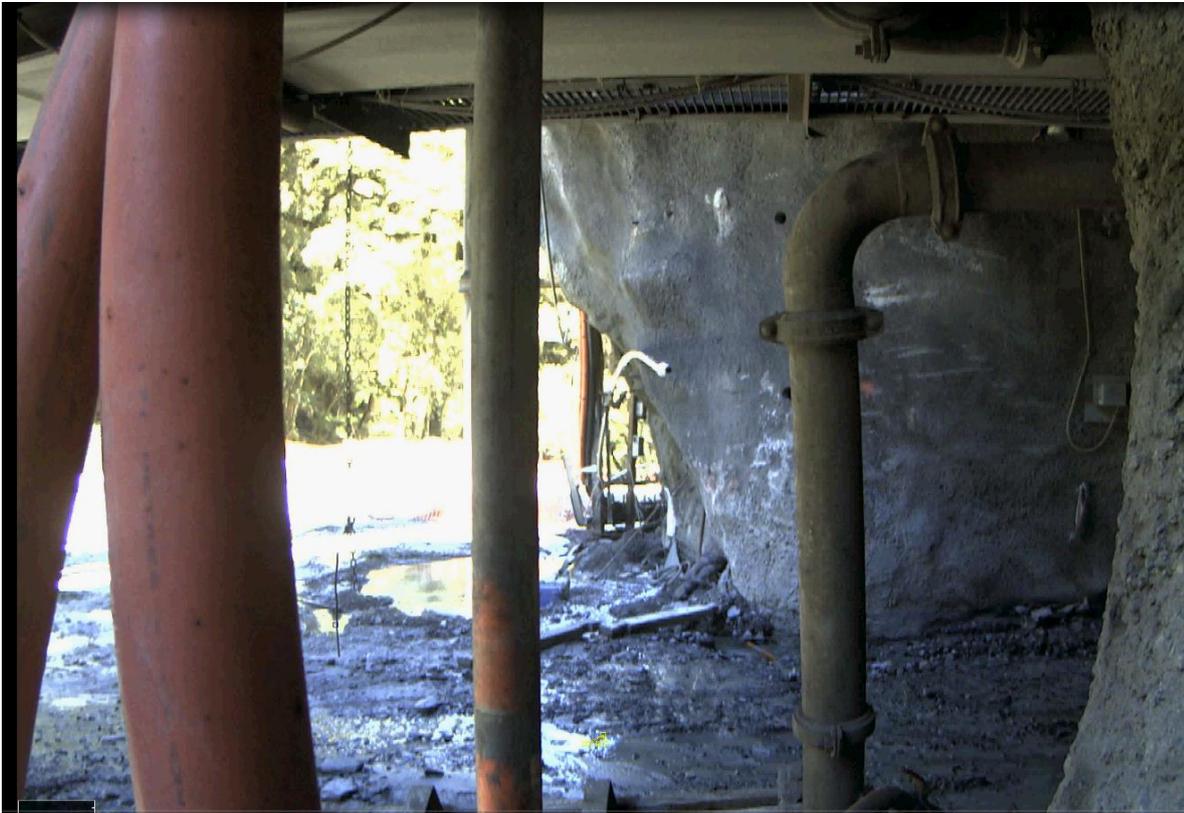
Of Critical importance of the assessment of the events at Pike River was the portal video camera and the innocuous piece of tape on the opposite rib. This allowed an analysis of the potential cause of the explosion and of the survivability of the persons in the mine.

It was unfortunate that there was no trigger to review the footage when there was a concern for the safety of persons in the mine. This should be an automatic trigger for mines today. Every mine should have a camera on the mine opening and a trigger to review the footage should any concern be raised about an event in the mine.

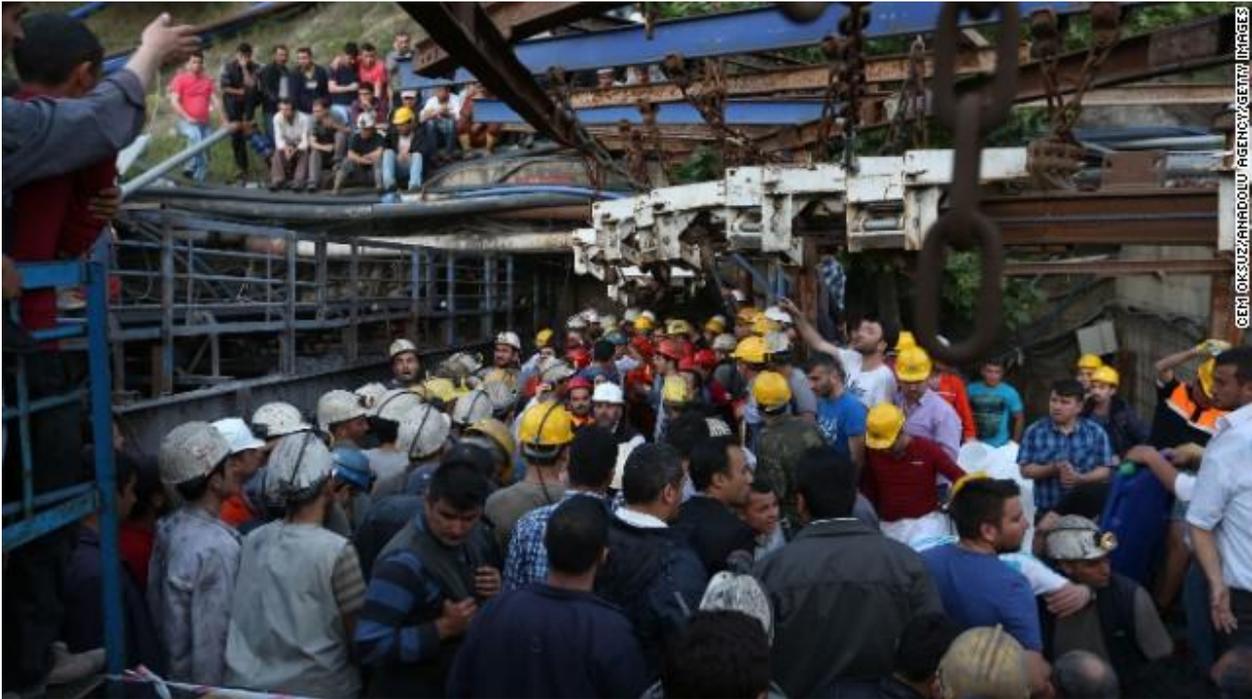
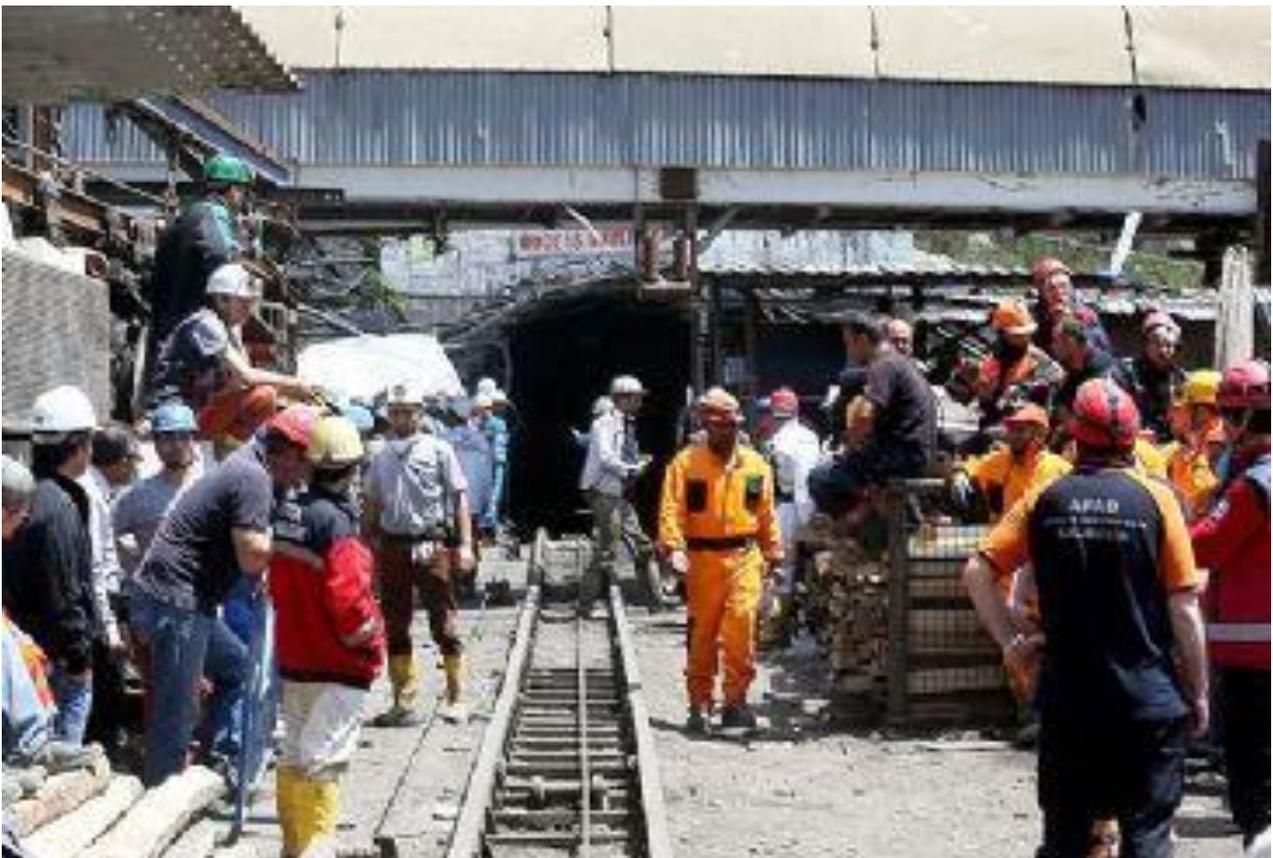
[Soma Turkey May 2014](#)

Whatever the cause of the disaster, 301 miners died following a fire in the mine. Hundreds of people gathered around the mine entrance to wait for news of rescued miners. Had there been a mine explosion, the death toll could have easily doubled.

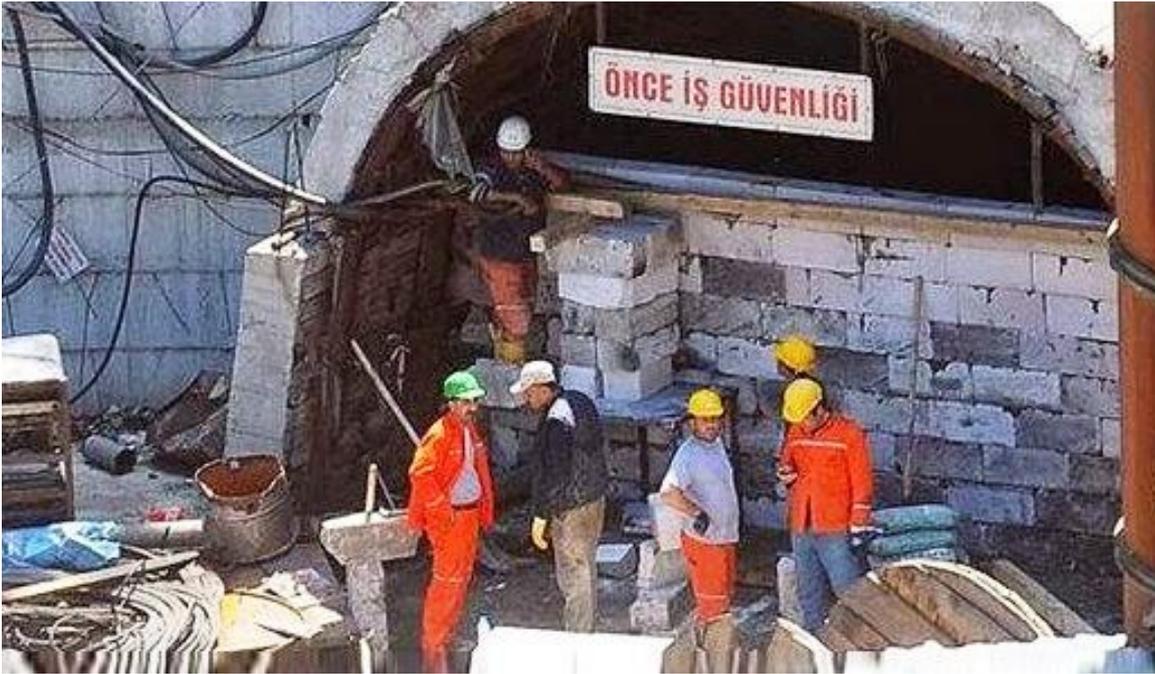
Even better, without any sealing capability, mine workers stand in front of the portal to seal the mine.
