ARG/87/3

LONDONDERRY OCCUPATIONAL SAFETY CENTRE

MOURA INVESTIGATION: FINAL REPORT

POSSIBLE CAUSES AND EXPLOSION DEVELOPMENT

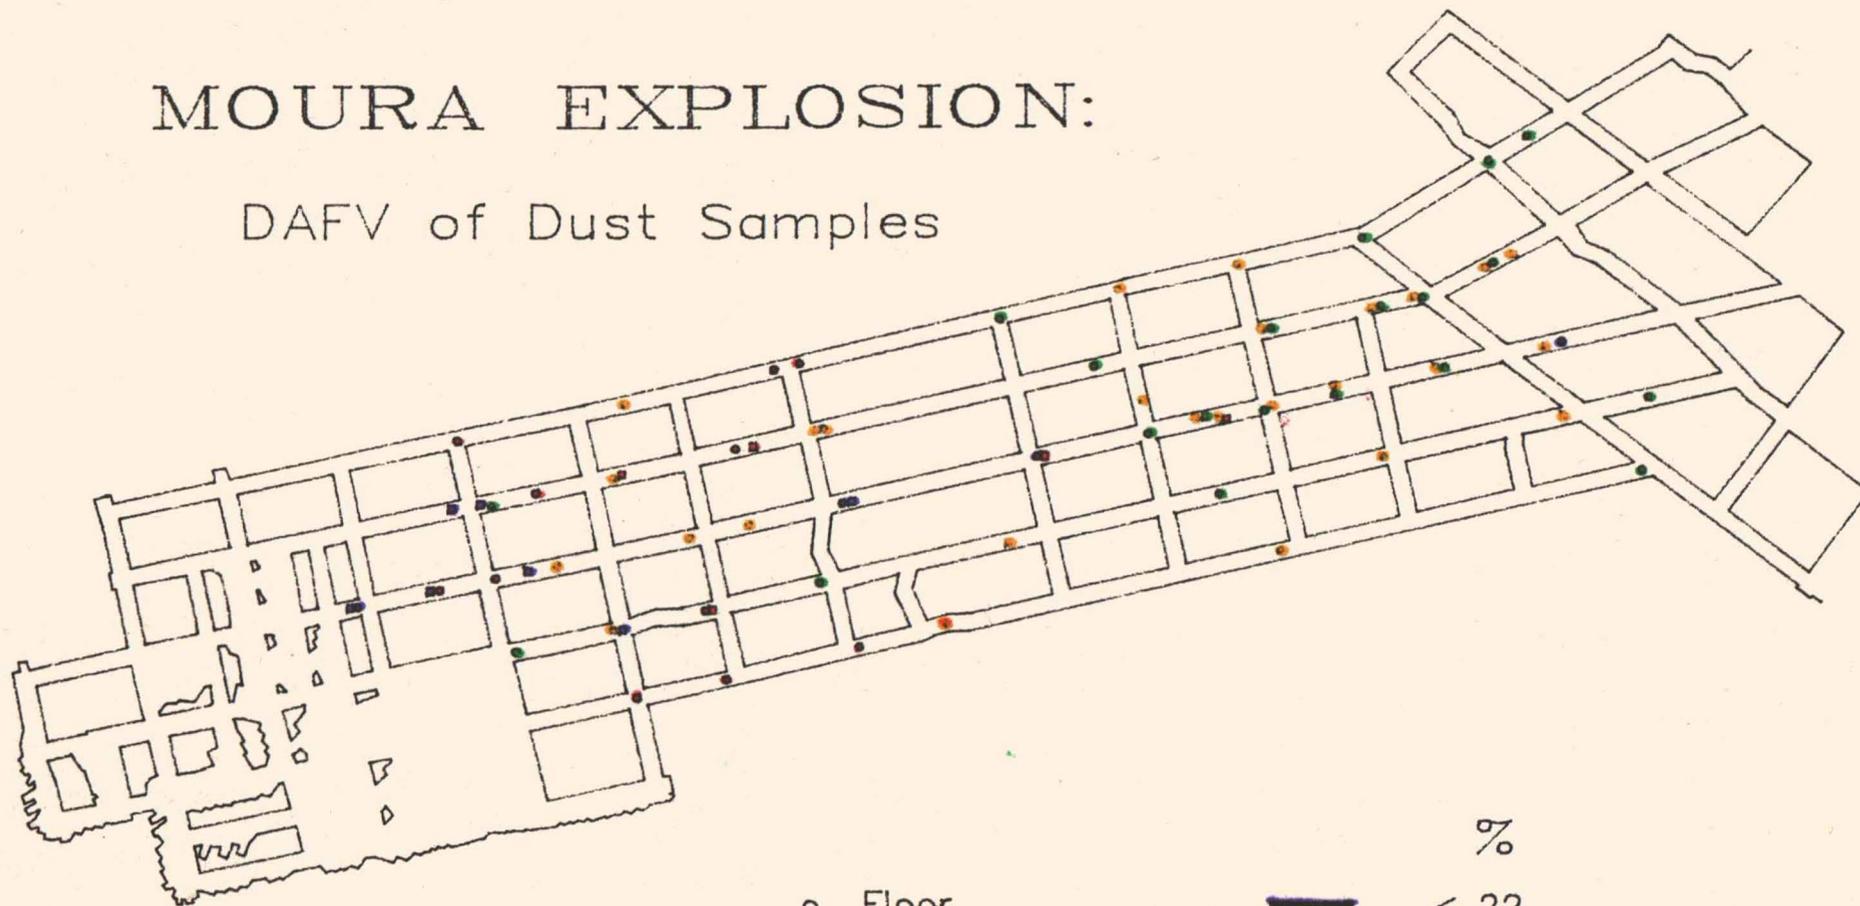
Figure 1.

The mine contains methane and coal dust. Both could have been the source of fuel for first ignition. Analysis of dust samples collected after the explosion show that the volatile content of the dust has dropped from the expected value around 33%. (Figure 1). This is indicative of a coal dust explosion. It doesn't necessarily imply that coal dust was the first fuel ignited.

The dry ash free volatile content of coal dust obtained from samples after the explosion (figure 1) show most combustion occurring along the belt roadway and in the vicinity of 26ct in No 4 heading. This is also consistent with an increased residence time of flame in these areas.

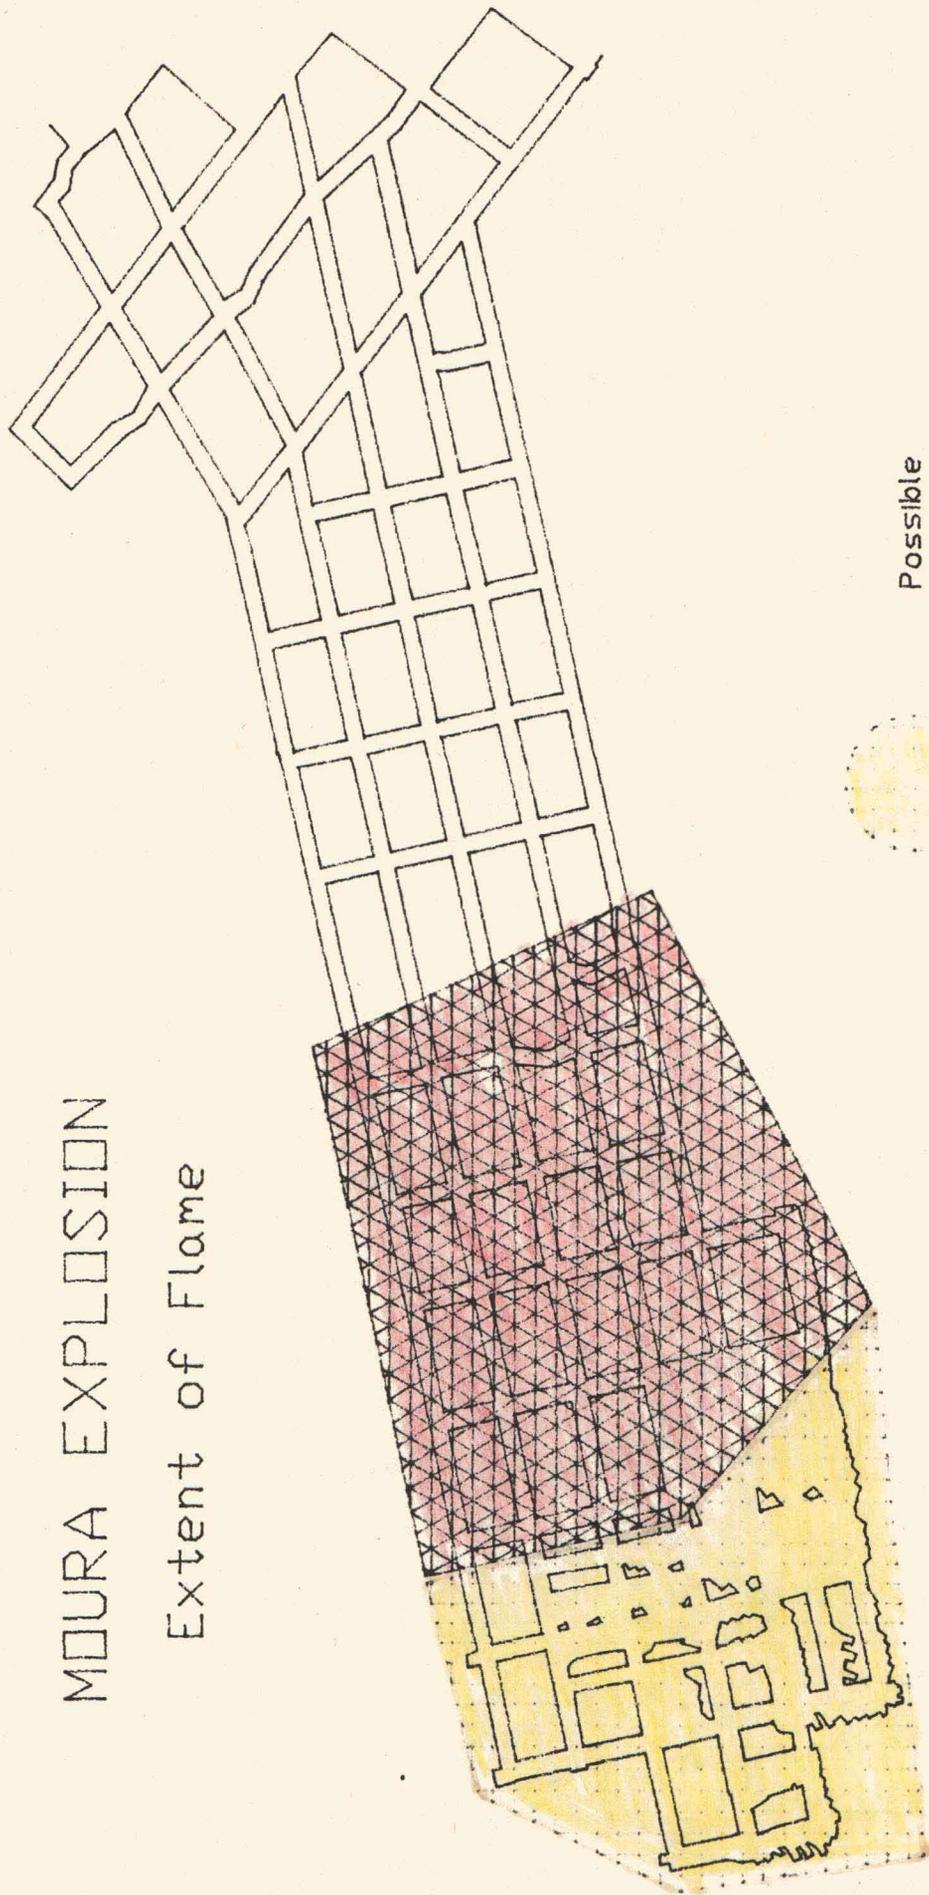
Figure 2.

The concentration of either gas or dust has to be above the lower flammable limit (LEL) before an explosion can be initiated. Figure 2 shows the extent of flame during the explosion. The red (triple hatch) area corresponds to the area found from the examination of dust and plastic materials recovered after the explosion. No samples of dust could be recovered from the yellow (double hatch) area on safety criteria. It is therefore not known how far flame extended into the goaf.

Estimates of minimum quantity of gas (LEL), based on Figure 2, that could cause this area of flame is between 280m^3 and 900m^3 , assuming no participation from any coal dust. The latter figure is based on revised estimates of the goaf volume given to me by the Queensland Department of Mines. As coal dust was involved in this explosion (Figure 1), then not as much gas would be needed for ignition.

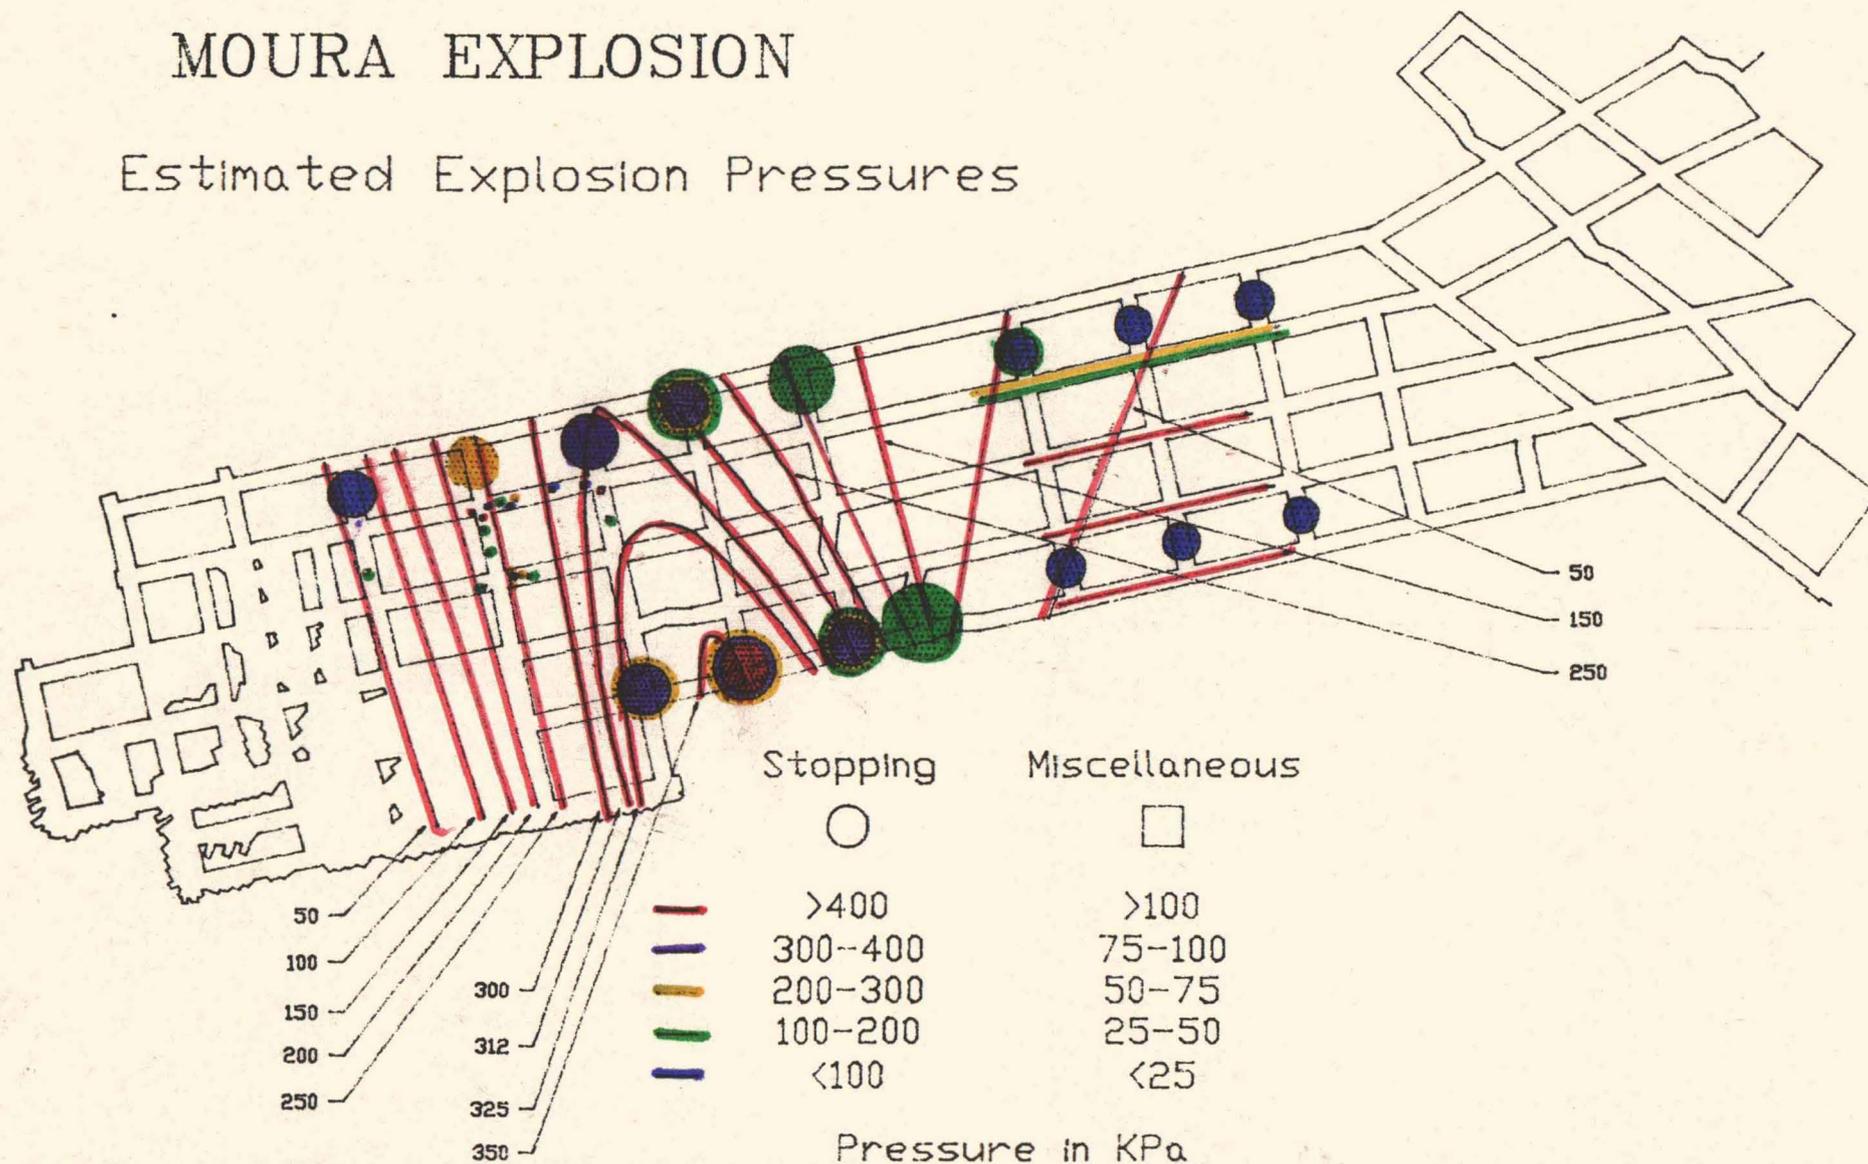
Figure 3.

Figure 3 shows the estimated pressures developed by the explosion.

The contours were obtained from the distances that bricks were moved from the stoppings between No's 4 and 5 headings and between No's 1 and 2 headings assuming that the dynamic pressure lasted for about 0.2s. The pressure was greater towards the south (a larger time would lead to lower pressures but the trend would remain the same) around No's 1, 2, and 3 headings and 24ct. This is consistent with the explosion being more confined in this area due to water in No's 1, 2, and 3 headings in the swilley between 22ct and 23ct. The higher pressures are consistent with an acceleration of the explosion in this area most likely by the belt roadway where partial blockage increases the rate of turbulence and hence the rate of energy release.

One consequence of the confinement of pressure and subsequent relief to the north would be to increase the length of time that dynamic pressure and heat was acting on objects, compared with a single explosion moving only in one direction. This is seen on figure 3 by the overprediction of pressures associated with the water being pushed outward along headings No's 1, 2, and 3 and associated with movement of prep-seal doors and tyres along heading No 4. Increasing the time to about 1 second instead of 0.2 seconds decreases the estimated pressures to about those estimated from the stopping data.

The pressure in the vicinity of 26ct would be about 200 KPa at the upper limit and about 50KPa at the lower limit (figure 3). These limits correspond to air velocities of 280 m/s and 100 m/s respectively: enough to knock a man over. These velocities are also enough to move an 18 tonne shuttle about 2cm sideways: certainly enough to lift the vehicle up on its wheel base. Hull could have been trapped under the shuttle as a result of the explosion. Furthermore, air velocities in excess of 100m/s can

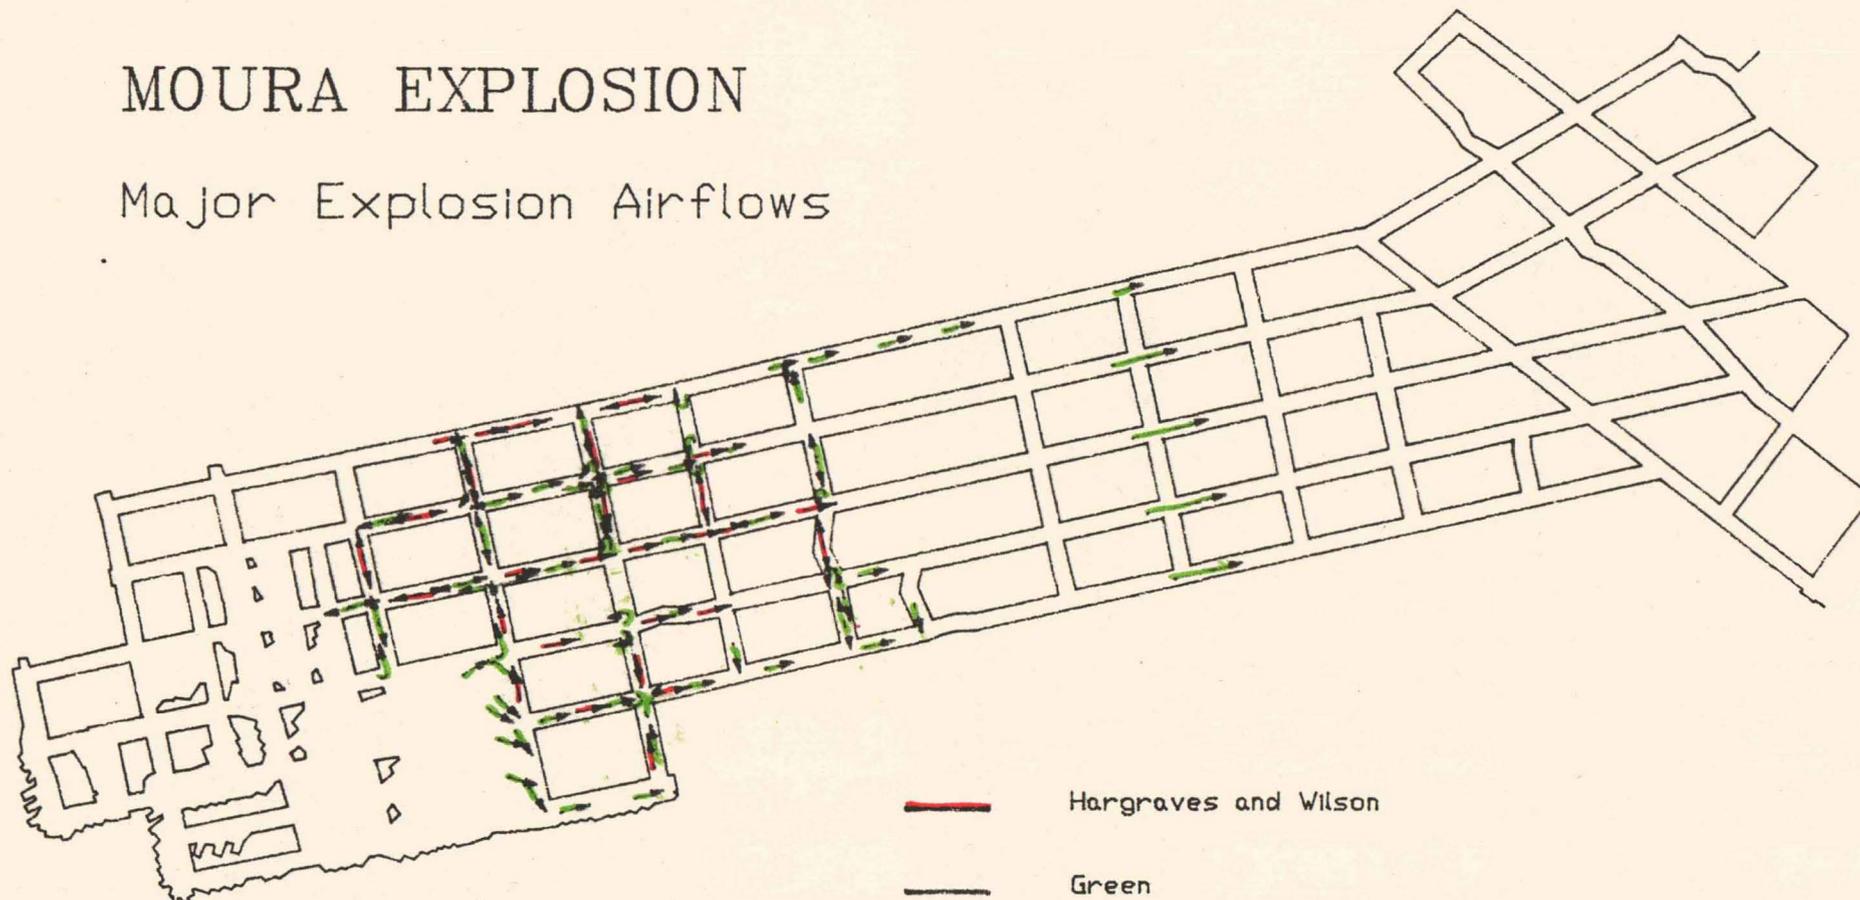
Figure 4.

Figure 4 shows the major airflows during the explosion obtained from observation of dust deposition and scouring of roof bolts, plates and props. The observed pattern fits with a main flow moving outward and a second flow moving inward towards the north west of the mine. This is also consistent with a high pressure zone on the south side of the mine trying to relieve the pressure to the north, reversing the flow north west and going with the outward flow to the north east. The water in headings 1, 2, and 3 acted as a water barrier, quenching the explosion. This is shown by the more rapid decay of pressure on the south side of the mine outbye of 22ct. To the north the decay was slower due to less water on that side of the mine.

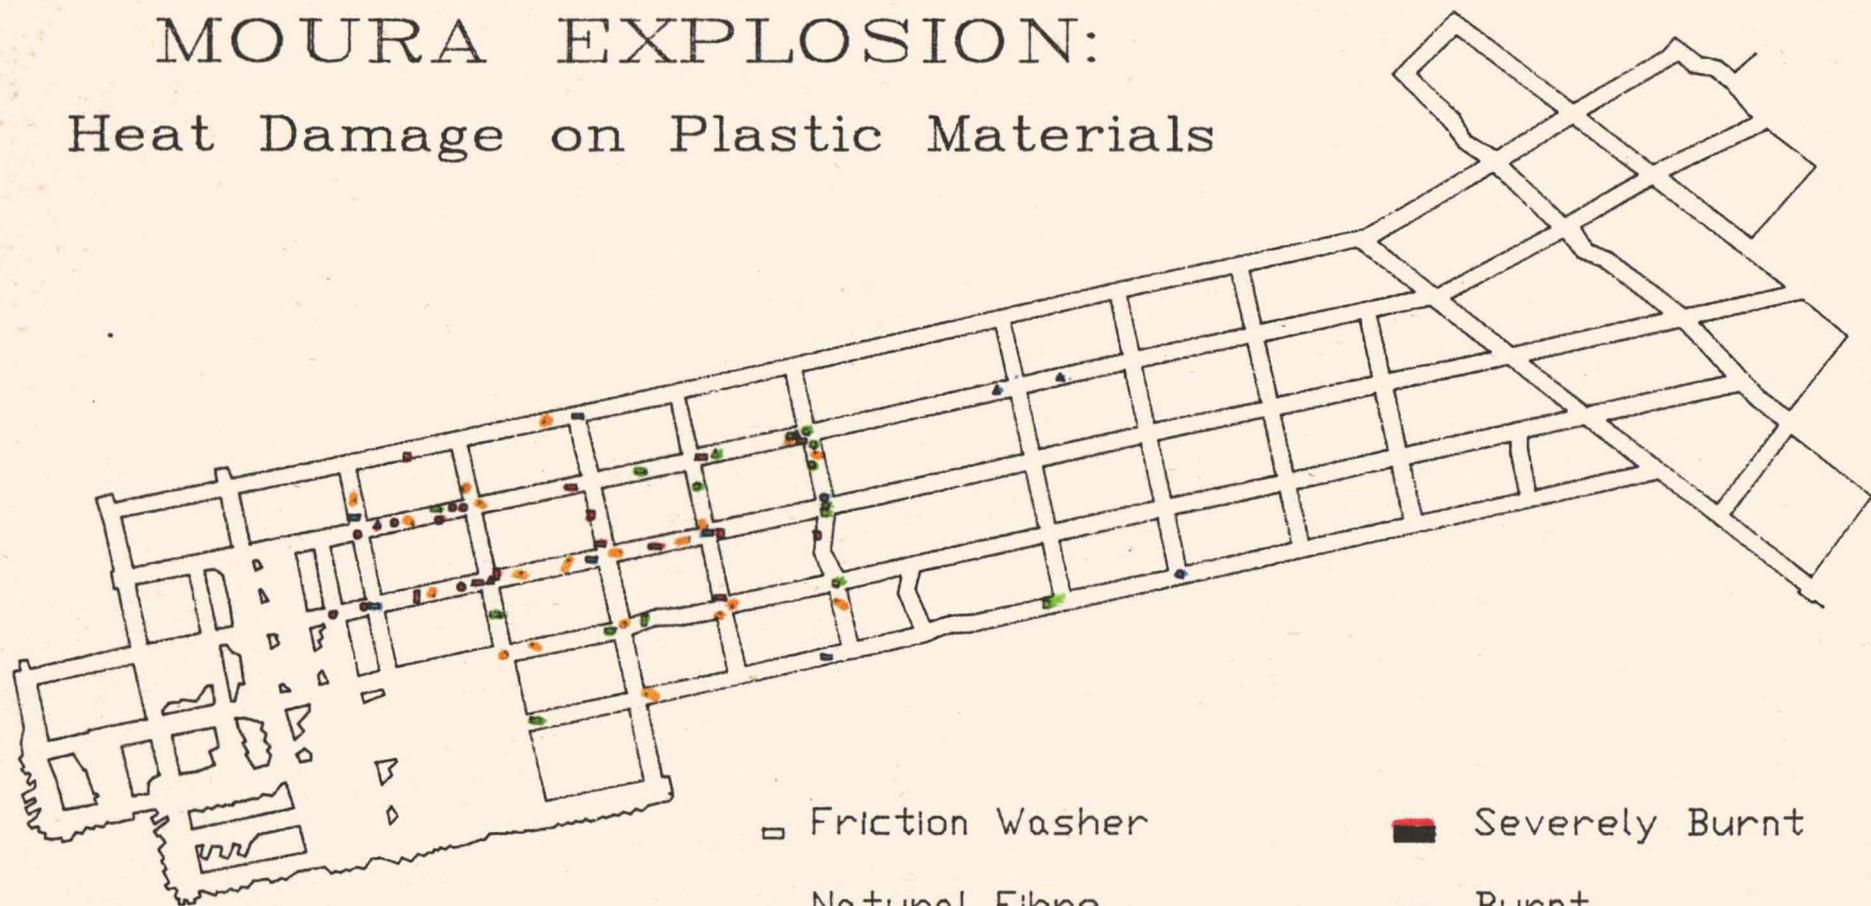
Figure 5.

Figure 5 shows the heat damage caused to various objects in the mine. The main heat damage occurred around 26ct in No's 3 and 4 headings and along the belt roadway (No 3 heading) as far as 24ct. This pattern of damage is consistent with increased residence time of the flame due to reversal of the airflow in this region.
