Investigation into Potential Lightning Ignition Sources Blakefield South Mine

20th February 2012
Report 00182gp

Gillespie Power Consultancy

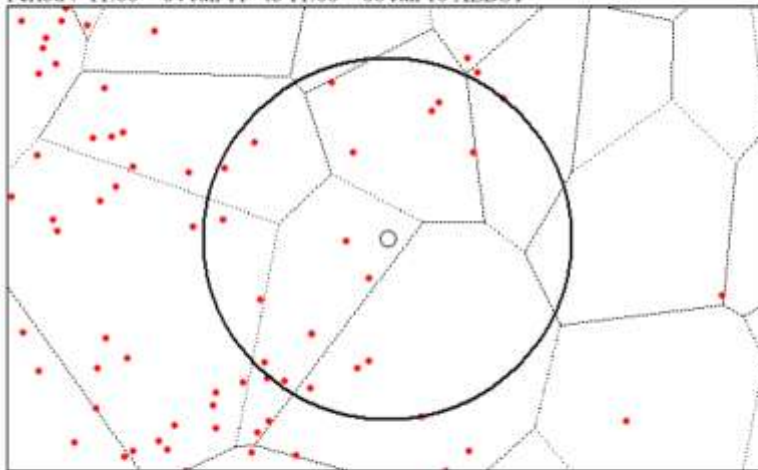
Zoom View

This view shows an area, centred on the location. The list of strokes gives the detected location, time, date, polarity and amplitude for close strokes detected. Distance relates to location given above. The circle shown has a 10 km radius.
