**REPORT ON AN
ACCIDENT**

**KIANGA NO. 1.
UNDERGROUND MINE**

**SATURDAY, 20th SEPTEMBER,
1975.**

WARDEN'S INQUIRY

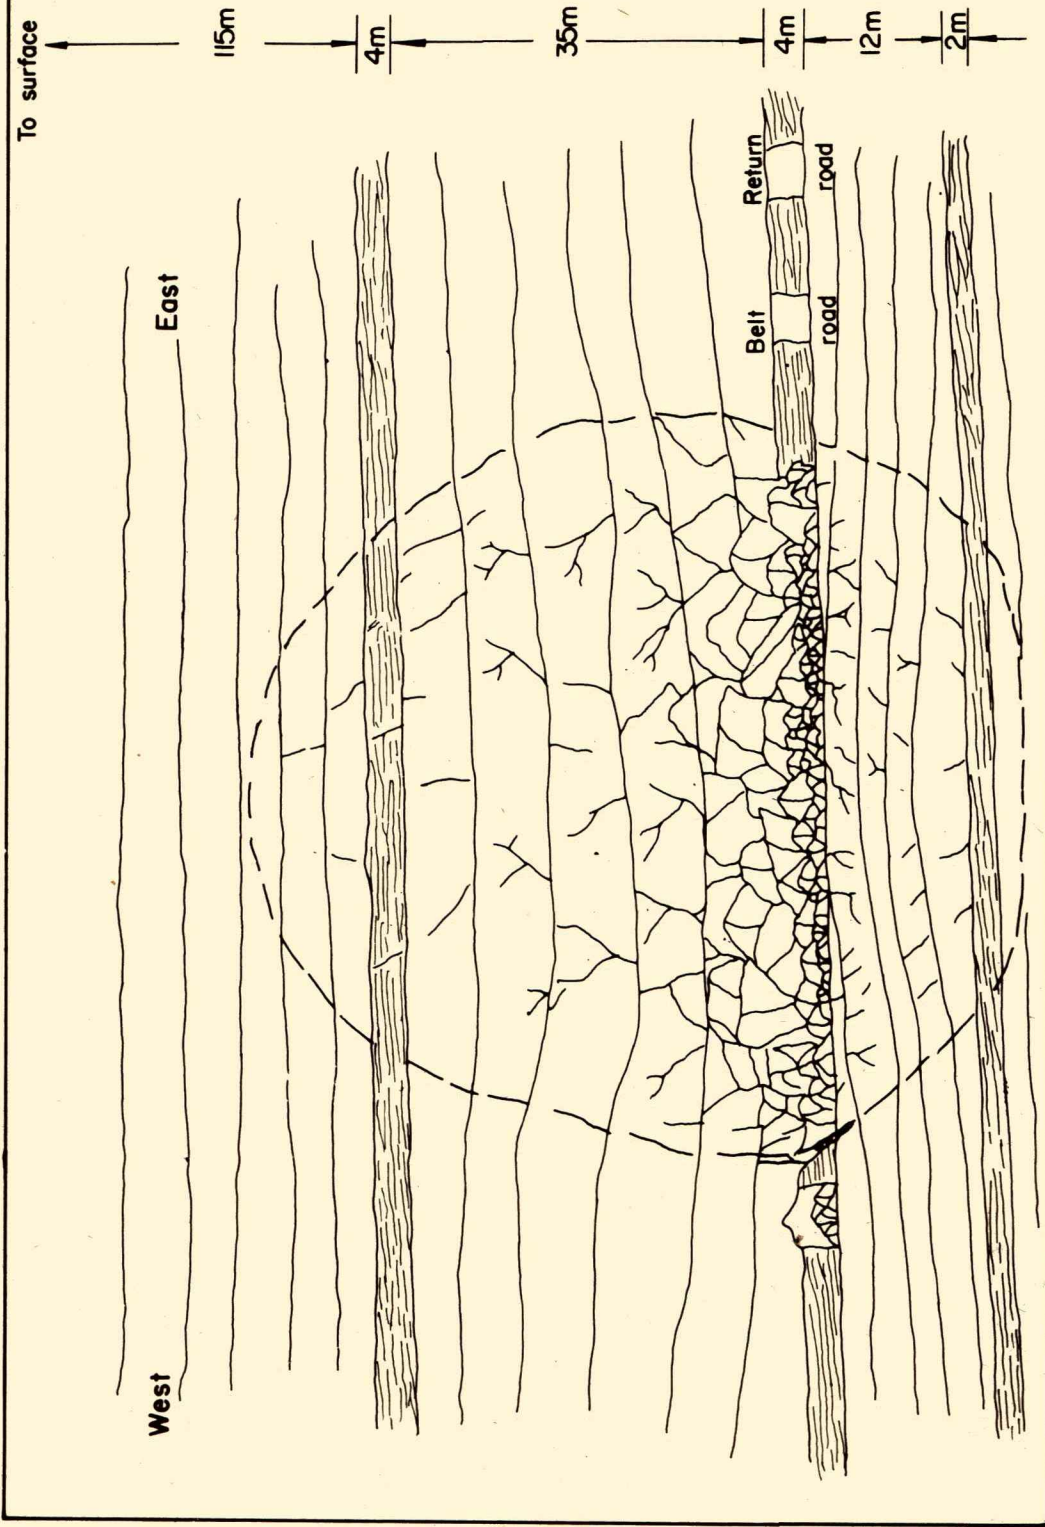
FIG. 1.

It would appear from the evidence of Deputy Stafford that the roof in the entry and fender section of 4 North caved rapidly and completely following extraction of the fender between entries. Considering the caved superjacent strata, (coal, shales, siltstone and sandstone) they, when broken, would occupy a volume of approximately 150% of their solid

volume. This means that the strata above the seam would cave for approximately twice the seam thickness, thereafter this caved material would offer some support to overlying beds which would be subjected to bed separation and fracturing. The degree of bed separation and fracturing becoming less intense as one proceeds away from the workings. (See Appendix "E")

DIAGRAMMATIC SECTION OF 4N GOAF
Based on borehole NS 55

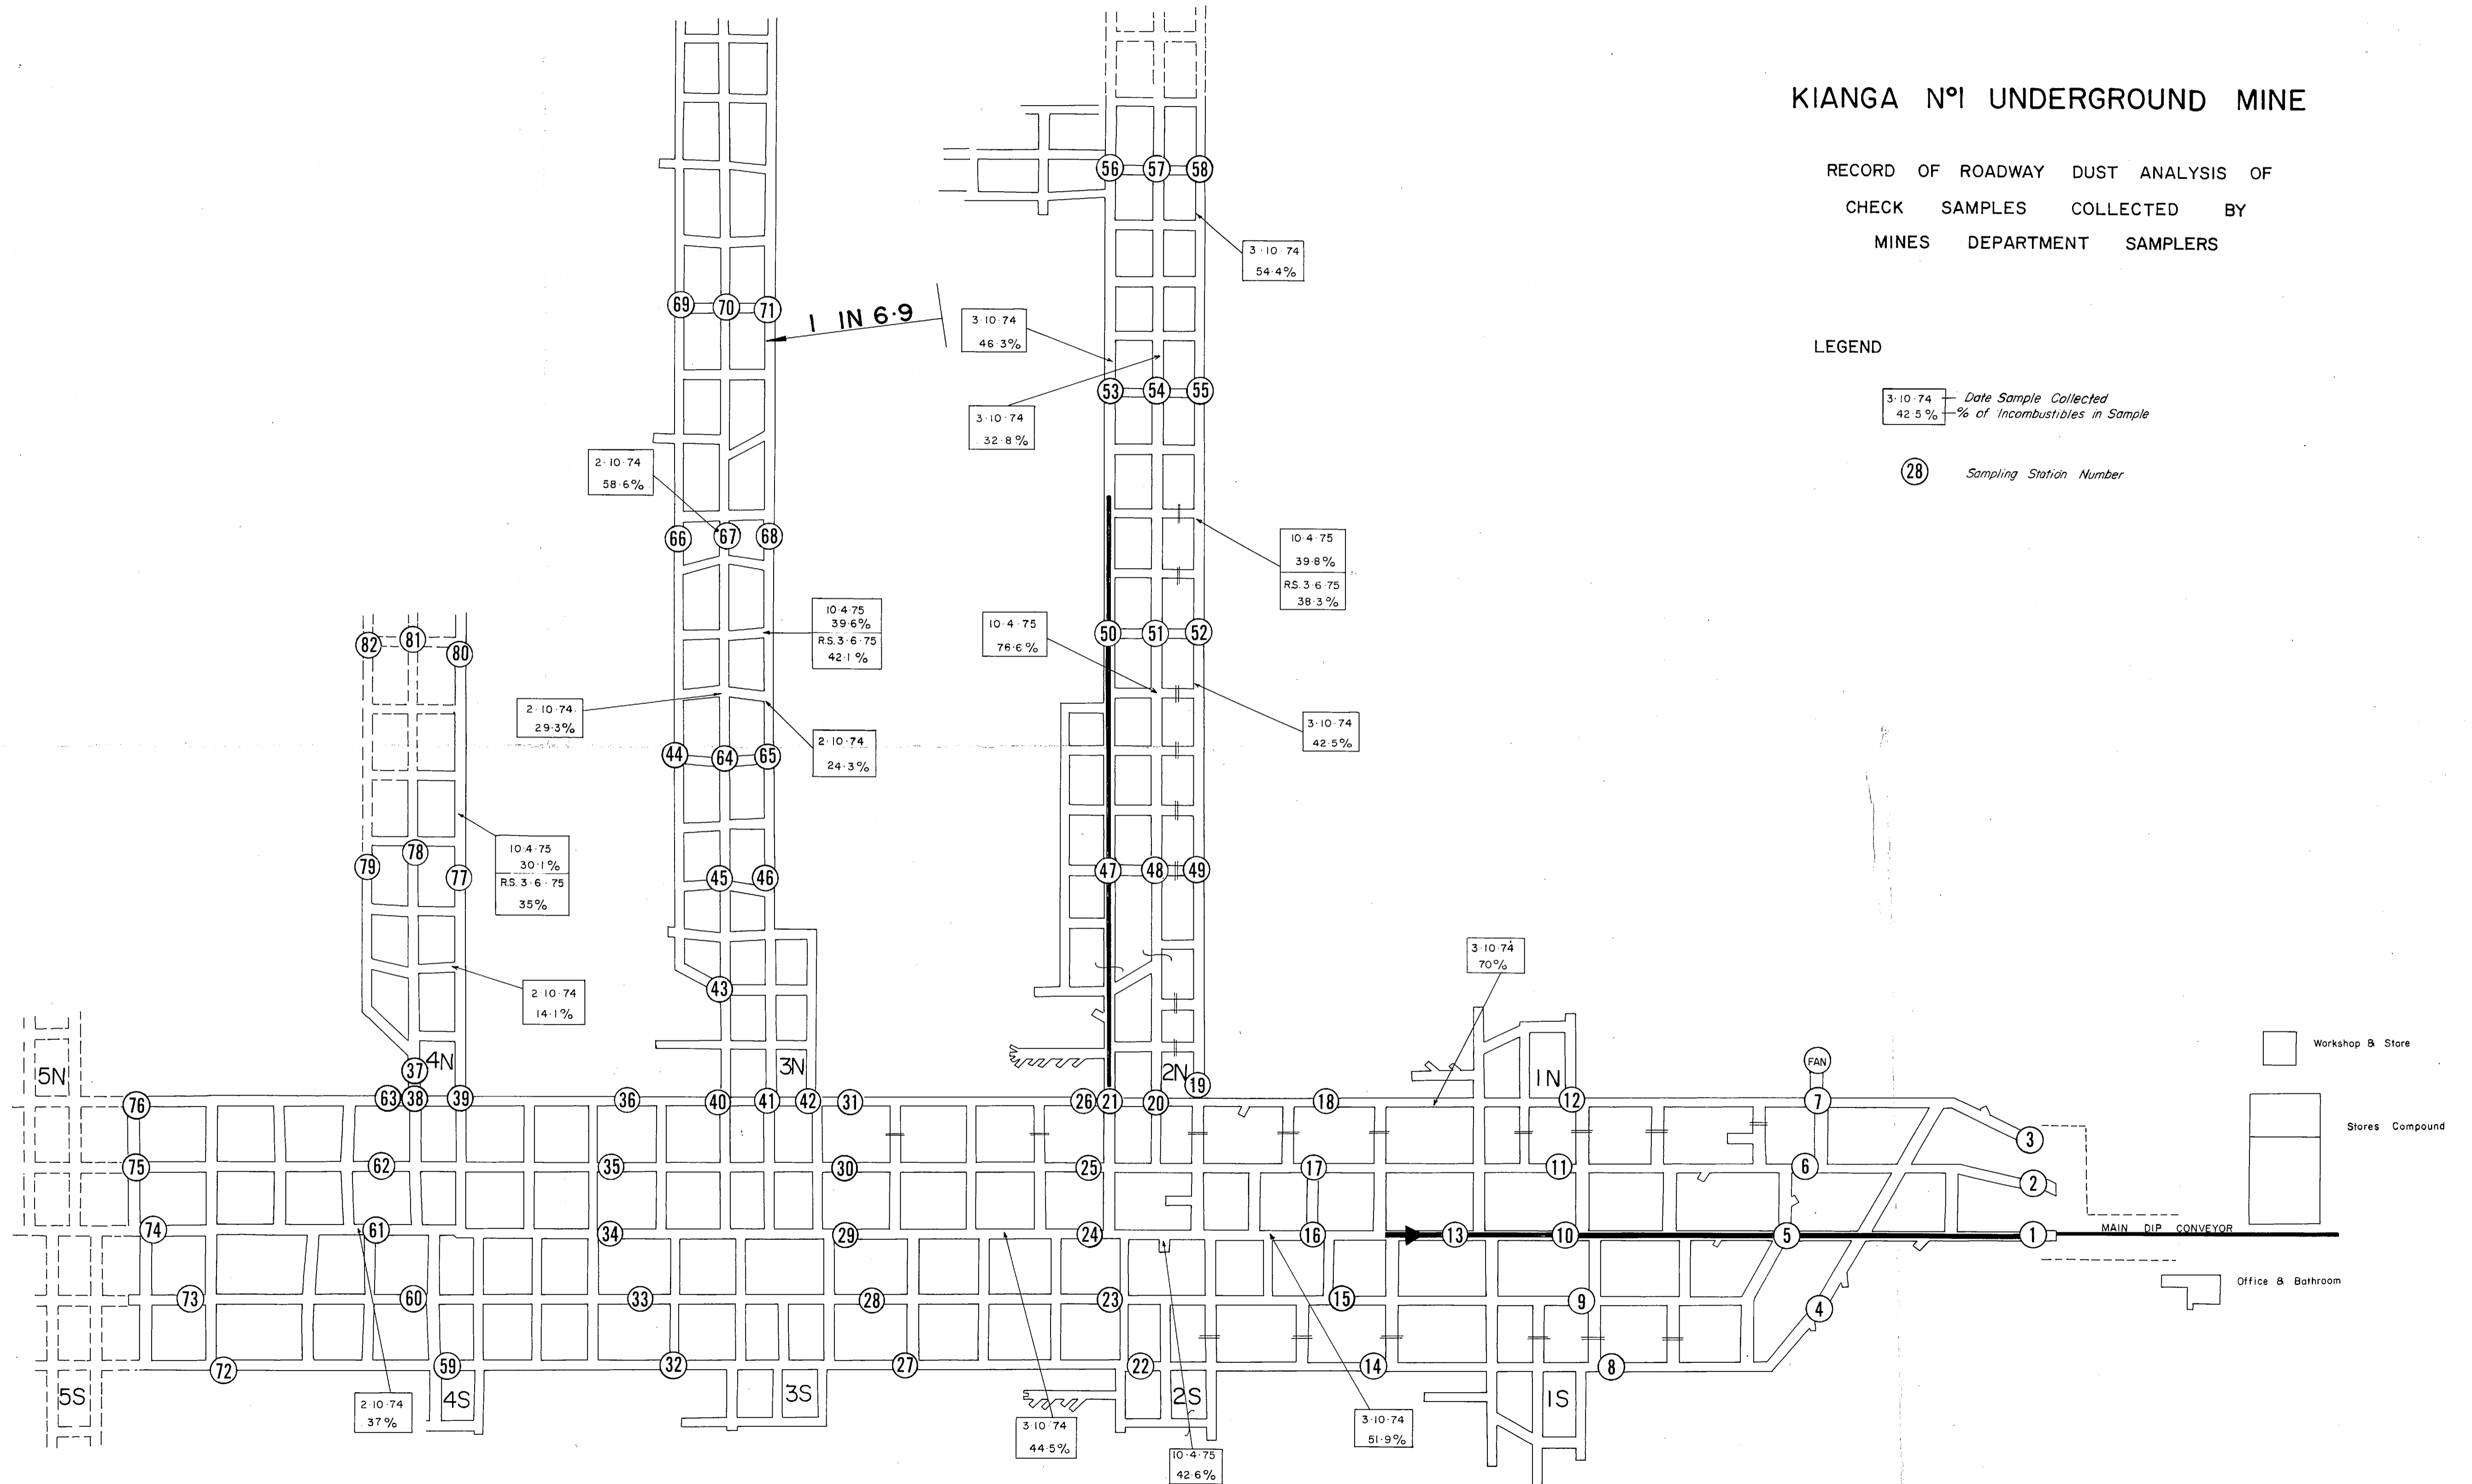
KIANGA N°1 UNDERGROUND MINE

RECORD OF ROADWAY DUST ANALYSIS OF
CHECK SAMPLES COLLECTED BY
MINES DEPARTMENT SAMPLERS

3-10-74 Date Sample Collected
42.5% % of Incombustibles in Sample
