THE EXPLOSION AT MOURA NO. 4 MINE QUEENSLAND

Consultant's Report No. 3

Results of tests and calculations made in the U.K.

A F Roberts
Health and Safety Executive
Buxton U.K.

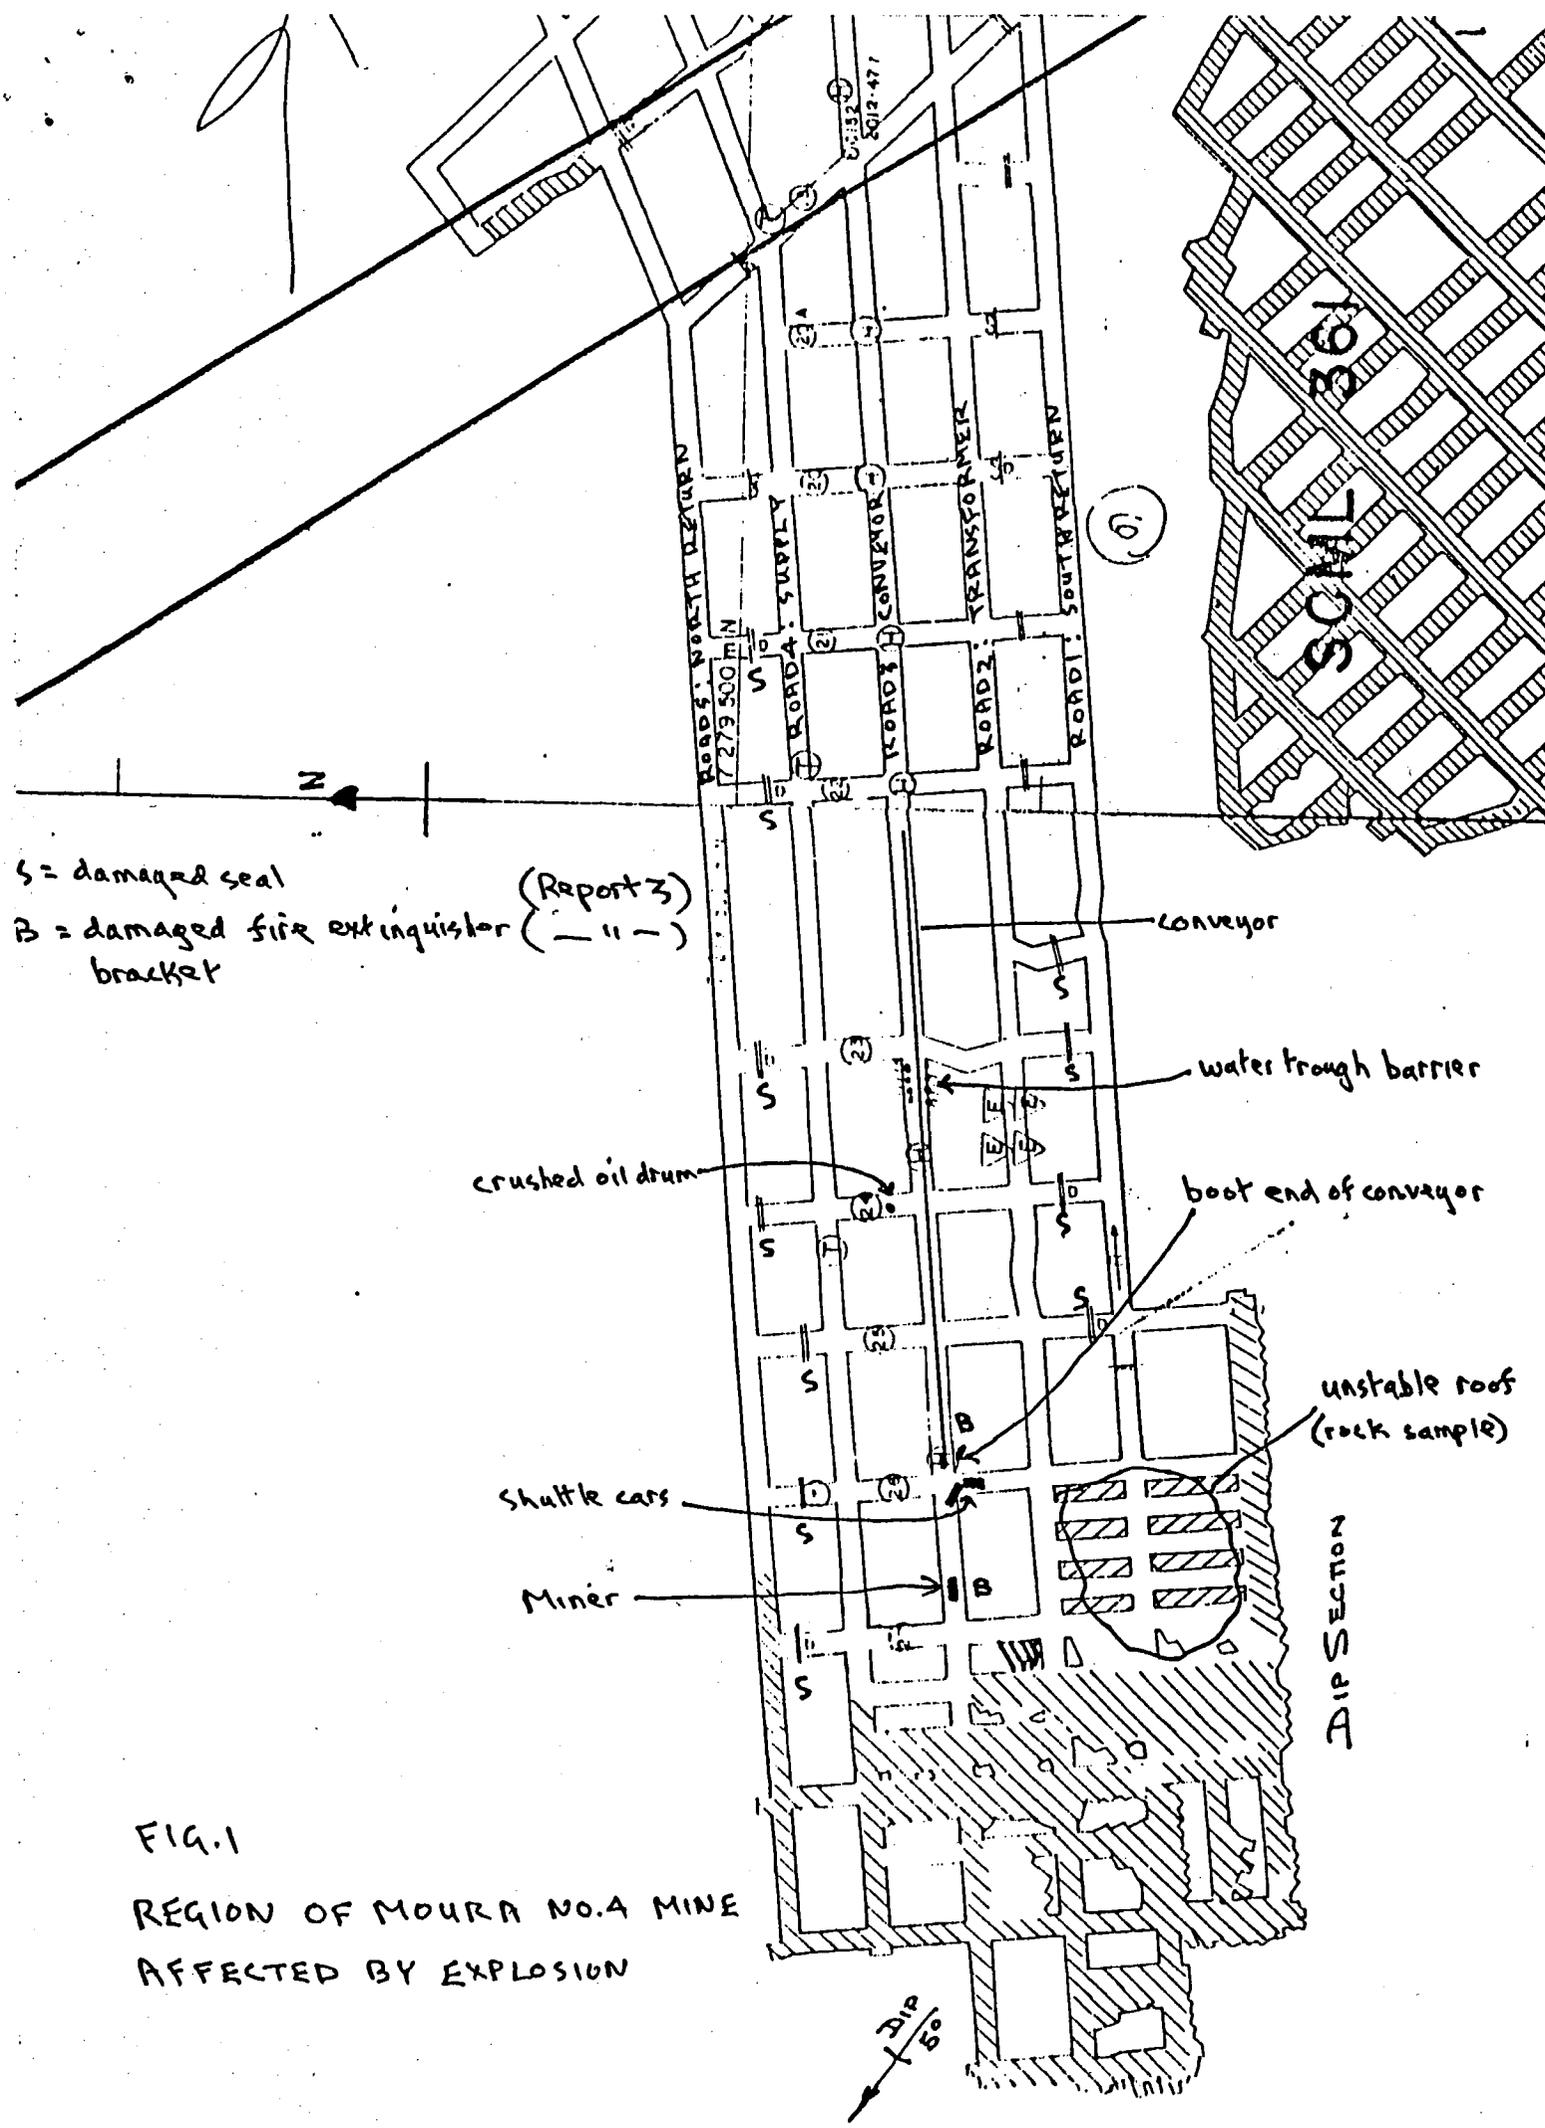
FIG. 1
 REGION OF MOURA NO. 4 MINE
 AFFECTED BY EXPLOSION

Two fire extinguisher brackets were located in the conveyor road, one slightly to the east of CT 27 and one about midway between CT 26 and CT 25.

Using this scale, the damage to this type of seal (another type was used in some other cut-throughs which can not be compared in this way) may be summarised as follows:

Seal Location	North Return	South Return
CT		
21	1	0
22	1	0
23A	-	3
23	4	4
24	5	4
25	4	2
26	2	-
27	1	-

This summary indicates that for both the north and south return roadways, the maximum damage to the seals was associated with the region near CT 23 and 24.

S = damaged seal
 B = damaged fire extinguisher (Report 3) bracket

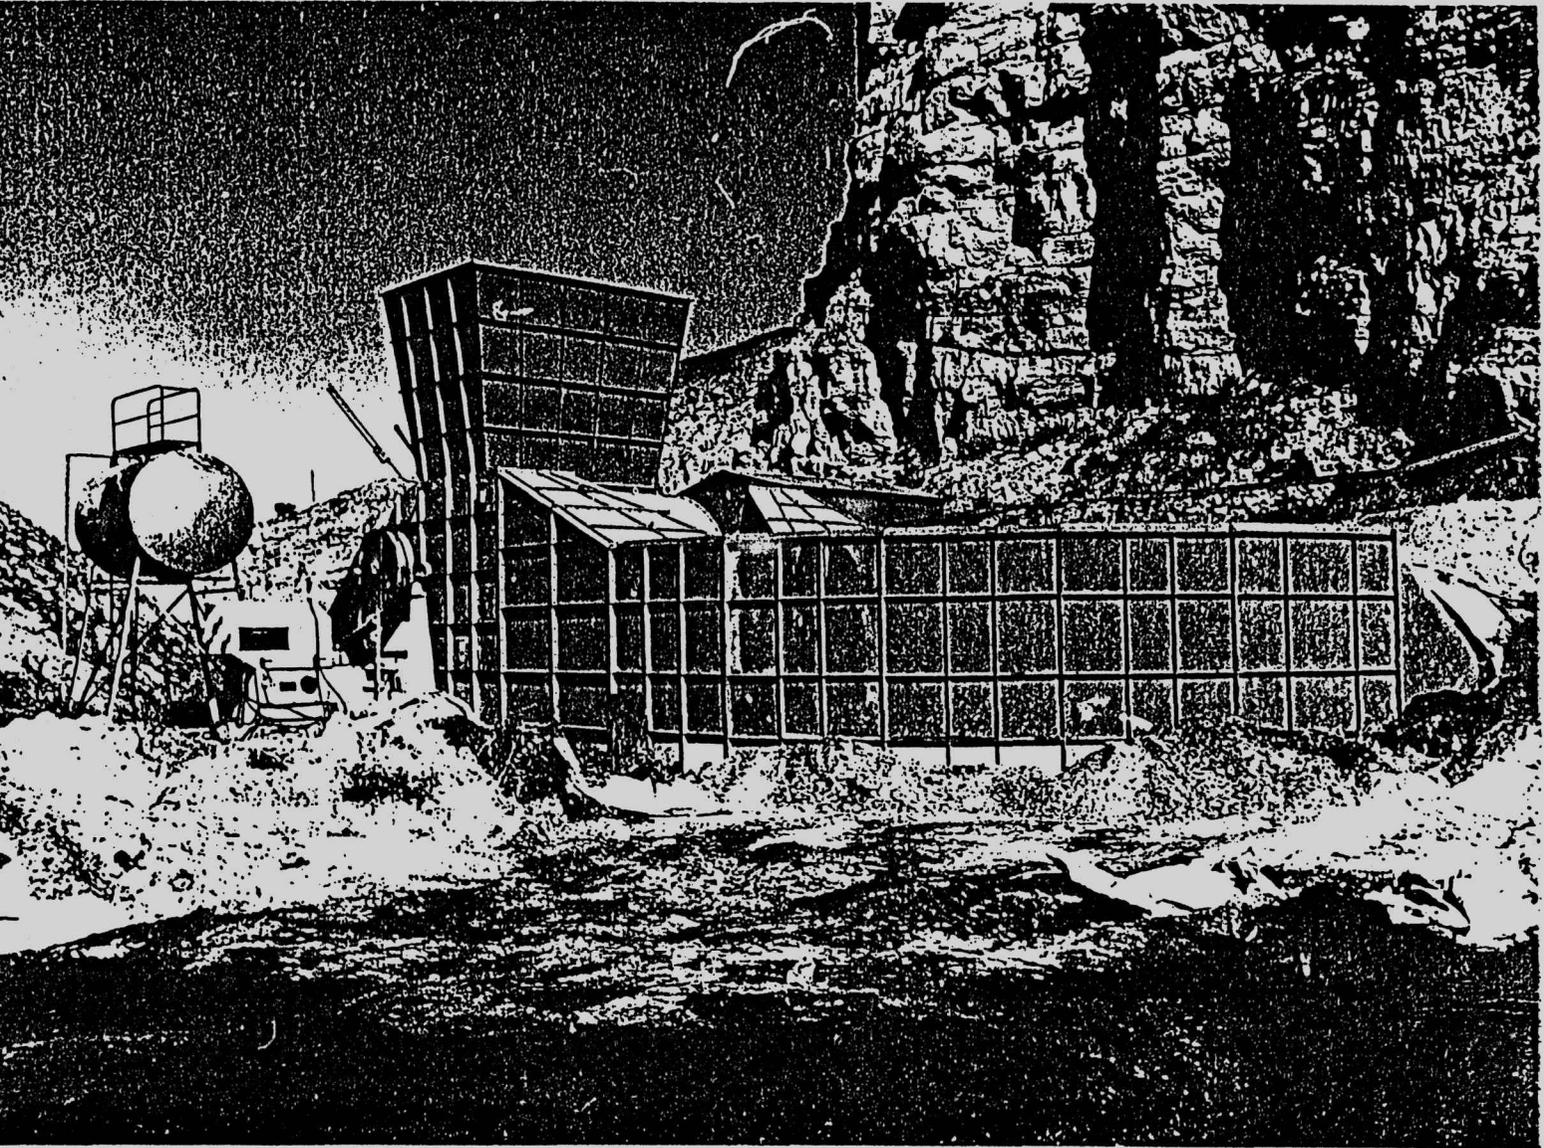
Fig. 2.

The explosion damaged this ducting by blowing out 3 vertical panels on the outside of the curve and distorting the flow straighteners.

Each of the displaced vertical panels was approximately 12 feet high by 7 feet wide with a flange along each side. The horizontal flanges, bolted to the roof and floor sections, each had three securing bolts; the vertical flanges, bolted to the adjacent panels, each had twelve securing bolts. The bolts used were thought to be $\frac{1}{2}$ inch diameter (the panels had been removed and the ducting repaired - see Fig. 2). The panels had been blown out of the ducting and also separated from one another.

If, however, one assumes a progressive failure in which the bolts on the horizontal flanges failed first, causing a loss of integrity of the structure and the vertical panels were then displaced causing bending of the bolts in the vertical flanges followed by failure, then each panel would only be retained by 6 bolts for the initial failure. The applied pressure required would then be 0.36 Bar.

The two sets of estimates are consistent if one accepts the 'progressive failure' assumption for the ducting panels. A pressure wave of 0.3 Bar peak pressure would then have produced a shock wave that travelled along the return for 1.6 km and had a peak pressure of 0.18 Bar at the portal.

←————→
The damaged panels were
in this area.
