**Resources Safety and Health Queensland
Summary Report regarding the fatality of
Connor-Shaye Campbell Milne**

**At Fairfield Quarry, Clermont, QLD
on 15 November 2018**

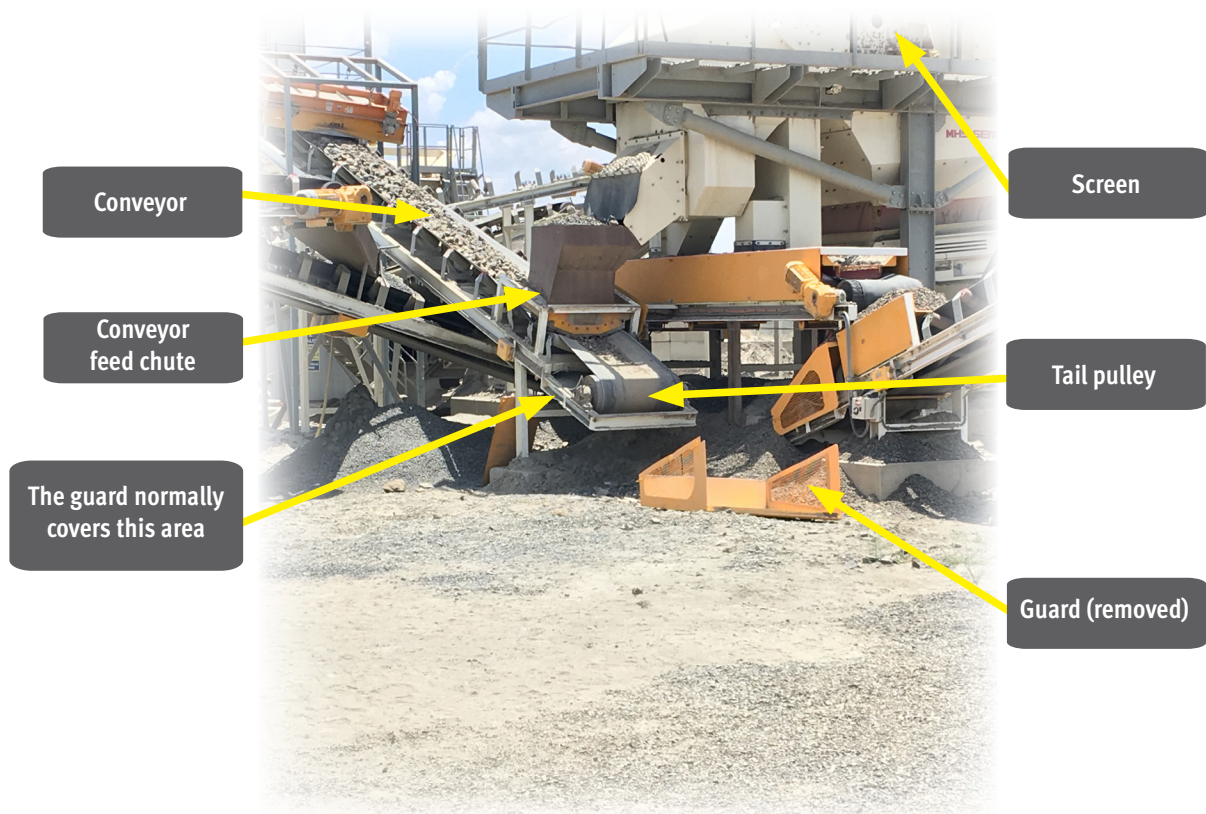
Photo of the Fixed Plant at Fairfield Quarry

When the plant was operating, rocks spilled over the conveyor and into the tail pulley area, this was due to a blocked crusher being cleared onto the screen feeding the conveyor. A surge of rock from the screen overflowed the conveyor feed chute. An impact roller under the conveyor, below the feed chute, was missing and the skirting rubber to contain the rocks on the belt was worn. These maintenance issues contributed to the spillage.

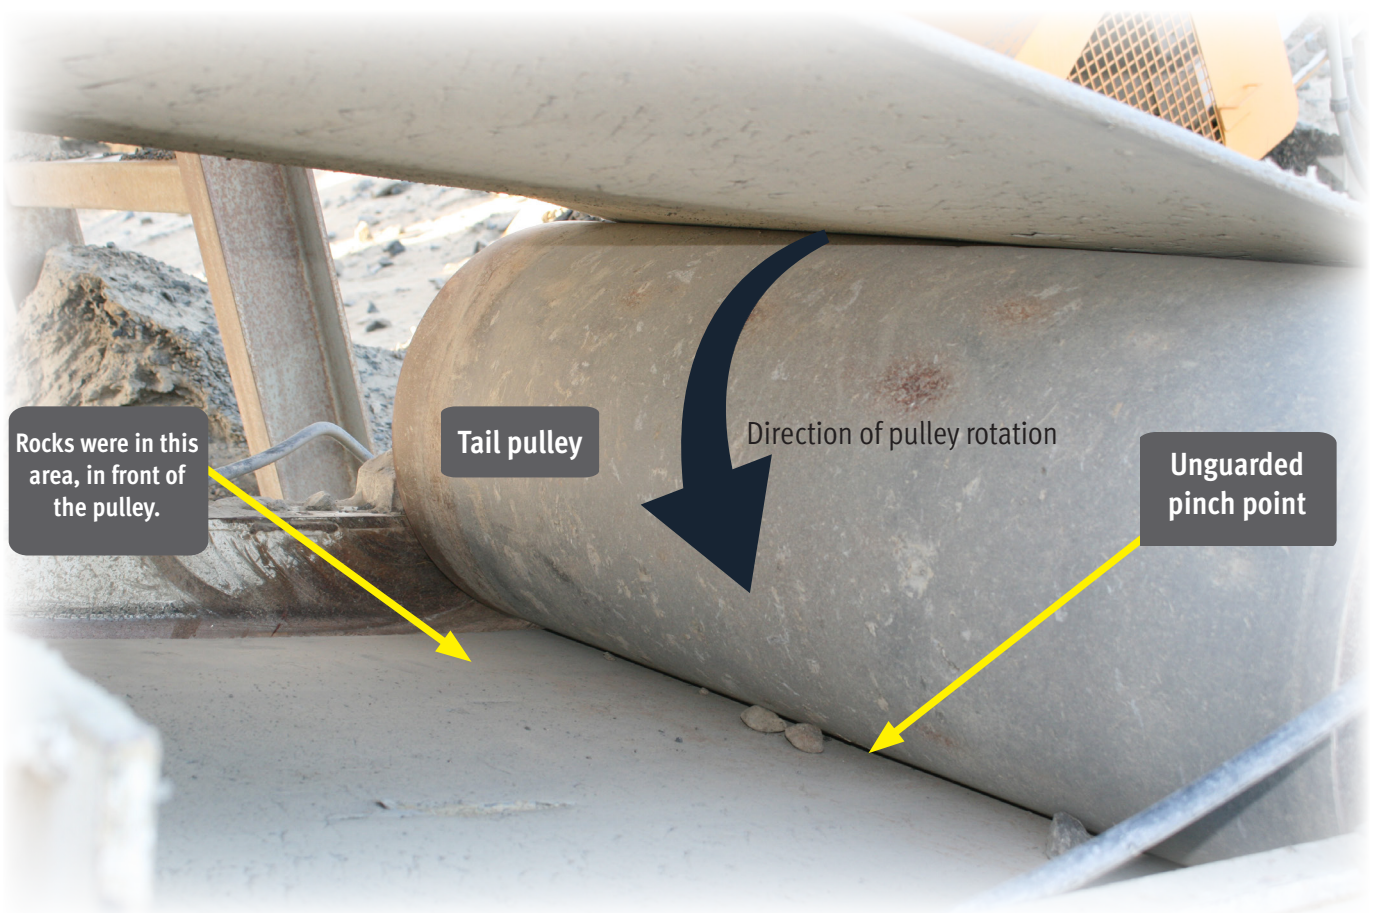
Photo of the tail pulley pinch point

With the conveyor still operating, Mr Milne and a co-worker removed the tail pulley guard to clear the spillage. They removed rocks using their hands - a practice at the quarry.

As a result of ongoing spillage, the plant required rocks to be removed from the affected area several times a week. The site did not have a documented procedure for safely removing rocks from the tail pulley area. It was a practice at Fairfield Quarry to remove rocks by hand, without a guard and with the conveyor still operating.

Never operate plant with guards removed or incorrectly fitted.

Always isolate and lock out plant before working on it.

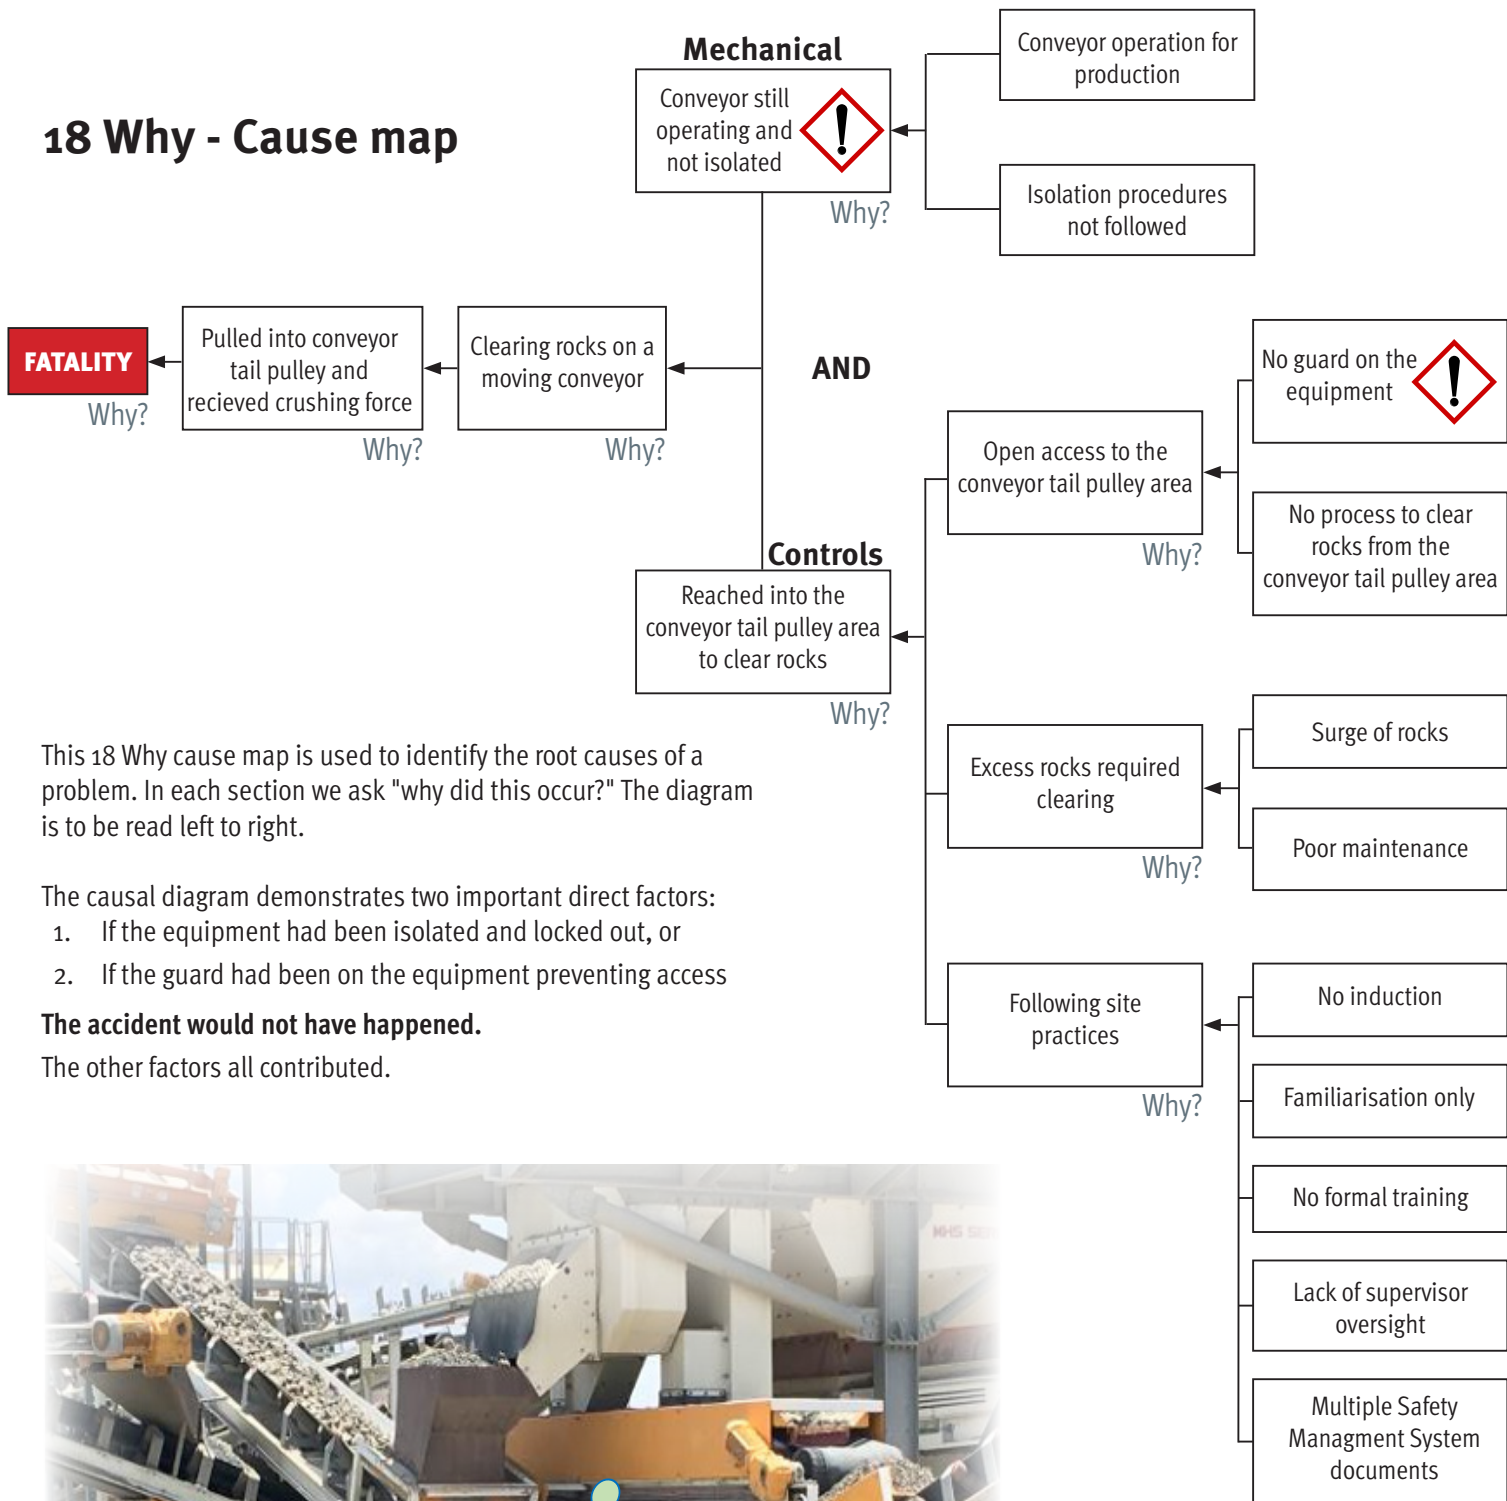
18 Why - Cause map

The causal diagram demonstrates two important direct factors:

1. If the equipment had been isolated and locked out, or
2. If the guard had been on the equipment preventing access

The accident would not have happened.
