Fatality involving an articulated dump truck

Mines safety alert no. 358 | 29 August 2018 | Version 1

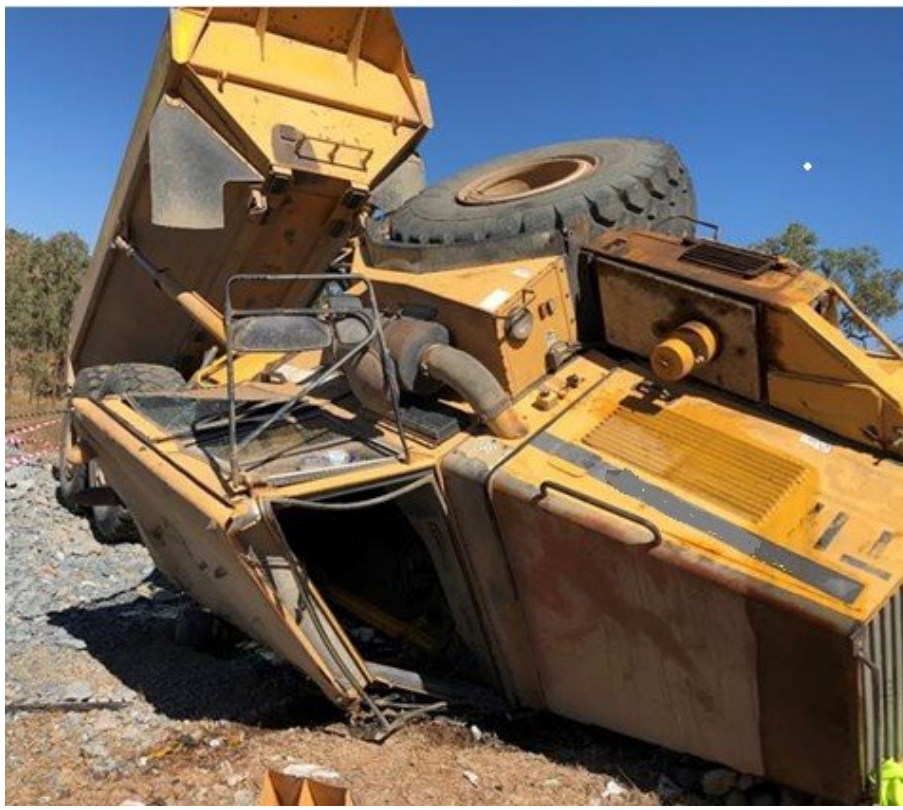
On Sunday 29 July the operator of an articulated dump truck was working at a quarry with his last load of the day. Moving fully loaded down the access ramp, it appears he lost control of the vehicle. At the bottom of the ramp the vehicle overturned (see photo), partially pinning the operator under the cab. He later succumbed to his injuries.

- Site senior executives must ensure machines are operated with reference to original equipment manufacturer (OEM) specifications.
- Site safety and health management systems must include safety requirements as stipulated by the OEM with respect to the use and maintenance of safety critical items.
- Site senior executives must ensure that all equipment on site is suitably maintained and serviced in accordance with OEM requirements and site specific hazards. Service and operational manuals for equipment must be available on site.
- Site senior executives must ensure all workers are competent to perform tasks on site and are competent on the particular equipment being operated. A record of the training must be maintained to show that workers possess the relevant competencies.
