Fatality involving a quarry plant operator

Mines safety alert no. 359 | 22 November 2018 | Version 1

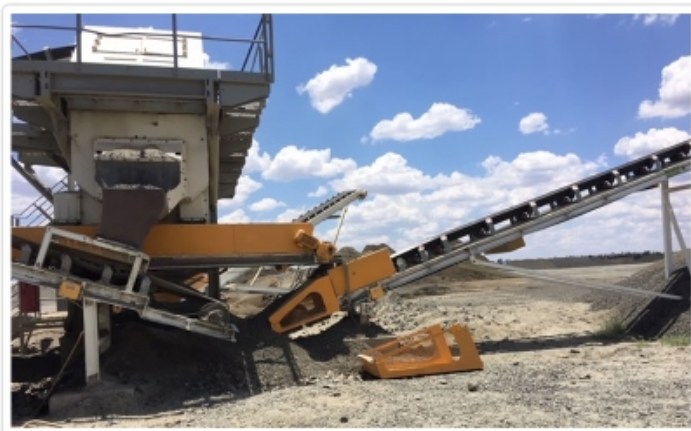
On Thursday 5 November 2018, a worker was fatally injured at a quarry when he became entangled in the rotating tail drum of a conveyor belt. A co-worker activated the emergency stop device fitted to the conveyor.

This tragic incident is under investigation. Preliminary findings indicate that the tail drum guard had been removed to allow rock to be cleared and the conveyor was operating with the guard removed when the incident occurred.

- **Always** stop and isolate a conveyor before undertaking work on the conveyor.
- **Never** operate a conveyor without the necessary guarding in place.
- **Always** operate and maintain the conveyor in a way that eliminates or reduces the occurrence of spillage, requiring the need to remove guarding to clear it.
- **Ensure** that personnel operating or maintaining conveyors understand the hazards and risks and the critical controls, such as separation through fixed guarding and isolation lock-out, necessary to prevent serious injury or death.
- **Conduct** regular inspections and monitoring to ensure that critical controls are in place and are effective.
