INVESTIGATING OFFICER'S REPORT

**Fatal Accident to
SEAN RAYMOND SCOVELL
At MCG Quarries
Moranbah South Quarry
Tuesday 5th June 2012**

INVESTIGATING OFFICER: Kevin Clough
Inspector of Mines (Mining)
Central Region
Mackay District

DATE: 7 May 2013
FILE REF:

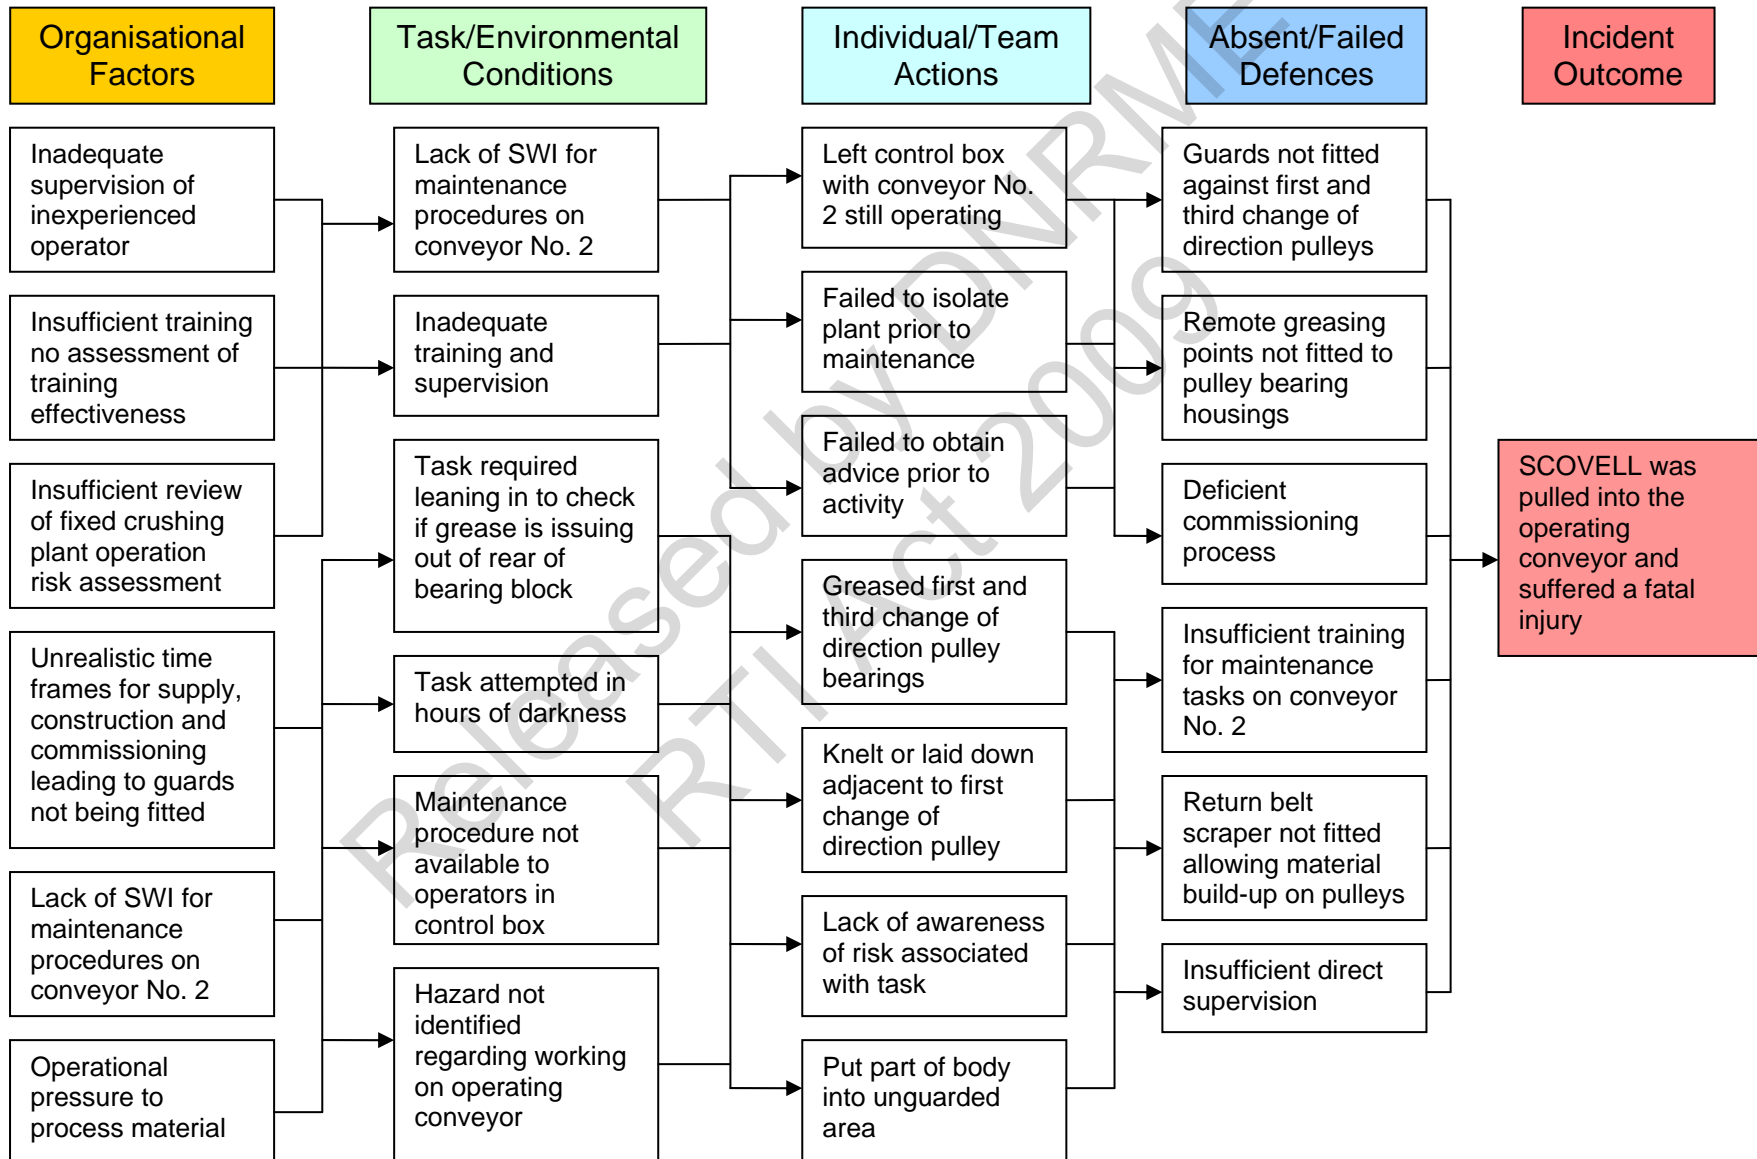
12. INCIDENT CAUSE ANALYSIS

The Incident Cause Analysis Method (ICAM) has been conducted to identify the underlying causes of the incident which are systematic in nature, e.g. related to failure in design, procedures, training, auditing or corrective action. This technique is designed to ensure that the investigation is not restricted to unsafe acts or active failures. The ICAM chart of the investigation represents the relationship of each contributory cause to the outcome of the accident.

Human involvement in incident-causing errors is not restricted to operators. The involvement of the organisation in shaping the behaviour of operators has become increasingly apparent. This leads to a distribution of errors across other members of organisations and across significant periods of time preceding the incident.
