INVESTIGATION INTO THE FATAL ACCIDENT

JOHN ANTHONY MAHER

COOK COLLIERY

30th AUGUST 2000

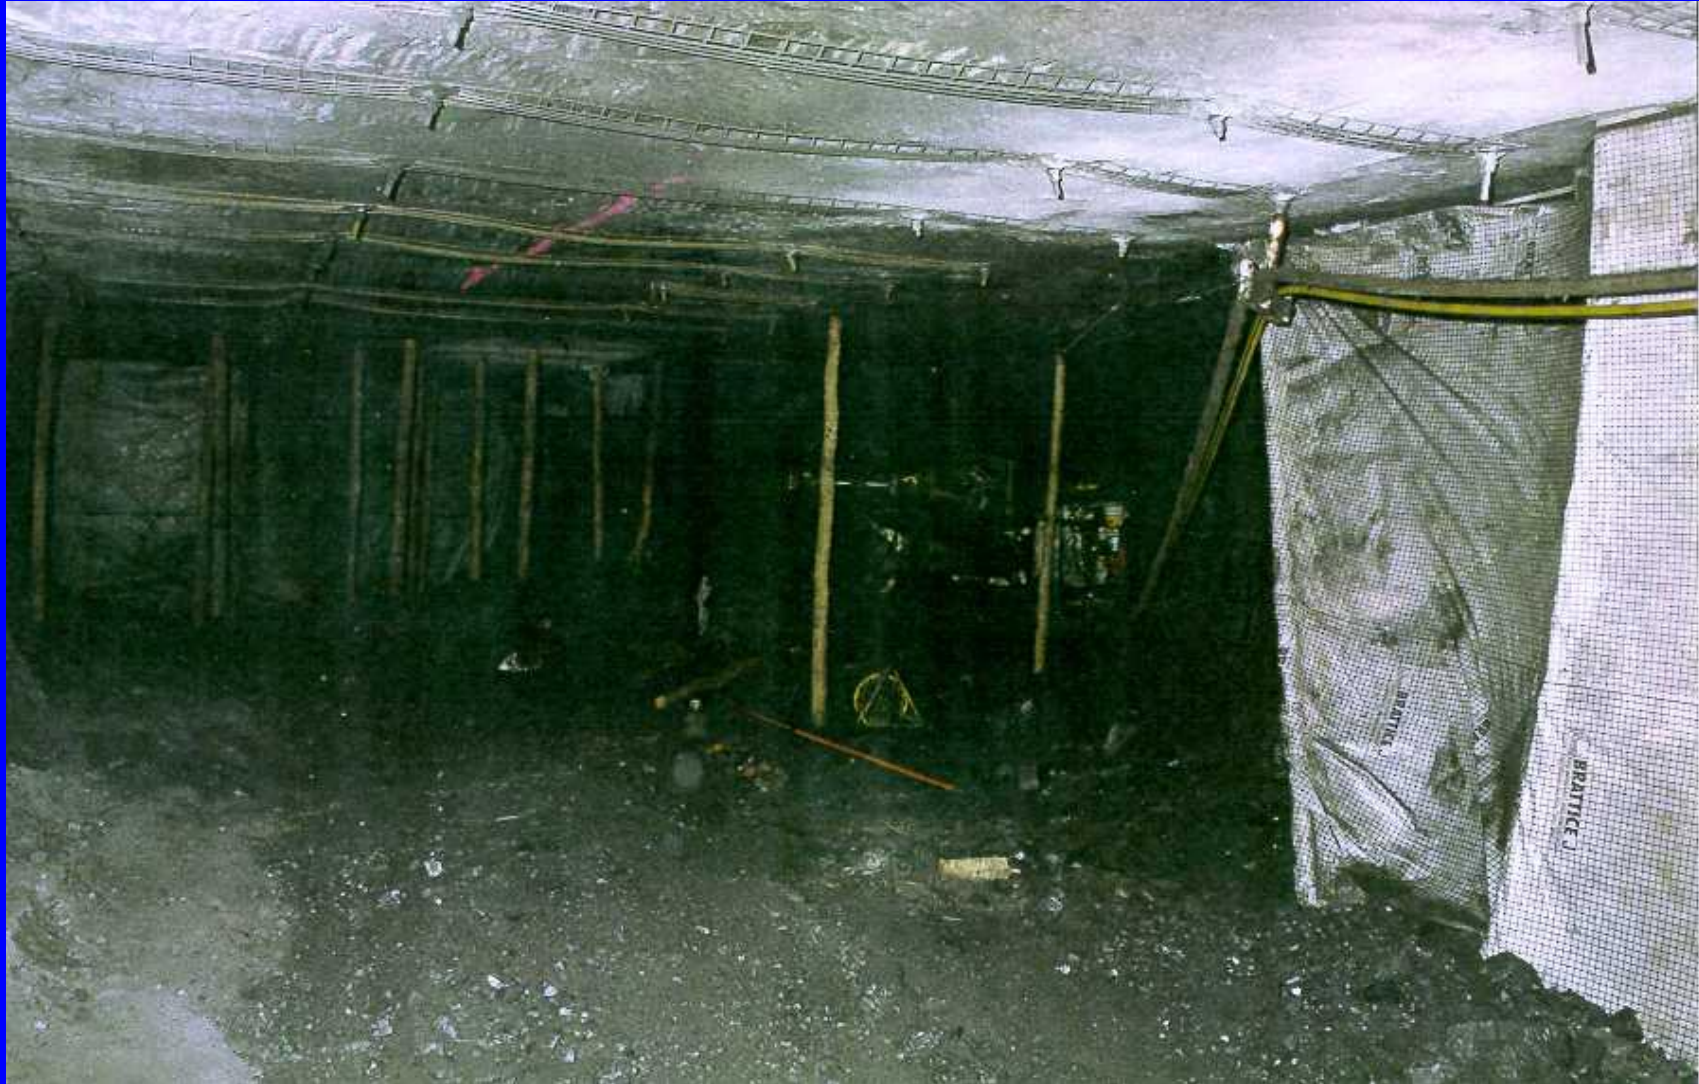
Photo P/p30 -view near breakaway into right sump with miner in background

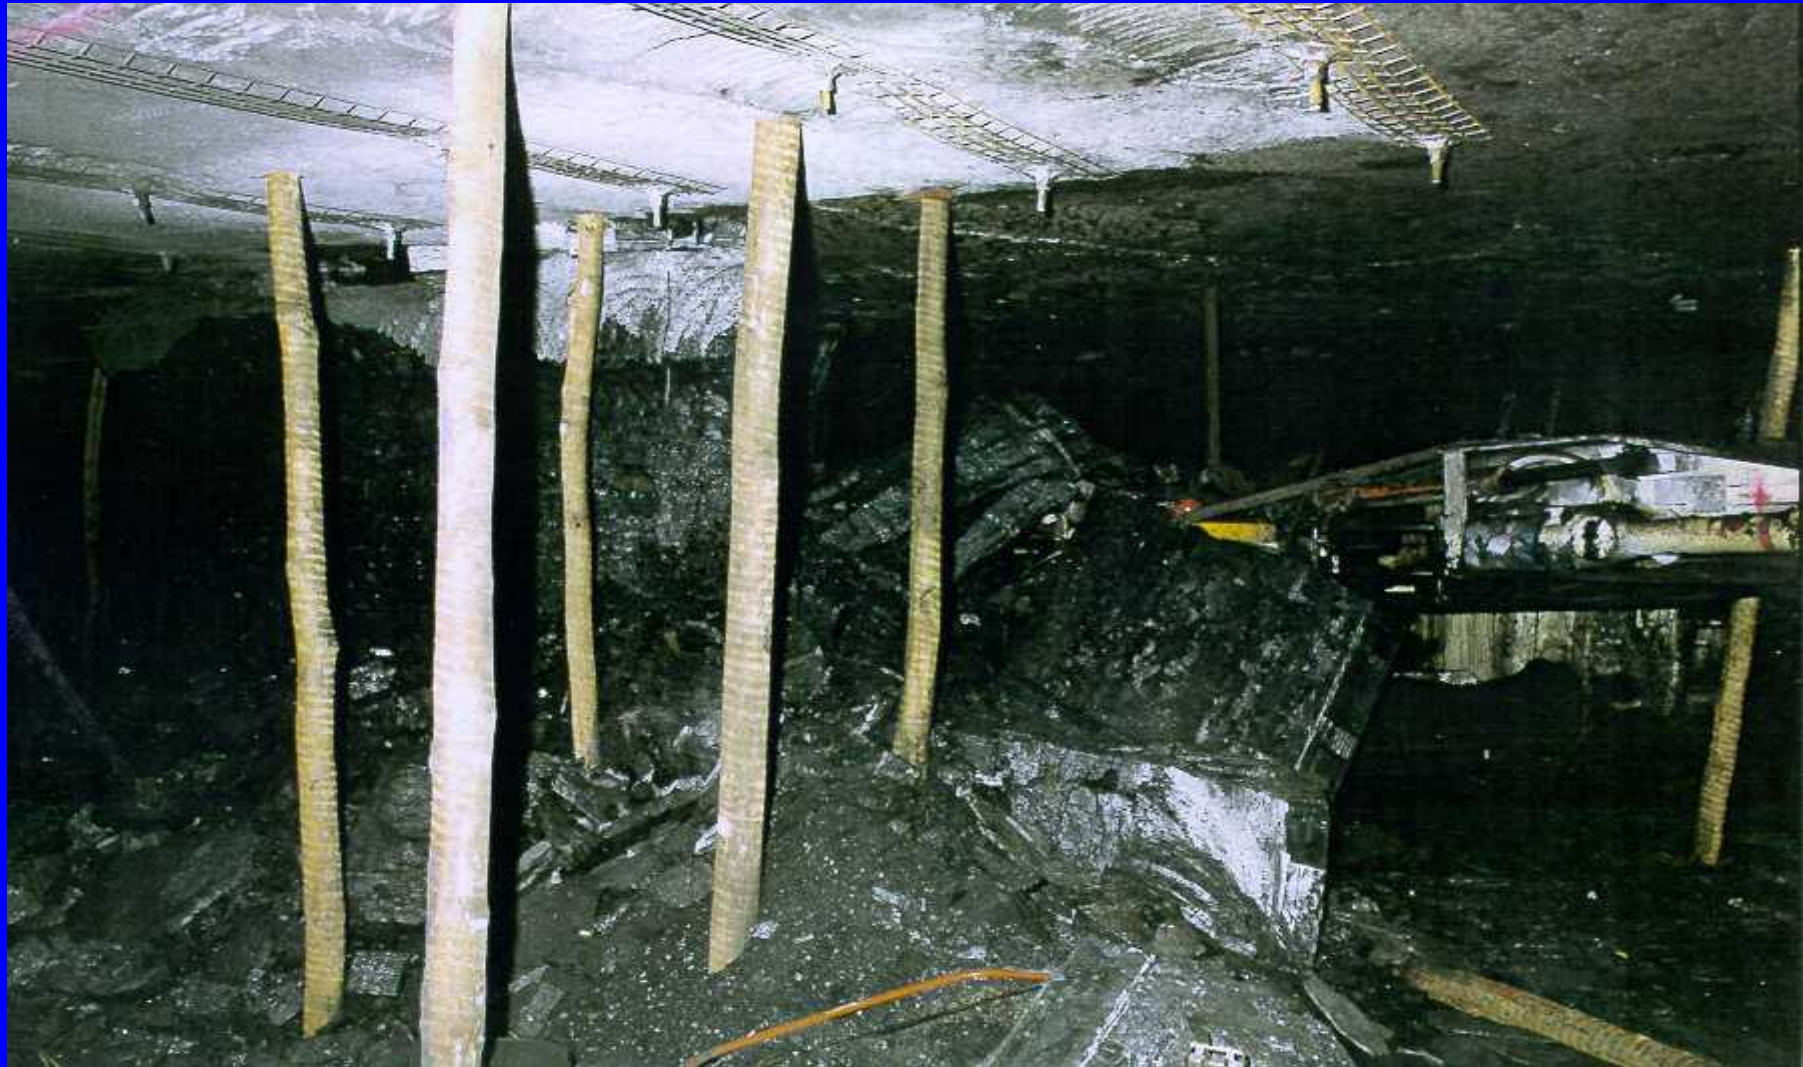
Photo P/p32 - General view of left hand side of sump showing props, tail of miner and lumps of coal

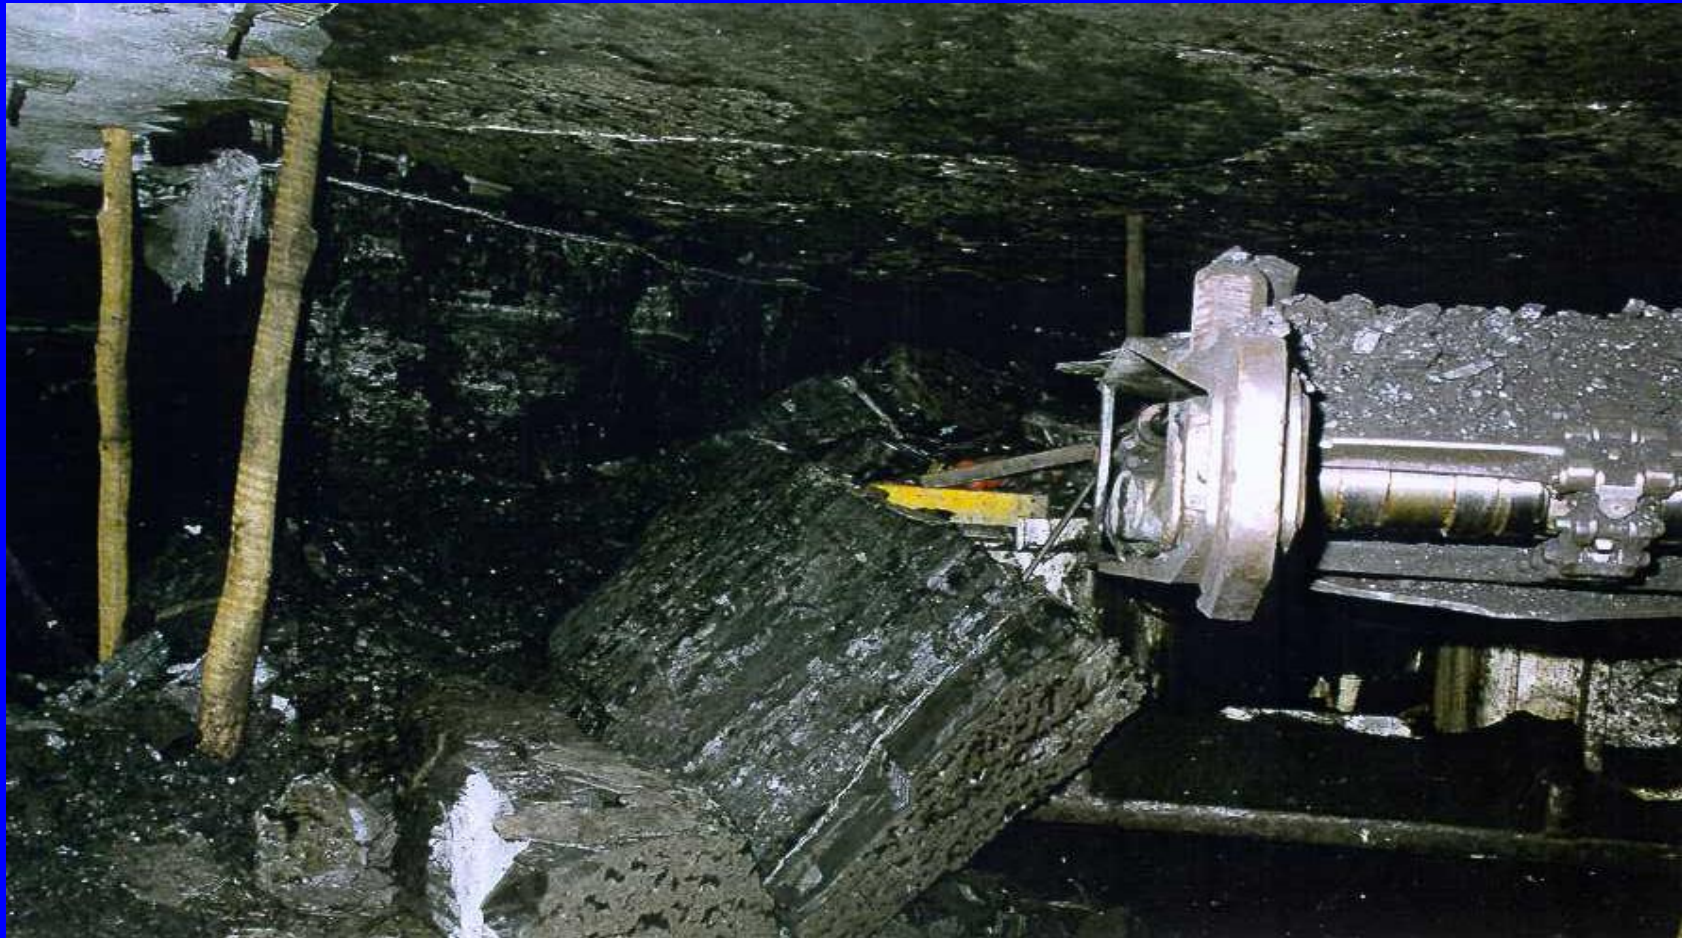
Photo P/p18 - View looking along left rib rib and side of miner showing coal lumps against miner

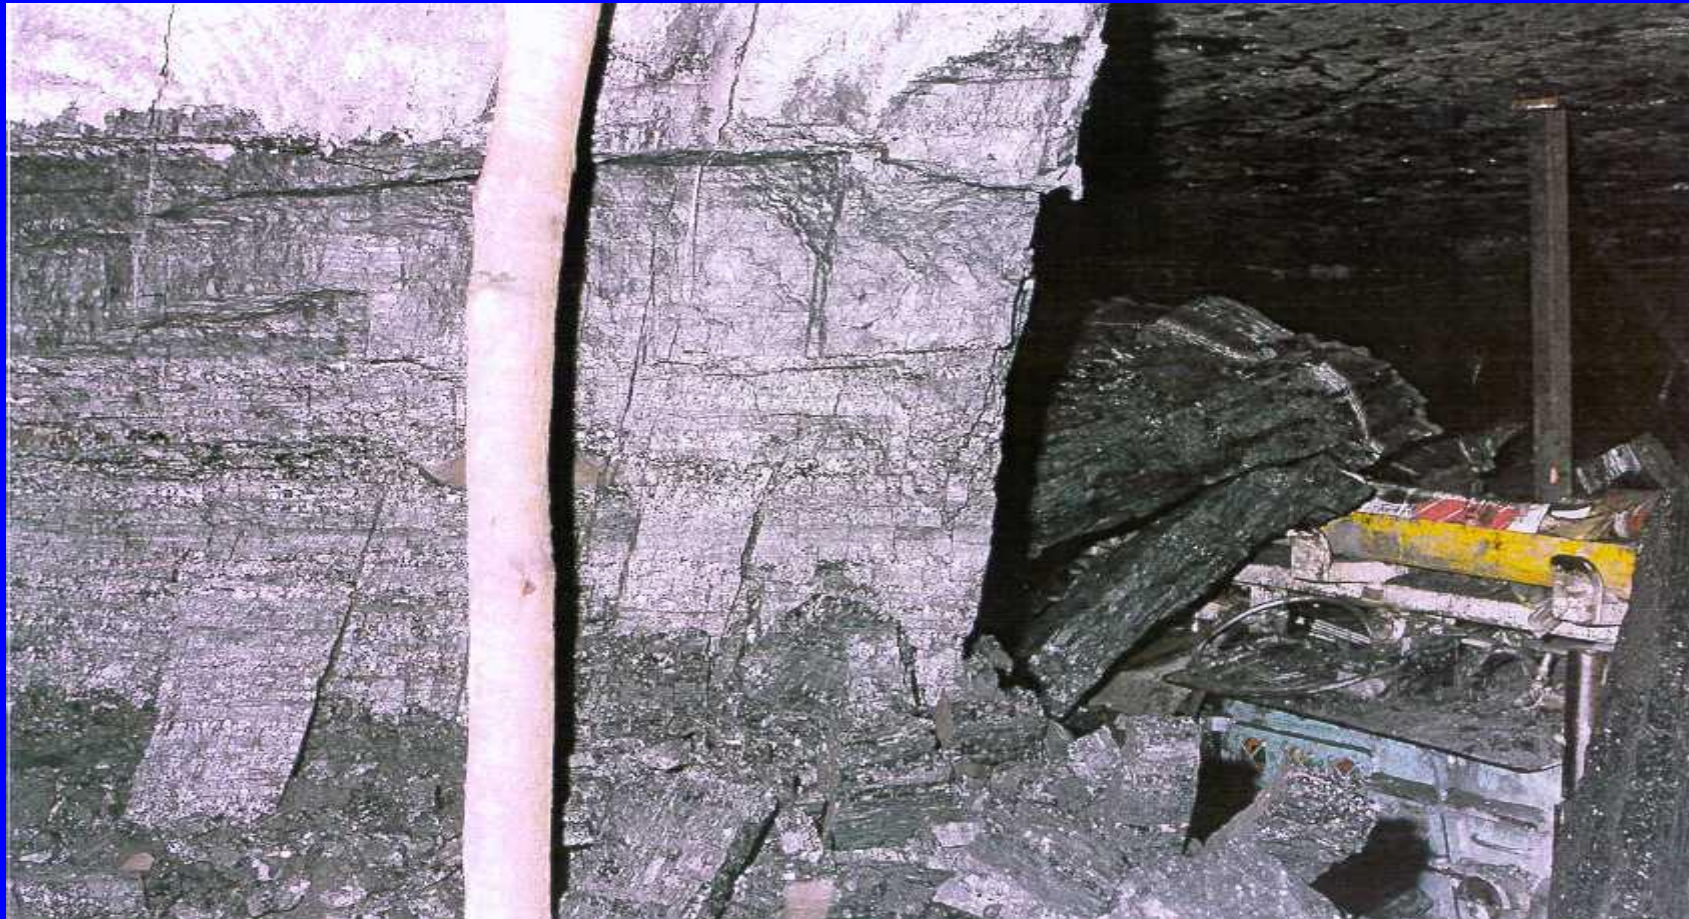
Photo P/p15 - View of left rear corner of miner where Mr Maher was positioned. Also showing cracks running through coal from roof towards floor.

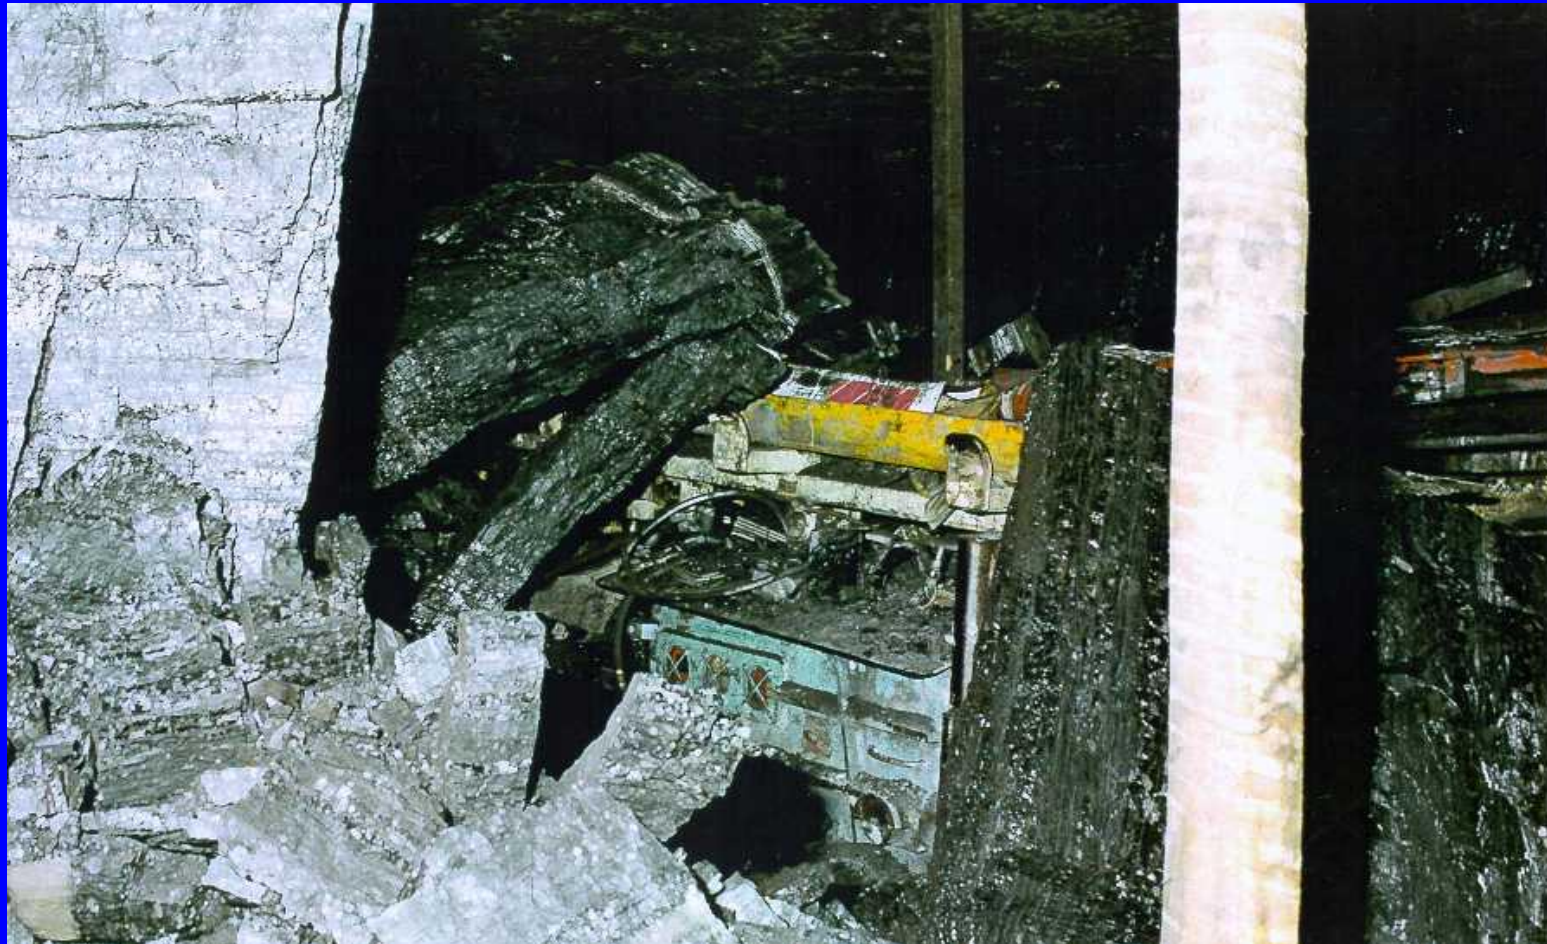
Photo P/p23 - close view of left rear side of miner where Mr Maher was struck by rib.
The coal lump that struck Mr Maher has been moved to right.

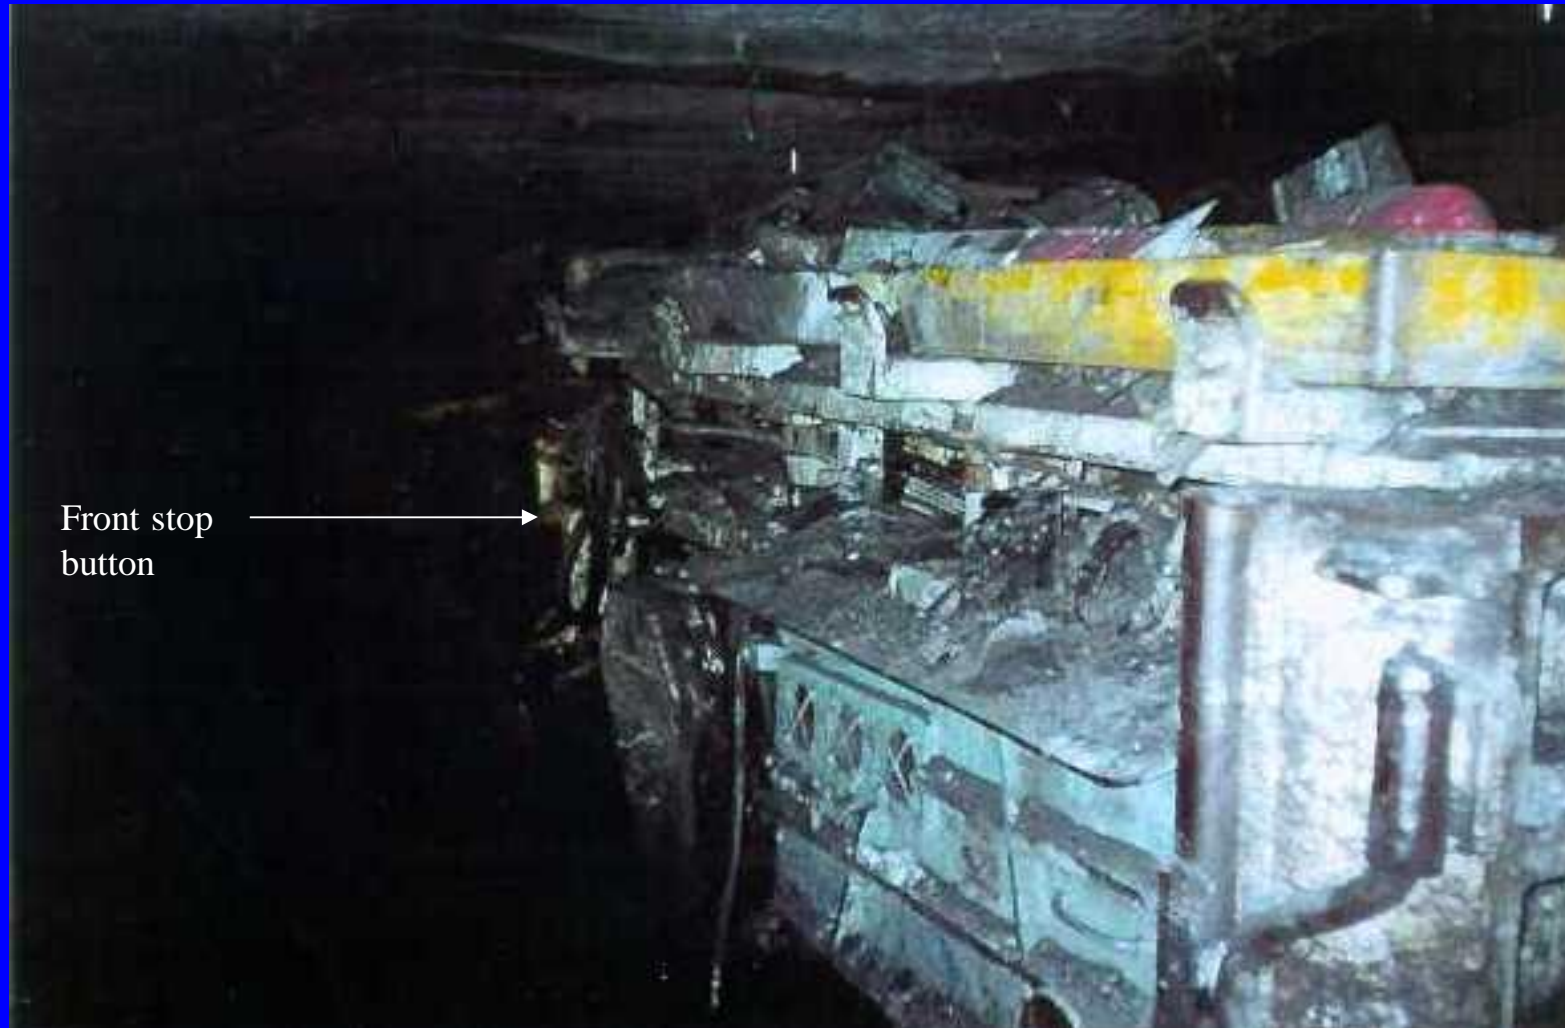
Photo P6 - View of left hand rear of HM9 after recovery from sump indicating position of front stop button

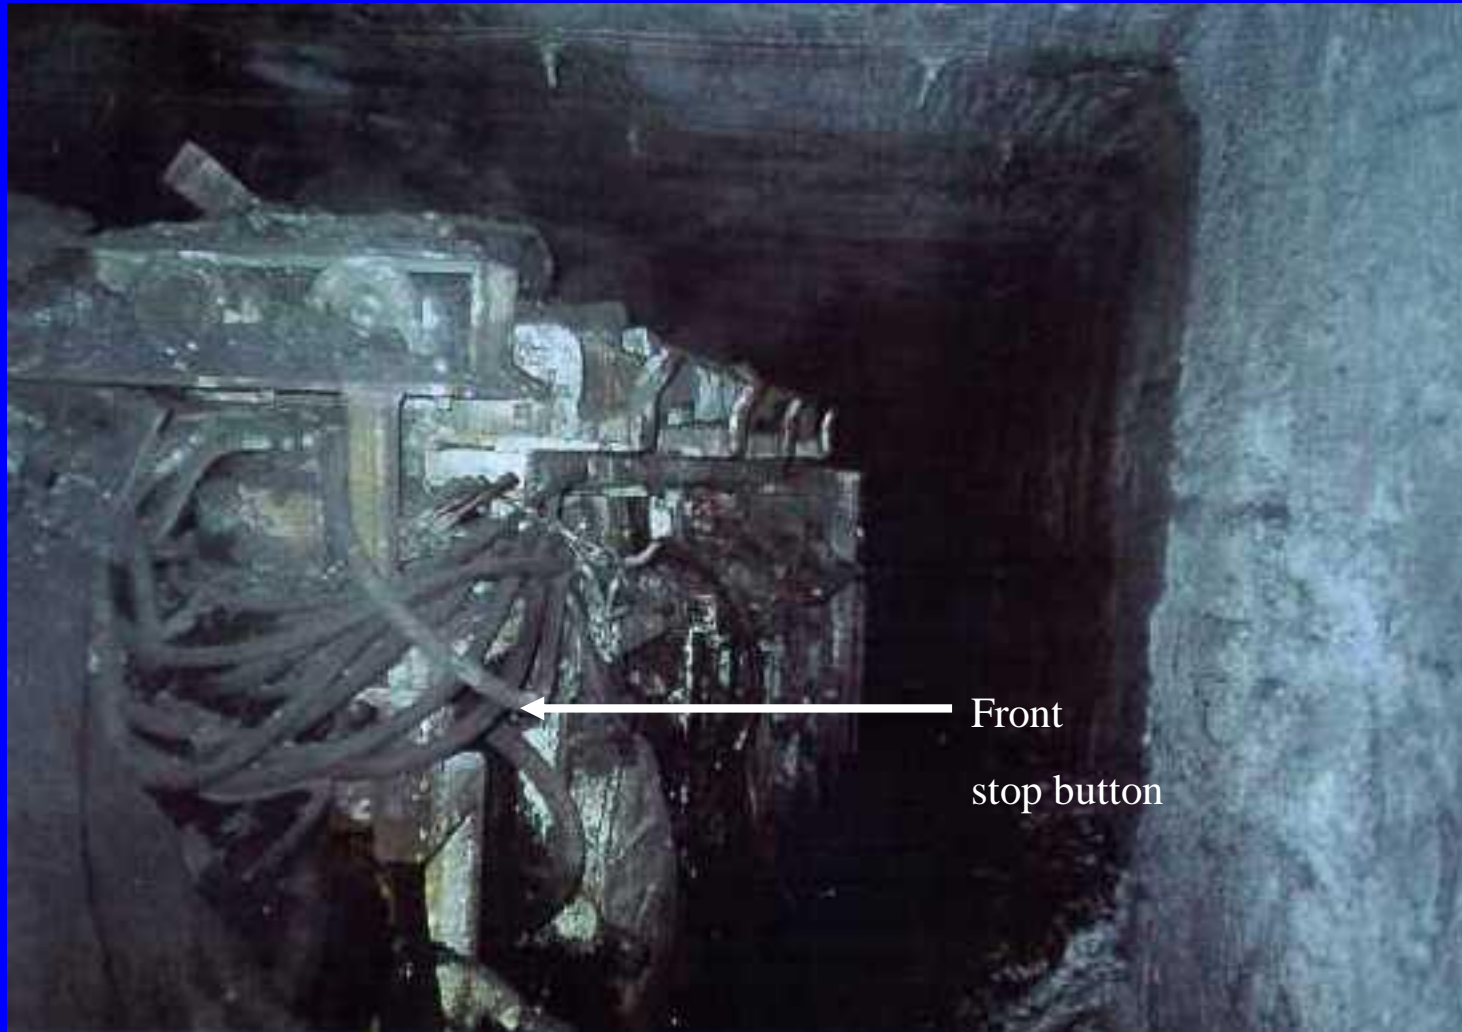
Photo P1 - View looking from front along left side of HM9 after recovery from sump and indicating position of stop button

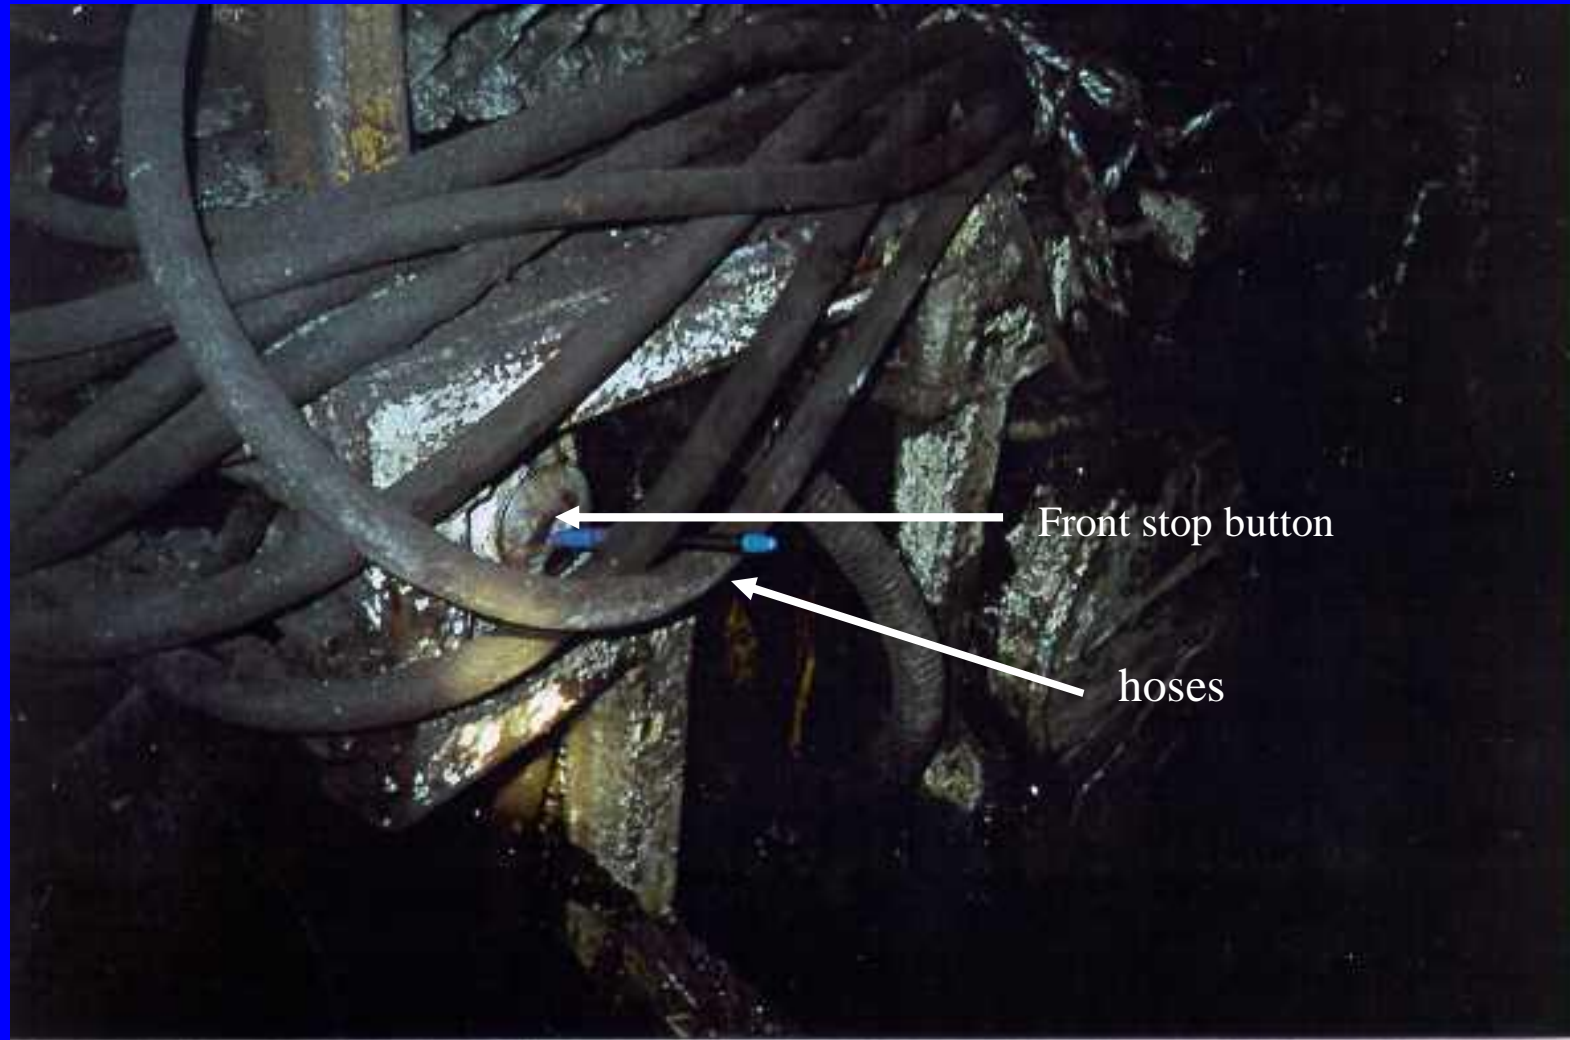
Photo P4 - View of front left stop button taken after recovery of HM9. View shows hoses passing in front as stated by witnesses to be the condition at the time of accident. 17

Hydraulic hoses are positioned across the stop button

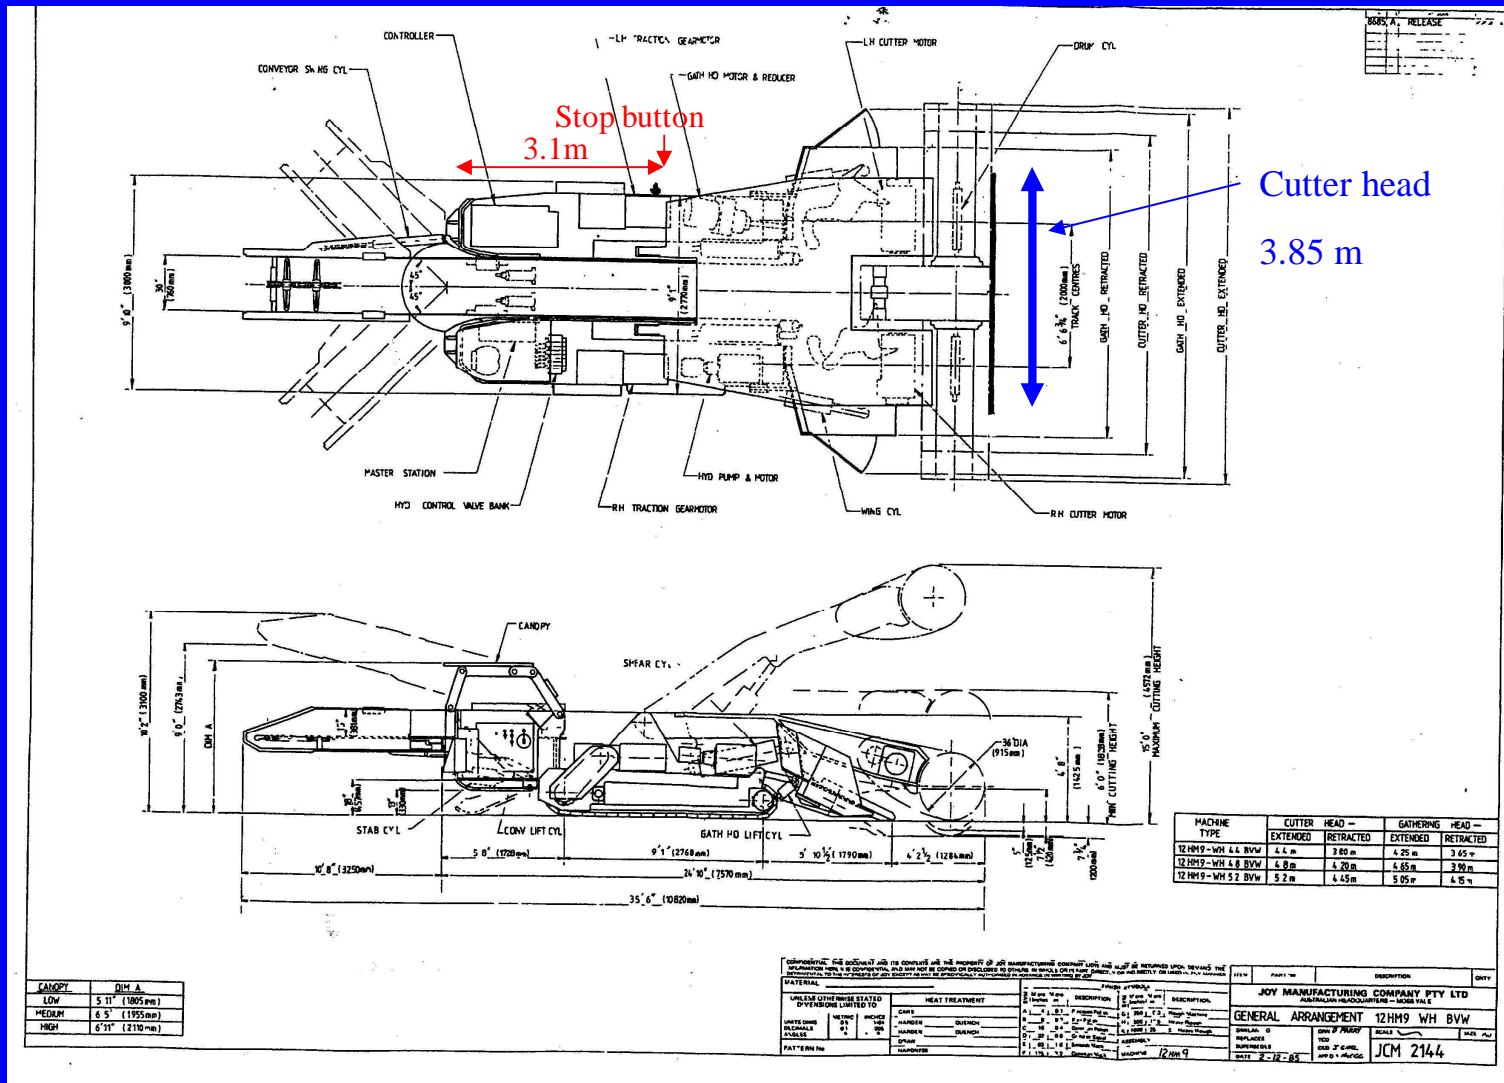
From App 12 general arrangement of HM9 showing dimensions of machine including width of cutter head. Also shown is position of left front stop button.

Forward stop button remained on machine for partial extraction

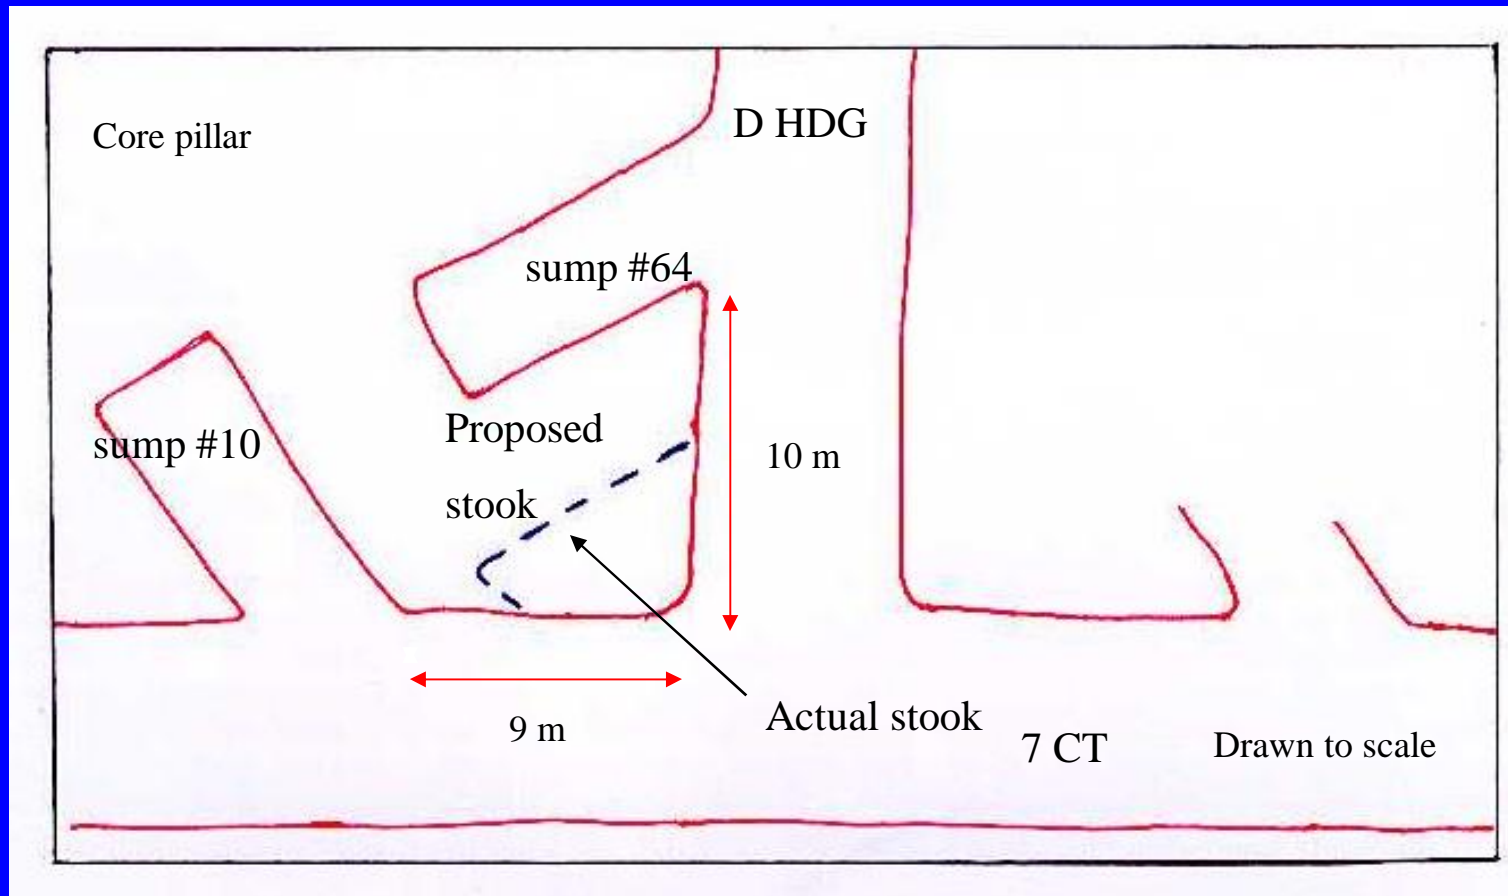
From 12 East sumping sequence plan for week ending 2/9/00 a representation of the design sump locations showing proposed corner stook

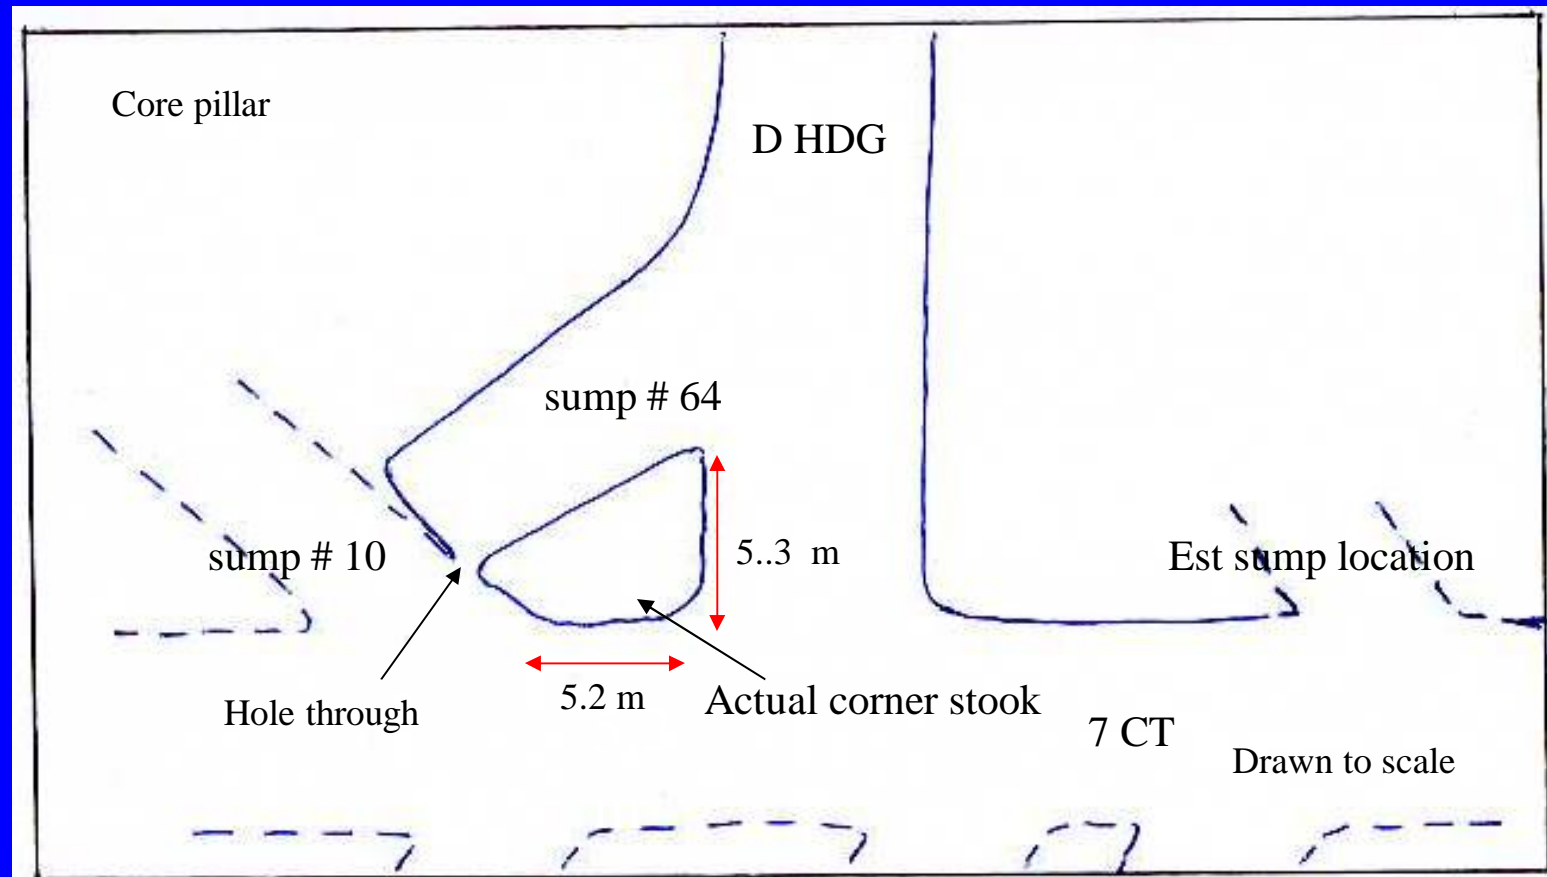
From survey plan of accident site a representation showing actual sump locations and corner stook

Two sumps were
not driven in
correct location

Corner stook
was only 33% of
design
