Resources Safety and Health Newsflash

An early report about an incident that may require action at your mine

Fatality – Tyre Fitting

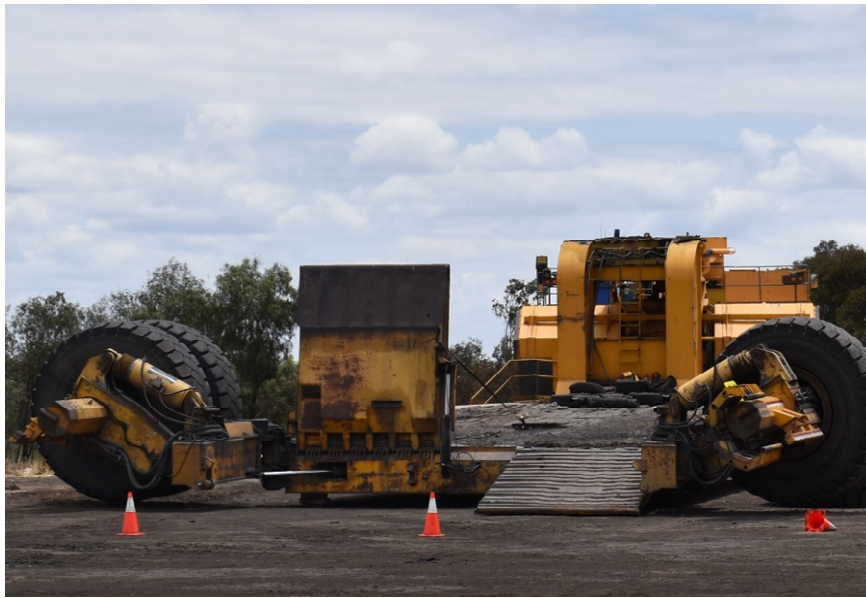
Figure 1.

On Sunday 12 January 2020 a 33yr old contract tyre fitter was fatally injured whilst changing a large wheel assembly (tyre and rim) on a rear axle expanding low loader at an open cut coal mine in Queensland's Bowen Basin (refer **Figure 1** below). The tyre fitter was found trapped underneath a wheel assembly.

1. Draw attention to the occurrence of a serious incident in the mining industry
2. Increase risk awareness
3. Promote mines to examine and check that their risk management controls associated with tyre wheel and rim changing are as low as reasonably achievable.
4. Site SOPs for fitting, removing, testing, maintaining and repairing tyres and rims should be reviewed against the requirements of Recognised Standard #13 "Tyre, wheel and rim management" as a minimum.
