TITLE  
OAKY CREEK No.1 COLLIERY  
LONGWALL 14 ACCIDENT 20/01/99  
SECTION DETAILS

NORTH ACCIDENT INVESTIGATION  
ACCIDENT FAULT TREE ANALYSIS OF BASE CAUSES

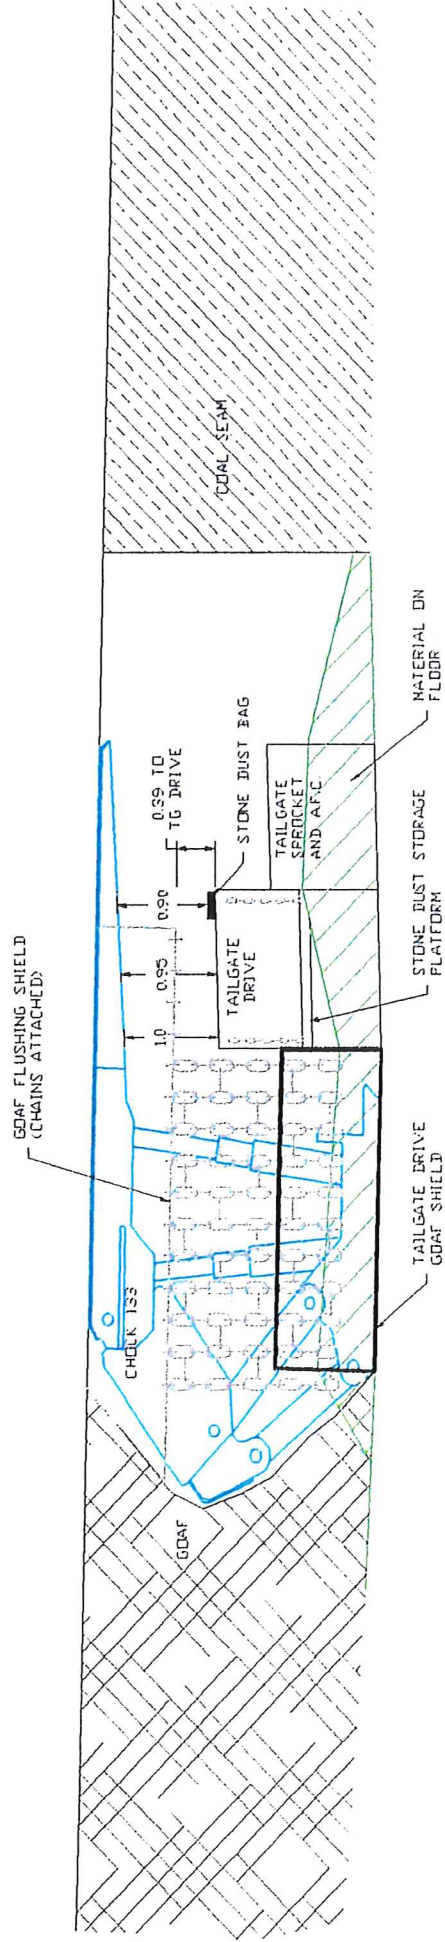
DRAWING No. VF11-352

SECTION THROUGH CHECK 133  
TO LONGWALL FACE

Figure 3: End view showing  
tailgate equipment.

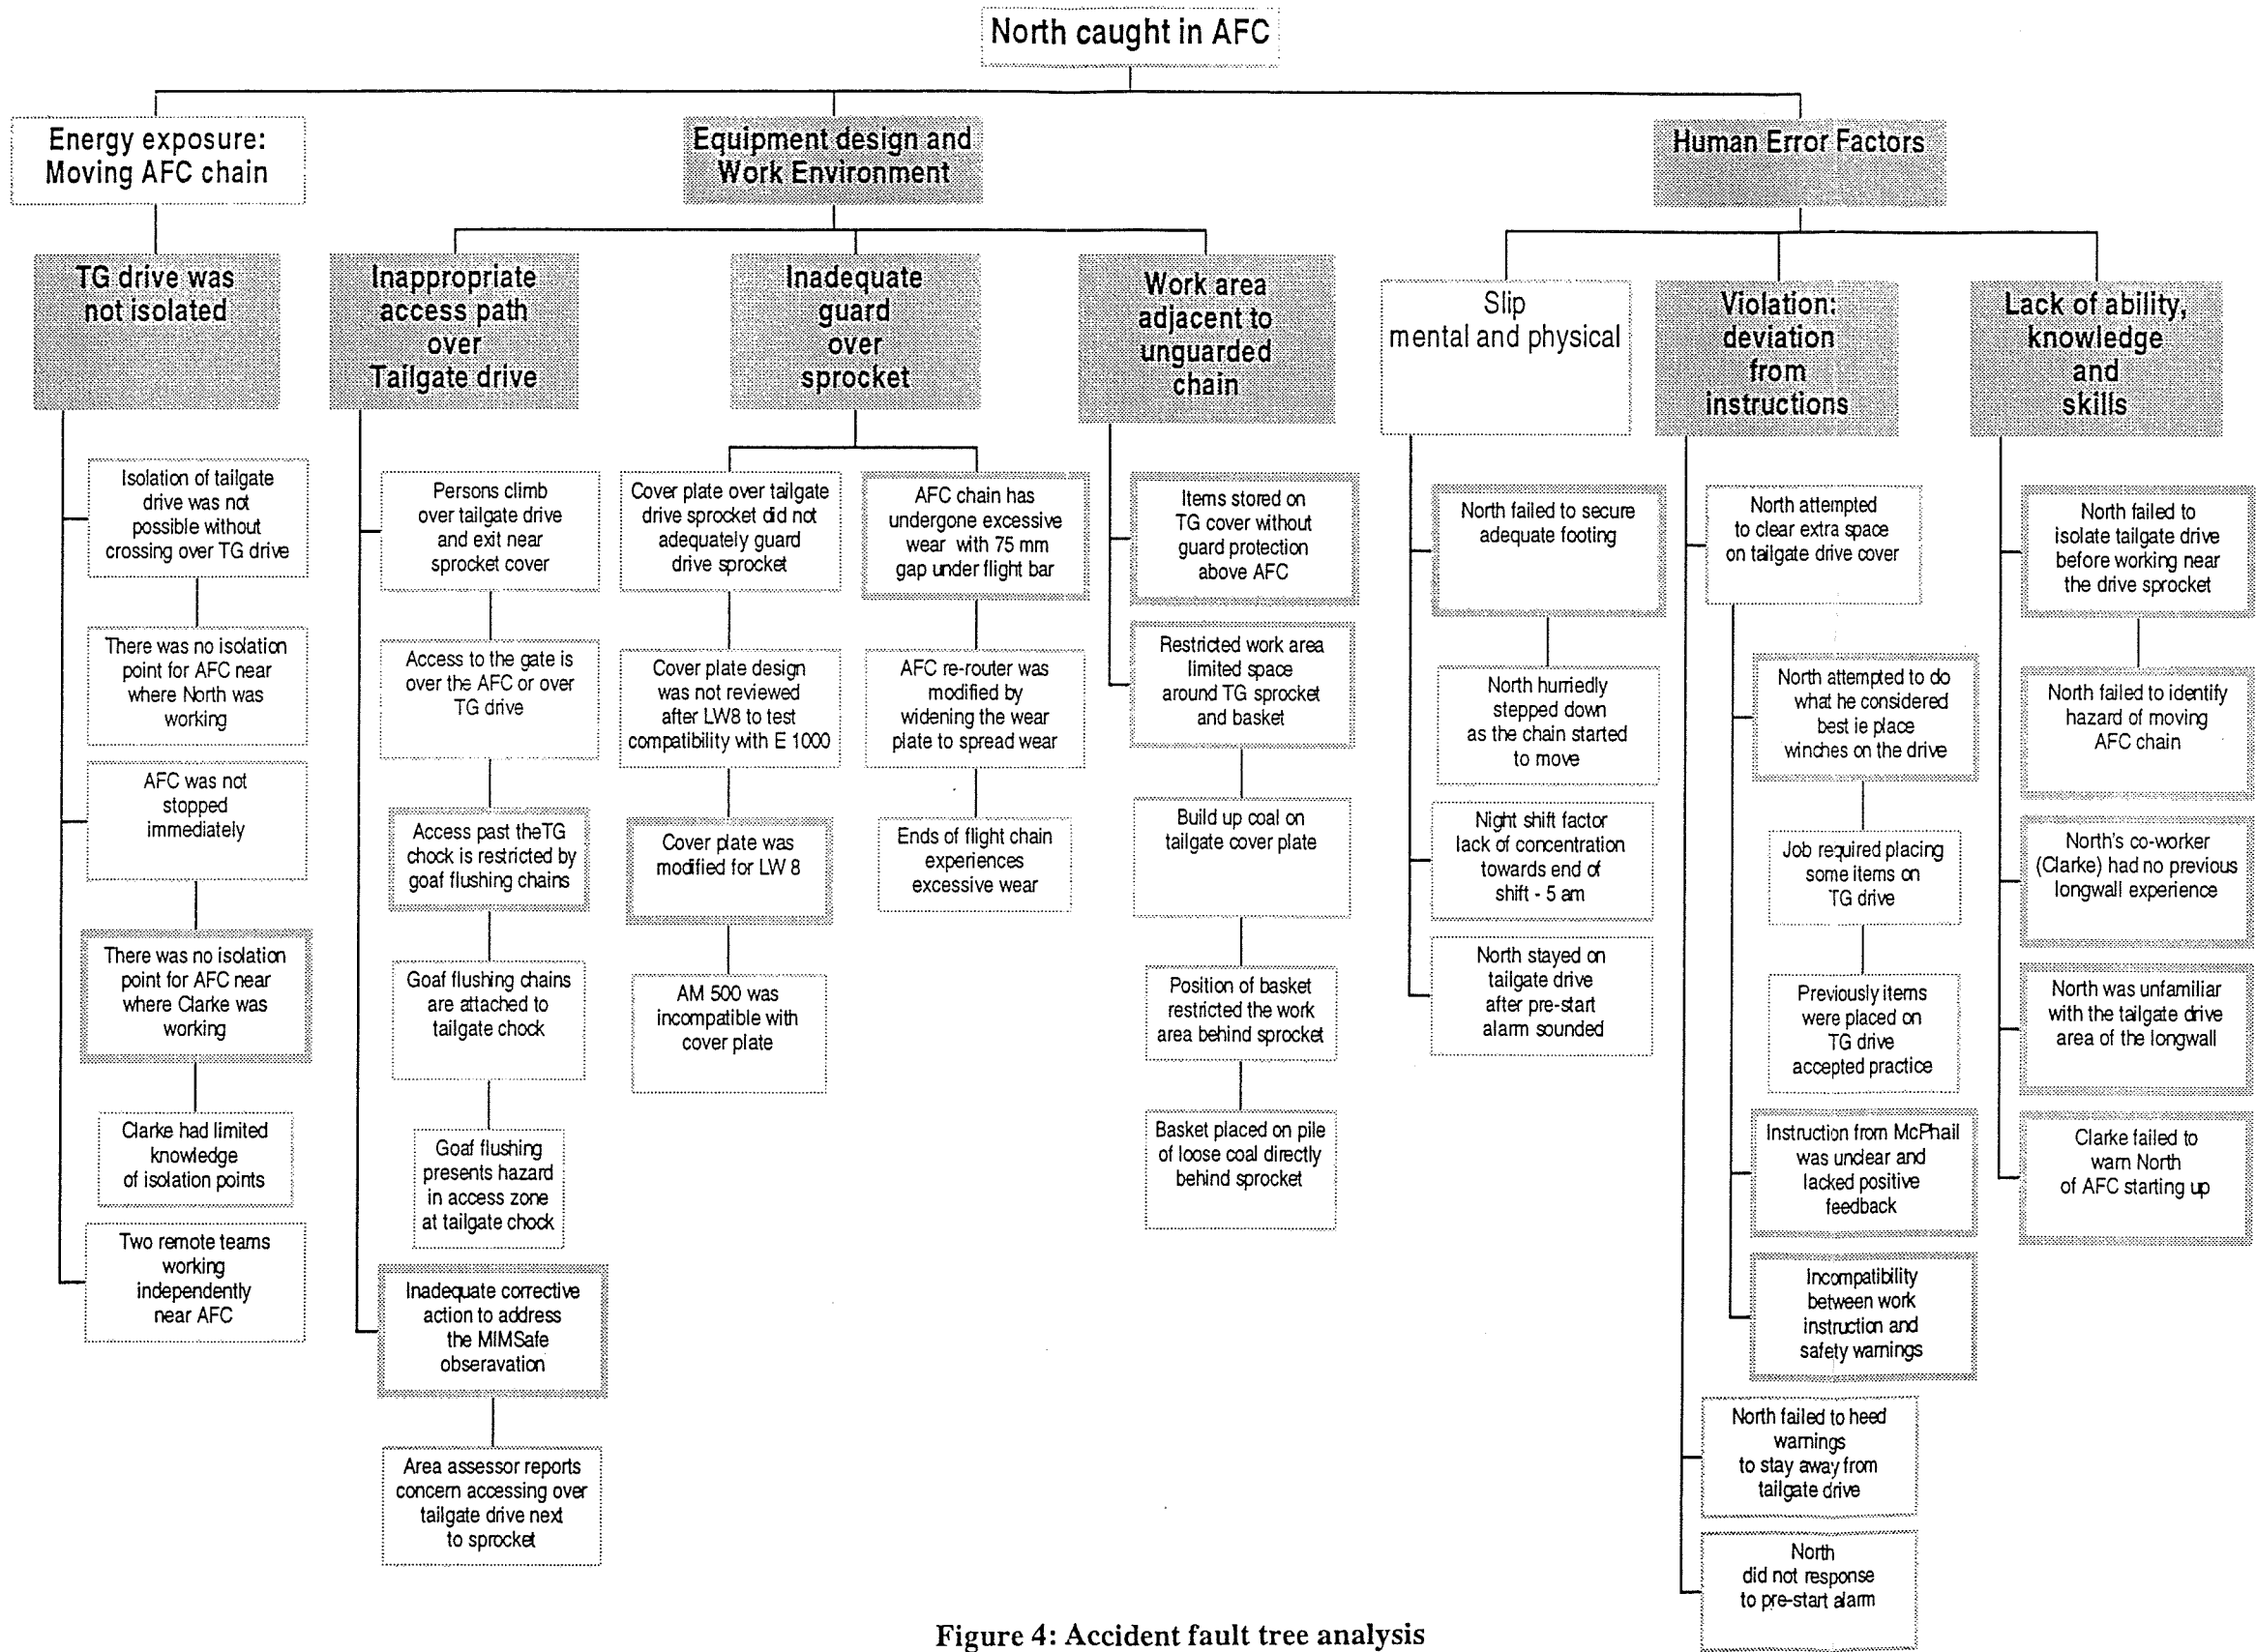
Figure 4: Accident fault tree analysis
