# UQ Materials Performance

## Fatality During Excavator Bucket Wear Plate Removal – Technical Learnings

Prepared for  
**Resources Safety & Health Queensland**

## Incident Summary

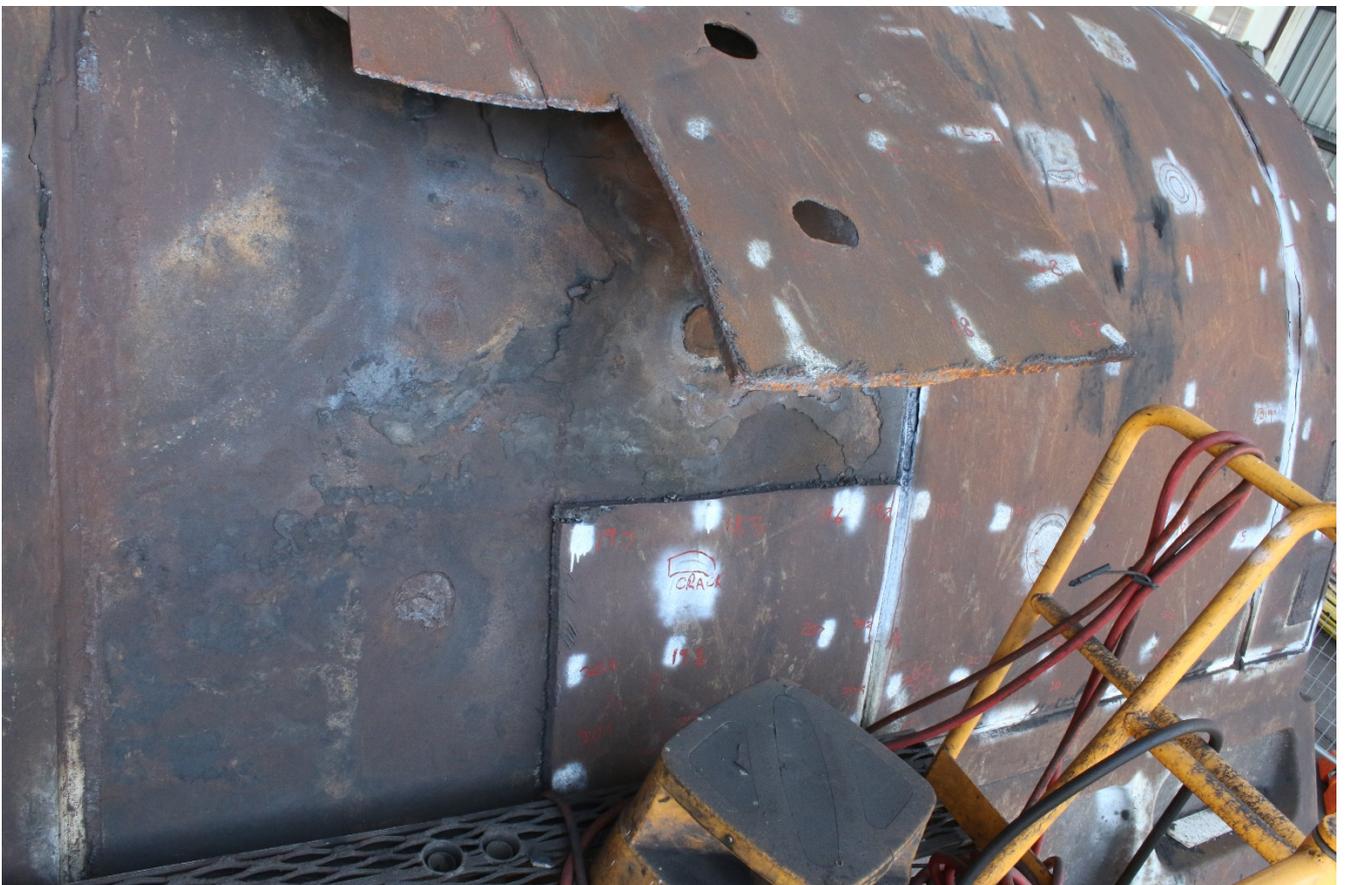
In August 2017 a fatal incident occurred at Goonyella Riverside mine during maintenance works on the underside of an excavator bucket. A worker was progressively removing large wear plates (1600mm x 2500mm) by arc air gouging them into small pieces. During gouging a large portion of the wear plate suddenly sprang away from the bucket (see Figure 1), striking and killing the worker.

The maximum spring back displacement was determined to be approximately 1.2m, before coming to rest at 0.6m from the bucket (see Figure 2). Modelling estimated that the impact experienced by the worker was approximately 4 times greater than the nominal survivable head injury criterion (HIC) of 1000. This demonstrates the severity of the hazard. Calculations predicted that the worker’s head experienced an acceleration of 185 g for a duration of 10 ms, with the plate moving at 20 m/s. This equates to a HIC of 4,650, which is 2.6 times greater than the maximum survivable HIC threshold of 1800 [1, 2].

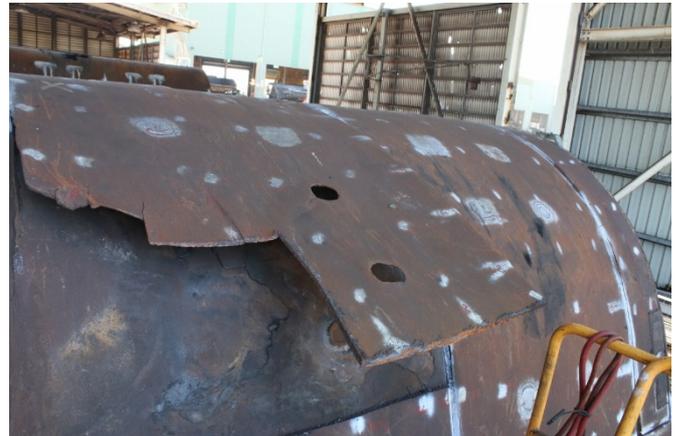
Figure 1 – Overview of plate after incident

The incident plate contained up to 30mm thick layer of dirt trapped between the wear plate and bucket structure (Figure 9). Dirt ingress occurred due to locations of the wear plate that had perforated from excessive wear (Figure 1 top left).

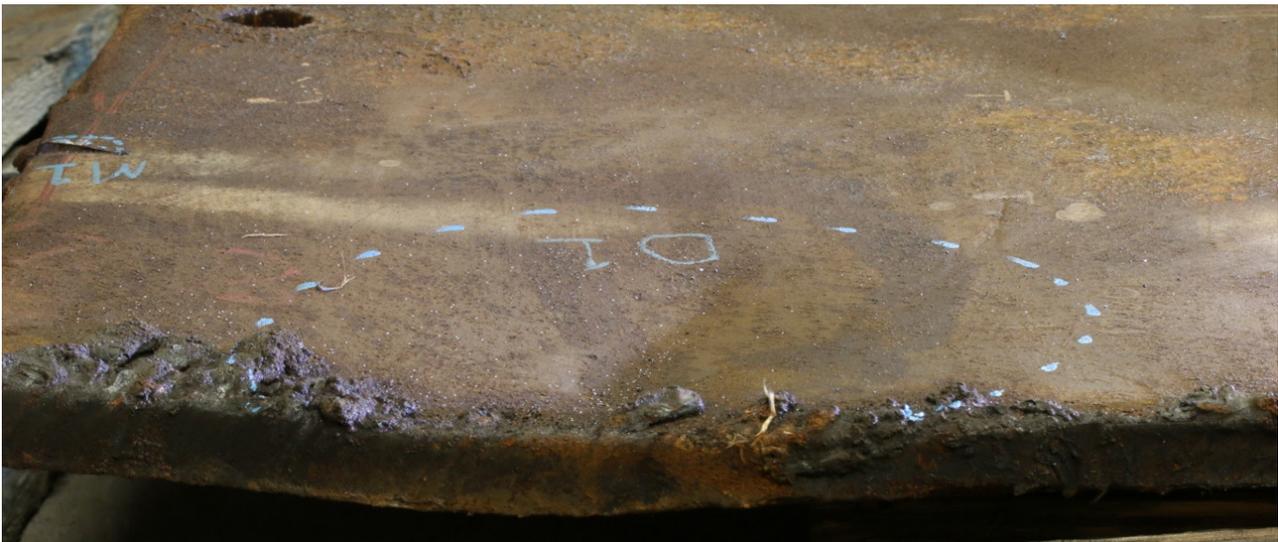
Residual stress builds up in wear plates when large forces or impacts sufficient to plastically deform the plate are applied, permanently changing the shape of the plate. This manifests as observable indentations, for example see Figure 3. It is important to note that residual stresses (i.e. stored elastic energy) only increases in-service due to permanent plastic deformation, not from elastic deformation.

Figure 3 – Dent located at the top of the incident plate (100mm radius of curvature)

In this incident, residual stress and spring-back potential accumulated as a result of repeated indentation from forcible contact with hard objects Figure 3. Calculations and finite element modelling showed that this phenomenon is able to explain the full spring-back displacement observed in the incident (Figure 2). It also explains the final position and shape of the incident wear plate, including the observed transverse curvature seen in Figure 1. The many dents observed on the plate are evidence that high contact load events had been experienced, each of which were sufficient to cause plastic deformation (Figure 3).
