## Leichhardt Colliery Outbursts and Signs

John Hanes

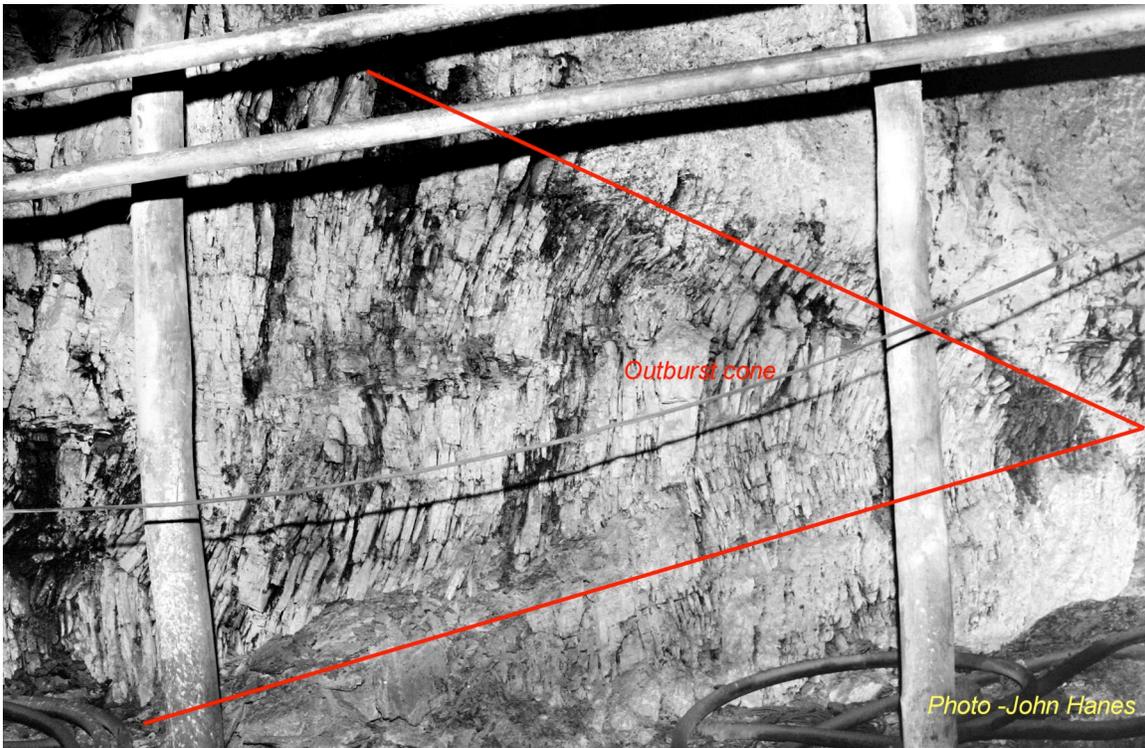
Figure 2  
Small outburst from lower part of left rib. Advance to right.

In the eastern part of the mine, outbursts occurred frequently (daily) from the rib. They were typically small and occurred as the violent buckling of a few tonnes of the cleated coal into the opening. At times, the miner driver could “turn on” an outburst for visitors.

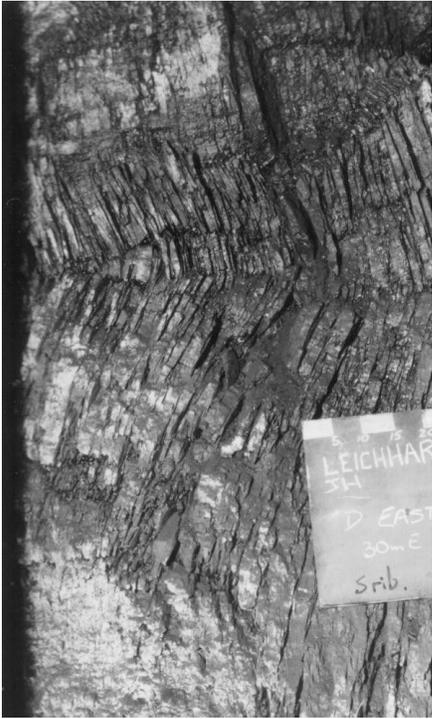
Figure 3  
Buckled coal in the core of  
a small outburst

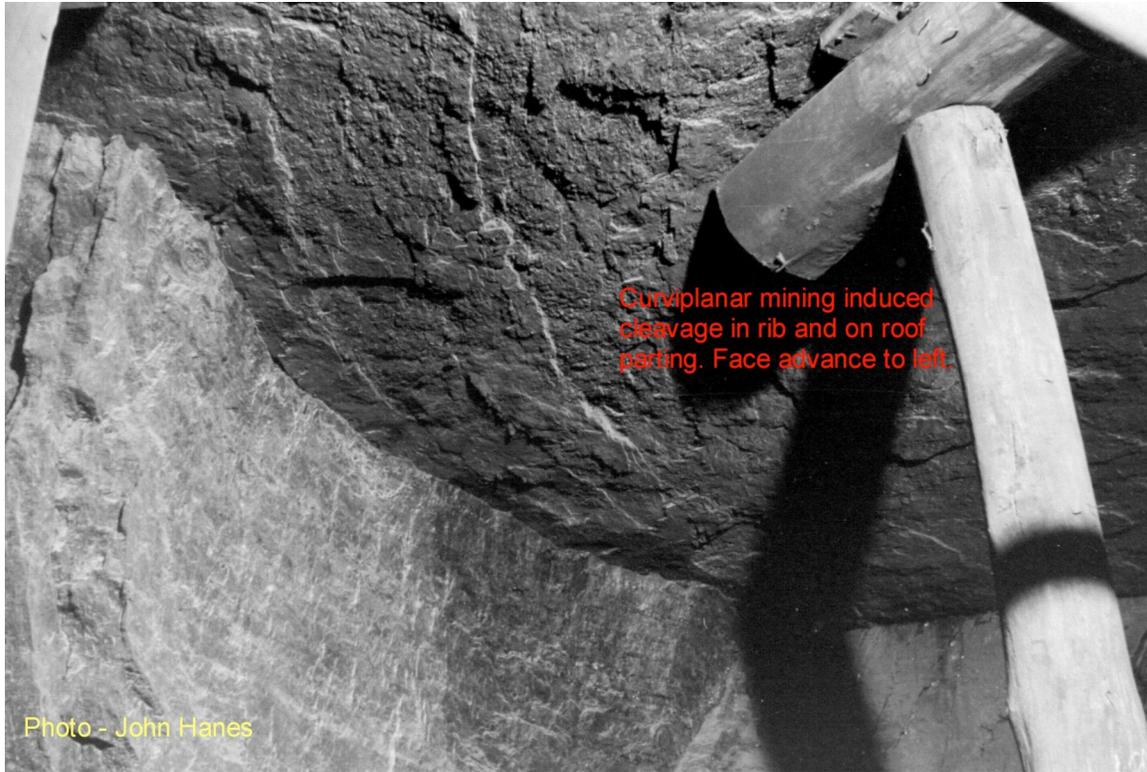
Figure 6  
The tracings of mining induced cleavage on the 3 m parting

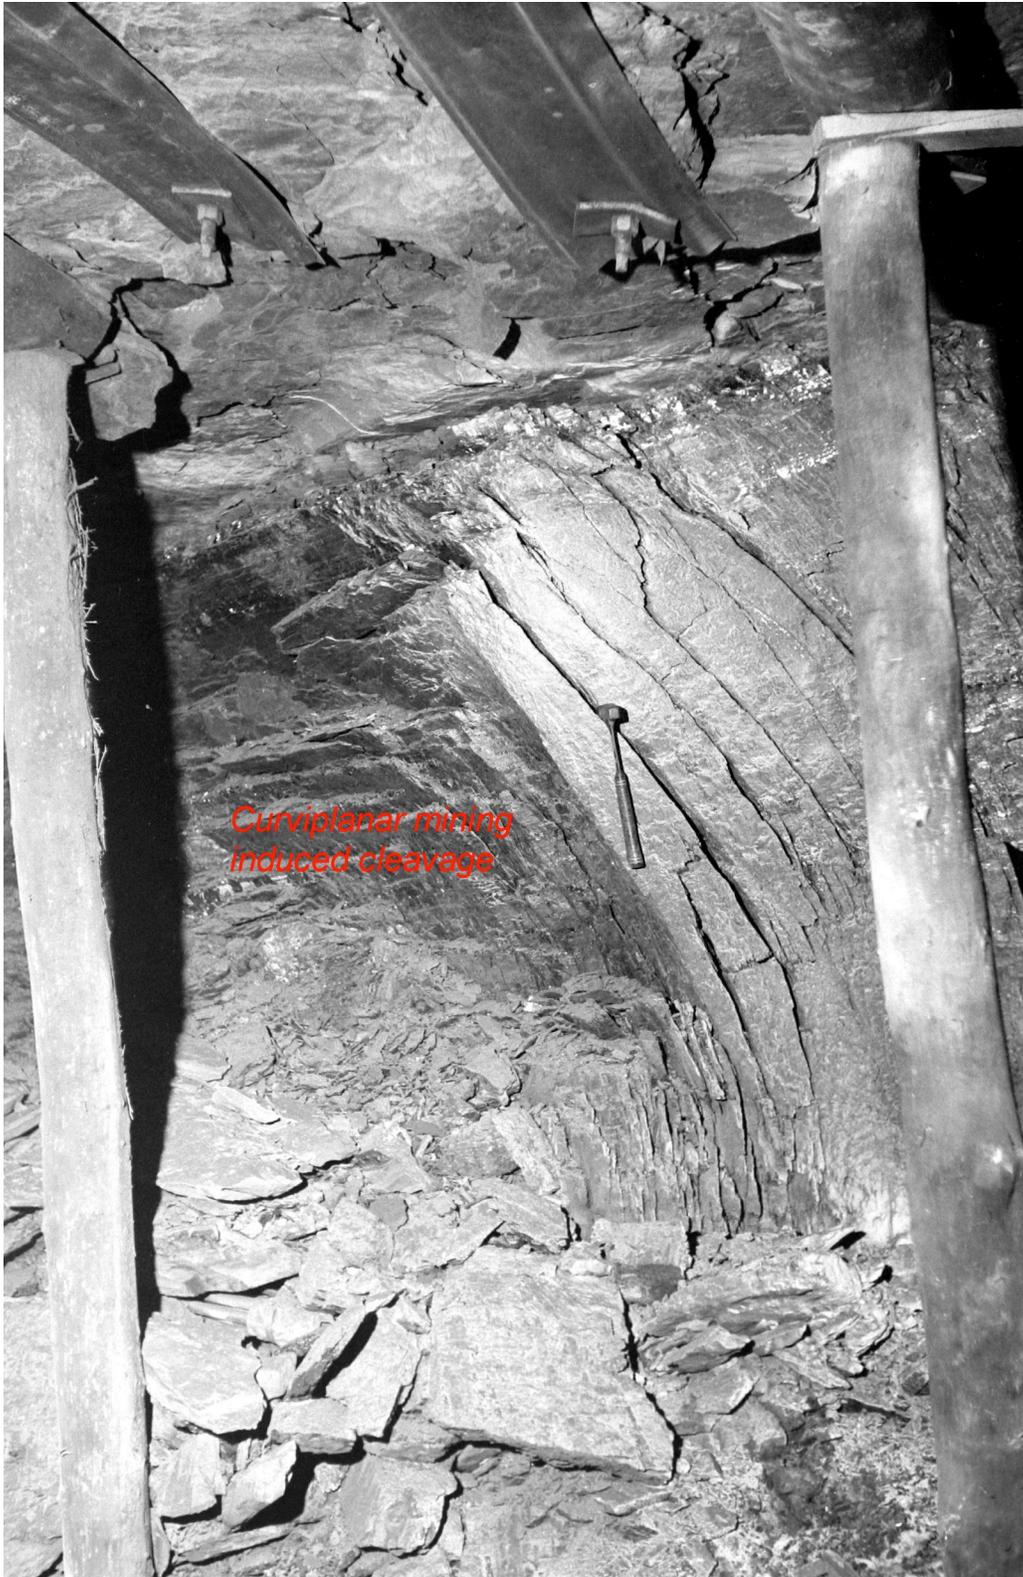
Figure 9  
Large scale mining induced cleavage slabs in left rib

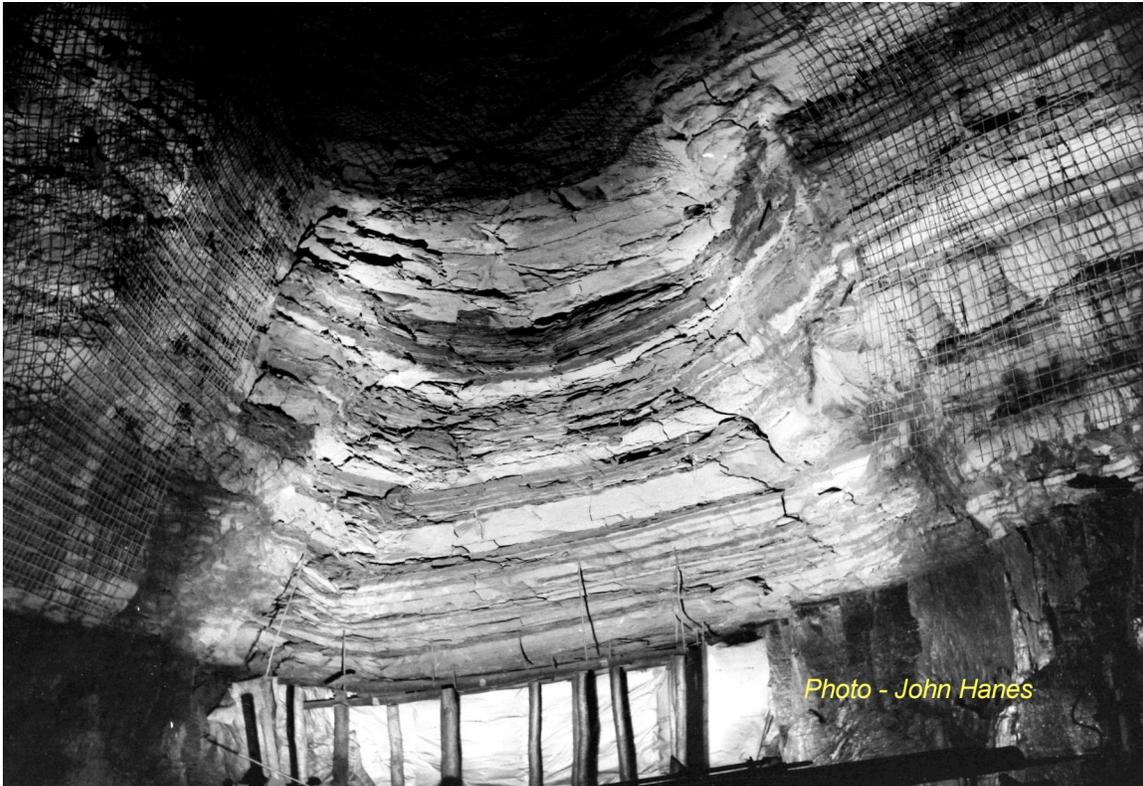
Figure 10  
Typical roof fall

The mining induced cleavage was prominent in the coal roof and in the stone roof. The roof strained considerably and assisted the interpretation of stress directions. Roof support was with timbers and chemically point anchored 2.1 m bolts which were tightened to 40 ft lbs torque due to the limitations of the available bolters. Mining strain increased the torque to well over 400 ft lb. The bolts did not prevent roof strain. In many cases the bolts held the roof together even when the roof fell and sat on the floor.

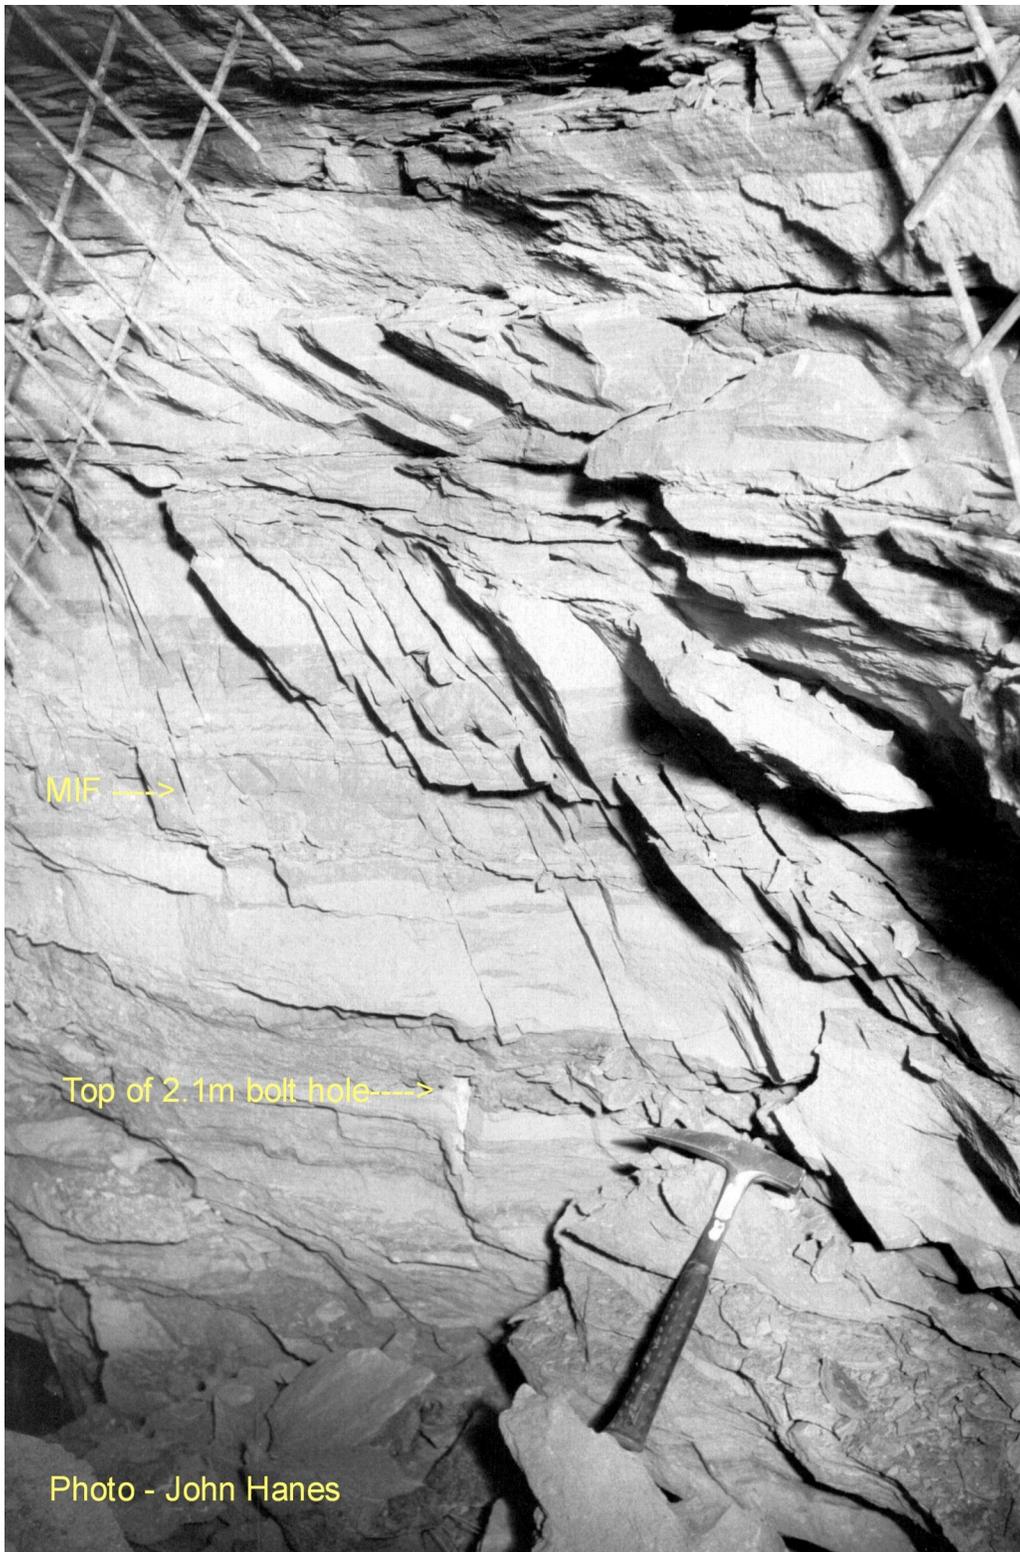
Figure 11  
Mining induced cleavage 2 – 3 m above seam roof

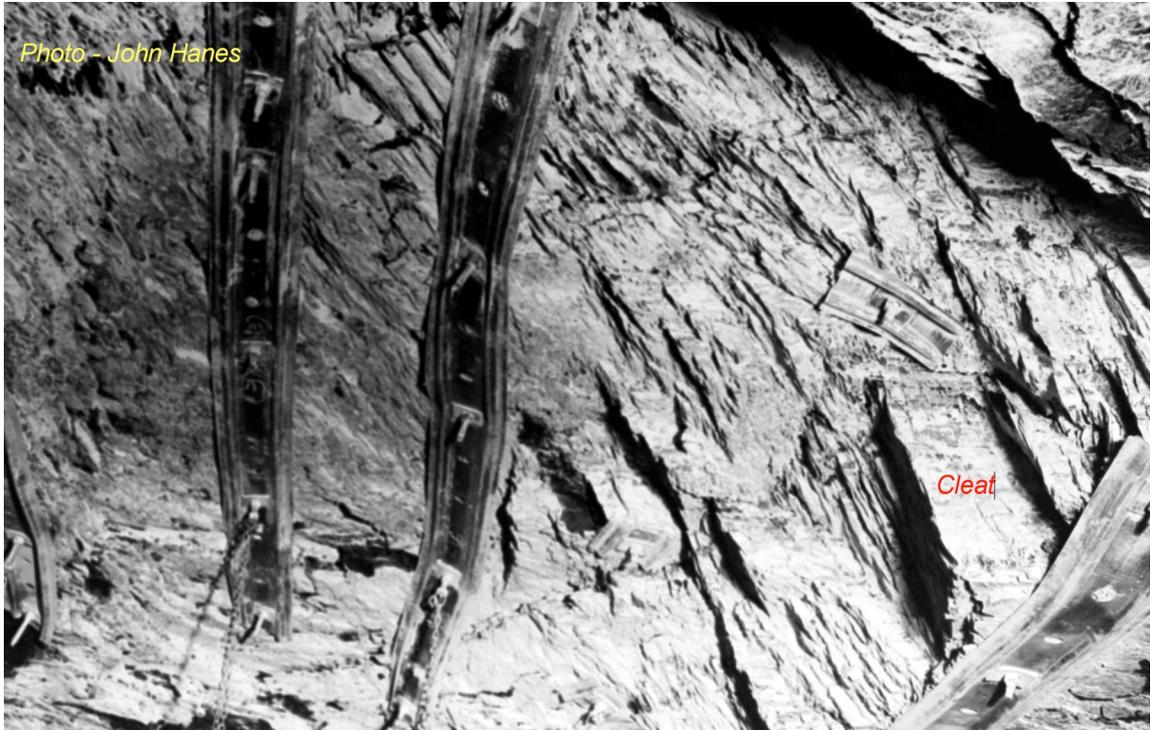
Figure 12  
Mining induced cleavage (perpendicular to photo plane) in roof coal outburst. Mining  
roof at strap bottom right. Mining direction left to right.

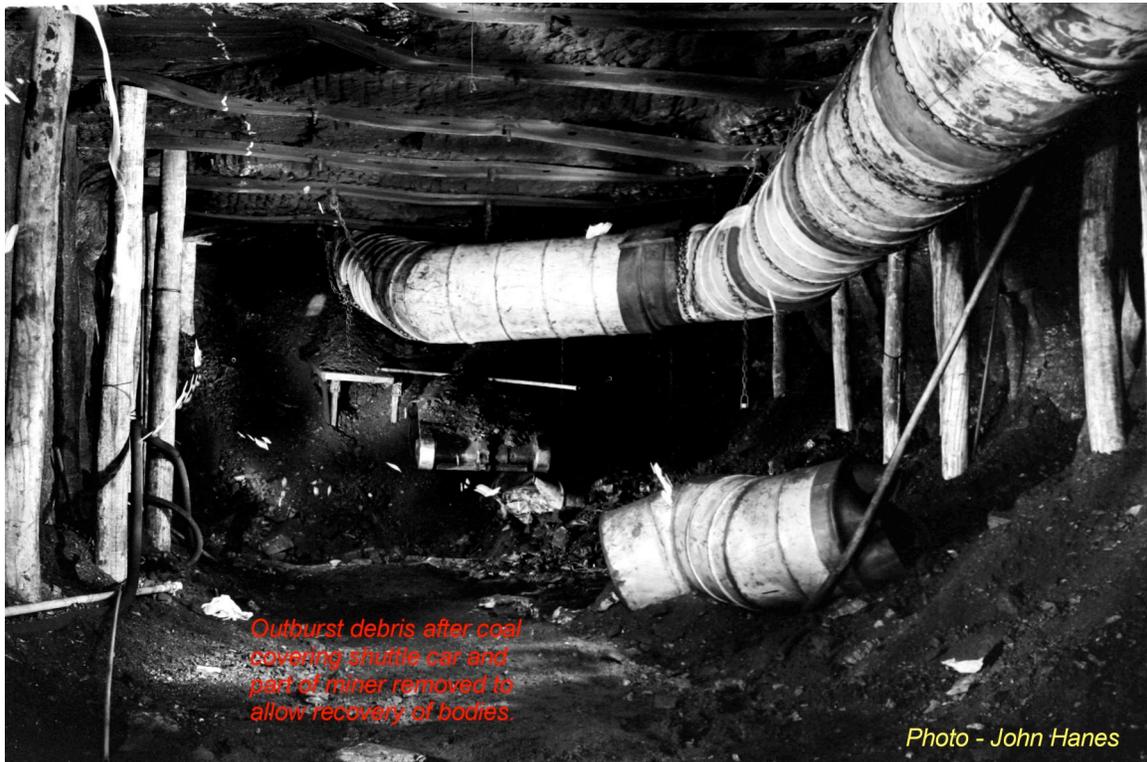
Figure 14

The situation of the fatal 1978 outburst after the coal debris, which half covered the shuttle car was sufficiently removed to permit recovery of the bodies of the miner driver and cable hand.

In December, 1978, a major outburst occurred and killed two men. The ejected coal completely covered the miner and half covered the shuttle car.

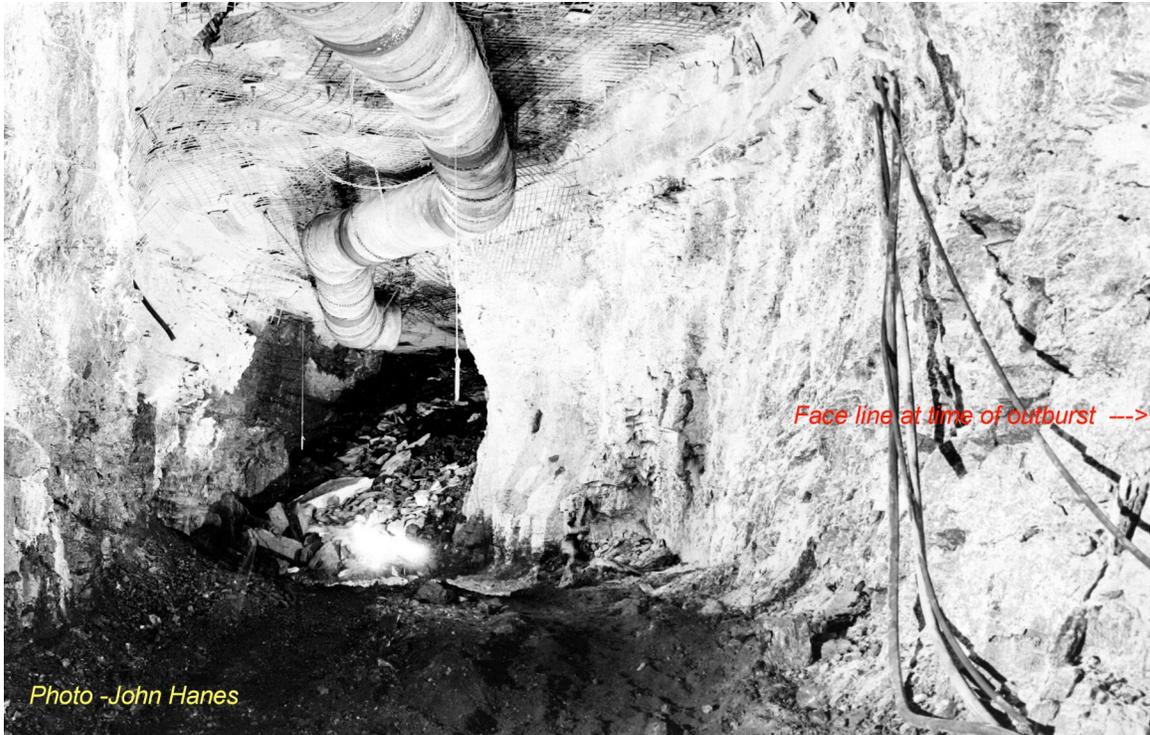
Figure 15  
The cavity of the 1978 outburst after all loose coal was loaded out

The resultant cavity was more than 20 m long. Around 500 tonnes of coal was involved. After this outburst, mechanized mining was stopped and the mine effectively became a research laboratory for a couple of years. The extensive gas investigations have been reported elsewhere.
