# Fatality involving front end loader

Mines safety alert no. 294 | 12 September 2012 | Version 1

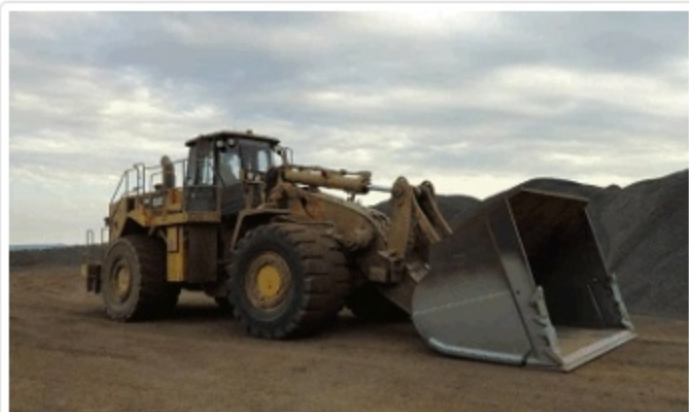
A worker on foot was struck and killed by a 988H Cat front end loader which was tramping forward. The worker was found on the run of mine (ROM) pad.

988H Cat front end loader

All sites should review their procedures, practices and plans to manage the risk of mobile equipment–pedestrian risk.

1. Designing operations, tasks and activities to eliminate or reduce the possibility of interaction between pedestrians and mobile equipment.
2. Maintaining positive communication between pedestrians and equipment operators.
3. Recognising the equipment operator's blind spots and the location of pedestrians or plant.
4. Developing clear and concise rules for the interaction of mobile equipment and pedestrians in all parts of the operation, including restricting pedestrians from areas where mobile equipment is operating.
5. Considering implementation of proximity sensing technology to limit equipment operation when persons are in the vicinity of mobile equipment.
