Coal Inspectorate | Bulletin | No.199 V 2 | 07 August 2023

# Pick and Carry Cranes

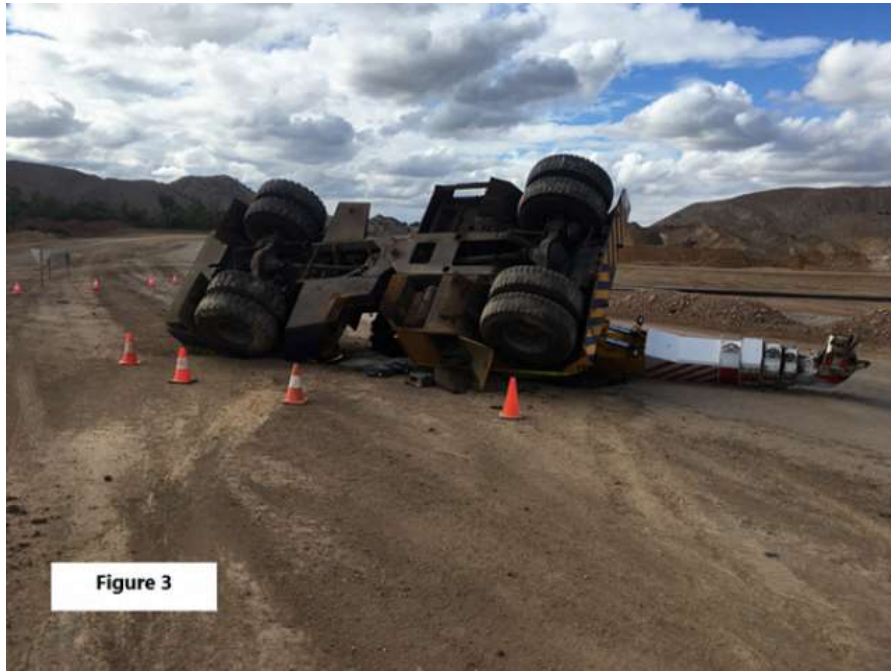
**Figure 3**

Whilst relocating a mobile pick & carry crane on site, the operator lost control and rolled the vehicle on its side (figure 3). The coal mine worker (CMW) was able to exit the vehicle, however suffered injuries requiring hospitalisation.

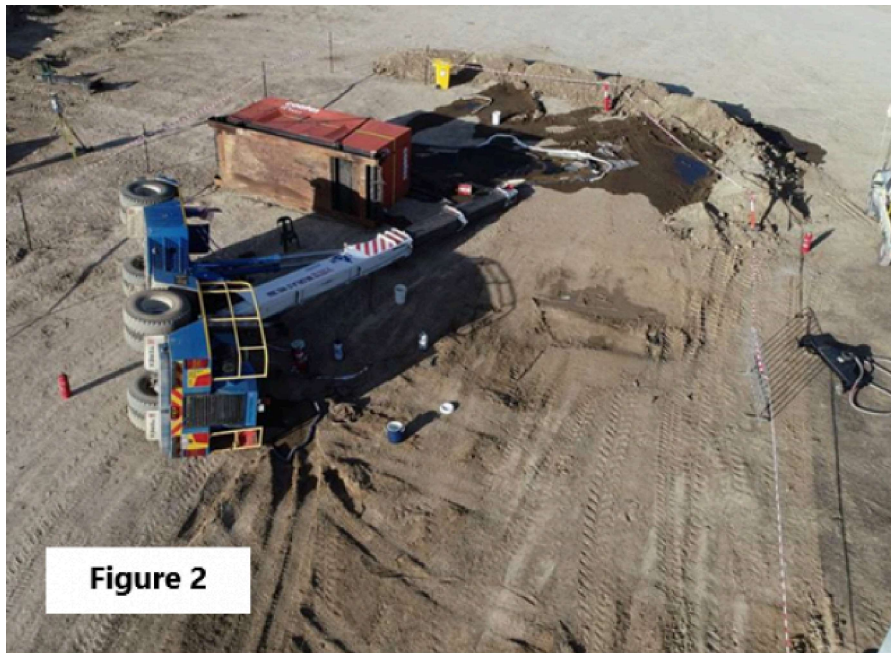
**Figure 2**

On 11 April 2021, whilst moving a large generator, a pick & carry crane tipped on its side (figure 2). The crane was operating at full safe working load, travelling on uneven ground and articulated. It was reported that the load monitoring system override function was activated multiple times prior to the rollover. No persons were injured in this incident.

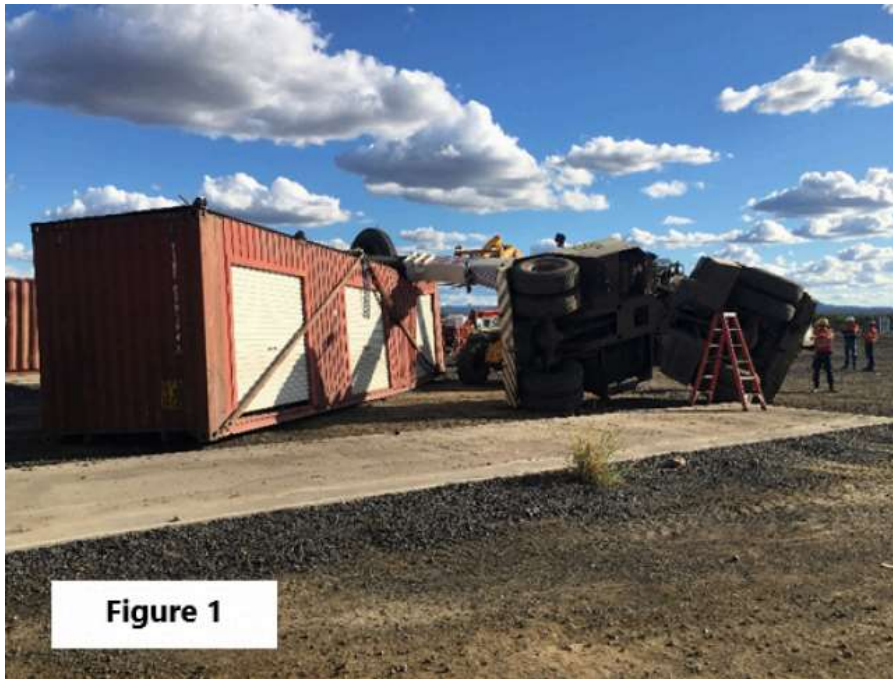
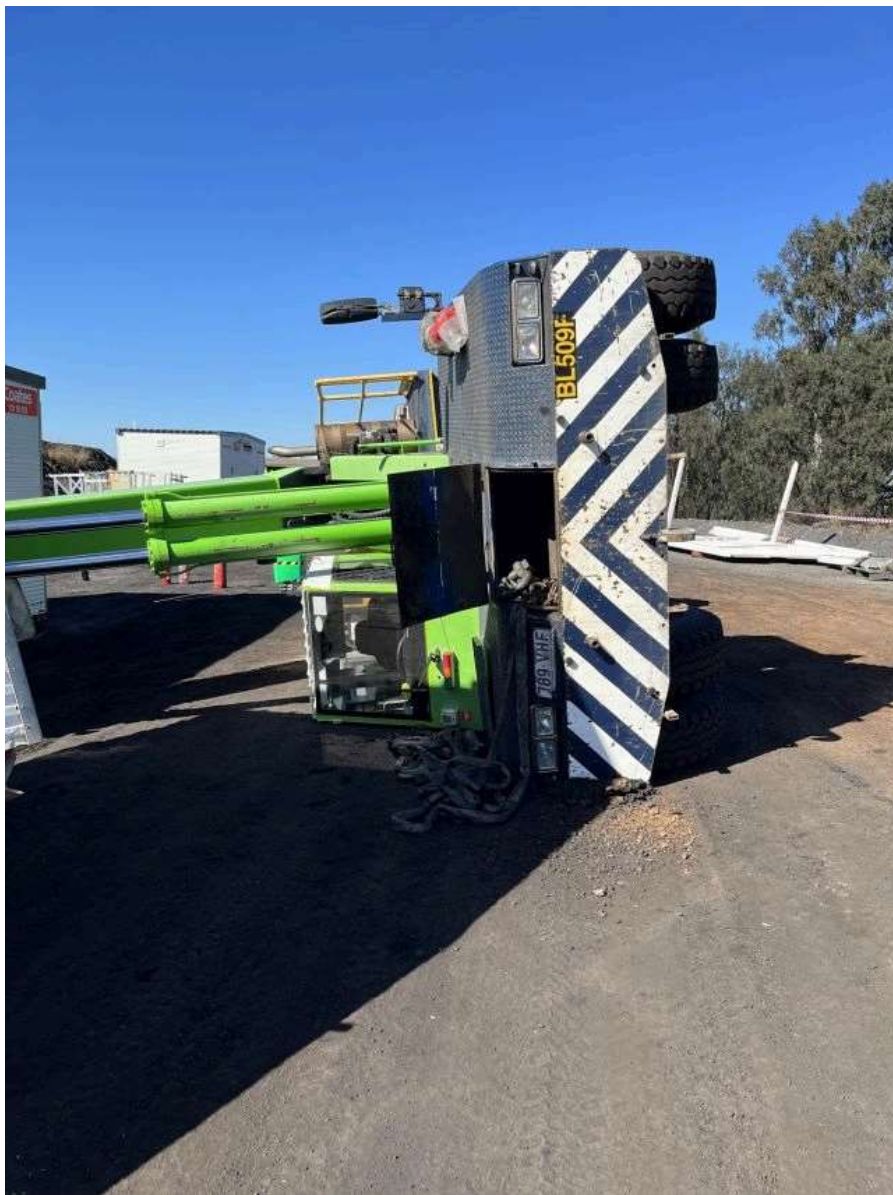
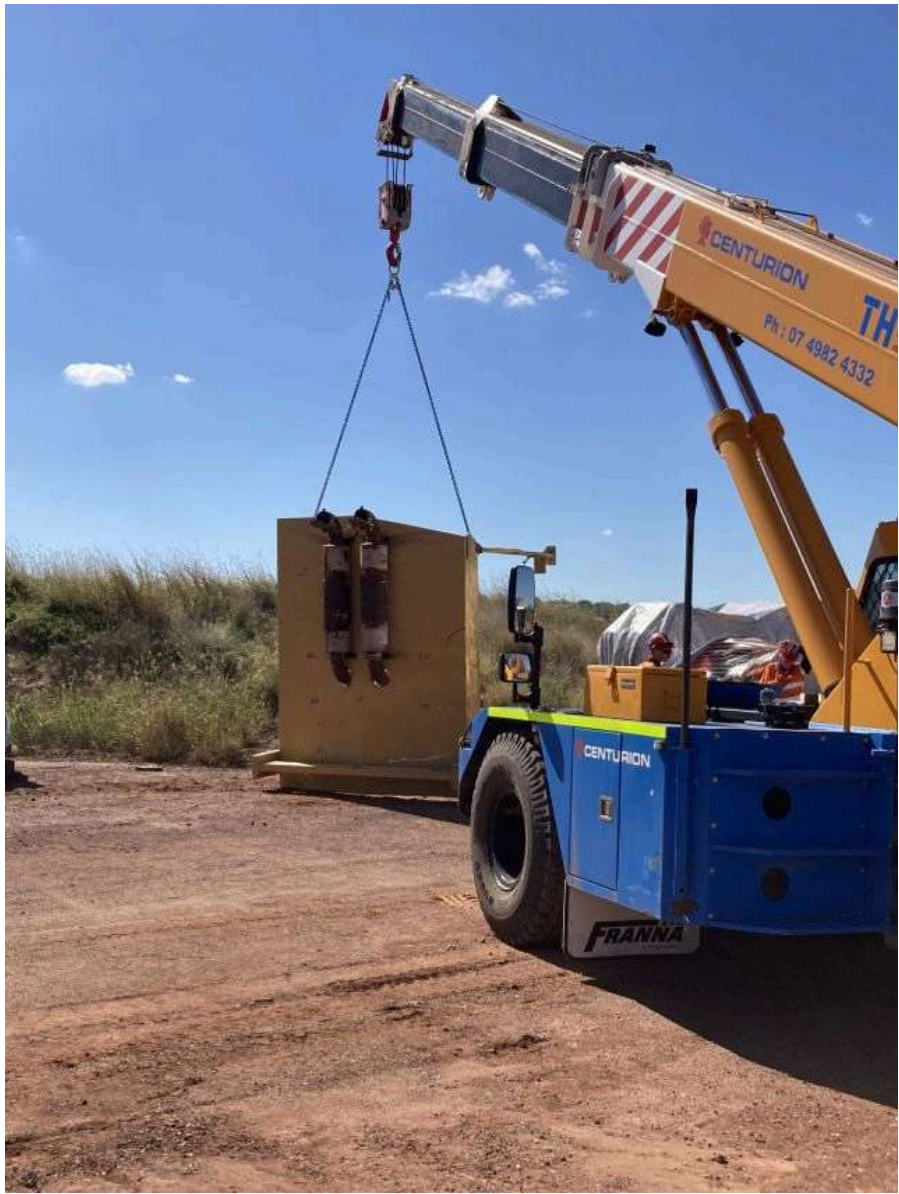
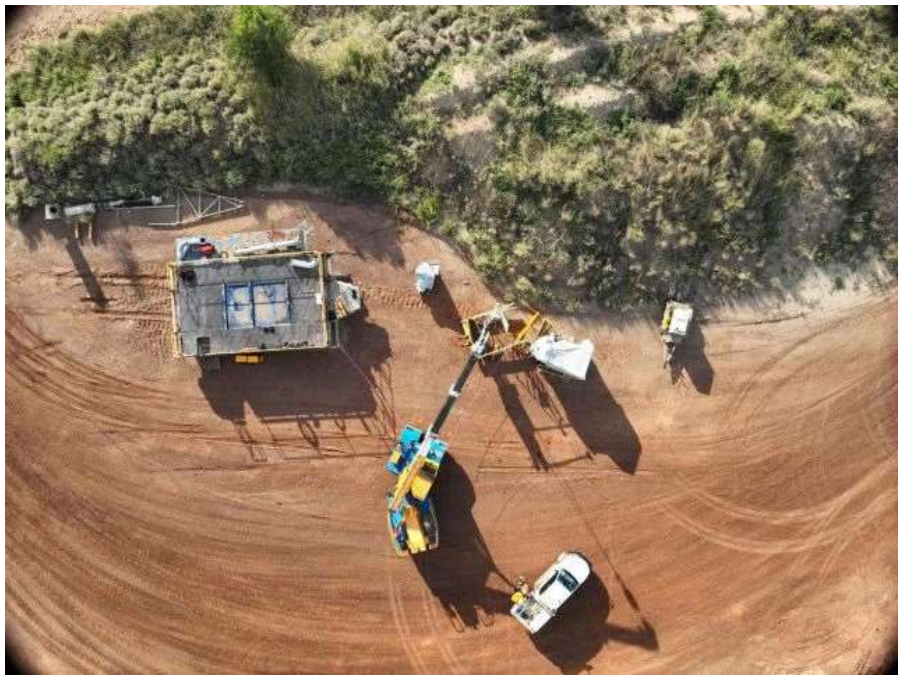
- A crane operator, whilst authorised, did not utilise the load monitoring system correctly, or understand the hazard created when fully articulating the crane under load.

- Operators did not assess travel routes prior to commencing pick & carry operations.
- Uneven ground conditions were not immediately rectified once identified.
- The crane operator deviated from the plan, fully articulating the crane in an attempt to navigate around obstacles in the travel path, resulting in a rollover.
- Alternative travel routes were not considered by CMWs completing the task.
- The dogman was focused on the load and did not observe the travel path while the crane was reversing.
- The crane operator did not stop the task when it did not feel right.
- The crane operator repeatedly used the load monitoring system override switch to continue crane operation prior to rollover.

- Alternative methods for equipment relocation were not considered.
- The crane's speed was not suitable for the surface conditions although less than posted speed.

- very few areas on a mine site where pick & carry cranes are utilised can be considered to be firm, level and uniform. Consider reducing the allowable crane load capacity to cater for wheel ruts, potholes, protrusions and depressions found on "flat" mine surfaces

- revision of speed limits for cranes travelling on-site.
- Implementation of a site-specific pick & carry crane form or permit that includes:
  - assessment of site conditions and load derating factors to be applied in determining the carrying capacity of the pick & carry crane
