# Lessons Learned from Mine Disasters: New Technologies and Guidelines to Prevent Mine Disasters and Improve Safety

By Jürgen F. Brune and Benjamin Goertz

## A Research Report

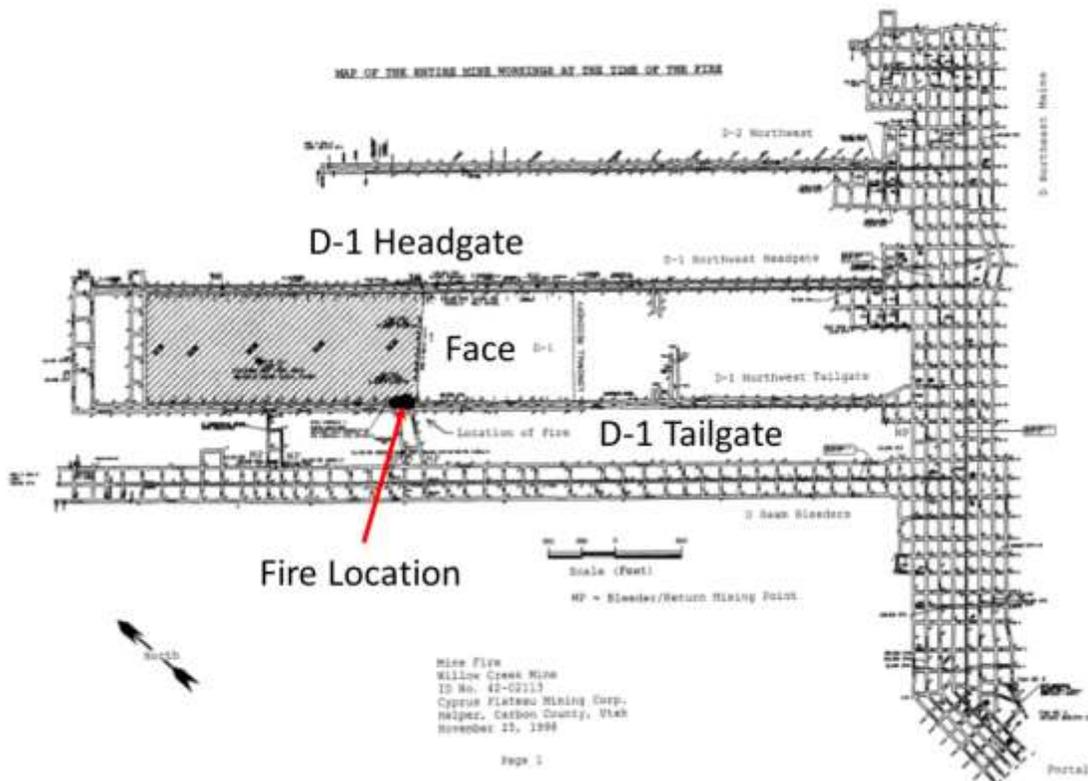
Figure 19: Map showing the location of the 1998 Willow Creek explosion and fire (Elkins, 2001)

After the explosion the face air flow returned to its normal direction and then briefly reversed again, suspending dust and reducing visibility. Dust-laden air was also observed pulsating in and out between the shields. The miners observed an orange colored flame in the gob behind the shields that appeared to move towards the face and then back into the gob.

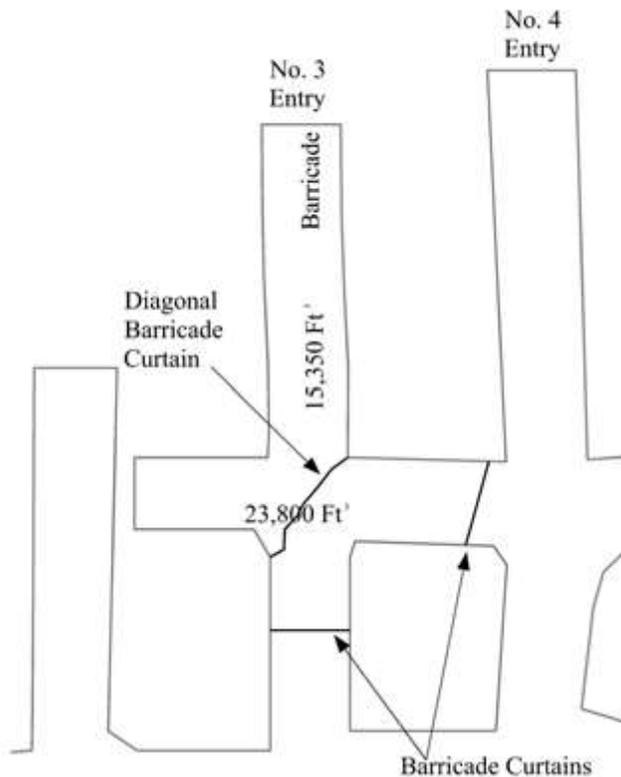
Figure 23: Drawing of Barricade (Gates et al., 2006).

It is unknown what the CO concentration was at the time the barricade was constructed but issues with barricade construction are believed to be the leading cause of its failure. The curtain across the crosscut between No. 3 and 4 entries was loosely hung and open about a foot on the inby side. The diagonal curtain that was hung was left open about a foot on each side and no material was found on the bottom of the curtain that would have acted as a sealing material to create a tight fit. MSHA noted that a number of locations around the crew had possible barricading materials such as pallets of 6-inch concrete blocks, mortar, wedges, headers, cap boards, 8-foot posts and spray sealant. The situation that the miners were in may have left them rushed and panicked making them think they needed to put up a barrier as quickly as possible even if it meant it was of subpar construction.

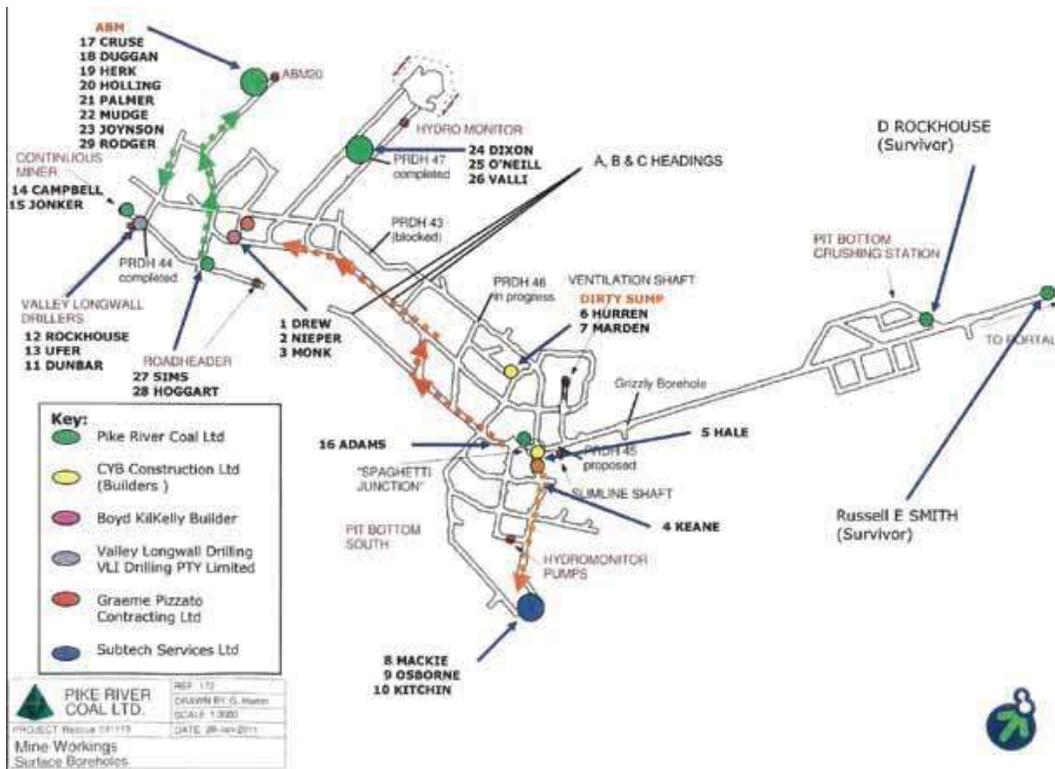
Figure 26: Last known position of the 29 deceased and two survivors (RCPRCMT, 2012).

The mine was new and the owner had not completed the systems and infrastructure necessary to safely produce coal in addition to its health and safety systems being inadequate. Pike’s ventilation and methane drainage systems were inadequate. There were numerous warnings of a potential catastrophe at Pike River. In the last 48 days before the explosion there were 21 reports of methane levels reaching explosive volumes, and 27 reports of lesser, but potentially dangerous, volumes. The reports of excess methane continued up to the very morning of the explosion.

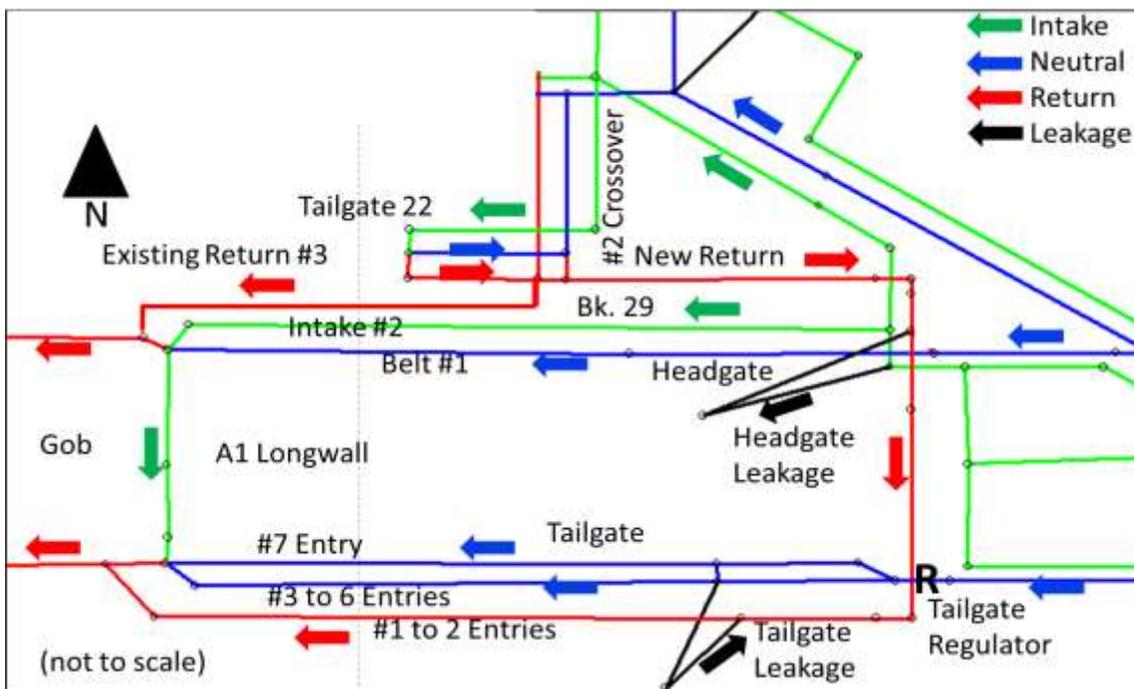
With revision B6-A13, major air changes on the longwall were approved on 12-18-2009. With this revision, UBB proposed to no longer use the No. 3 entry in the longwall headgate as a return entry for the CM development (MMU 40, cutting tailgate development TG 22) and instead convert it to an intake. Figure 34 shows this route labeled "Existing Return No. 3". Note that, at this time, the longwall belt was ventilating towards the face.

Figure 34: Routing of belt air and Tailgate 22 development return

The existing return used the No. 3 entry of the headgate to send the return air from the CM development directly to the bleeder fan, which was a ventilation method preferred by Massey-UBB (Massey Energy, 2010). Instead, in this ventilation plan revision, the mine operator proposed to route a new return to the bleeder fan via the mains and entries No. 1 and No. 2 in the tailgate (shown in Figure 34 as “New Return”).

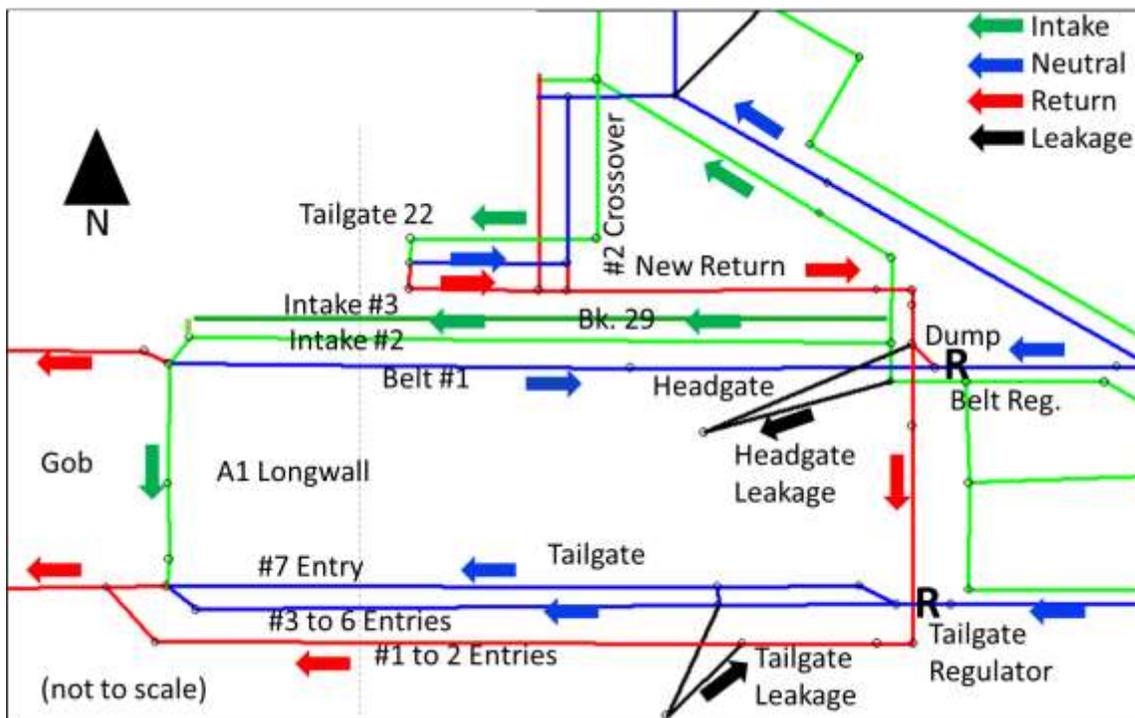
supply more fresh air to the face, as shown in Figure 35. This permitted UBB to reverse the longwall belt air to an outby direction (shown in Figure 35), as proposed by UBB and MSHA-approved in the same ventilation plan revision B6-A13 (12-18-2009). In order to reverse the belt air, UBB had to establish a belt dump regulator at the neck of the longwall headgate where the belt air is fed to the mains return and out the tailgate.

A model variant was generated from the base model to represent the longwall status in late December 2009 based this revision. Modeling shows that, in the entry configuration of December 2009 (plan revision approved on 12-18-2009), it would have been difficult to direct the belt air away from the longwall face while maintaining sufficient air quantities on all belts, to the newly necked-off HG22 development section, and the longwall. One key problem is that UBB tried to feed the belt air from the HG 22 section to the longwall belt as there was no suitable alternative route for this belt air.

Figure 35: Adding longwall intake No. 3 and intended routing of belt air outby

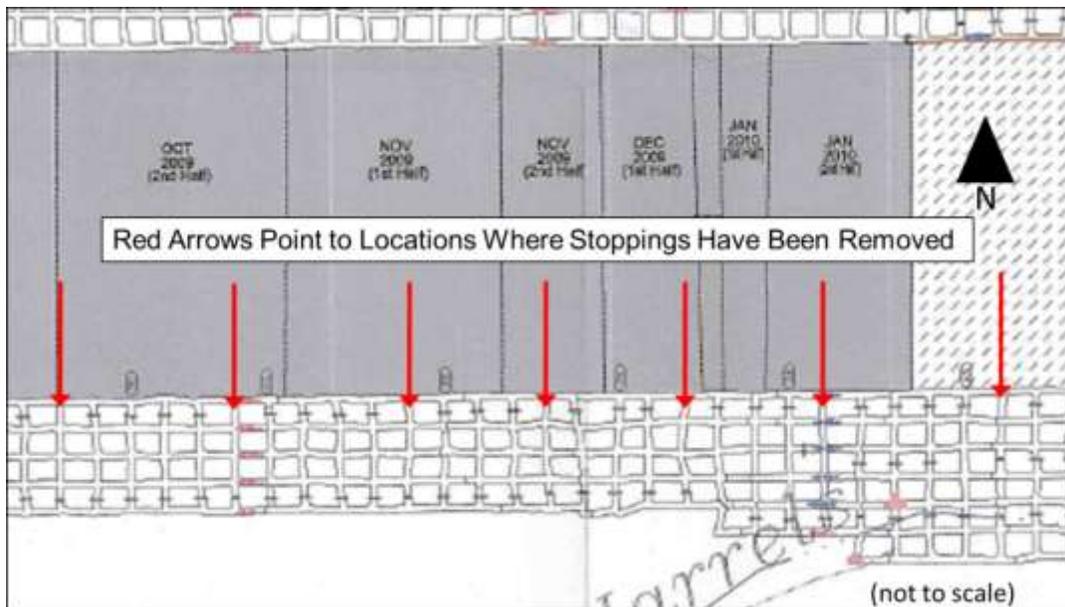
Figure 43: Pattern of tailgate stopping removal at UBB, Ventilation Plan Revision B6-A17, approved on 02-16-2010 [red arrows added].

Figure 43 shows the pattern of stopping removal between the No. 6 and No. 7 entries in the longwall tailgate, per the UBB Ventilation Plan Revision B6-A17, approved on 02-16-2010. This map shows that UBB removed only every 4<sup>th</sup> or 5<sup>th</sup> stopping (as indicated by the red arrows), while the other stoppings are shown as having remained intact inby the face. It is unknown why UBB chose such a stopping removal pattern. In contrast, it is interesting to note that the approved ventilation map showing the “typical longwall face ventilation” per the UBB Base Ventilation Plan and Annual Map - Part 1 - approved on 9-11-2009 (Figure 44) does not show any intact stoppings inby the tailgate

The major problem that might be caused by leaving the tailgate stoppings intact inby the face would restrict tailgate air from flowing from the No. 7 entry to the No. 6, 5, 4 and 3 entries. Typically, the No. 7 entry caves tightly shortly inby the face. Leaving the stoppings in could cause a restriction on the tailgate that might severely reduce the face quantity.

In addition, such a restriction could cause an air reversal in the No. 7 tailgate entry outby the longwall face. This reversal could carry return air from the face for several hundred feet outby and could contaminate the outby area of the tailgate with float coal dust as well as methane. In fact, the base model shows this ventilation configuration might create a negative pressure gradient that could pull methane- and dust-contaminated air from inside the gob area out to the tailgate entries where miners work and travel. This was also noted by the MSHA inspector who cited the air reversal on the tailgate on March 9, 2010<sup>11</sup>.

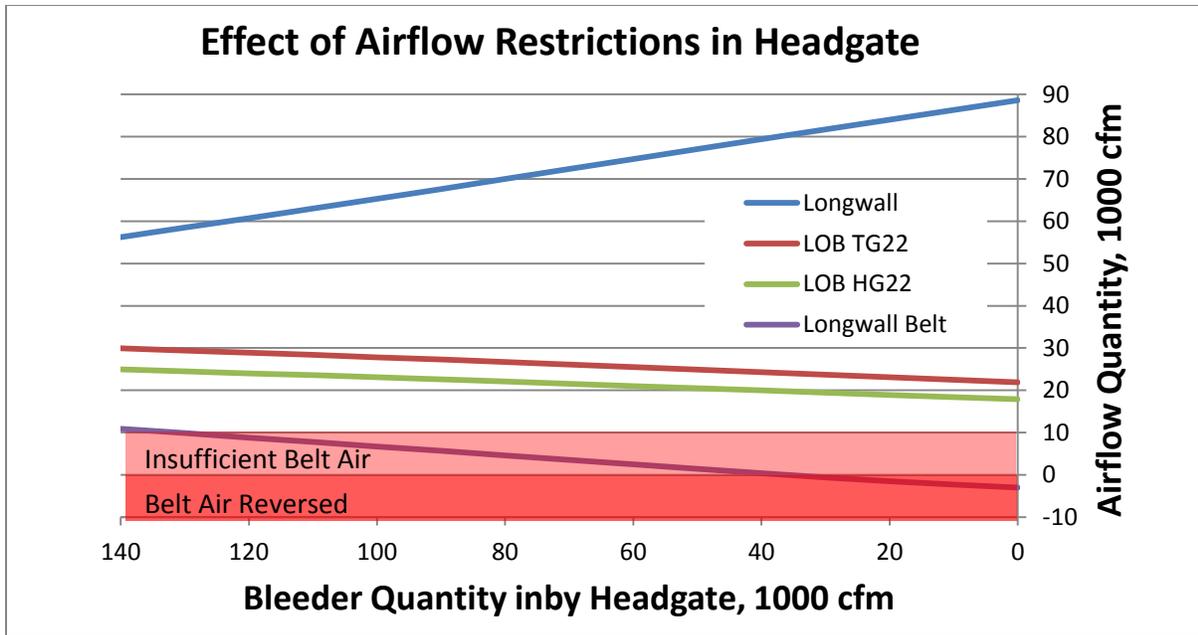
Figure 46: Effect of resistance in headgate bleeder entries.

Figure 46 shows the results of modeling a resistance increase in the headgate that could be caused by roof deterioration, floor heave, and/or water pooling in low-lying areas and would lead to reduced airflow through the headgate bleeder system inby the longwall panel. The mine map<sup>13</sup> shows such water pooling in No. 3 entry of the headgate from break No. 71 to break No. 75. Also, the report by the WV Governor's Independent Investigation Panel (McAteer, 2011) indicates that, on the day of the explosion, water pumps had failed in both the longwall headgate and tailgate.

As expected, higher resistance in the headgate would increase the face quantity, since more air would be available at the headgate and the bleeder fan would pull harder on the longwall tailgate exhaust. Since, at the time of the explosion, the returns of the TG 22 and HG 22 development sections also ventilated to the longwall headgate bleeder, the LOB quantities of these sections would be significantly reduced if the headgate was closed off. In general, reducing airflow due to blockage in a longwall headgate would render the bleeder system ineffective since there would not be sufficient air available from the headgate side to dilute methane in the gob.

Figure 46 also shows that the longwall belt air quantity, flowing away from the face, would be affected significantly if there were a restriction in the headgate. If the headgate flow was restricted below about 33,000 cfm, the belt air would reverse.
