## INSPECTOR'S REPORT

**FATALITY**  
**IAN DOWNES**  
**GRASSTREE MINE**  
**11 DECEMBER 2014**

DATE of REPORT: 12 April 2015  
FILE REF: [FILE NUMBER FROM DATABASE]

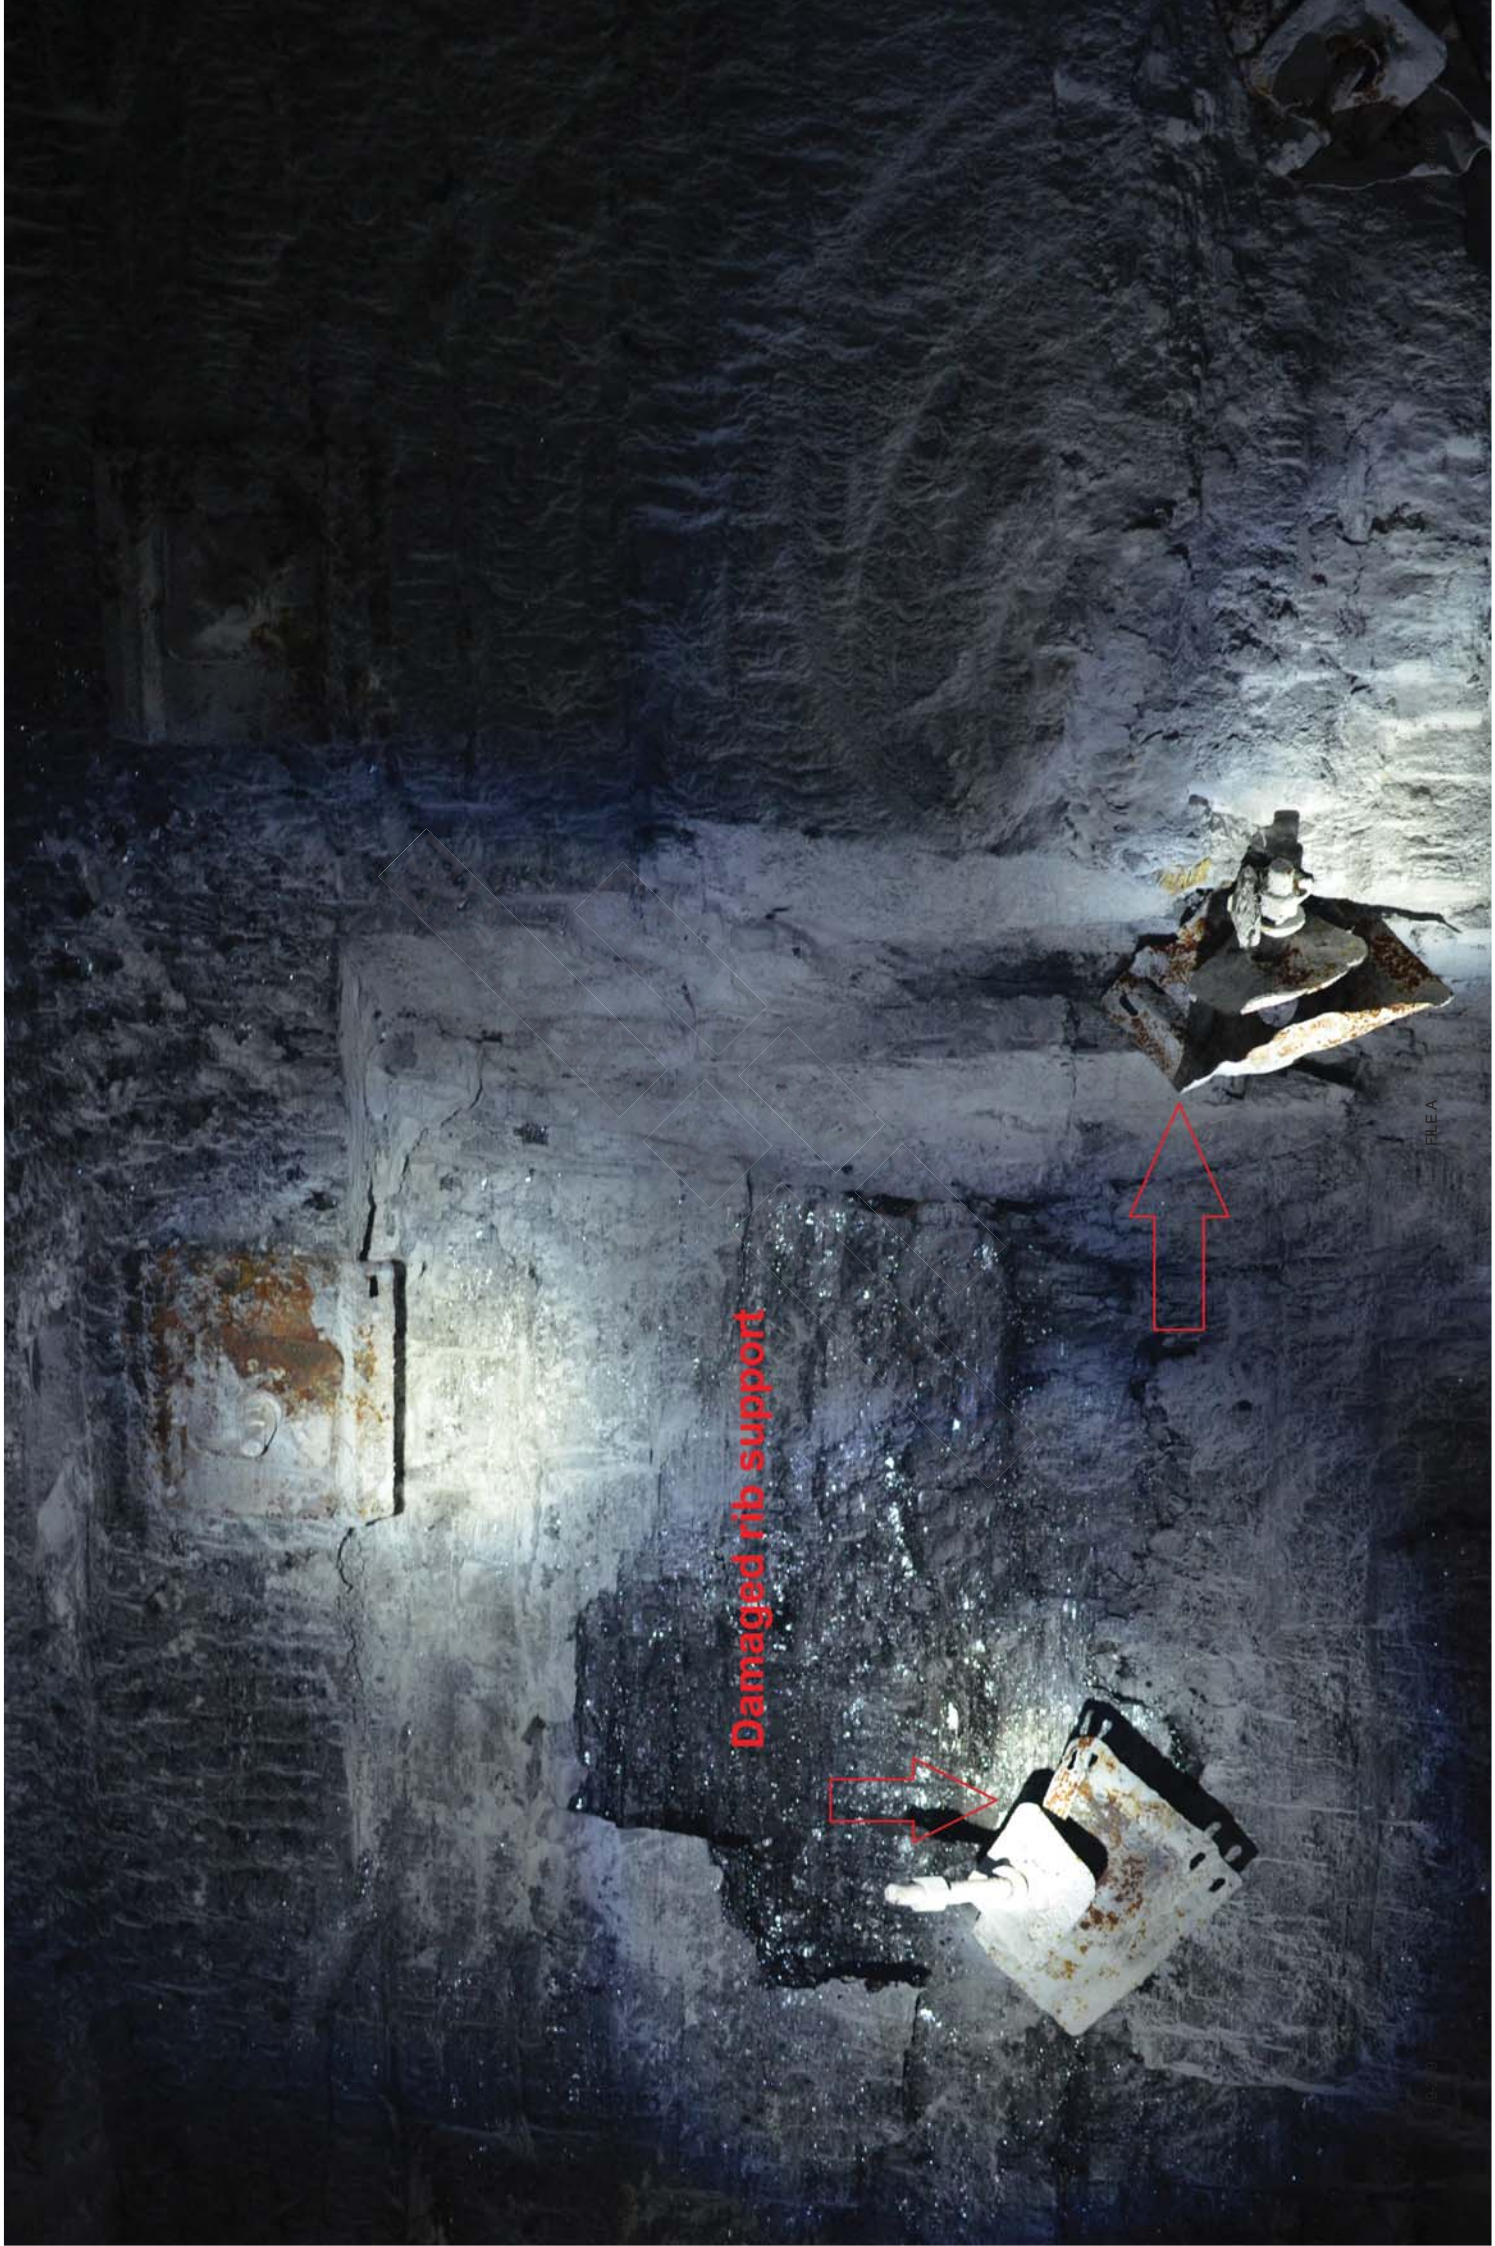
The roadway where the incident occurred was driven in August/September 2011. The area of the rib failure was not supported in accordance with the Manager's Support Rules, despite operations being under the supervision of an ERZ Controller. At least two rib bolts (1.2m long) were not installed in the area of the rib that failed.

Damaged rib support

Coal and Rock fell from this area
