Investigation report

Fatality at Baralaba Coal Mine on 7 July 2019

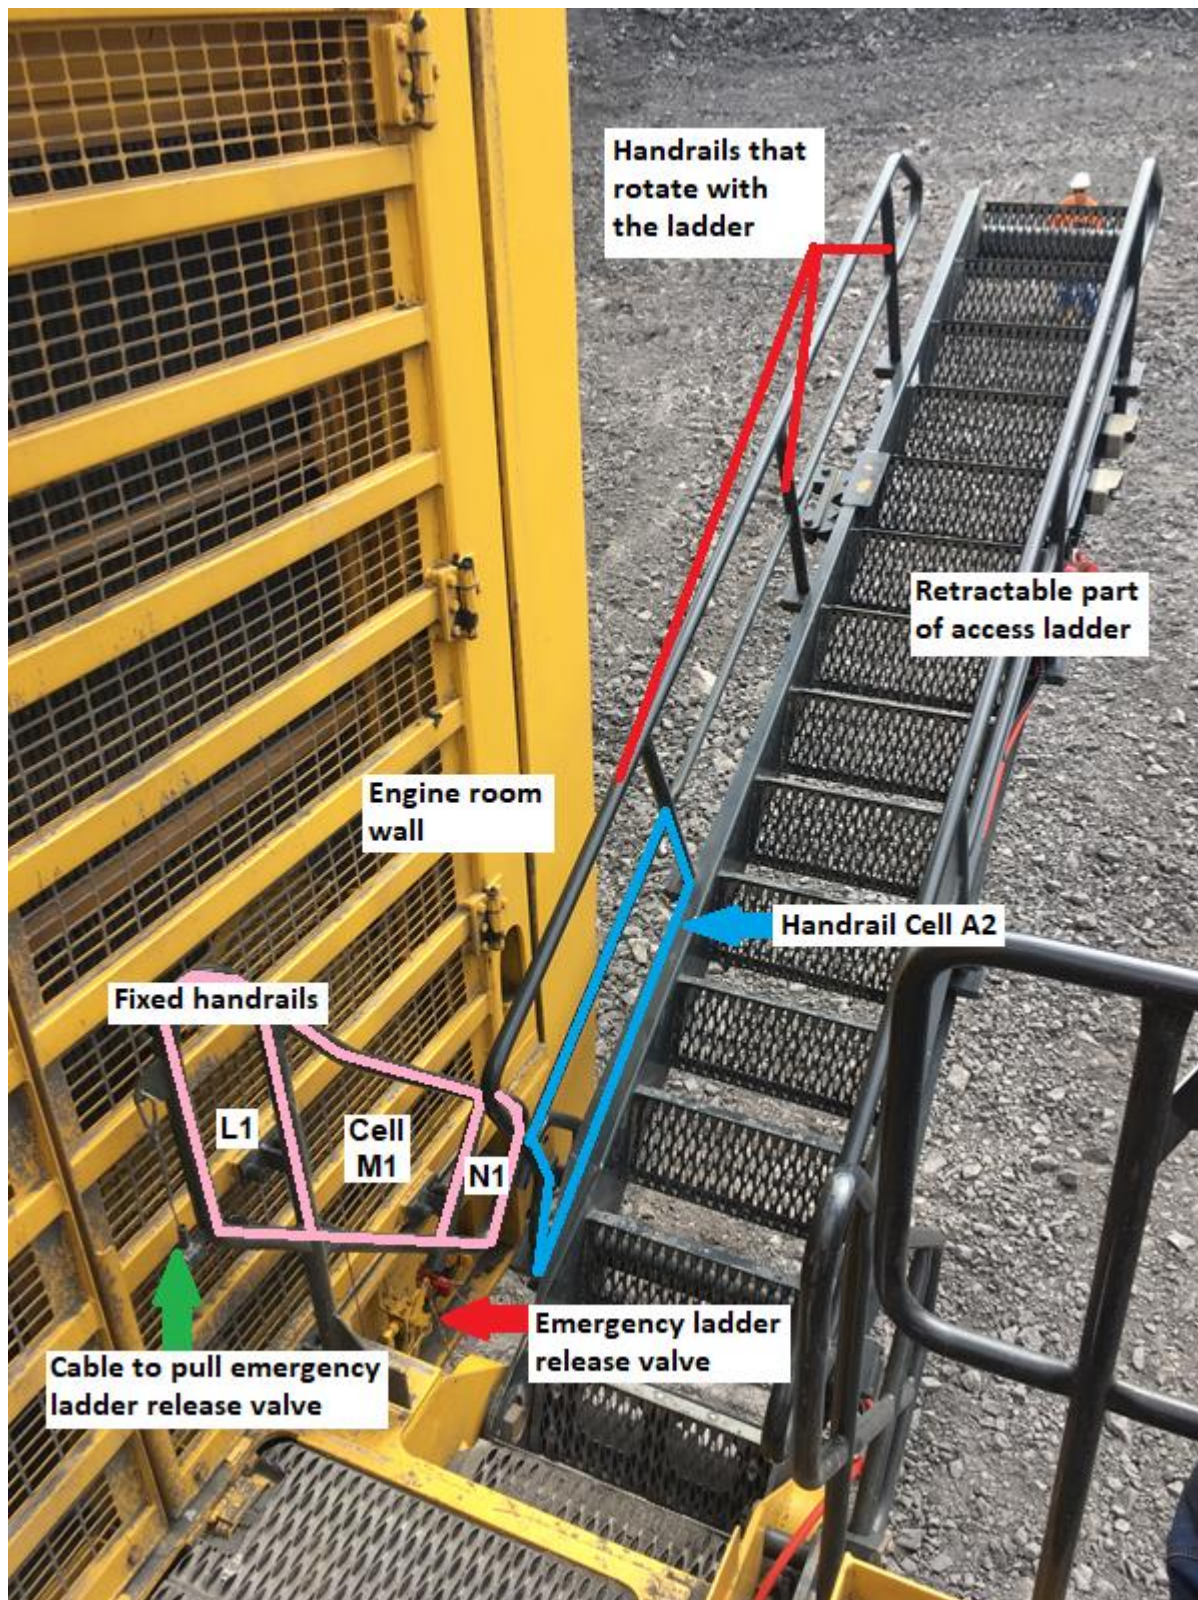
Image 7 Retractable ladder parts defined for this report

Shortly afterwards, at around 1.55 am, Mr Gerdes was found entangled between the movable part of the excavator's access ladder and the wall of the engine room. He suffered serious injuries as a result of the entanglement.

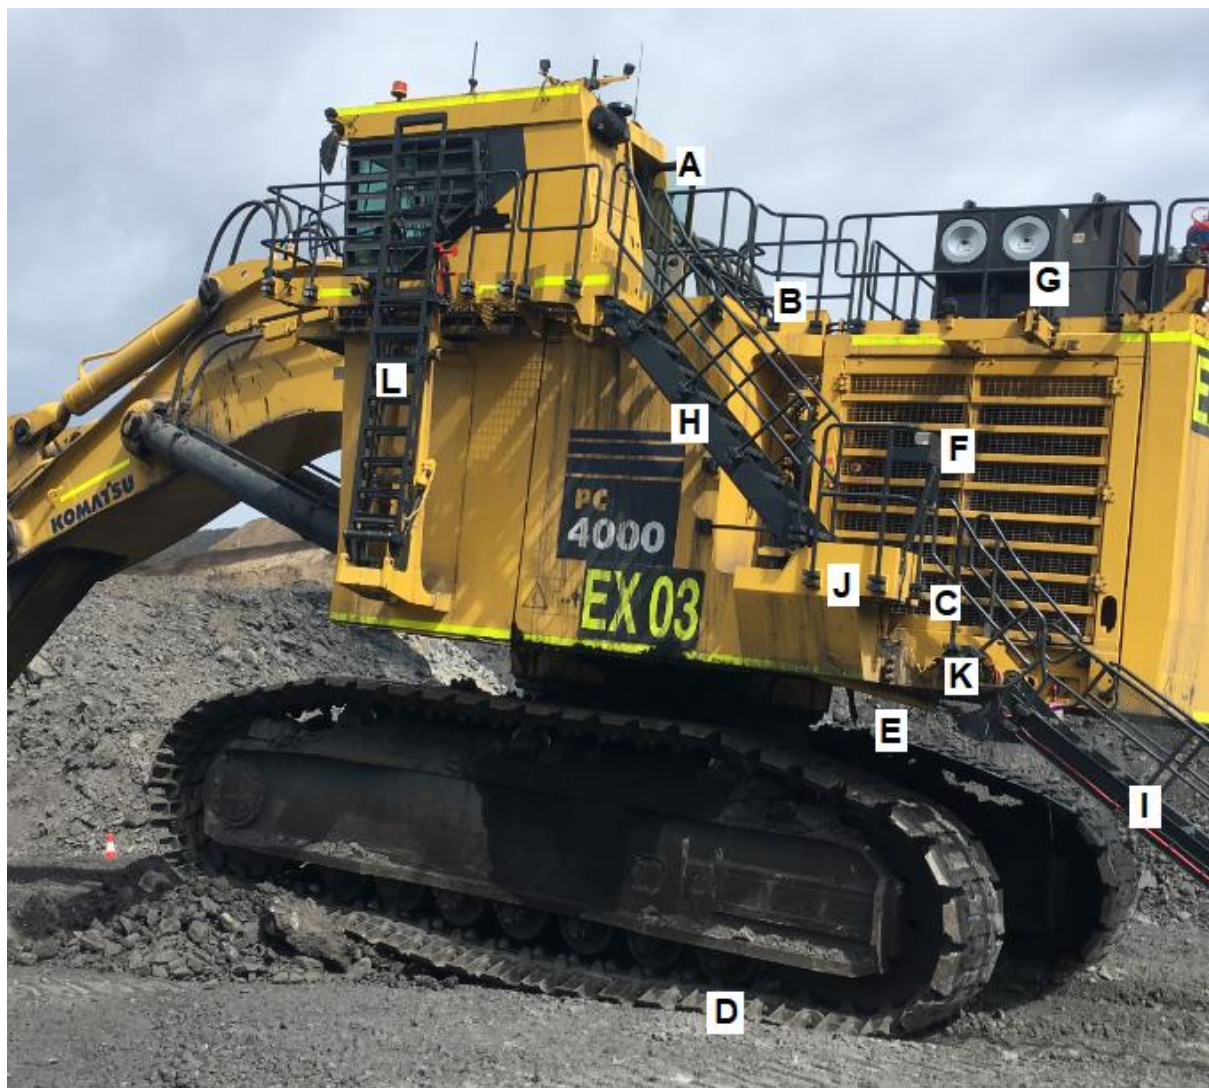
The excavator features two main personnel floors—level 1 (3020 mm from ground level) and level 2 (6105 mm from ground level). A fixed upper stairway (or ladder) provides access between level 1 and level 2 (see Image 8 Komatsu PC4000 access stairway—side view and Image 9).

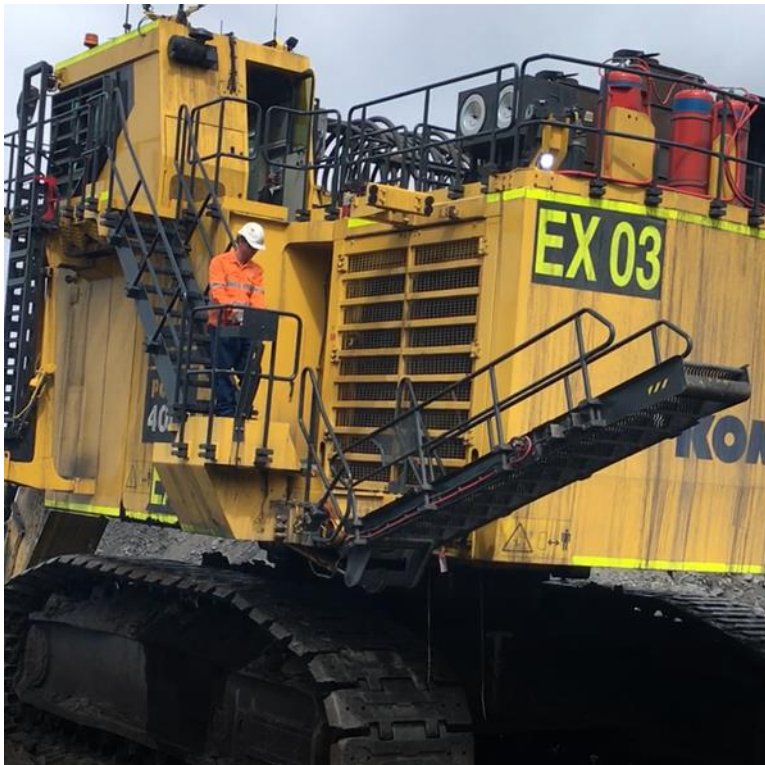
Image 11 Lowering retractable stairway with ladder control switch

When raising and lowering the access stairs with the ladder control switches a continual alarm is activated.
