BEACONSFIELD INVESTIGATION REPORT

PREPARED FOR THE CORONER

The Death of Larry Knight

Which occurred at the Beaconsfield Mine

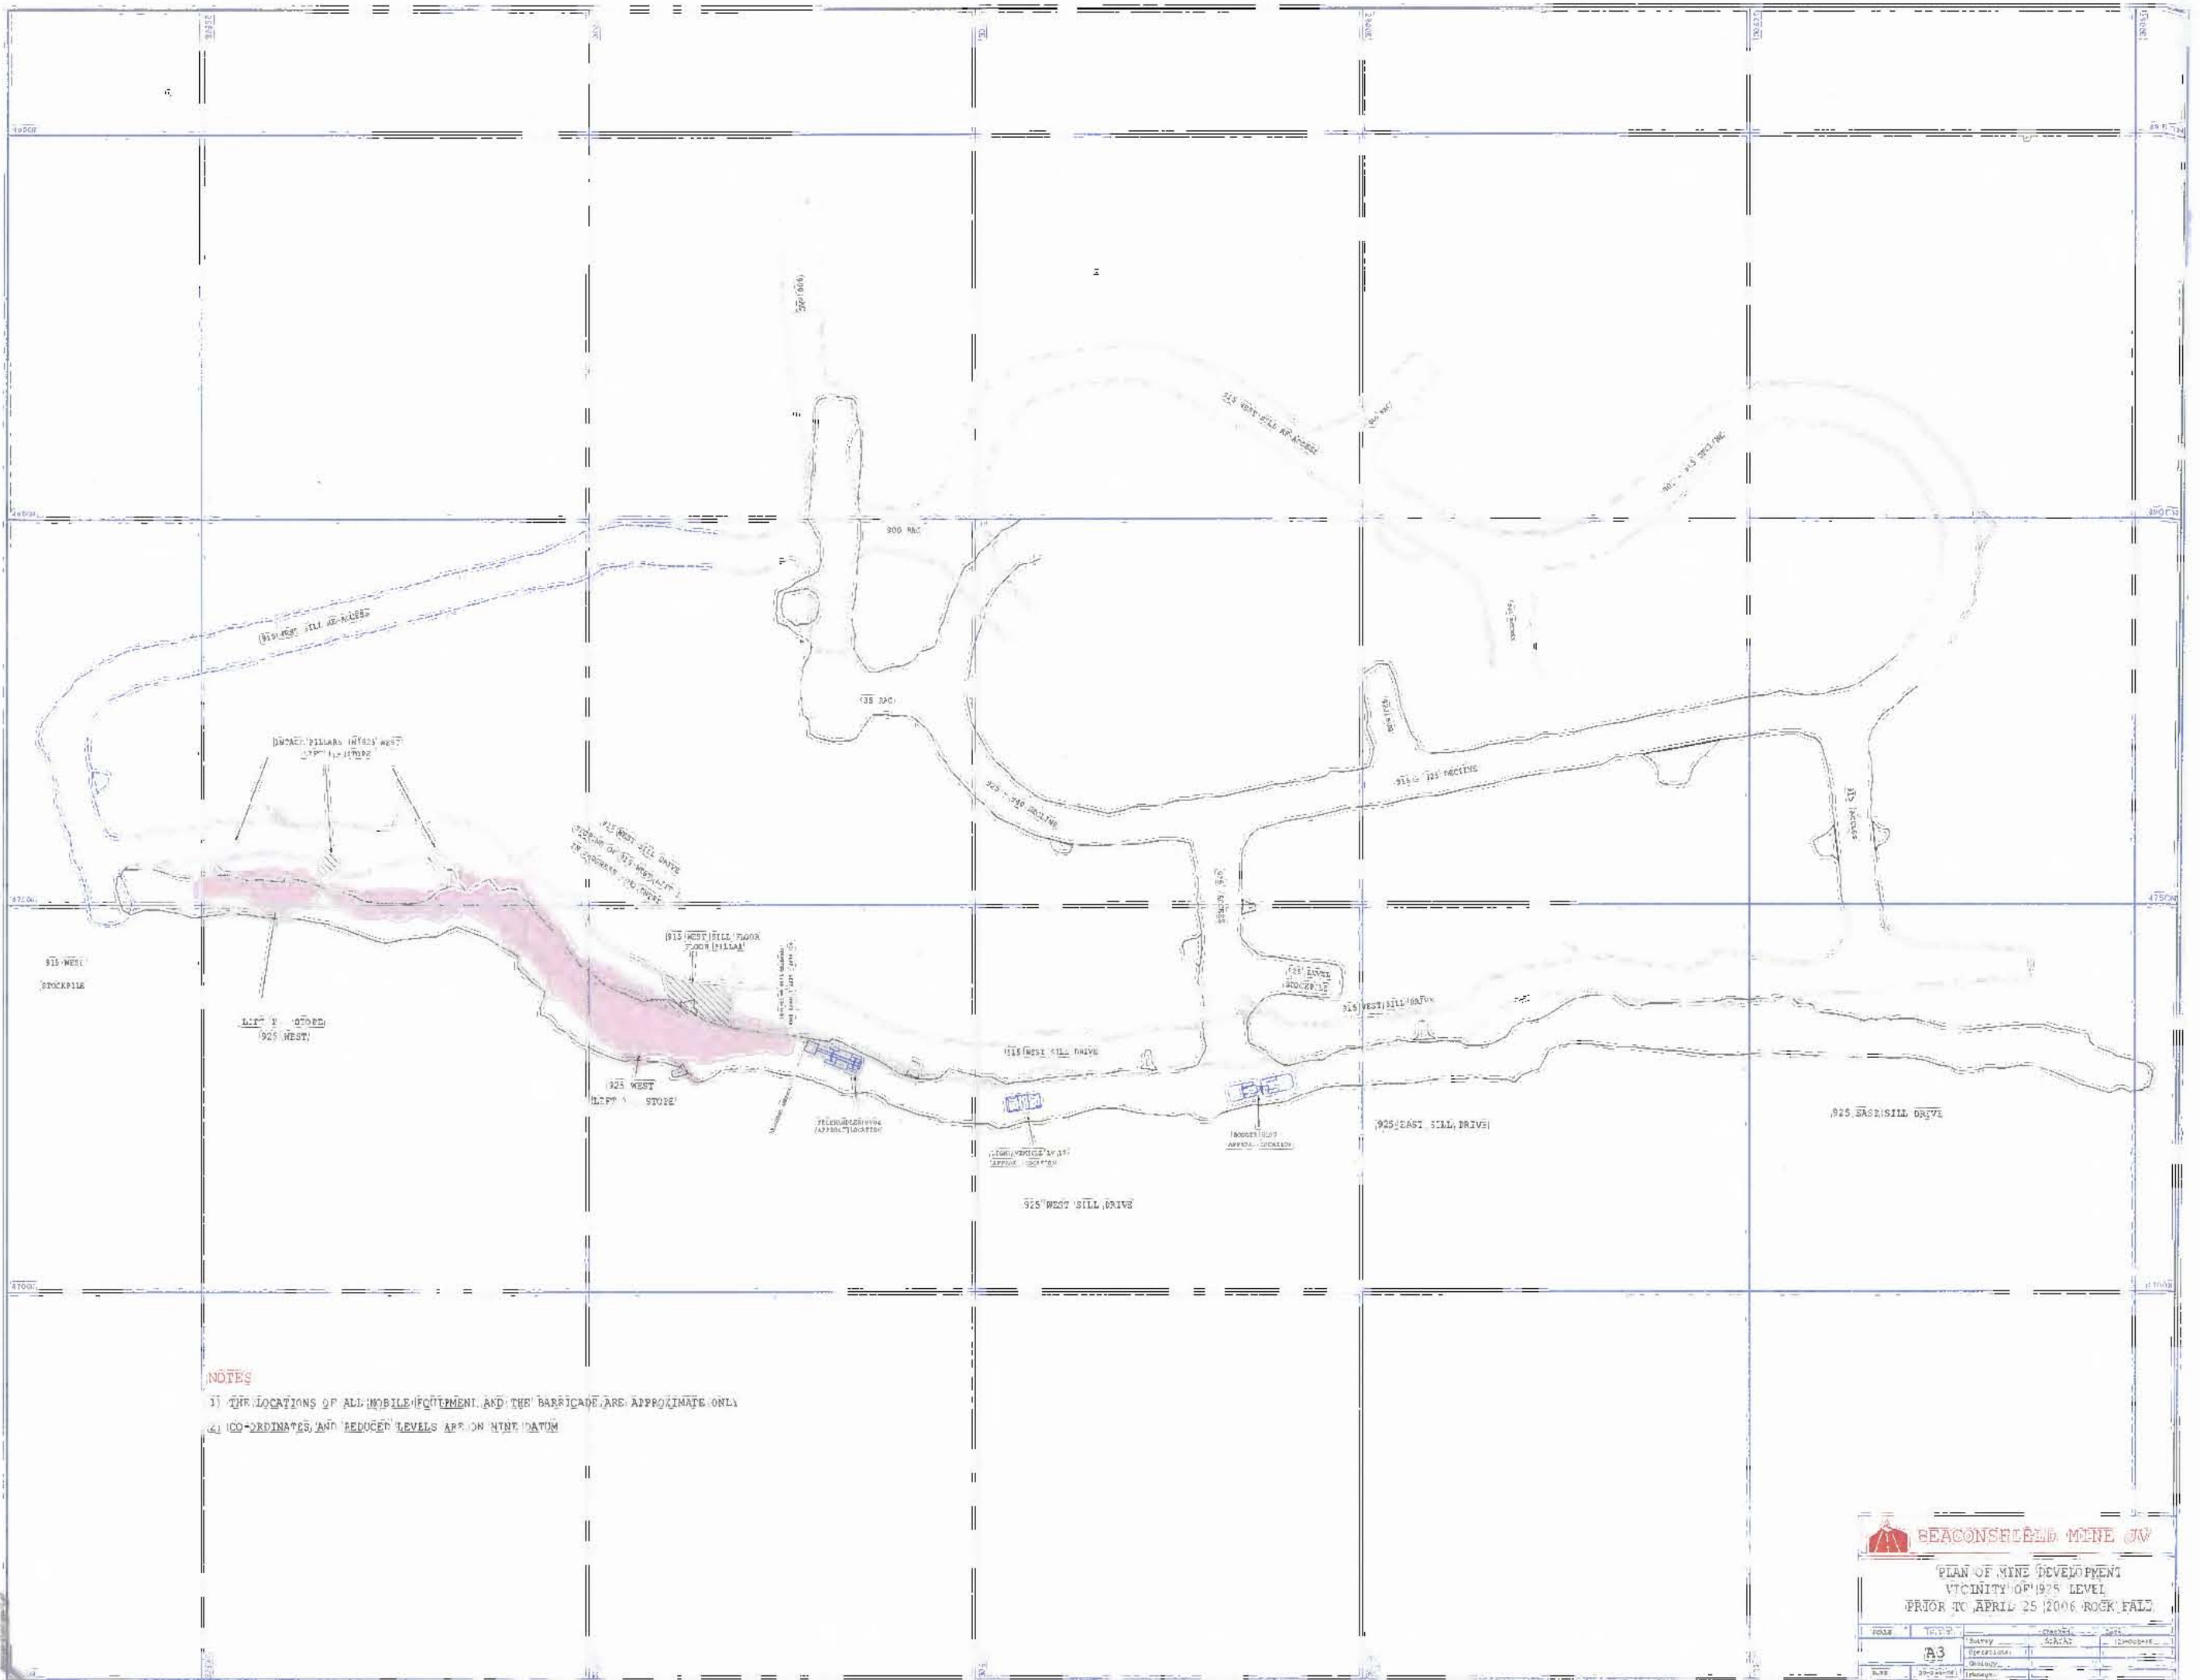
On 25th April 2006, Messrs Knight, Russell and Webb were allocated the task of placing netting at the brow of the remains of the eastern edge of panel 10 to allow the placing of rock fill from the 915 west sill on to the 925 west sill. Figure 13 shows a long section of the operation immediately prior to the rock fall. Messrs Russell and Webb were in a basket at the front of the telehandler which was being operated by Larry Knight. Immediately prior to the rock fall, Mr Knight had lowered the cage onto the rock bund and had left the telehandler to collect some mesh. An overhead plan of the same position is shown at Figure 14. At 9.23 pm there was a seismic event of approximately 2.3 magnitude level, which caused rock falls on both the 925 and 915 levels. Figure 15 is a long section of the mine showing the position of those rock falls and Figure 16 and Figure 17 show overhead plans of the position of the rock falls. Also shown on Figures 16 and 17 is the position of the raise bore tunnel which was drilled to allow the rescue of Messrs Russell and Webb.

PLAN OF MINE DEVELOPMENT
VICINITY OF 925 LEVEL
PRIOR TO APRIL 25, 2006 ROCK FALL
